RE: Project # PSC-1816 B: Sampling of Import Soil for Backfilling the Excavation located at the PG&E Facility at 205 Brush Street, Oakland, California.

PG&E at 205 Brush Street, Oakland, California
- Backfill Material Sampling at Hanson Aggregate Clayton Quarry -

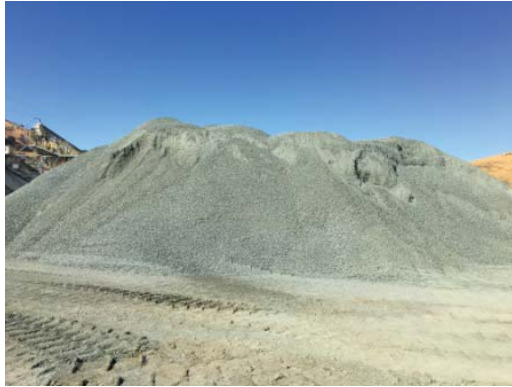
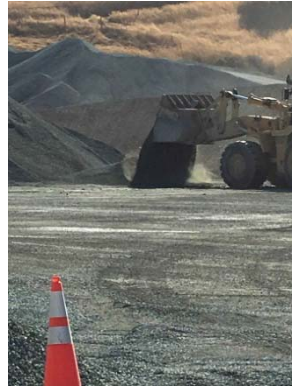
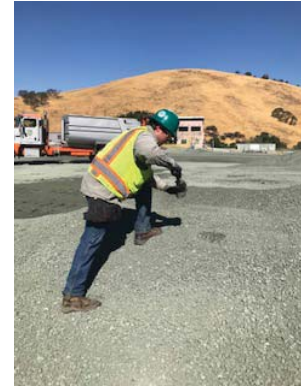
September 7, 2018, Environmental Technical Services (ETS) collected representative soil samples from two (2) separate stockpiles of proposed backfill material, located at the Hanson Aggregate Clayton Quarry in Concord, CA, which is intended for the PG&E 205 Brush Street project in Oakland, California. PSC proposes to use approximately 2,000 cubic yards of 3/4-inch Class 2 Base Rock, and 250-cubic yards of 3-inch Minus (1-1/2 inch) Base Rock. With the assistance of Hanson Quarry, ETS collected four (4) representative 4-point composite samples from the approximate 800-cubic yard stockpile of 3/4-inch Class 2 Base Rock (Pile "BR1" illustrated above), and one (2) representative 4-point composite sample from the approximate 700-cubic yard stockpile of 1-1/2 inch Base Rock (3-inch Minus) Stockpile (Pile "BR2"). A representative from ERM was on-site during the soil sampling to ensure the sampling was conducted in accordance with their Soil Import Management Plan for the project.

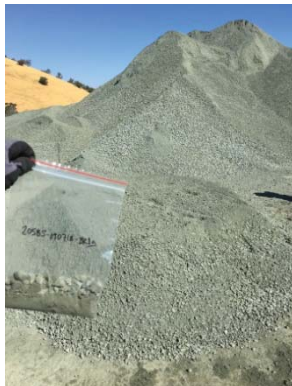
SAMPLE ID: 205BS-090718-BR1a

Two (2) representative 4-point composite soil samples (initial) collected from the Representative Sample Stockpile 1 taken from the 800-cubic yard stockpile of 3/4-inch Class 2 Base Rock located at Level 1 of the Hanson Clayton Quarry.

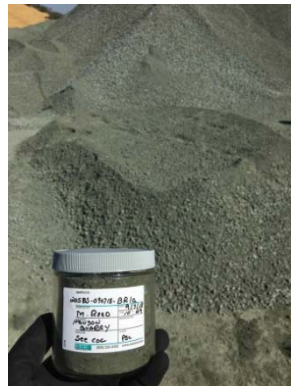
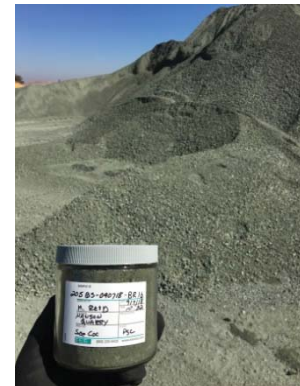
SAMPLE ID: 205BS-090718-BR1b

Representative 4-point composite soil sample collected from the Representative Sample Stockpile 2 taken from the 800-cubic yard stockpile of 3/4-inch Class 2 Base Rock located at Level 1 of the Hanson Clayton Quarry.

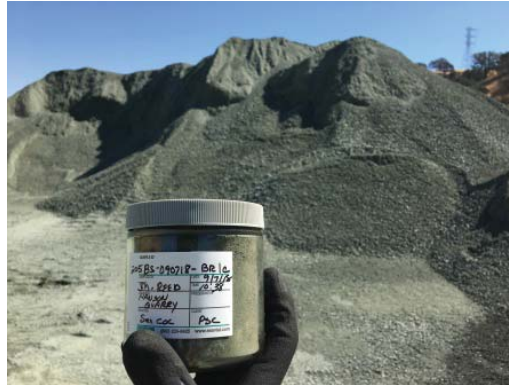
SAMPLE ID: 205BS-090718-BR1c

Representative 4-point composite soil sample collected from the 800-cubic yard stockpile of 3/4-inch Class 2 Base Rock located at Level 1 of the Hanson Clayton Quarry.

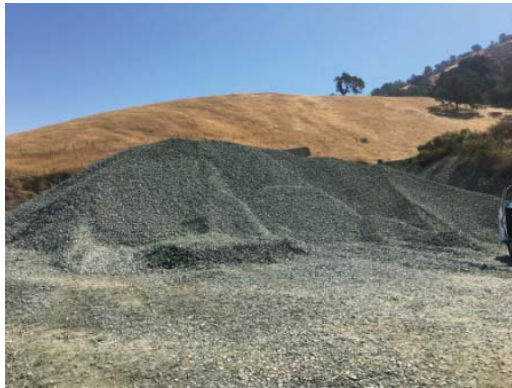
Approximately 700-cubic yard stockpile of 1-1/2 inch (3-inch Minus) Base Rock located at Level 3 of the Hanson Clayton Quarry.

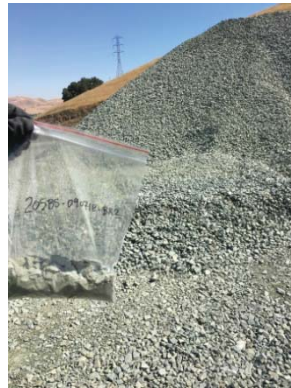
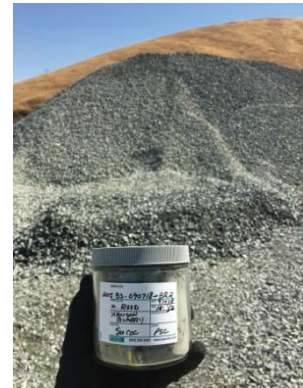
SAMPLE ID: 205BS-090718-BR2

Two (2) representative 4-point composite soil samples (initial) collected from the Representative Sample Stockpile 1 taken from the 700-cubic yard stockpile of 1-1/2 inch (3-inch Minus) Base Rock located at Level 3 of the Hanson Clayton Quarry.
