**PHASE I
ENVIRONMENTAL SITE ASSESSMENT
UPDATE**

927 MAIN STREET
PLEASANTON, CALIFORNIA 94566

AEI PROJECT No. 289175

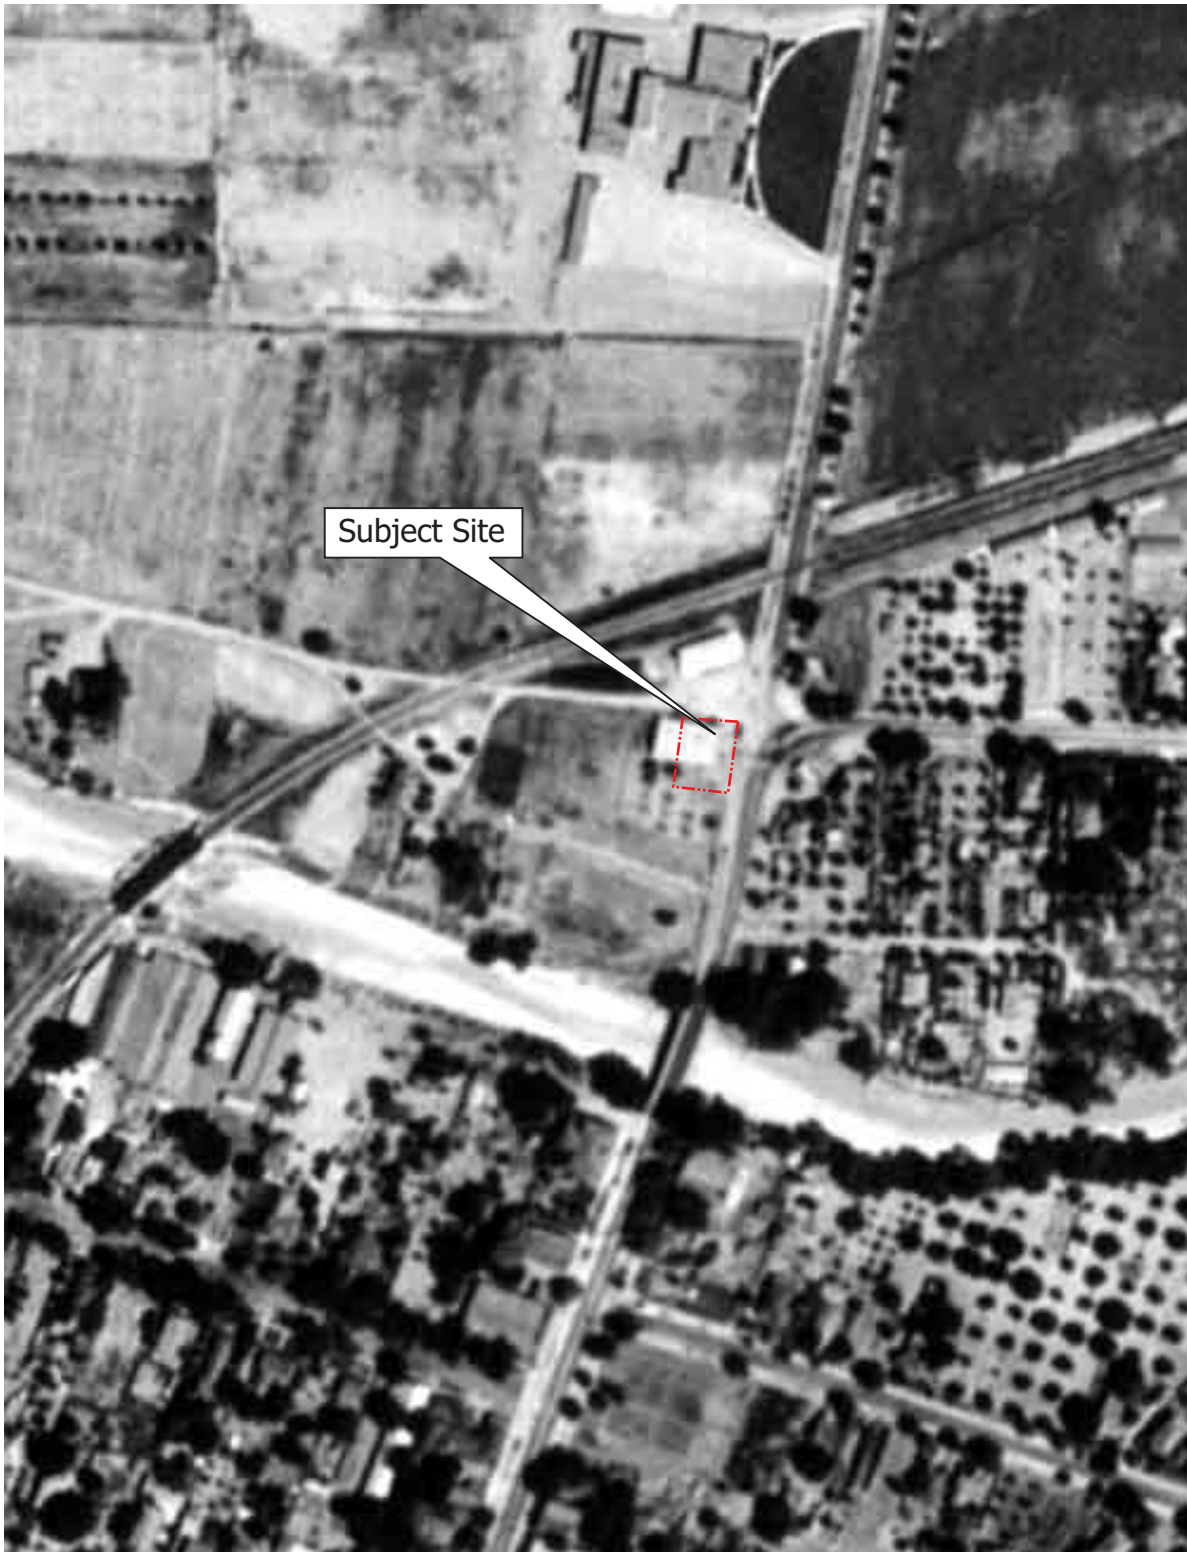
FIGURE 3
Job No: 289175

Source: Fairchild
Year: 1939

AERIAL PHOTOGRAPH

- The earliest historical resource obtained during this investigation was an aerial photograph from 1939 which indicated development of the subject property as a portion of an adjacent warehouse to the west. The lack of historical sources for the subject property dating back to first developed use represents historical data source failure. However, in the 1939 aerial photograph, the subject property appears developed with a portion of an adjacent warehouse. However, it is assumed that prior to 1939 the subject property would have been used for similar purposes, if not undeveloped. Therefore, this data gap is not expected to significantly alter the findings of this investigation.

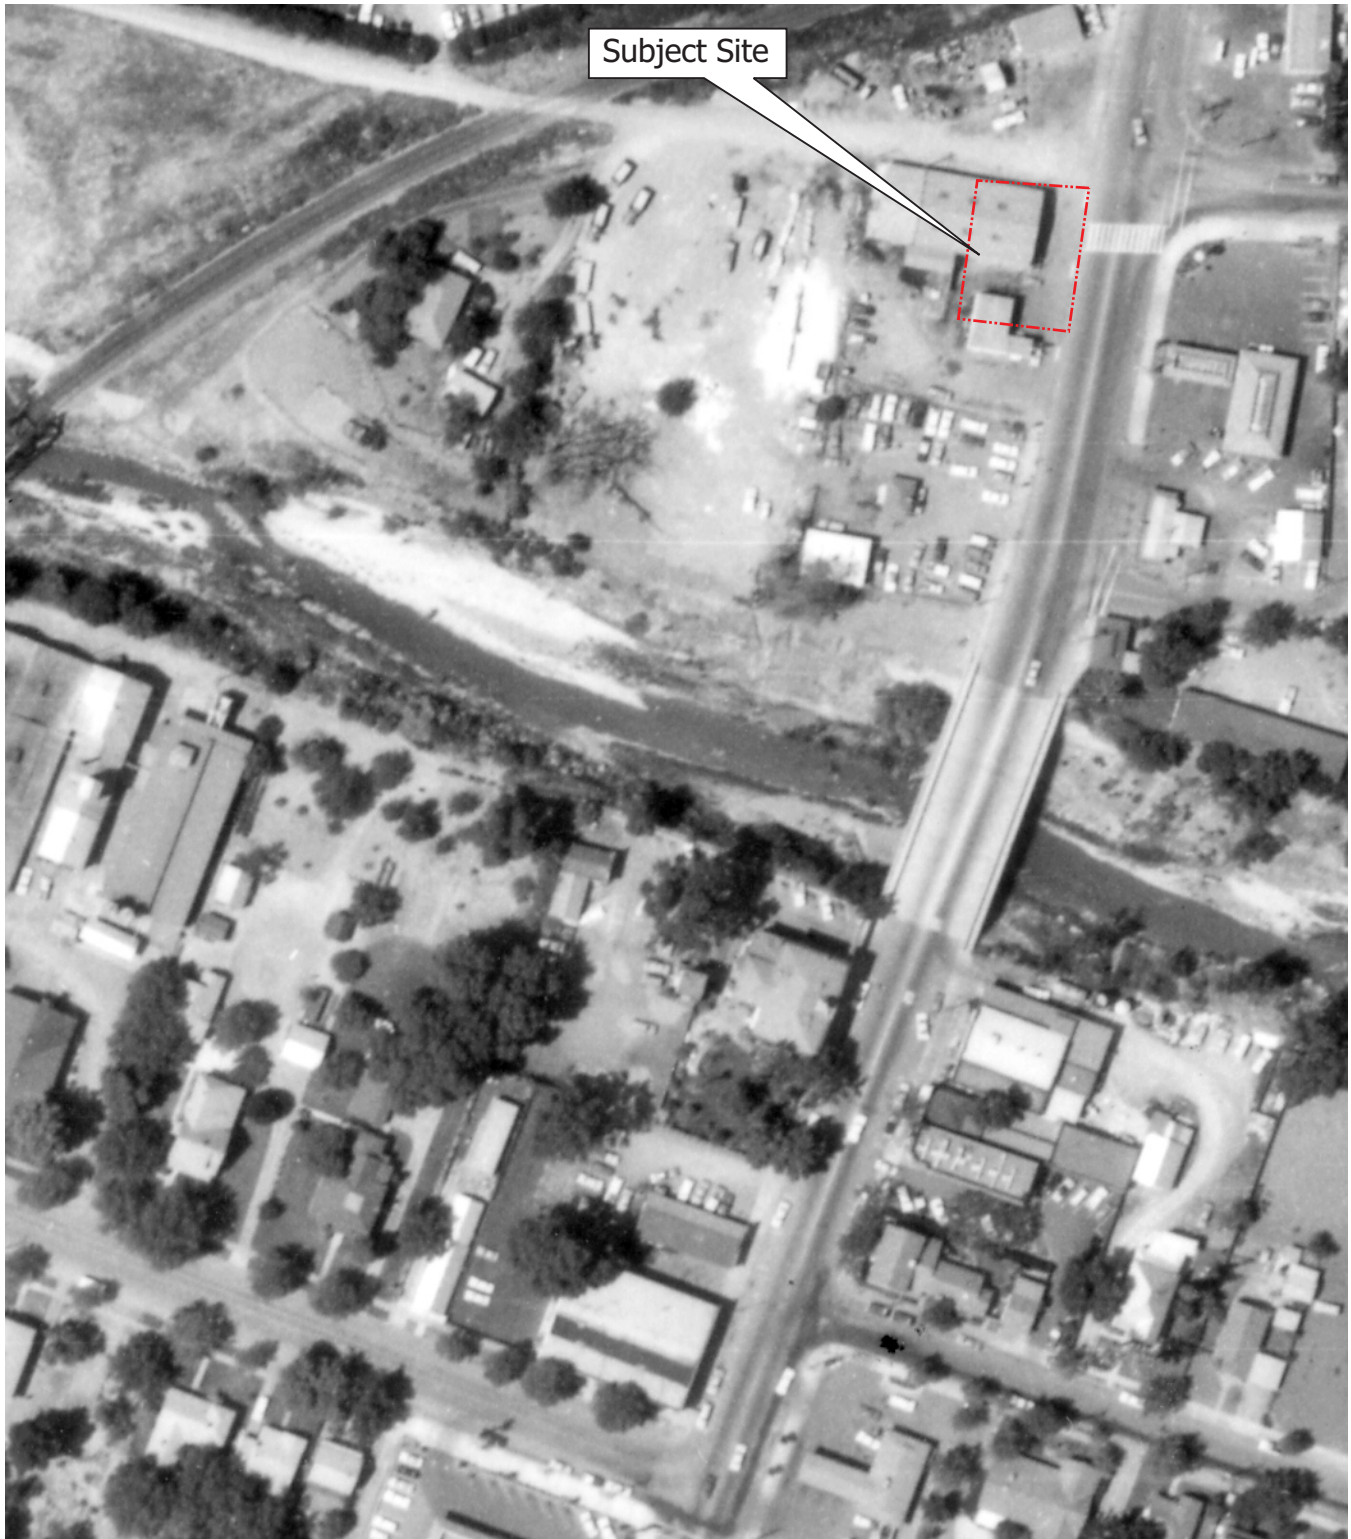
FIGURE 3
Job No: 289175

Source: Pacific Aerial Surveys
Year: 1969

AERIAL PHOTOGRAPH

No significant changes were noted in the 1969 aerial photograph. The adjacent property to the north is developed with a small commercial building.

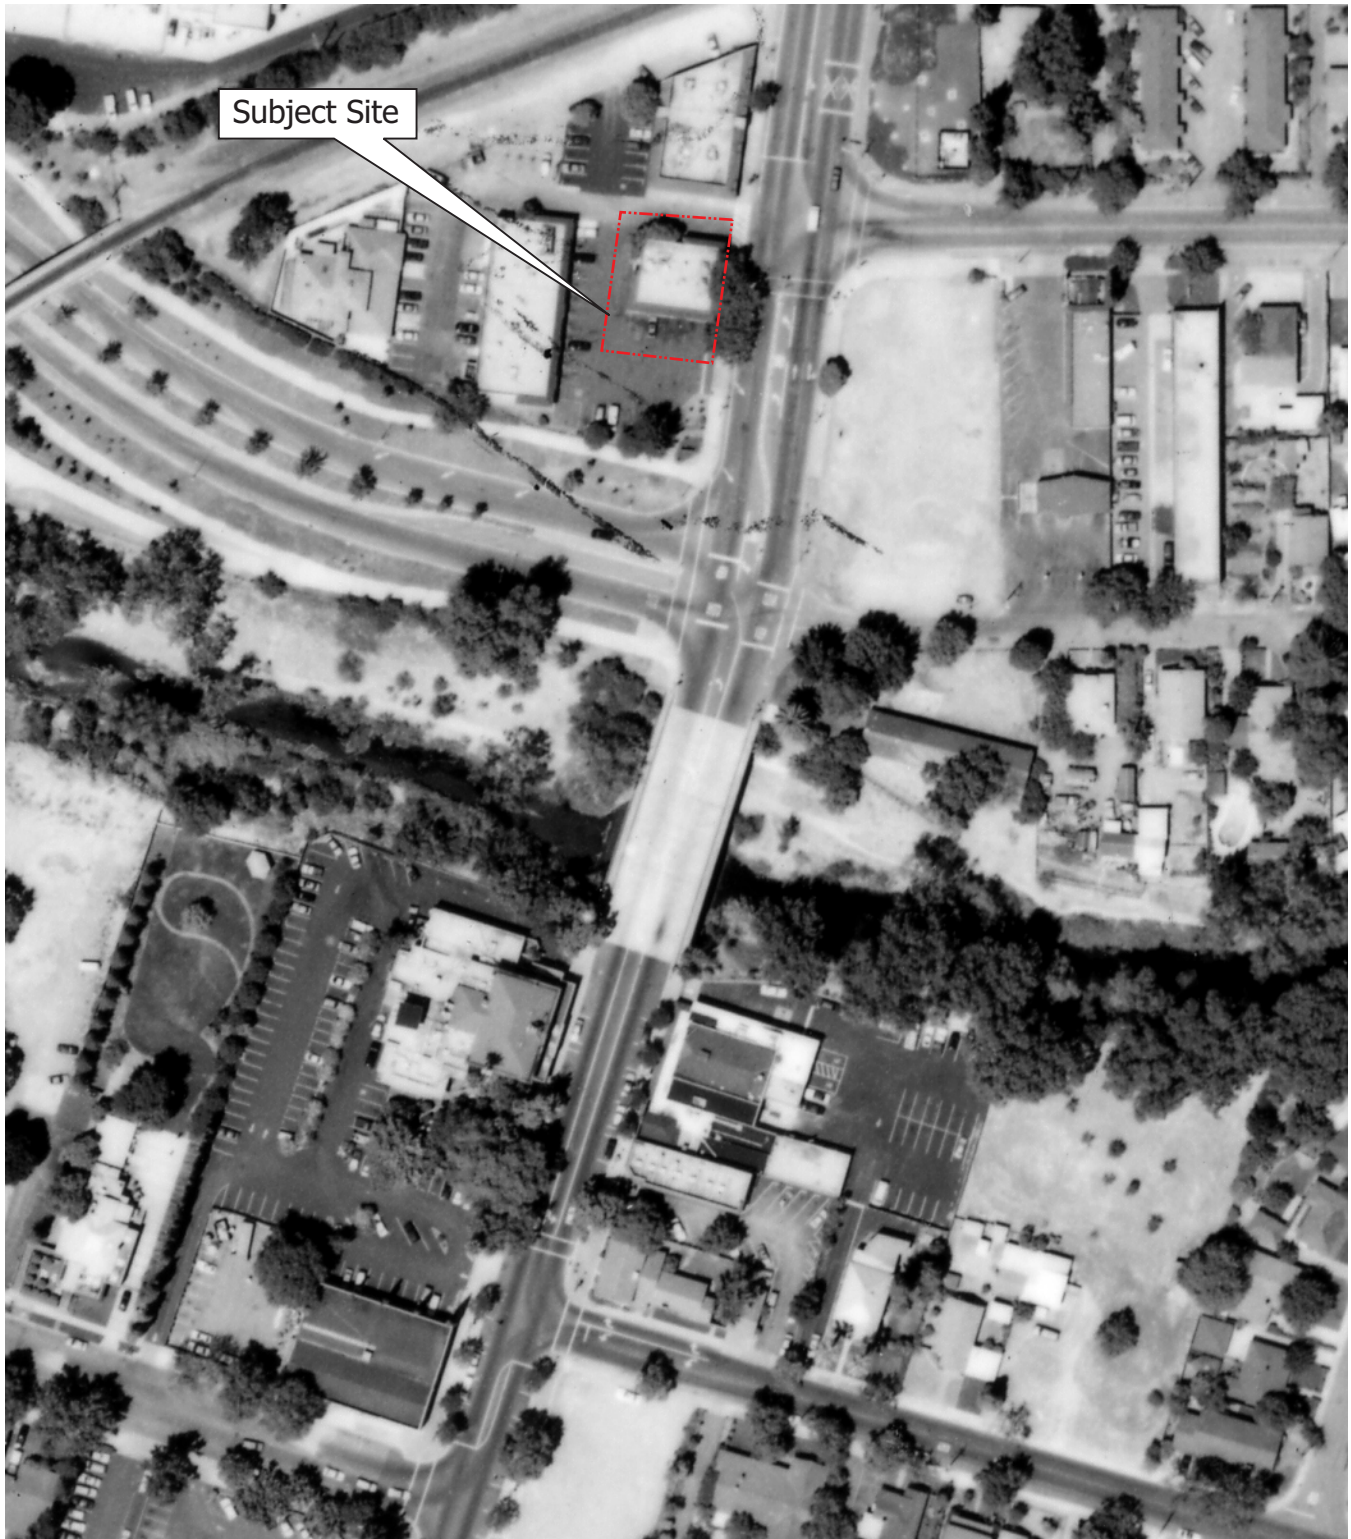
FIGURE 3
Job No: 289175

Source: Pacific Aerial Surveys
Year: 1996

AERIAL PHOTOGRAPH

In the 1996 aerial photograph, no significant changes were noted to the subject property and adjacent properties to the north, south and west. The adjacent property to the east is vacant.

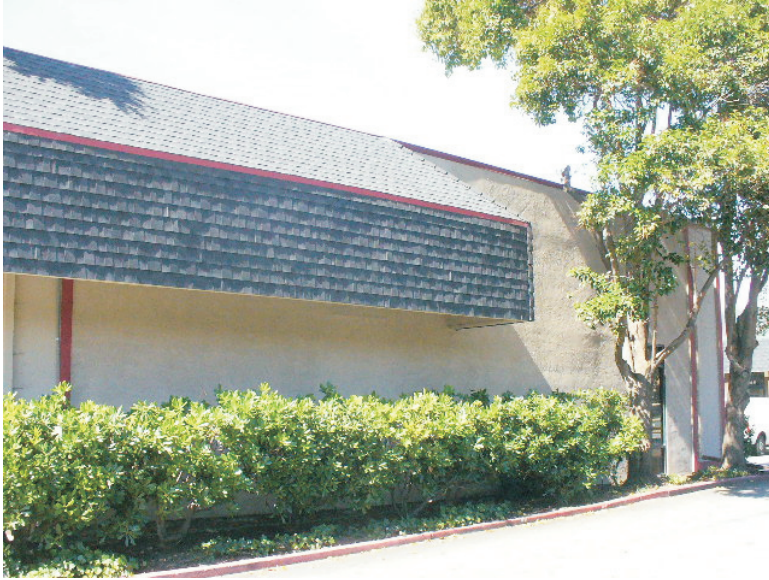
1. View of the north side of the subject property building.

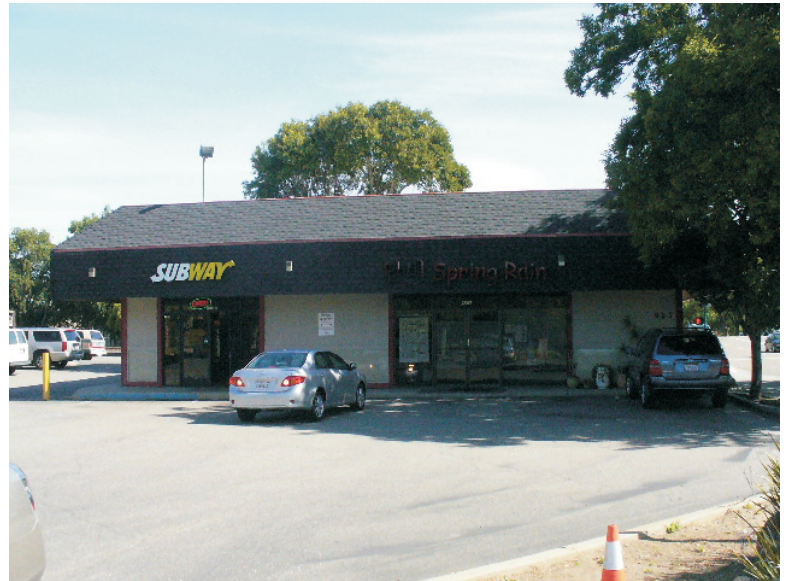
2. View of the south side of the subject property building.

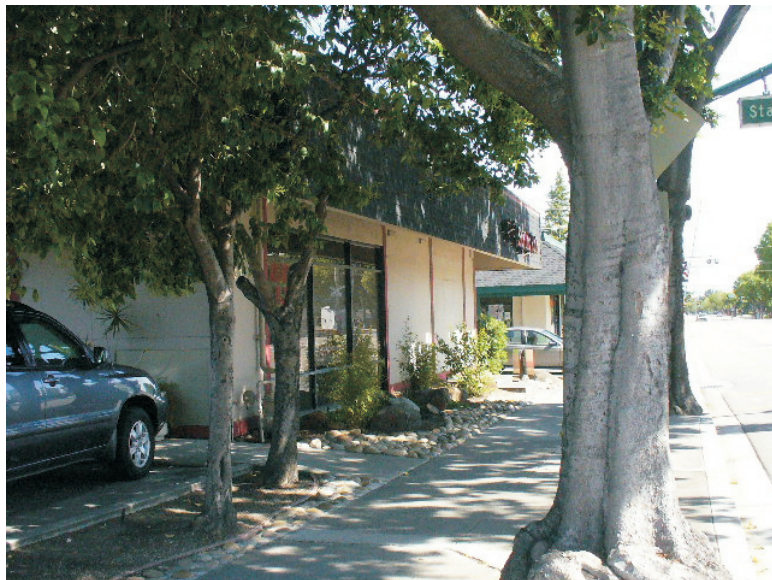
3. View of the east side of the subject property building.

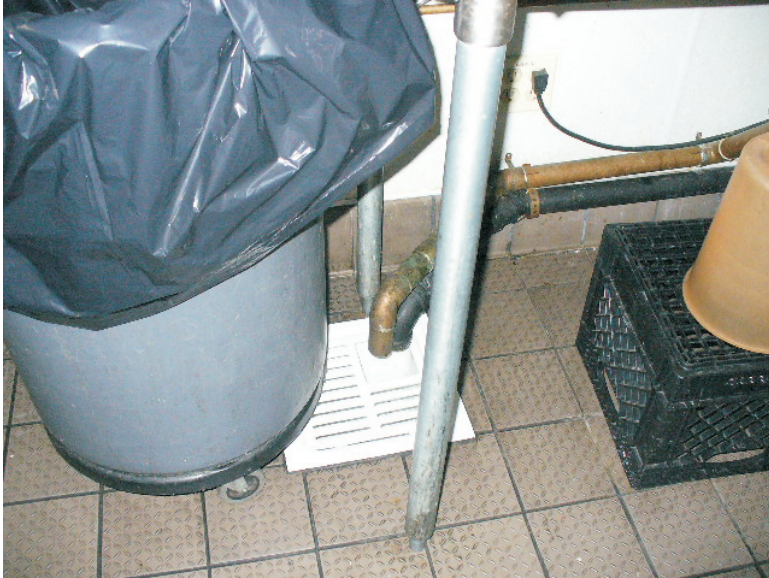
10. View of a floor drain in the Spring Rain tenant space.

Several floor drains were observed in the subject property. No hazardous substances or petroleum products were noted in the vicinity of the drains. Based on the use of the drains solely for housekeeping purposes, as well as the nature of use of the subject property, the presence of the drains is not expected to represent a significant environmental concern.

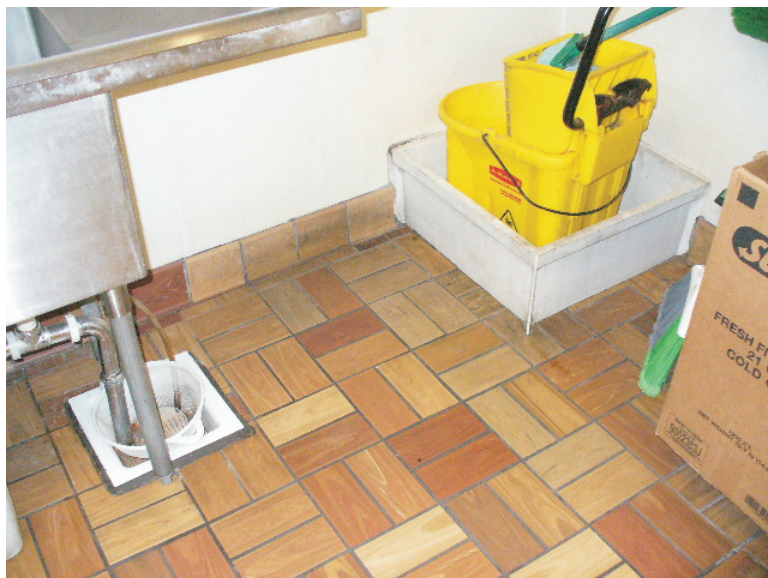
12. View of a floor drain in the Subway tenant space.
