**PHASE I ENVIRONMENTAL SITE ASSESSMENT**

**9400-9500 INTERNATIONAL BOULEVARD  
OAKLAND, CALIFORNIA**

**APNs 046-5423-1-1, 046-5423-2-2, 046-5423-22, 046-5423-21, 046-5423-007  
046-5423-20 046-5423-19, 046-5423-18-2**

June 25, 2015

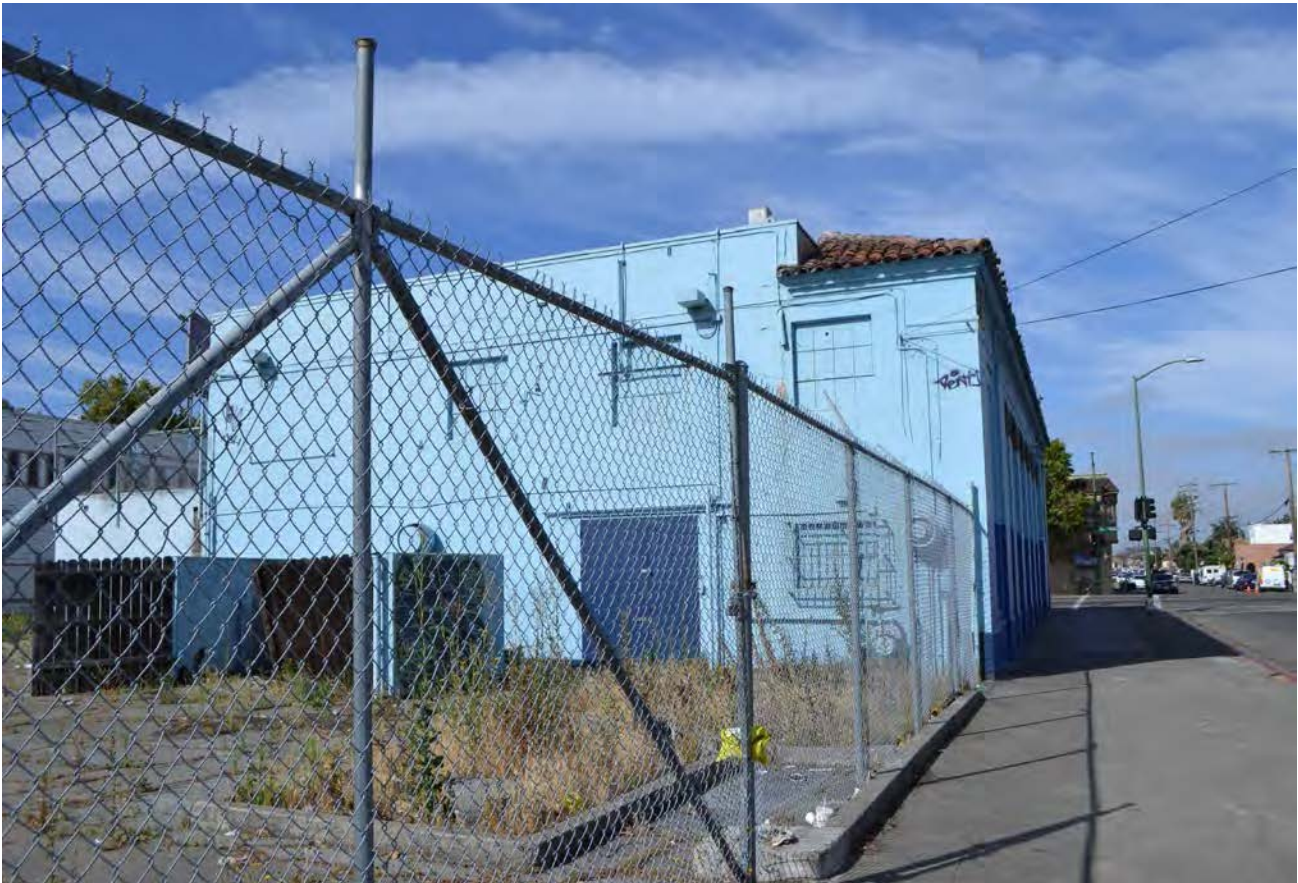
A small fenced area measuring 15 feet by 12 feet along the eastern side behind the Church in the parking lot shown on photo 2 contained evidence of petroleum, grease, stains and corrosion on the six feet concrete and concrete floor. There were marks on the floor for that resembled a 75-100 gallon rectangular steel structure like an aboveground tank that appeared to containerize oil and grease and there were signs of discharge on the concrete slab within this area of the parking lot. There was a rancid odor emanating from this area that reeked like a mixture of old decayed refuse and petroleum compounds.

Photo 2: Church looking from the east, note waste storage area to the left of photo.

Thus, we recommend conducting a Phase II ESA to include the drilling and sampling of several borings to assess soil quality on the Property.

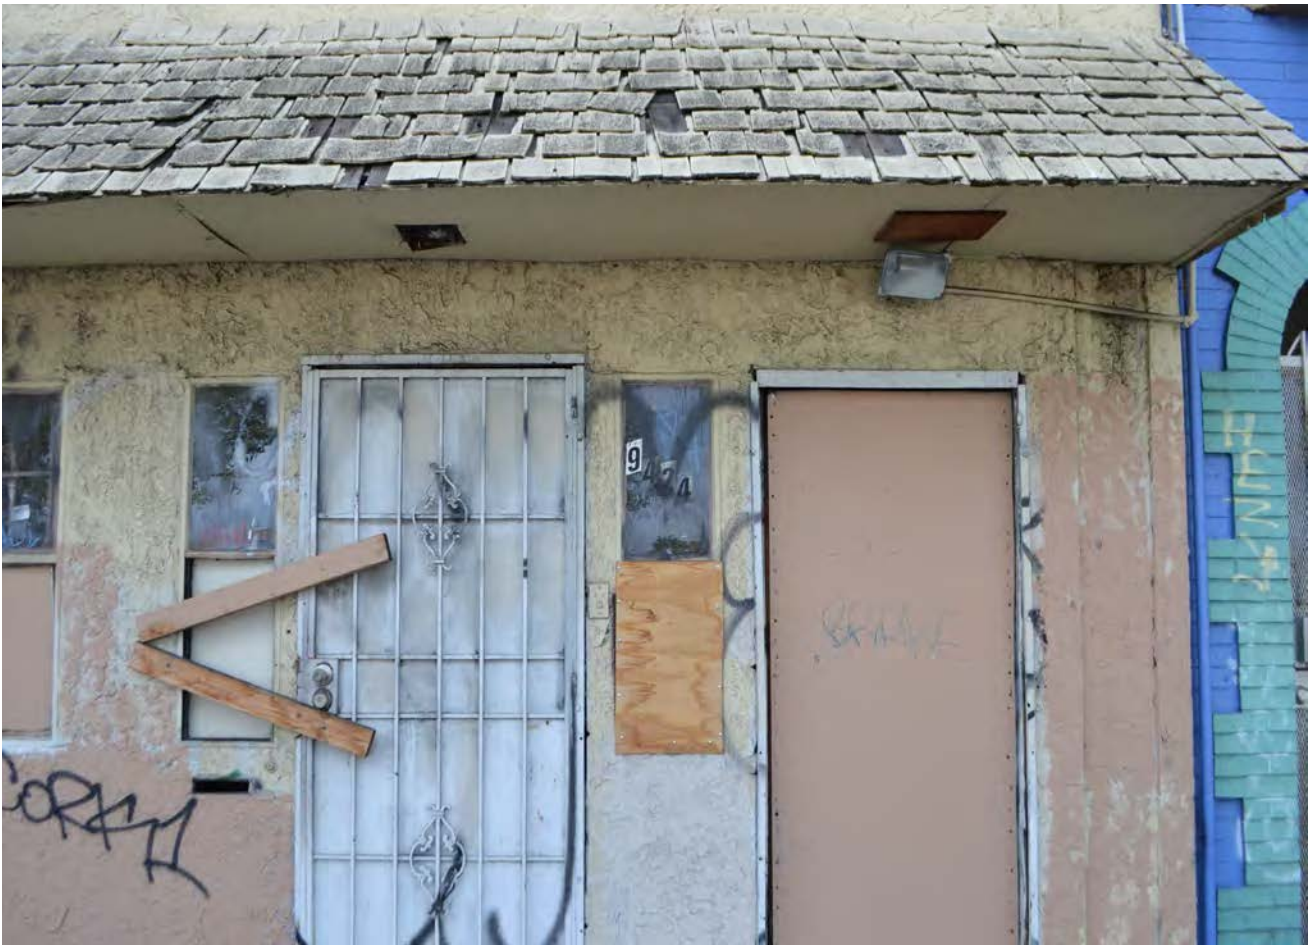
Photo 5: Dilapidated property at 9424 apartment units in very poor condition

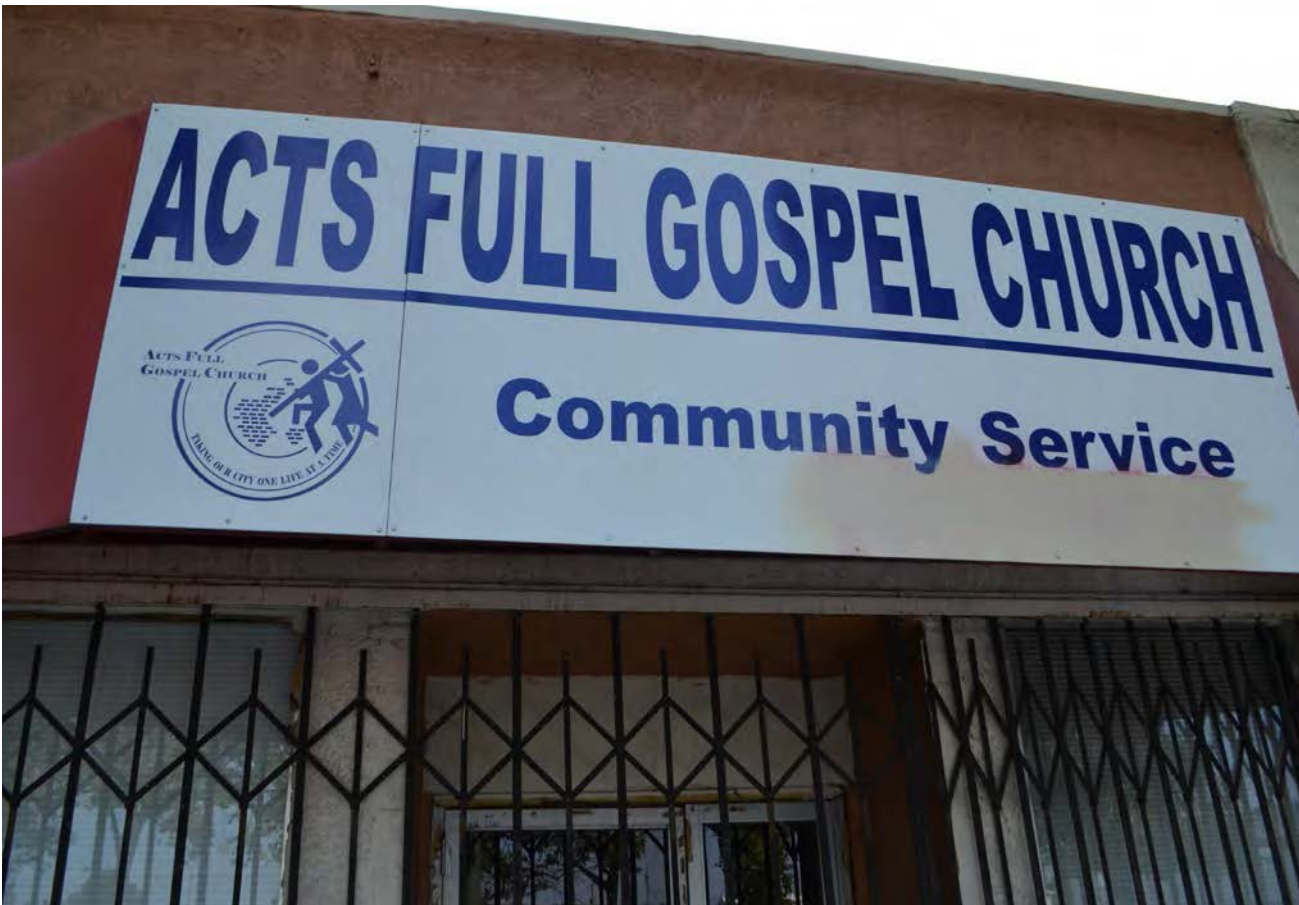
Results of the Phase I ESA identified one potential recognized environmental condition (RECs) relative to past activities on the Property. City directories review indicated the presence of Elmhurst Cleaners & Laundromat at 9434 East 14<sup>th</sup> Street (currently International Boulevard) from the late 1940s to at least 1970. Potential dry cleaning solvent (Stoddard solvent or Tetrachloroethene) releases from this cleaner could have impacted soil and/or groundwater beneath the Property. Results of the Phase I ESA indicate no other actual or potential RECs relative to historical activities on the Property.

Photo 8: Acts Full Gospel Church believed to be located at 9434 International Blvd. was the former location of a dry cleaner that operated at this Site for at least 30 years.
