IRIS ENVIRONMENTAL

November 4, 2015

**Re: Report of FOIA File Review Requests and Limited Phase II Subsurface Site Investigation
9400-9500 International Boulevard
Oakland, California**

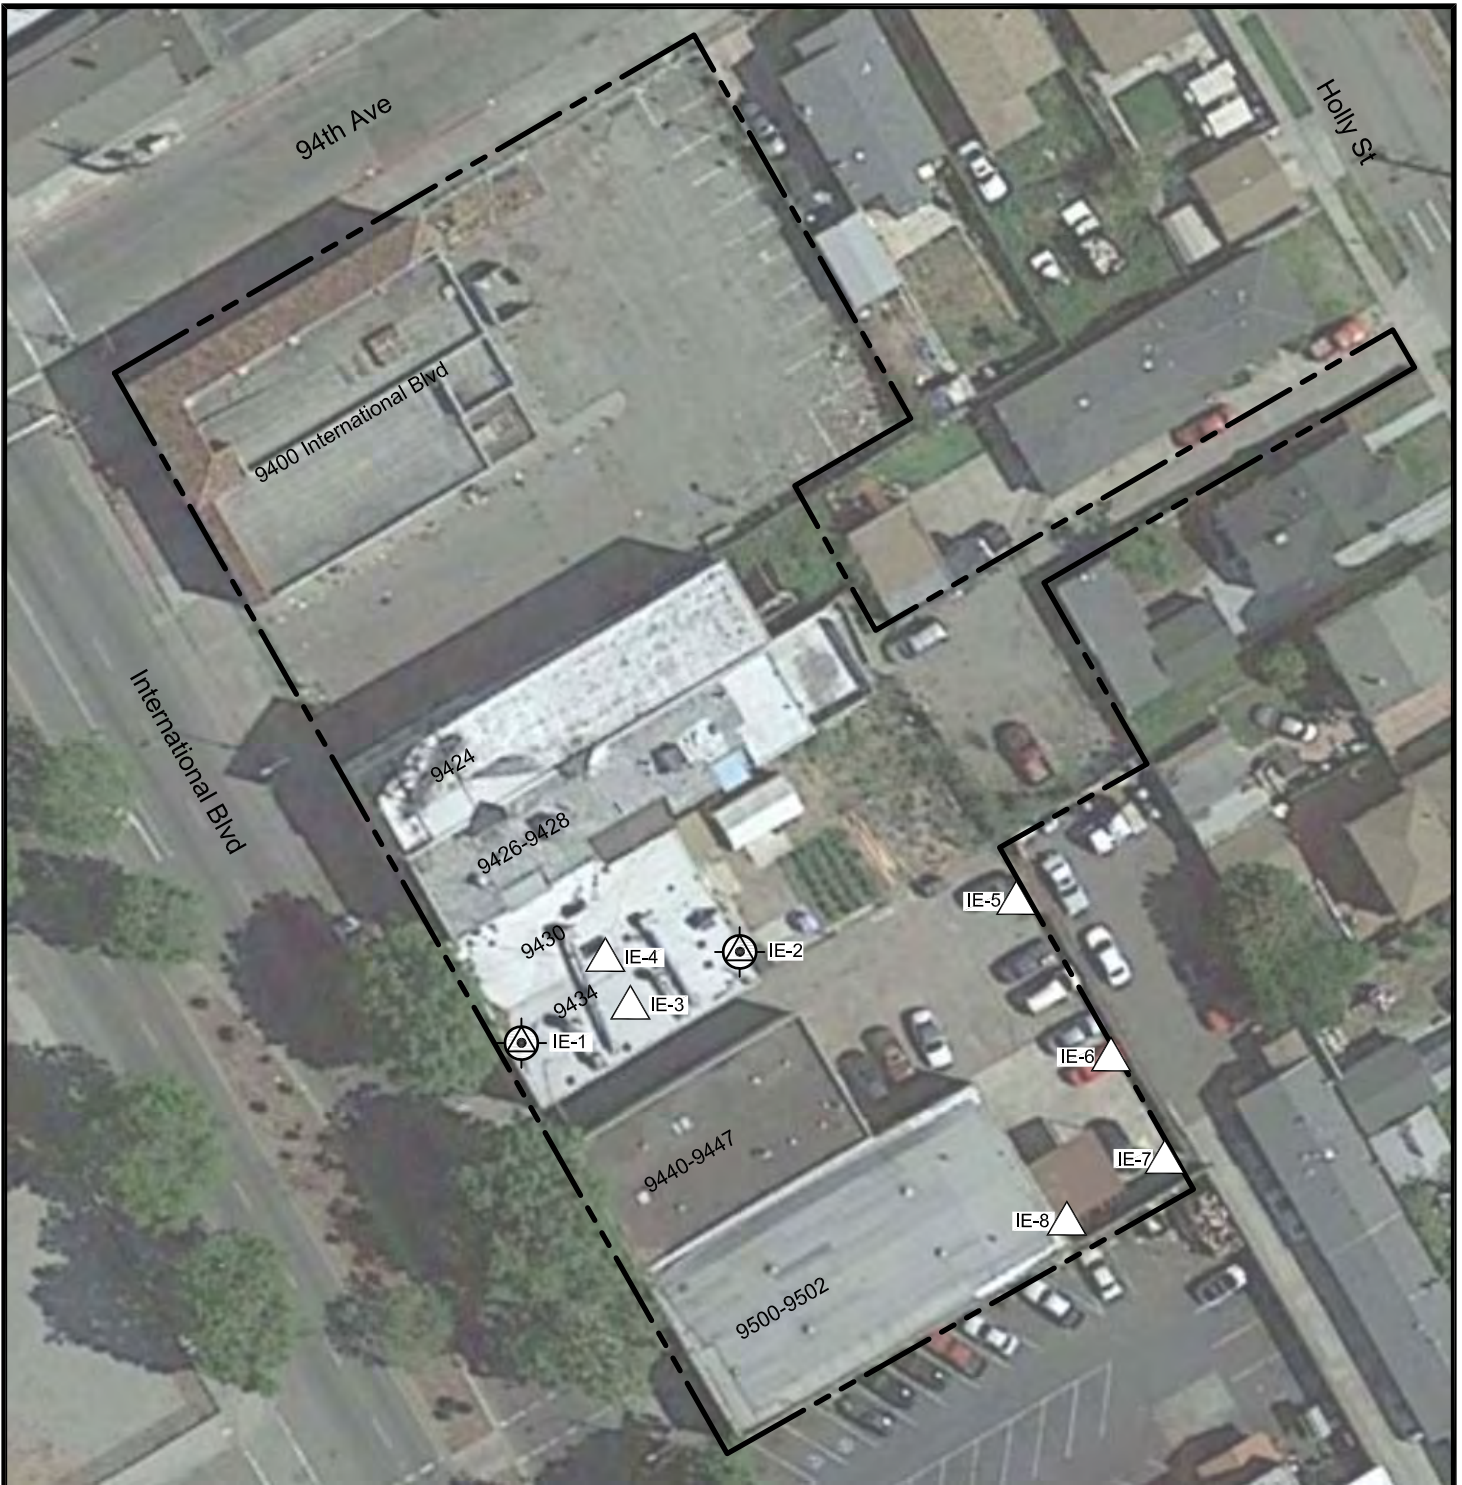
As requested by Union Bank in their October 2, 2015 memorandum, Iris Environmental collected two (2) soil samples for analysis for VOCs by USEPA Method 8260B. One soil sample was collected from an approximate depth of 5.0 feet from each of two borings (IE-1 and IE-2) located within the 9434 International Boulevard building. Iris Environmental collected samples for VOC analysis using USEPA Preparatory Method 5035 with a Terra Core® sampler. Samples were labeled and stored in iced coolers for transport under chain-of-custody protocol to Curtis and Tompkins Laboratories in Berkeley, California.

At the same two boring locations (IE-1 and IE-2), Iris Environmental collected grab groundwater samples at depths of approximately 10.5 and 11.5 feet below ground surface, respectively. A 1.0-inch diameter temporary PVC casing with a 5-foot interval of 0.010-inch slots was lowered into the borehole to collect a grab groundwater sample using a stainless steel bailer, which was decontaminated between sampling locations. The grab groundwater samples were submitted in iced coolers under chain-of-custody protocol for analysis for VOCs by USEPA Method 8260B.
