## Soil and Groundwater Investigation Work Plan

DW Nicholson Property  
24747 Clawiter Road  
Hayward, California 94545

ACDEH Fuel Leak Case No. RO0003213

ERA Project No. 01-2015-1200-001

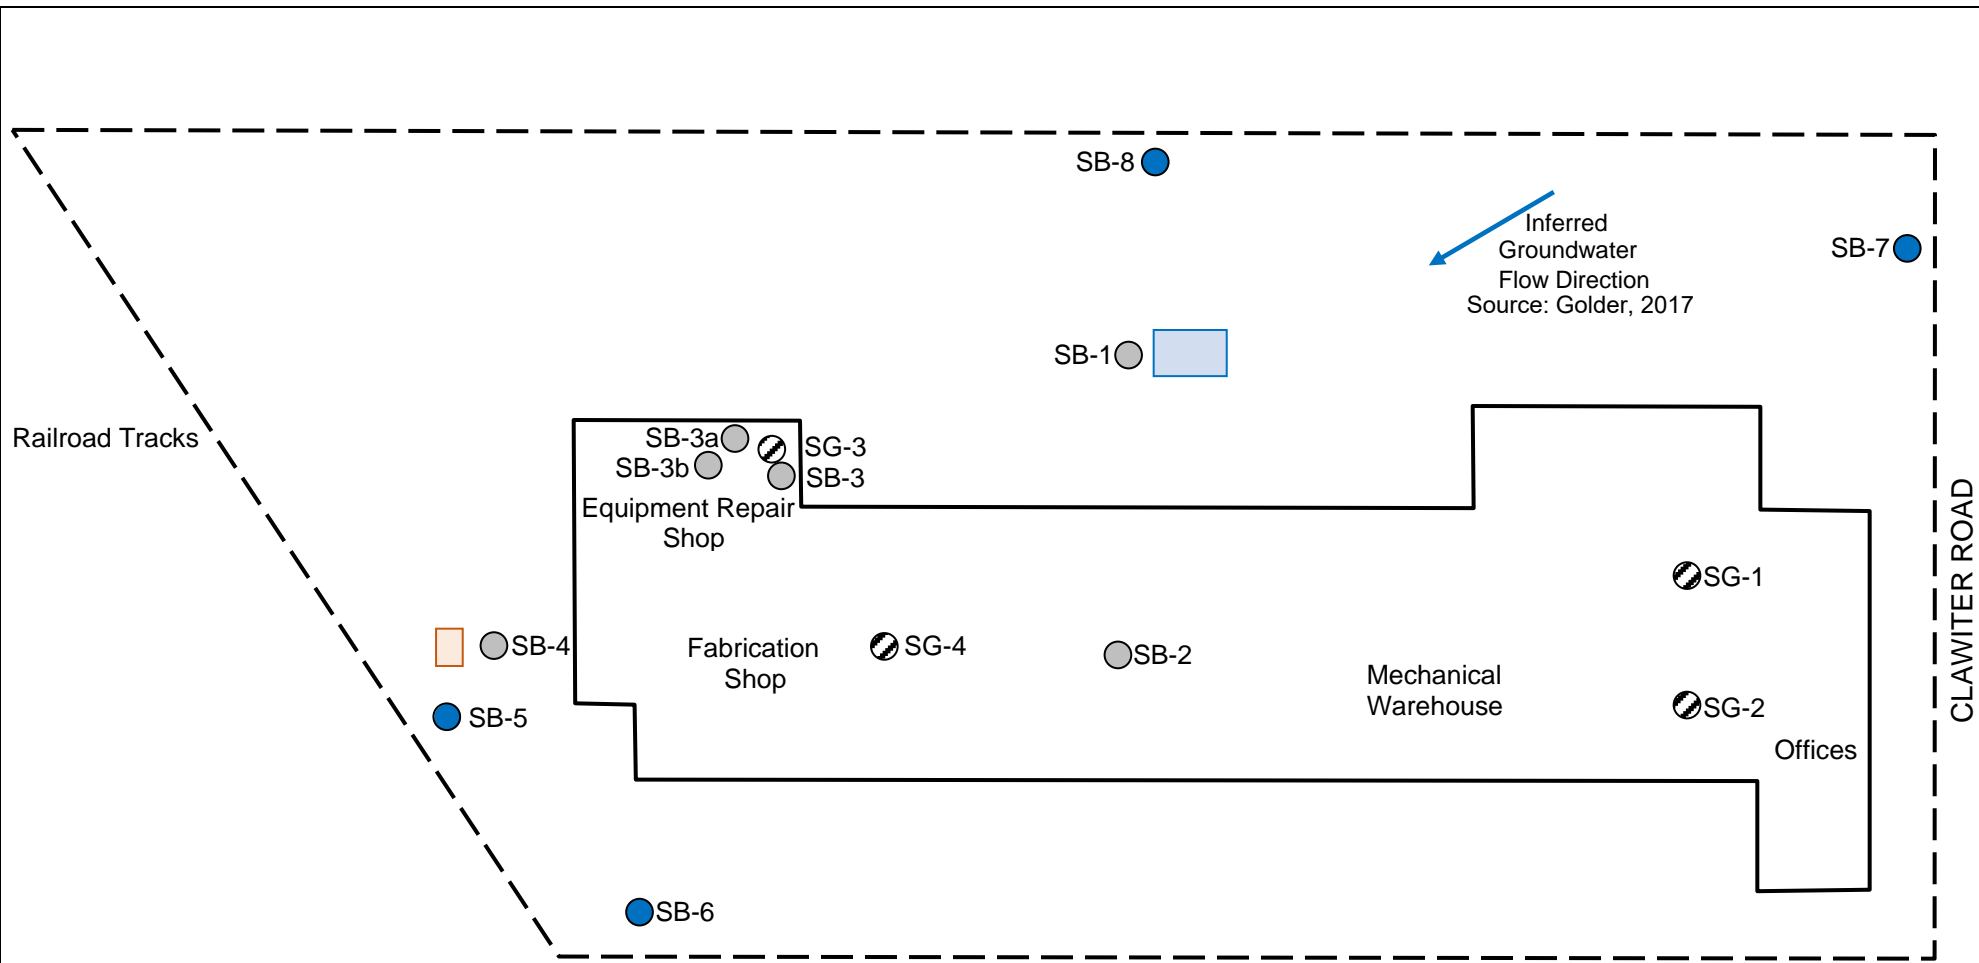
<b>Site Plan with Proposed Sampling Locations</b>	PN: 01-2015-1200-001
	Date: May 15, 2017
<b>SOIL AND GROUNDWATER INVESTIGATION WORK PLAN</b>	EP: Lita Freeman
24747 Clawiter Road, Hayward, California	<b>Figure 3</b>

-----	Approximate Property Boundary	○	Previous Sampling Location (ERA, 2015)
————	Building Footprint	●	Proposed Soil and Groundwater Sampling Location
□	Fuel UST	⊗	Proposed Soil Gas Sampling Location
□	Paint Storage Shed

- Soil gas sampling locations SG-1 and SG-2 in the eastern portion of the Mechanical Warehouse near the offices to evaluate sub-slab conditions in these areas;

- Soil gas sampling location SG-3 in the Equipment Repair Shop to confirm the data collected in 2015 and evaluate deeper (5 feet) sub-slab conditions in this area;

- Soil gas sampling location SG-4 in the Fabrication Shop to evaluate sub-slab conditions in this area;
- Boring SB-5 to the west of the building to evaluate soil quality and the extent of petroleum hydrocarbons and VOCs in groundwater downgradient (southwest) of boring SB-4;

- Boring SB-8 along the northern site border and upgradient of the Equipment Repair and Fabrication Shops to evaluate soil quality and potential groundwater impacts from off-site releases.

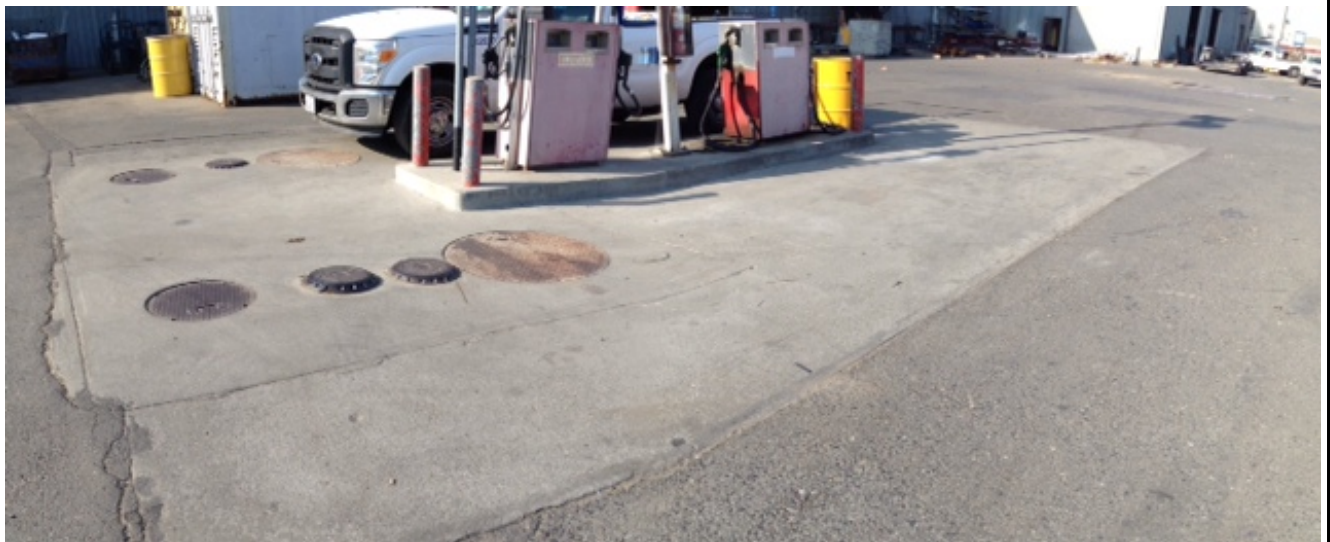
Photo 22: Subject Site (Facing Southwest)  
Fuel Dispensers and Underground Storage Tanks

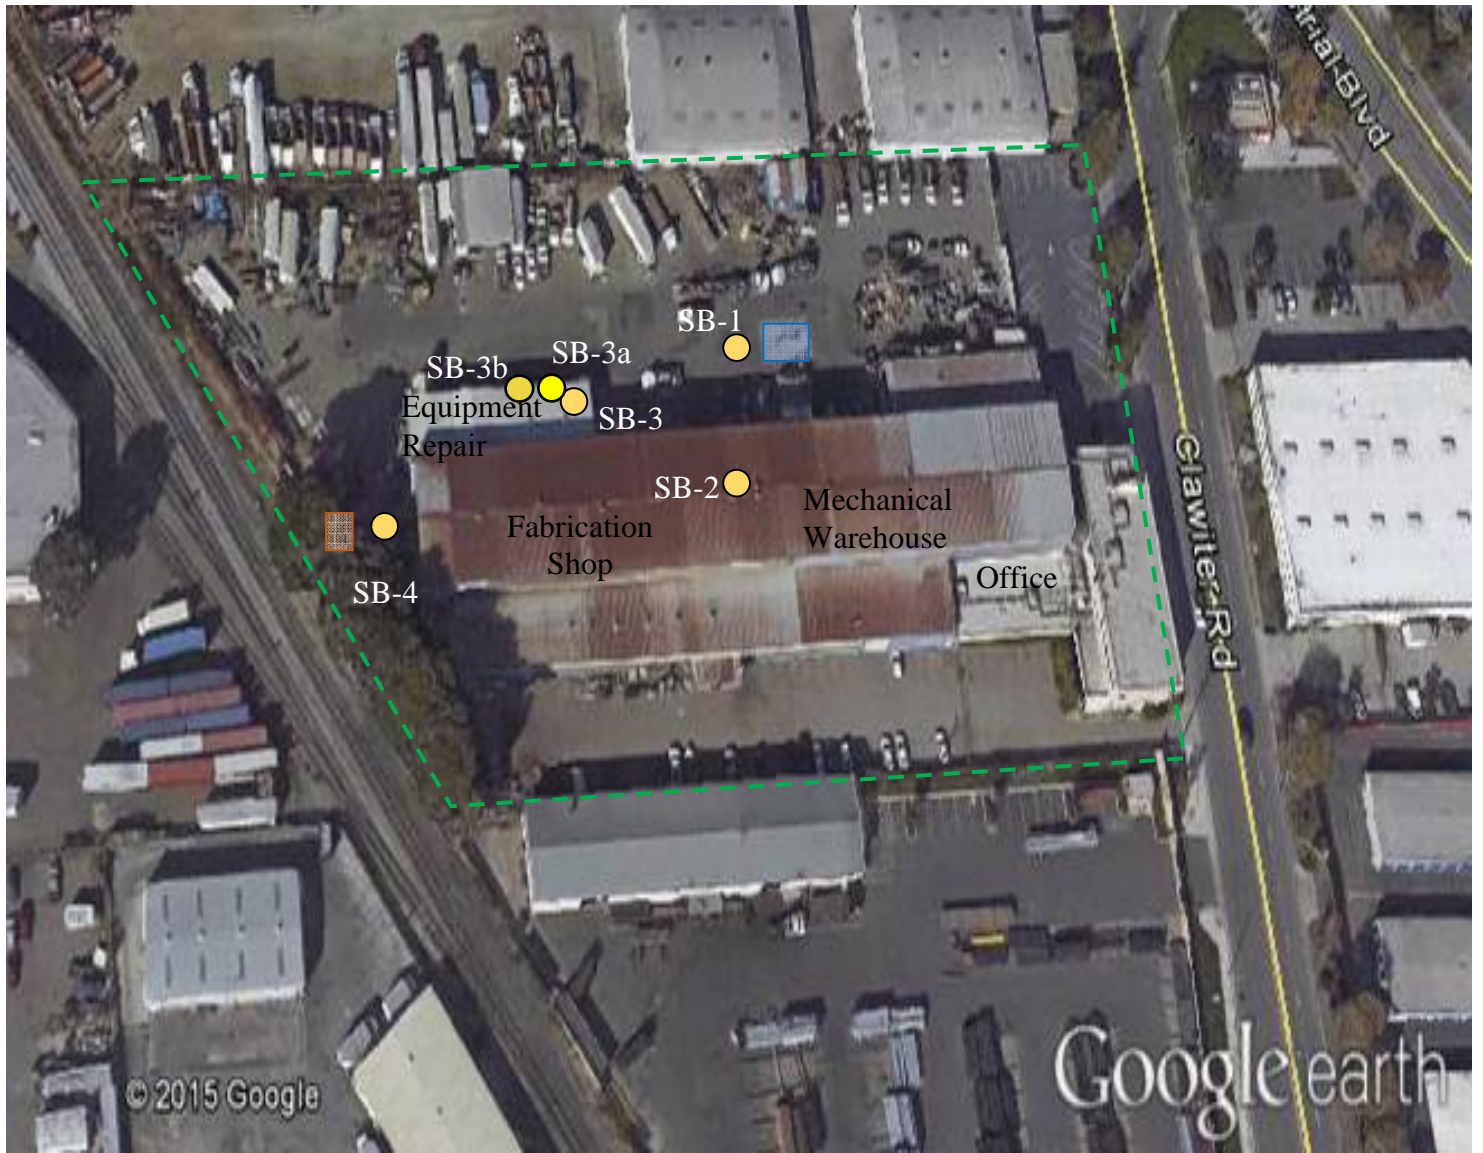
<p>--- Approximate Property Boundary</p> <p>■ Fuel UST</p> <p>■ Paint Storage Shed</p>	<p>● Sampling Location</p>	<p>0 ↑ North 200</p> <p>Scale (feet, approximate)</p>
--	----------------------------	---

Petroleum hydrocarbons were not reported in soil samples at concentrations at or above their respective LRL except in sample SB-4-2. Petroleum hydrocarbons were detected in soil sample SB-4-2 (near the paint shed/hazardous waste storage area) as follows:

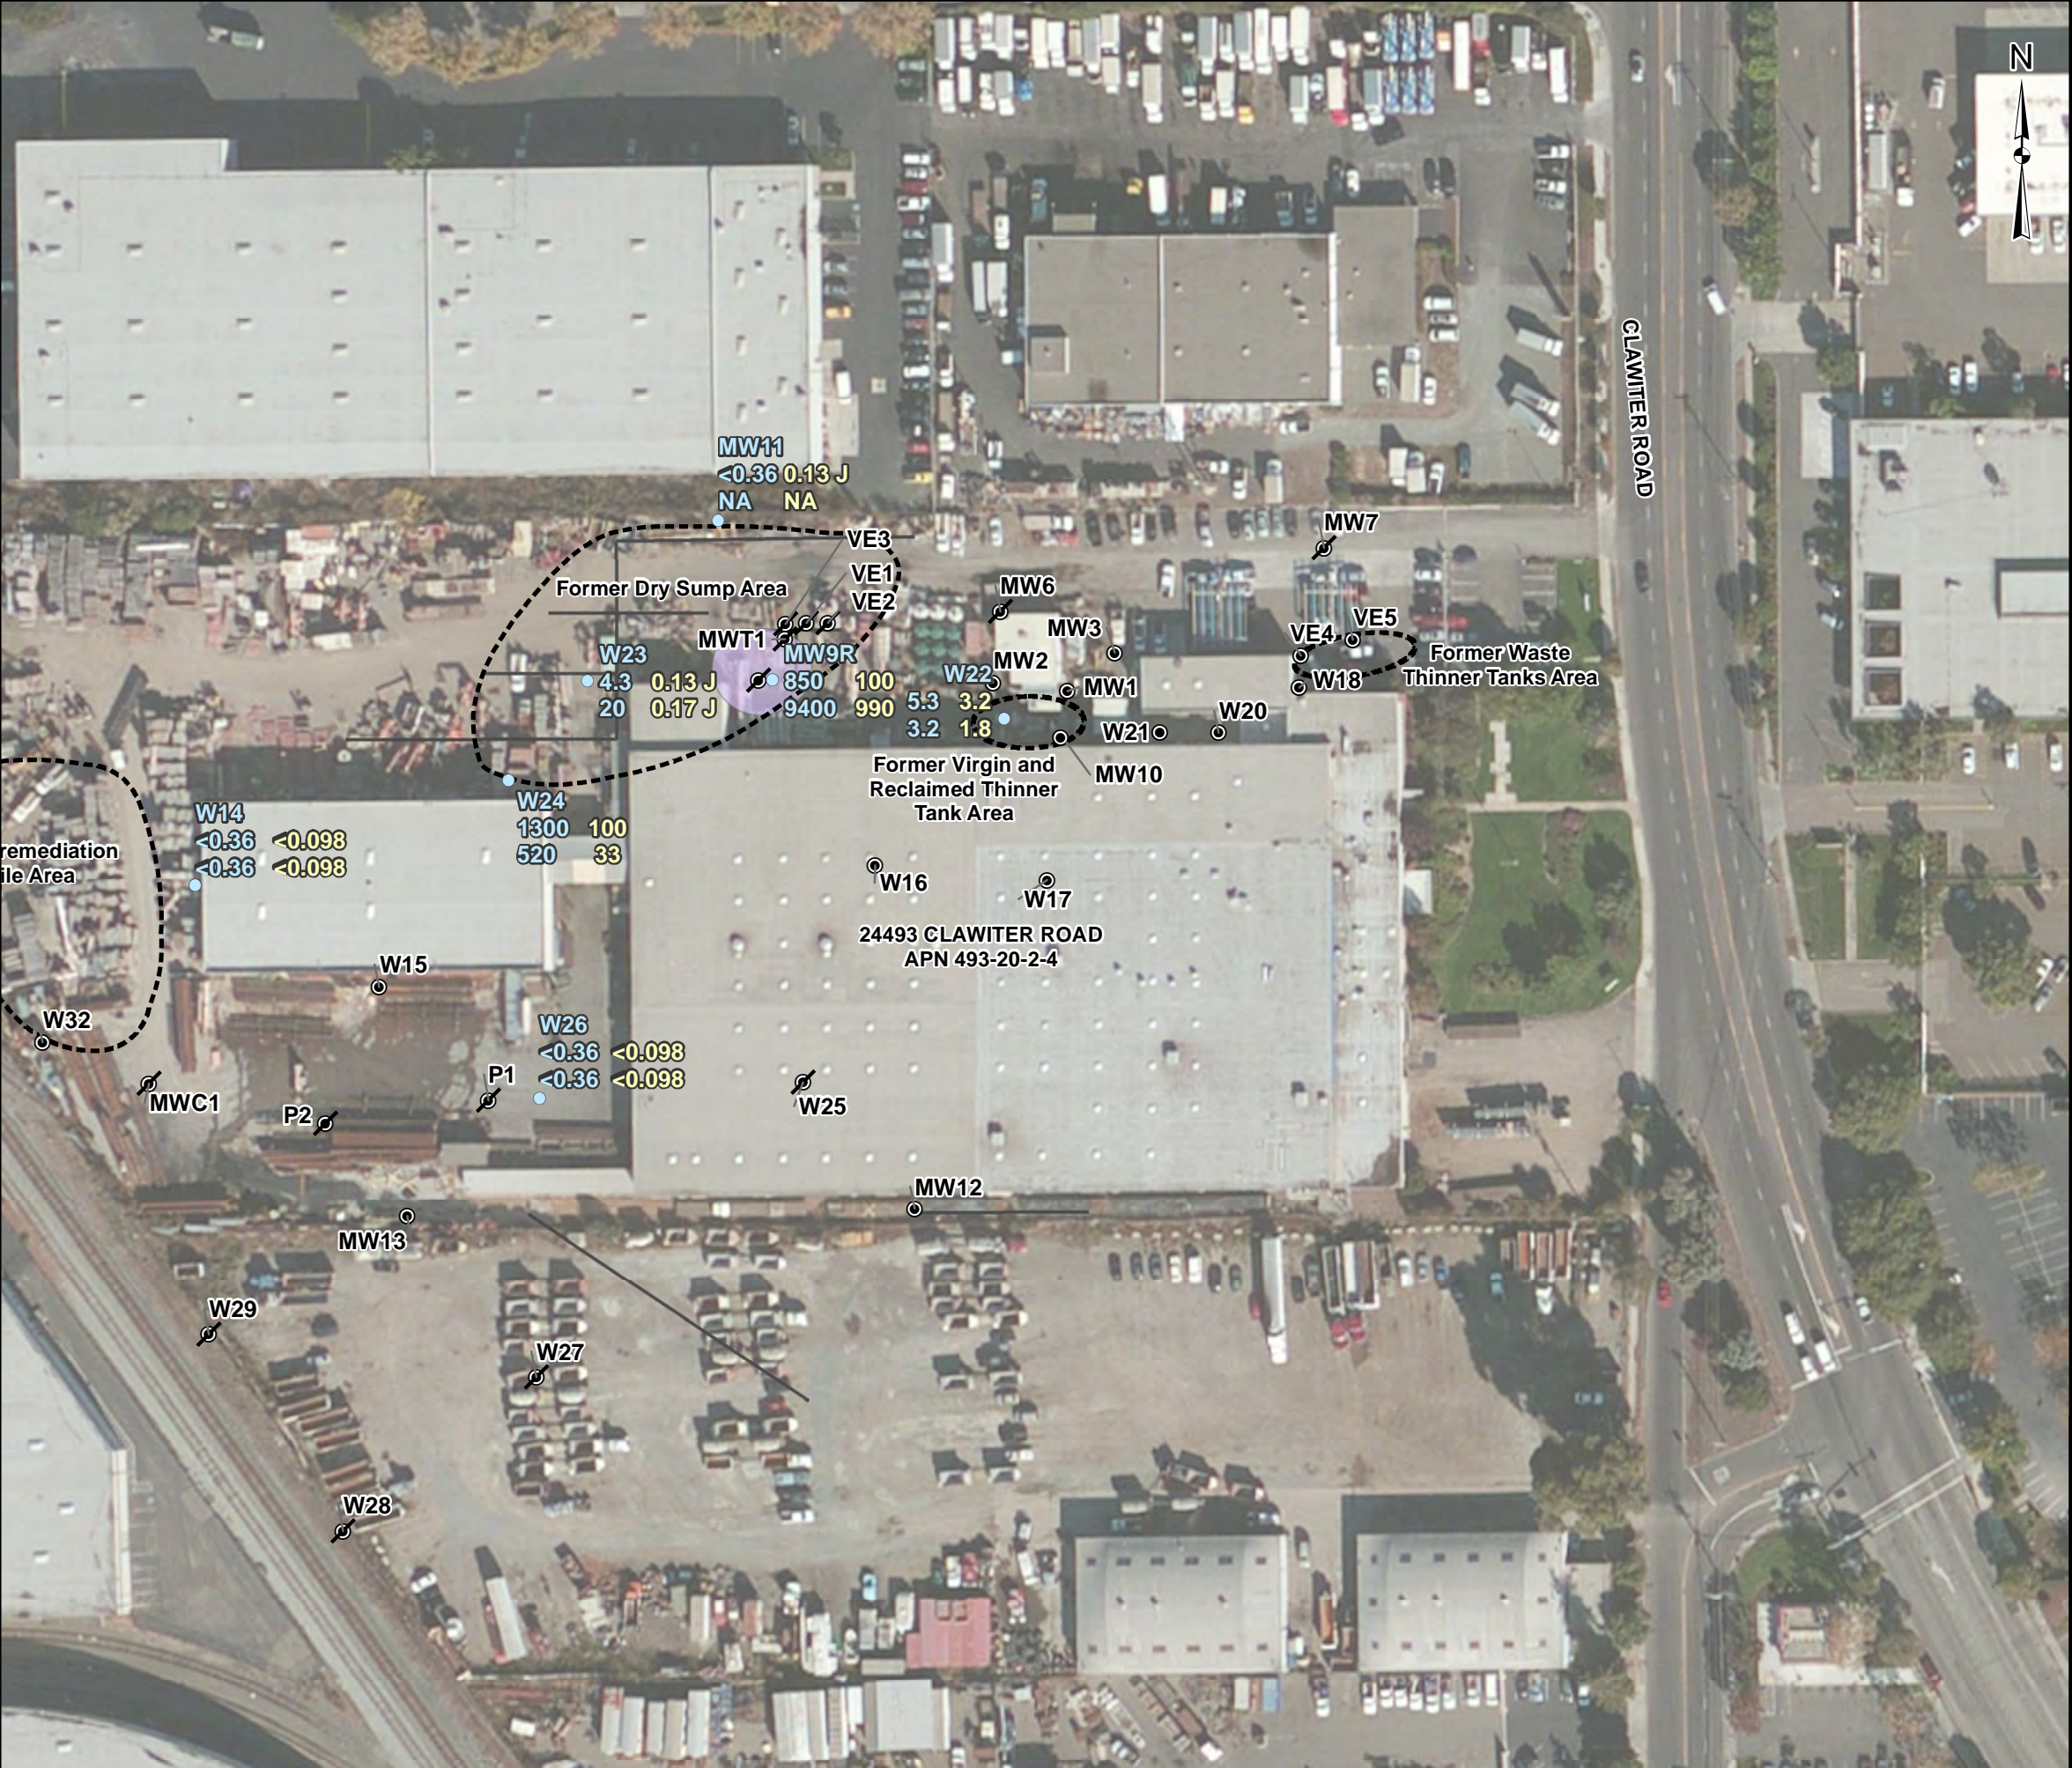
- Well With Analytical Results (µg/L)
- Existing monitor well
- ⊗ Destroyed well
- ▤ Former Process Areas
- Infiltration trench
- ▭ Property Boundary
- Approximate area that exceeds clean-up goal

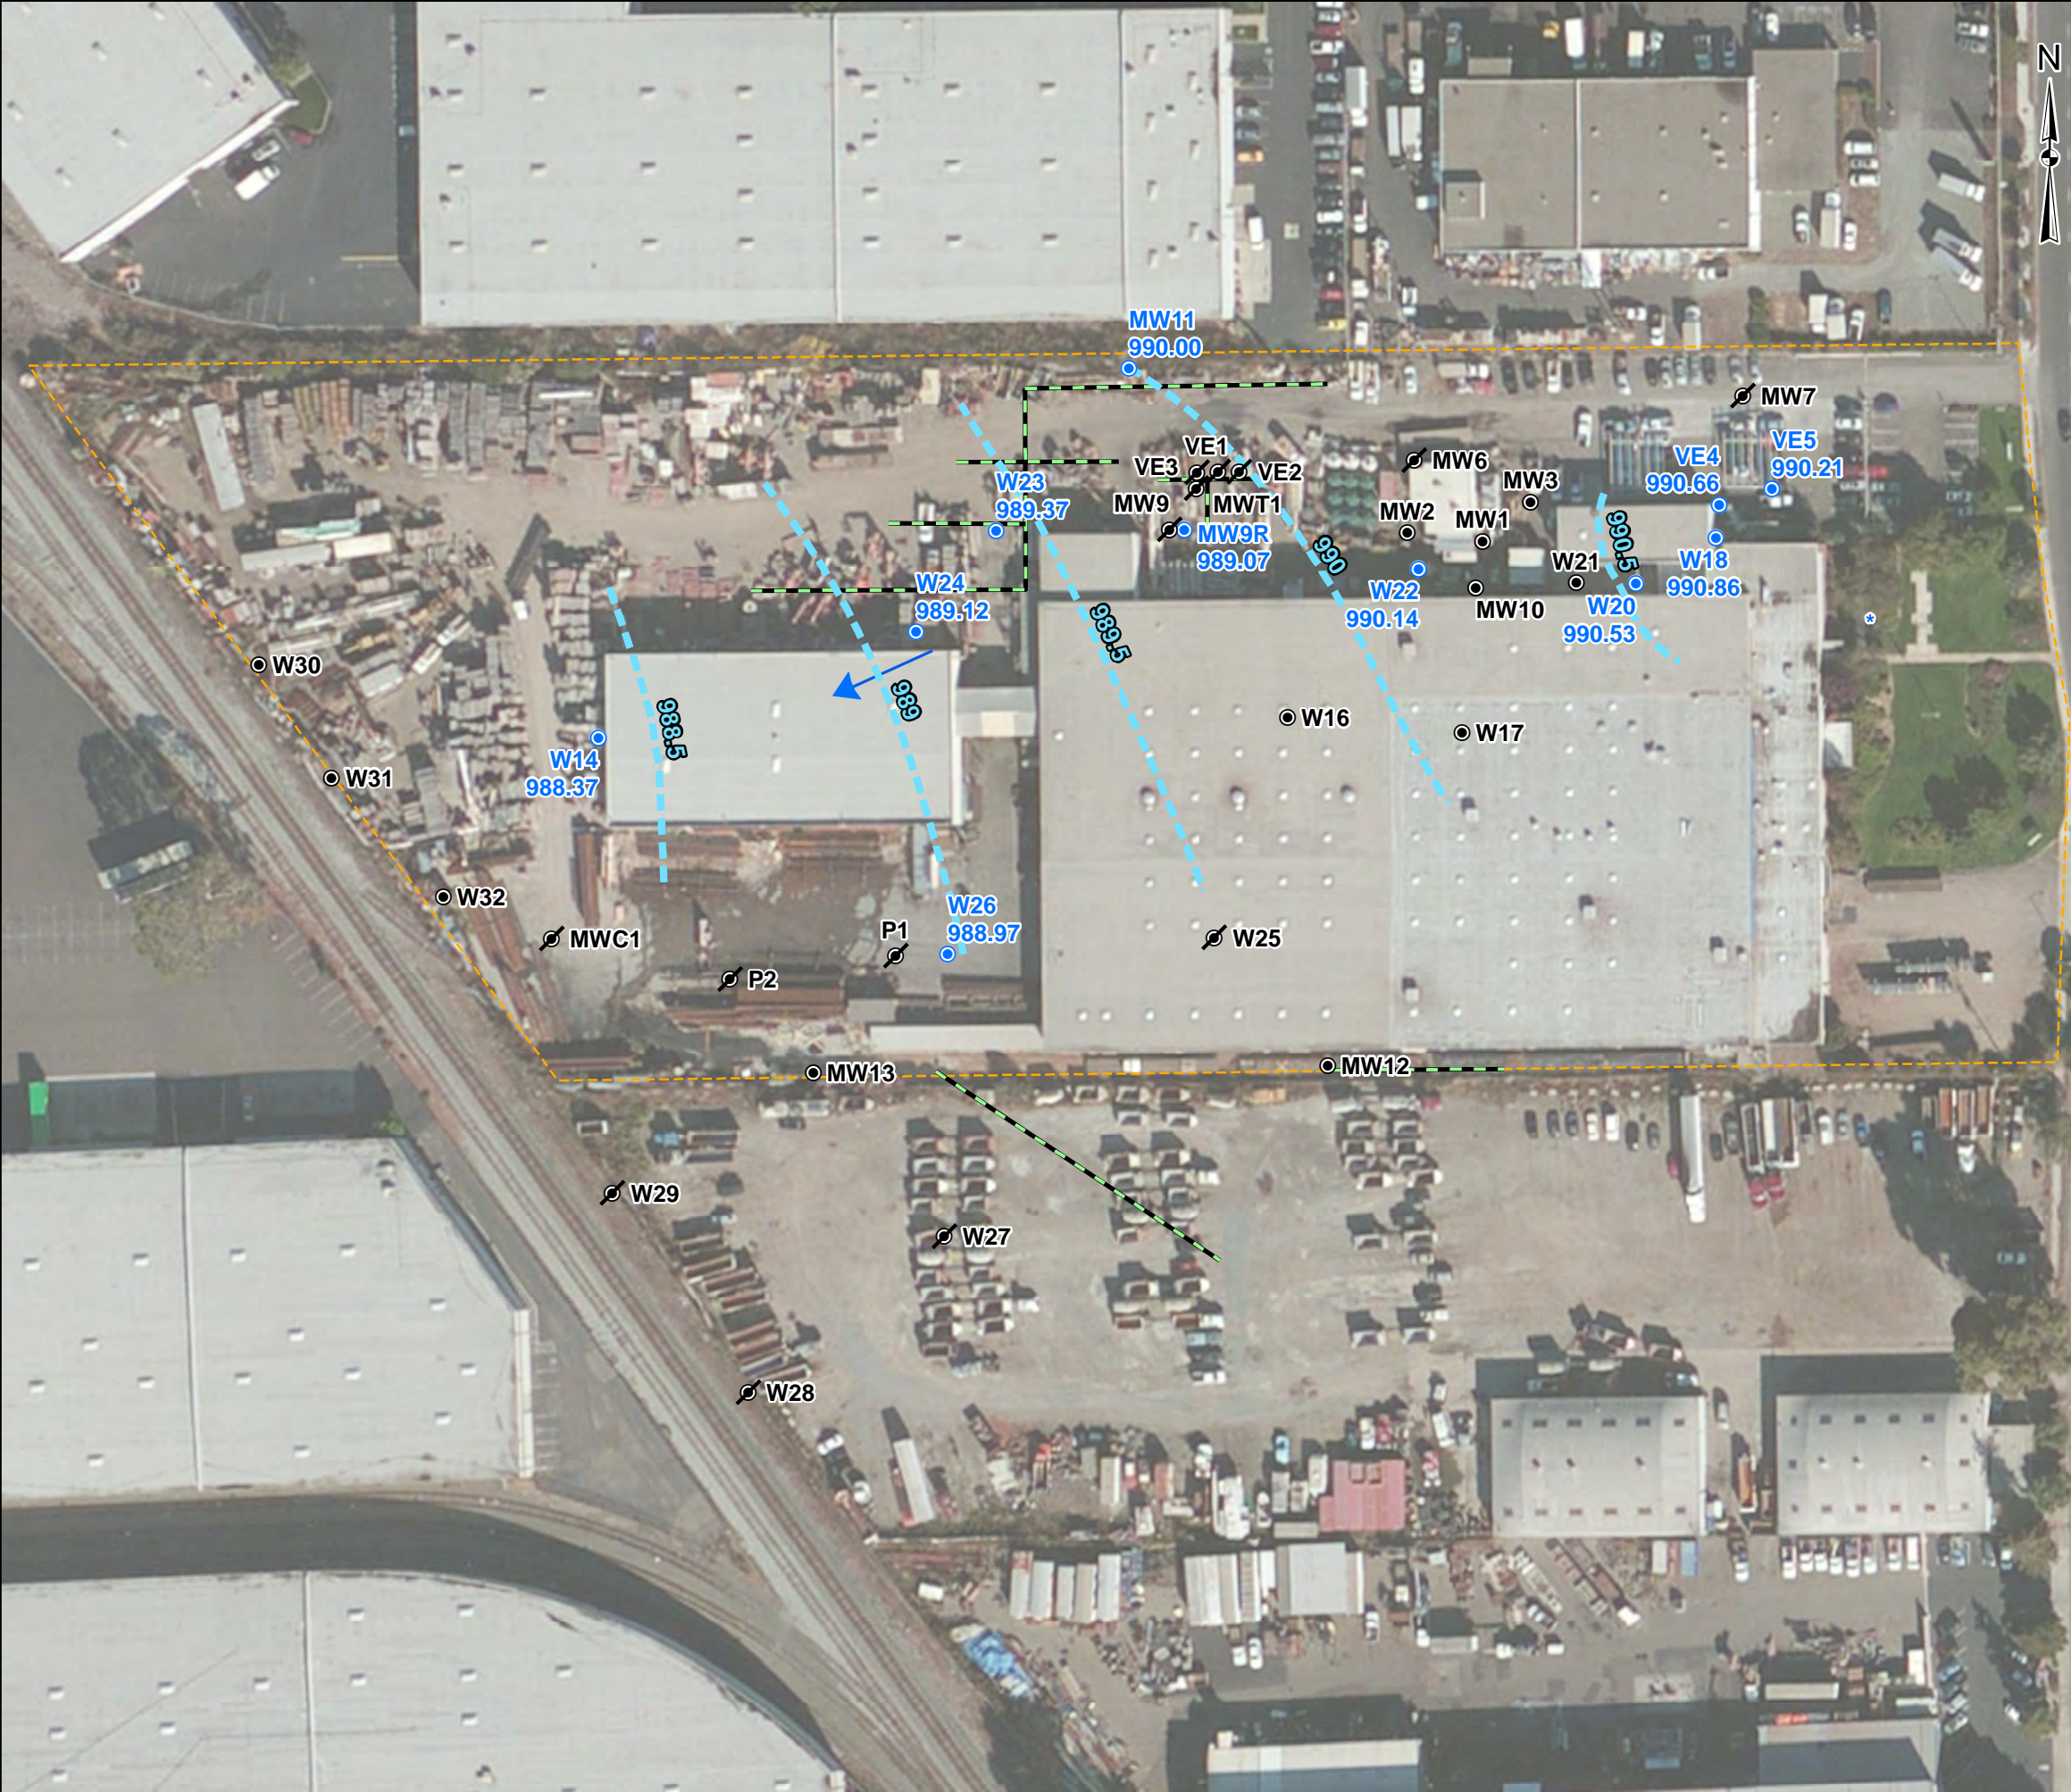
PROJECT No. 113-97305		FILE No. GWE_201604.mxd	
	DESIGN	MM	9/12/2012	SCALE: AS SHOWN
	GIS	MR	2/9/2017	REV. 0
	CHECK	GW	2/9/2017	<b>FIGURE 3</b>
	REVIEW	WF	2/9/2017

- Existing monitor well
- ⊗ Destroyed well
- Monitor well with groundwater elevation (ft)
- - - Groundwater elevation contour (ft)
- - - Infiltration trench
- ➔ Inferred groundwater flow direction
- - - Property boundary

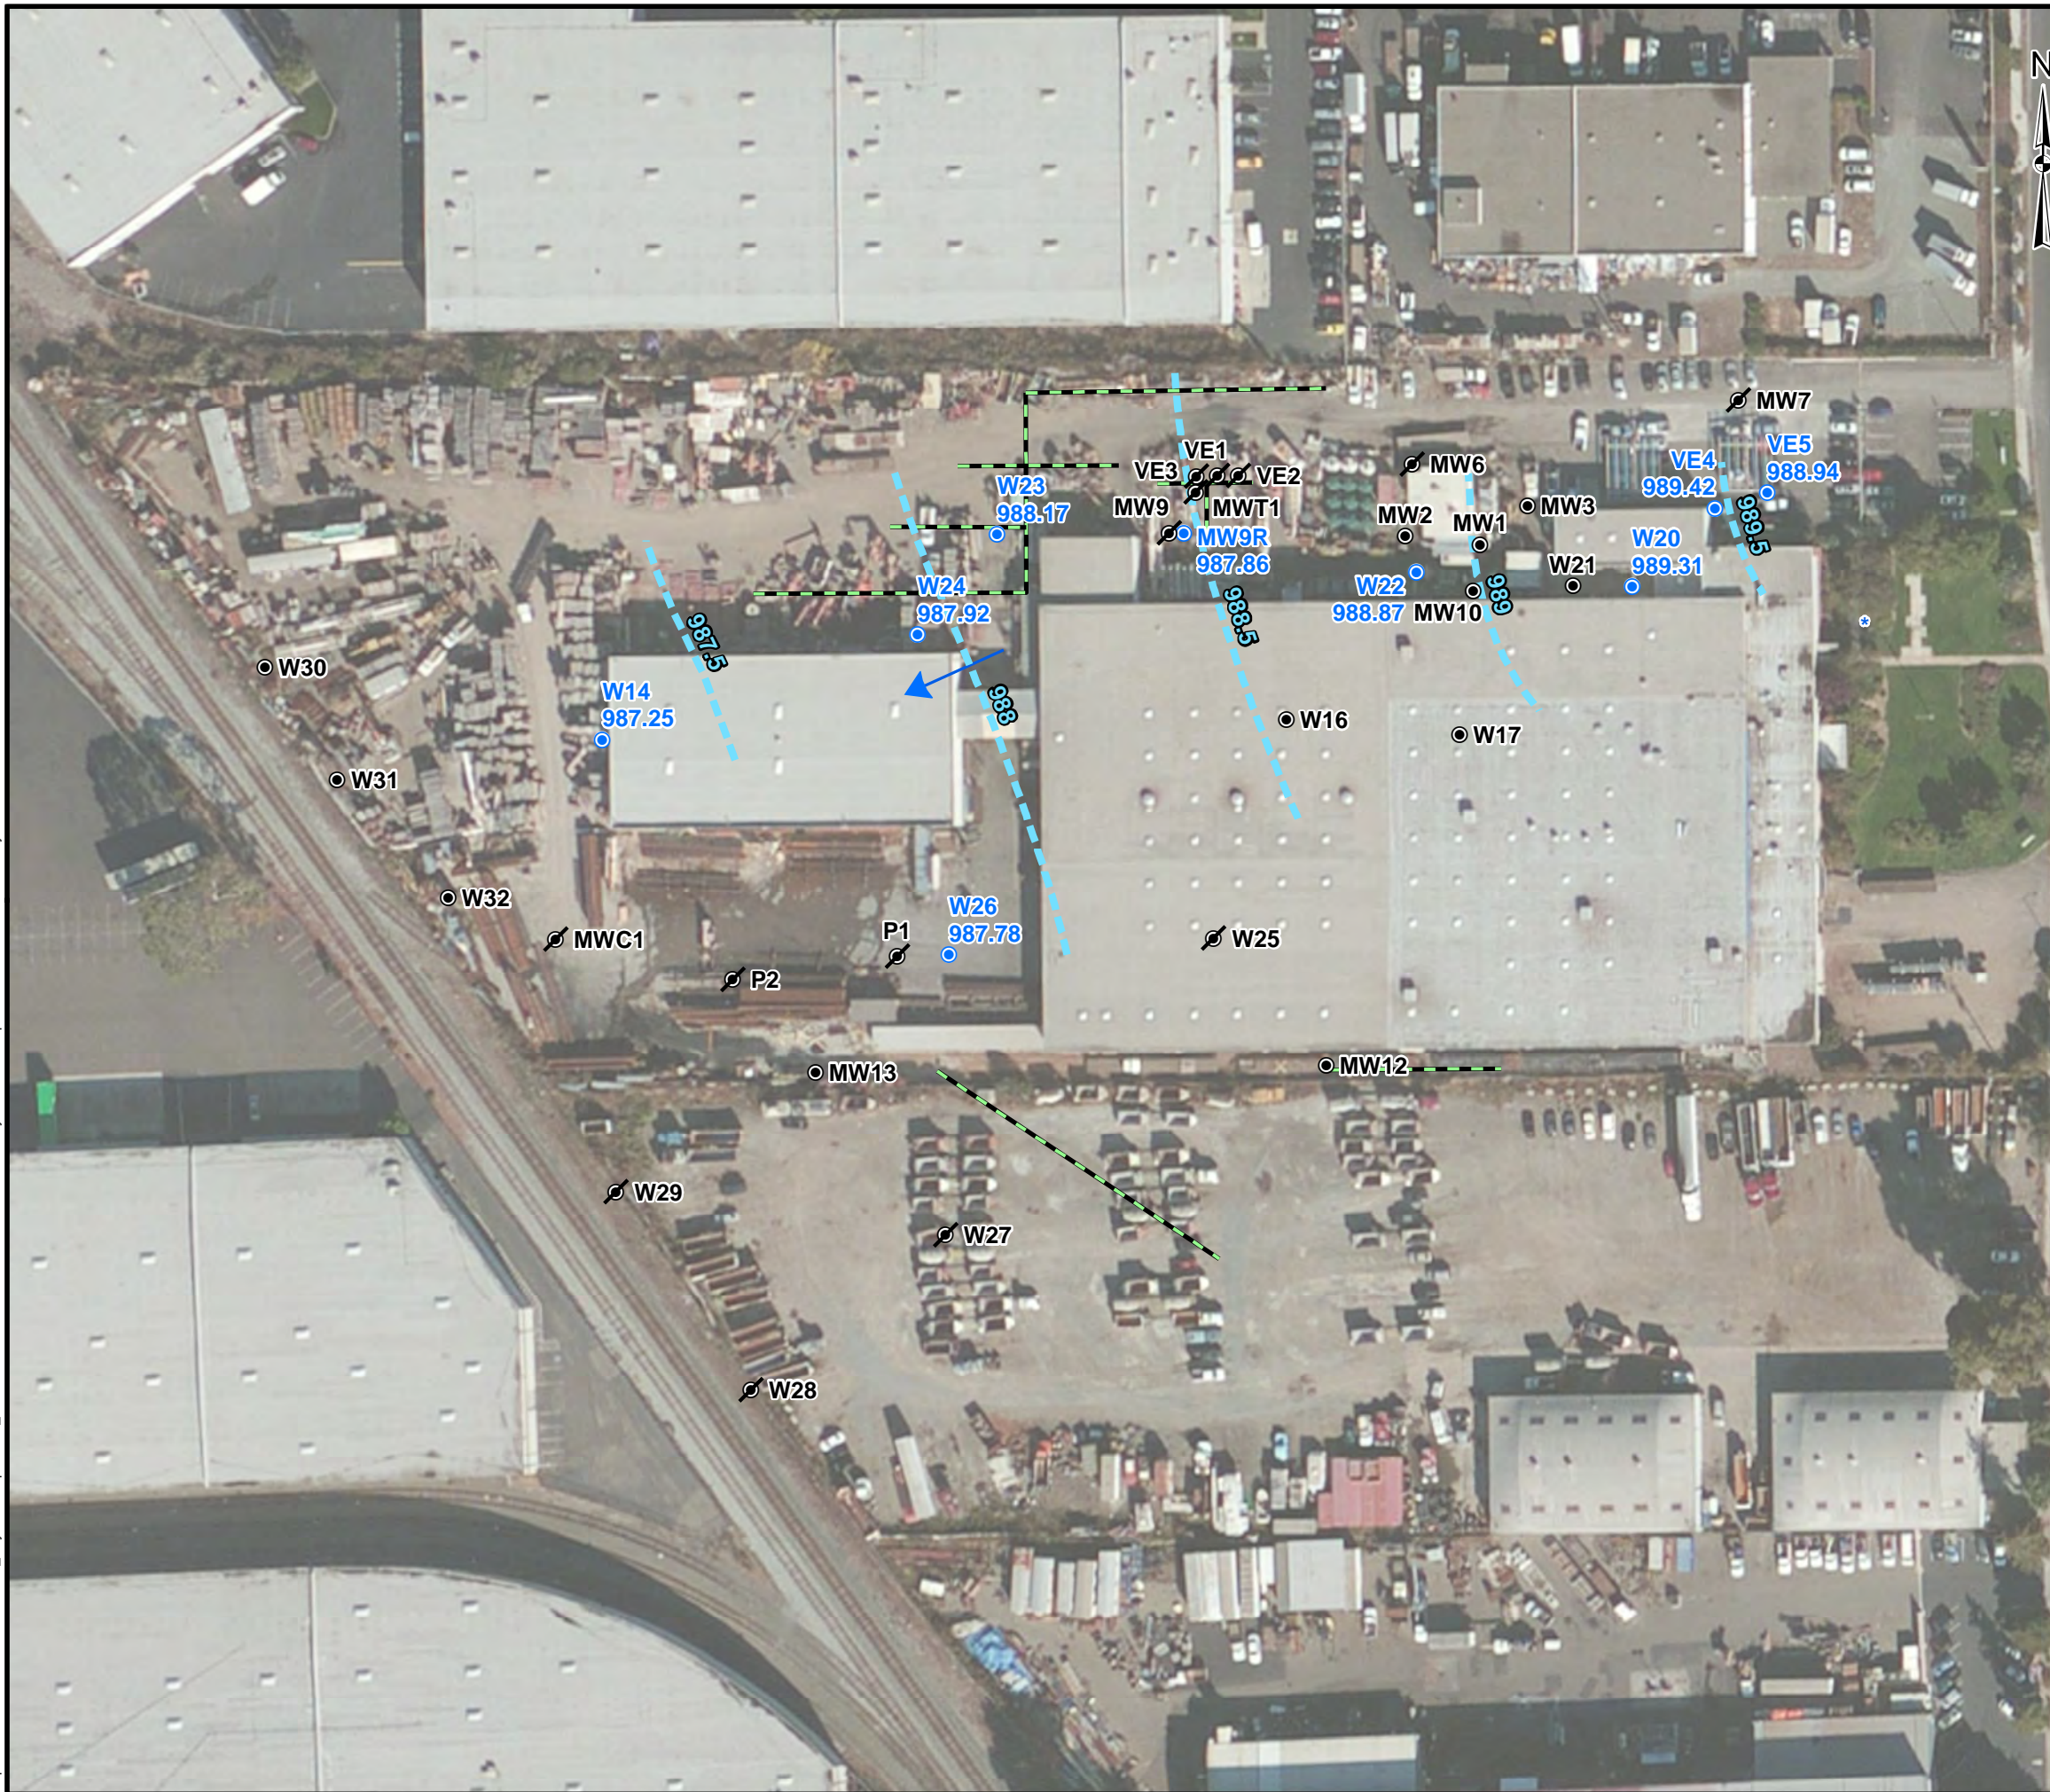
- Existing monitor well
- Destroyed well
- Monitor well with groundwater elevation (ft)
- Groundwater elevation contour (ft)
- Infiltration trench
- Inferred groundwater flow direction
- Property boundary
