**SUBJECT:** Soil and Groundwater Investigation Work Plan  
139<sup>th</sup> Avenue Property  
295 139<sup>th</sup> Avenue  
San Leandro, California 94578  
ACDEH Fuel Leak Case No. RO0003214  
GeoTracker Global ID No. T10000009956

## Soil and Groundwater Investigation Work Plan

139<sup>th</sup> Avenue Property  
295 139<sup>th</sup> Avenue  
San Leandro, California 94578

ERA Project No. 01-2017-1500-001

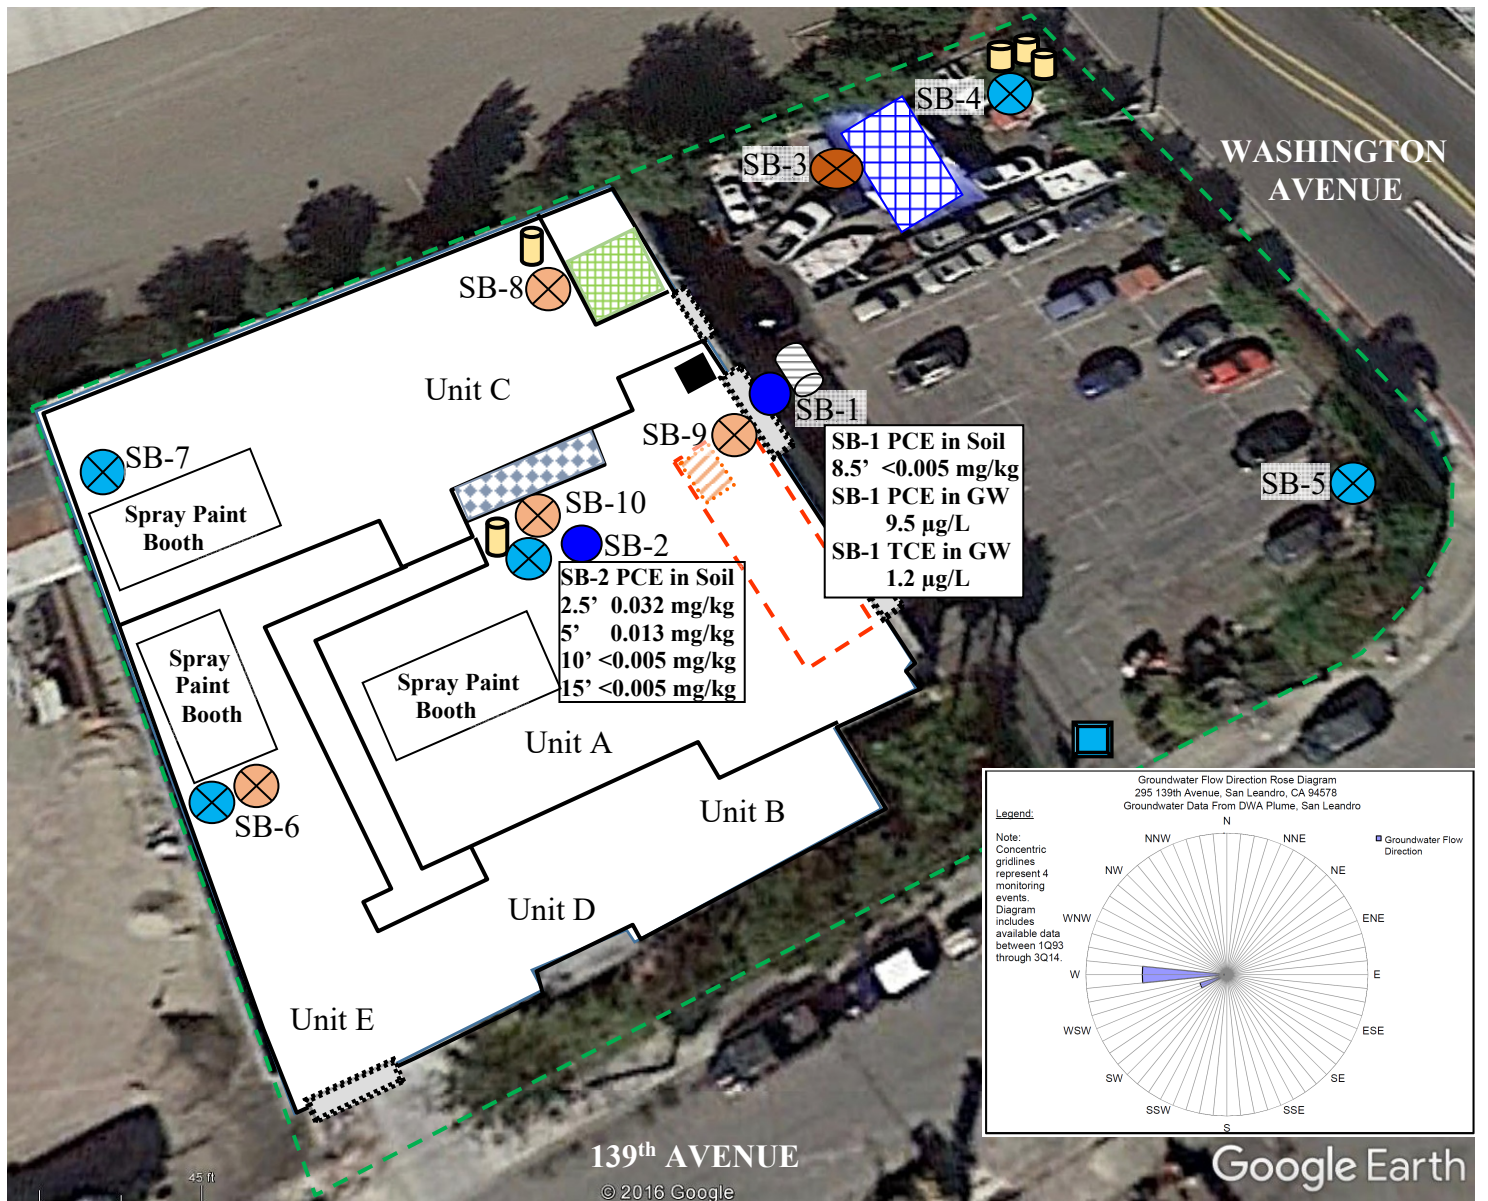
**Figure 2**

<b>Legend</b>		Current Paint Mixing/Storage Room
Approximate Property Boundary	Hazardous Substances Containers	Roll-Up Door
Former Gasoline Underground Storage Tank	Roll-Up Door	Storm Drain
Former Machine Shop Area		
Former Supply Room		
Former Store Room		
Auto Repair Area (under tarp)		
Sample Location (ERA, 2016)		
Proposed Soil Sampling Location		
Proposed Soil Gas and Soil Sampling Location		
Proposed Soil and Groundwater Sampling Location

SB-1 PCE in Soil / Tetrachloroethene (PCE) in Soil  
8.5' <0.005 mg/kg / Sample Depth-Concentration  
in milligrams per kilogram

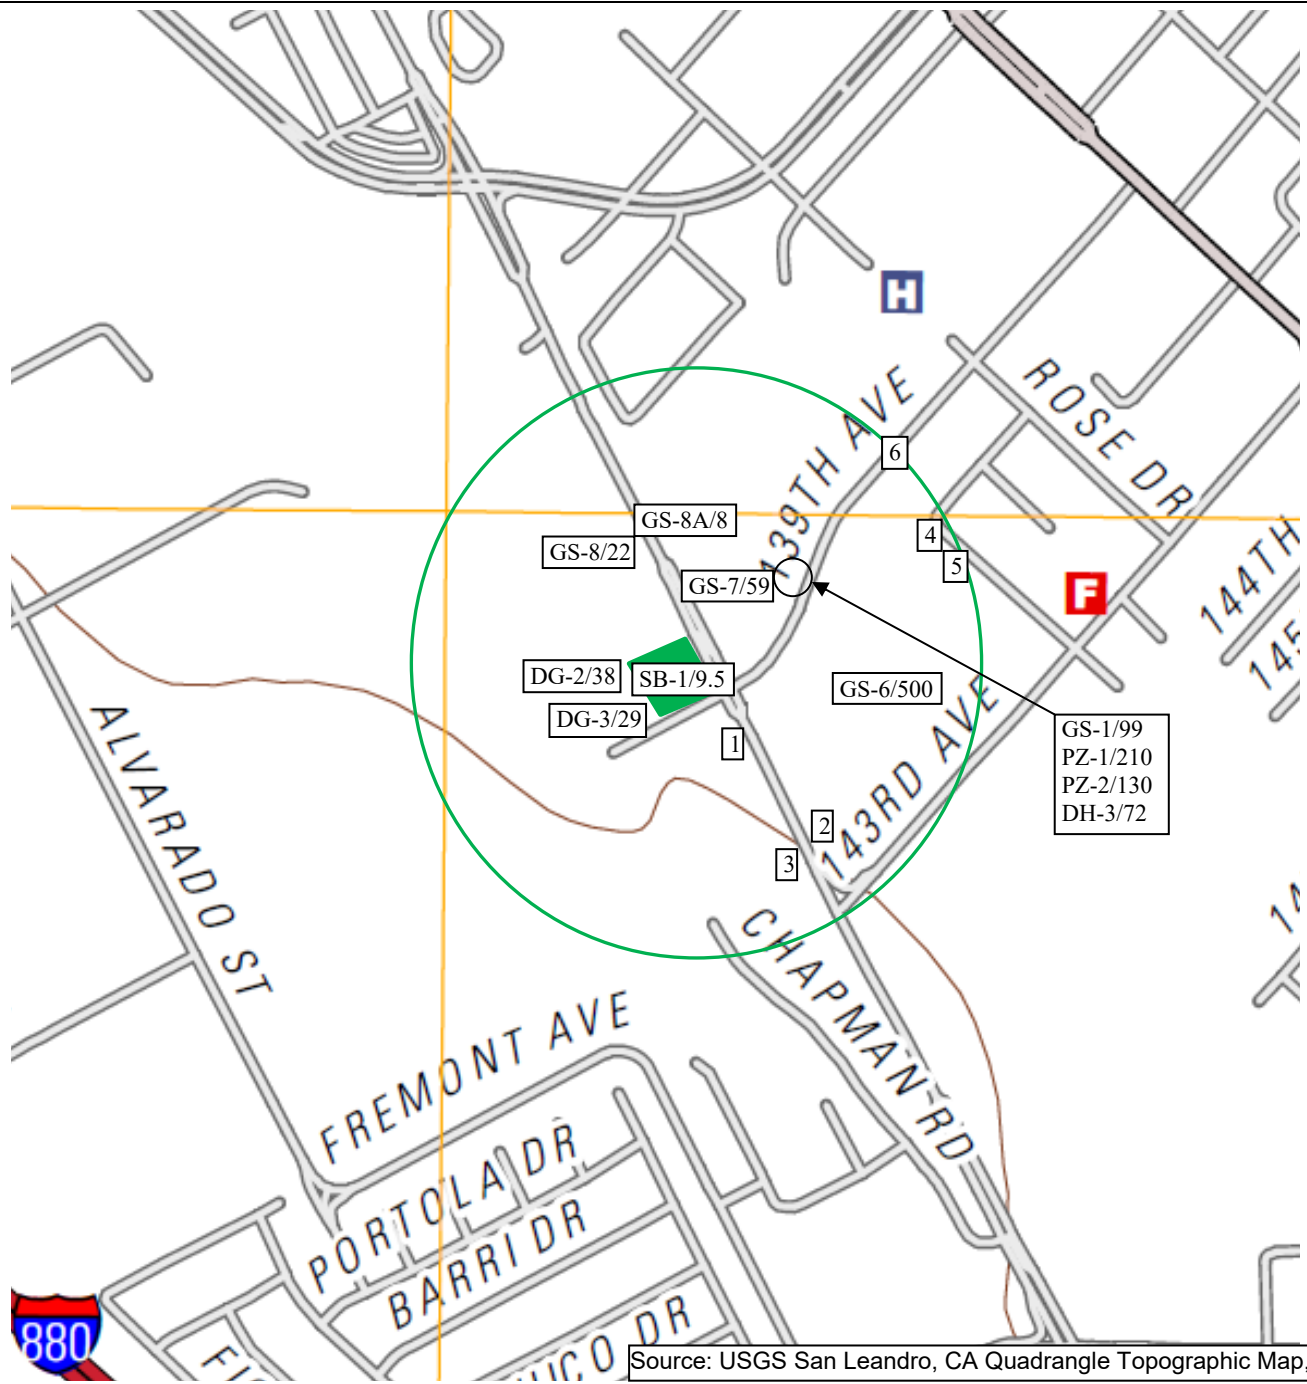
PCE (Tetrachloroethene) data for SB-1 from Environmental Risk Assessor, *Limited Phase II Environmental Site Assessment, Body Repair Shops, 295 139<sup>th</sup> Avenue, San Leandro, California 94578*, March 3, 2016. Data for GS-6, GS-8 from Woodward-Clyde Consultants (WCC), *Hydrogeology of Central San Leandro and Remedial Investigation of Regional Groundwater Contamination, San Leandro Plume, San Leandro, California*, December 29, 1993. Data for DG-2, DG-3 from WCC, *Data Report, Volume 1, Summary Tables and Figures, Remedial Investigation of Regional Groundwater Contamination, Industrial (Datagap) Area, San Leandro Plume Project, San Leandro, California*, March 29, 1995. Data for GS-7 GS-8A, GS-1, PZ-1, PZ-2, DH-3 from The Source Group, Inc., *Groundwater Monitoring Report, DWA Plume, San Leandro, California*. May 11, 2015.

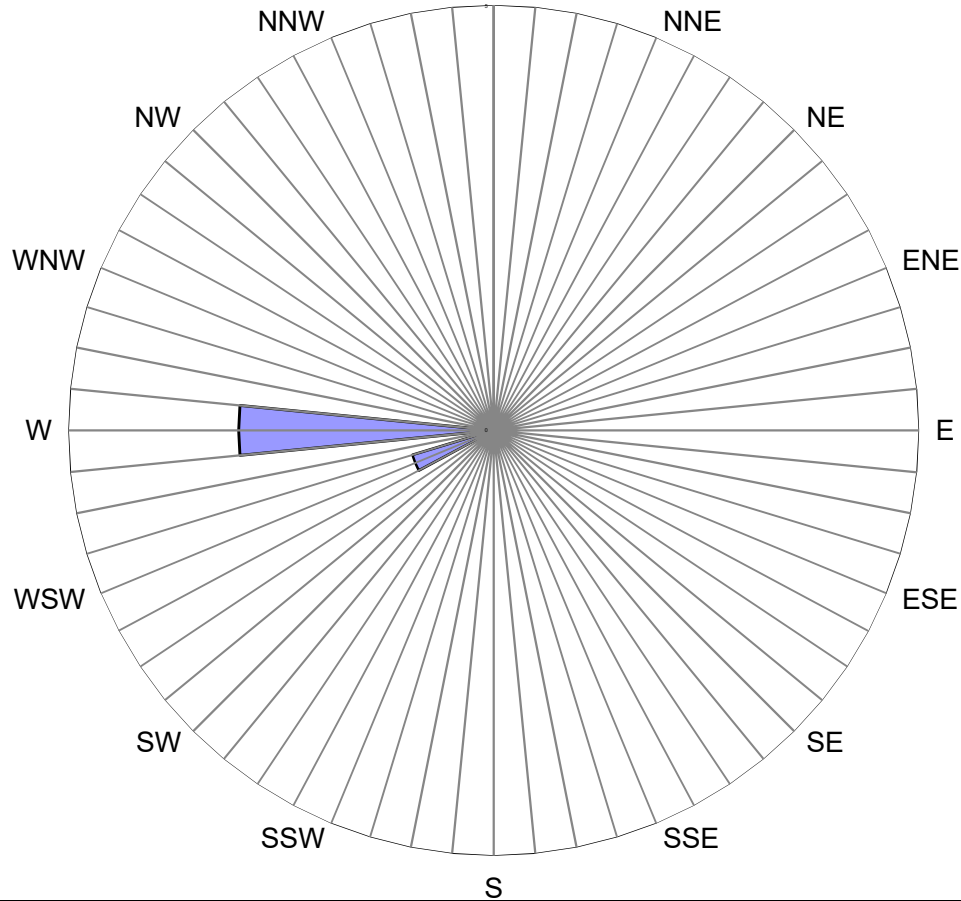
**Figure 4**

Note:  
 Concentric gridlines  
 represent 4 monitoring  
 events. Diagram  
 includes available data  
 between 1Q93 through  
 3Q14.

■ Groundwater Flow Direction

**Rose Diagram**

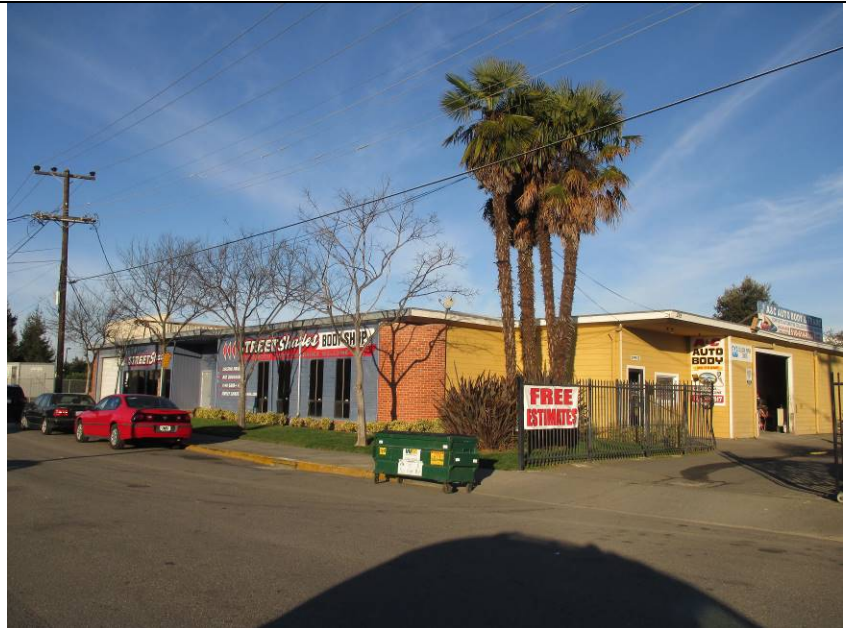
**Photograph: 2**

Photo depicts the track-mounted direct push drilling rig set up at sampling location (SB-1) near the former UST.

- Boring SB-1 was placed in the area of the 500-gallon gasoline UST and was drilled to a depth of 38 feet below ground surface (bgs); and
- Boring SB-2 was placed in the area of the paint and thinner storage/mixing room observed in Unit A and was drilled to a depth of 24 feet bgs.

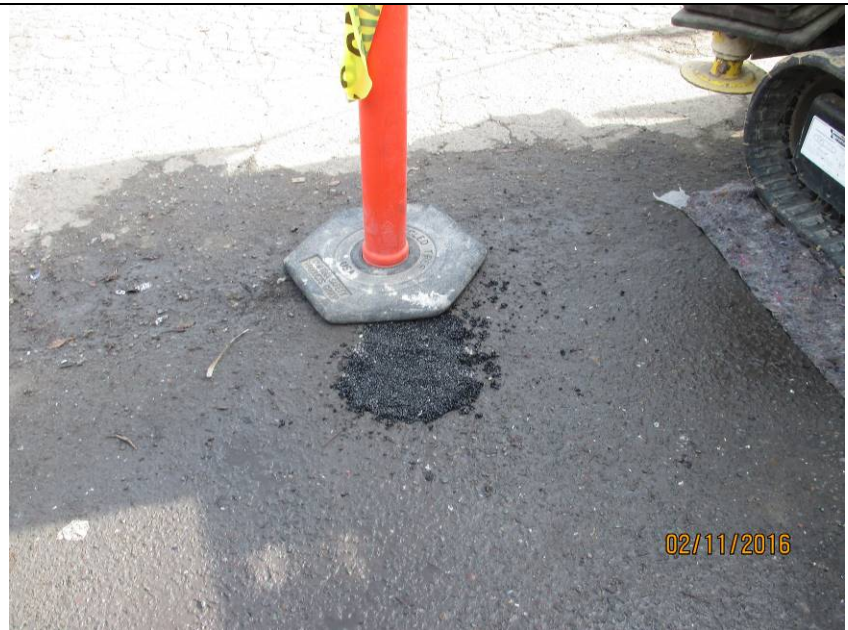
**Description:**

Photo depicts backfilled boring SB-1.

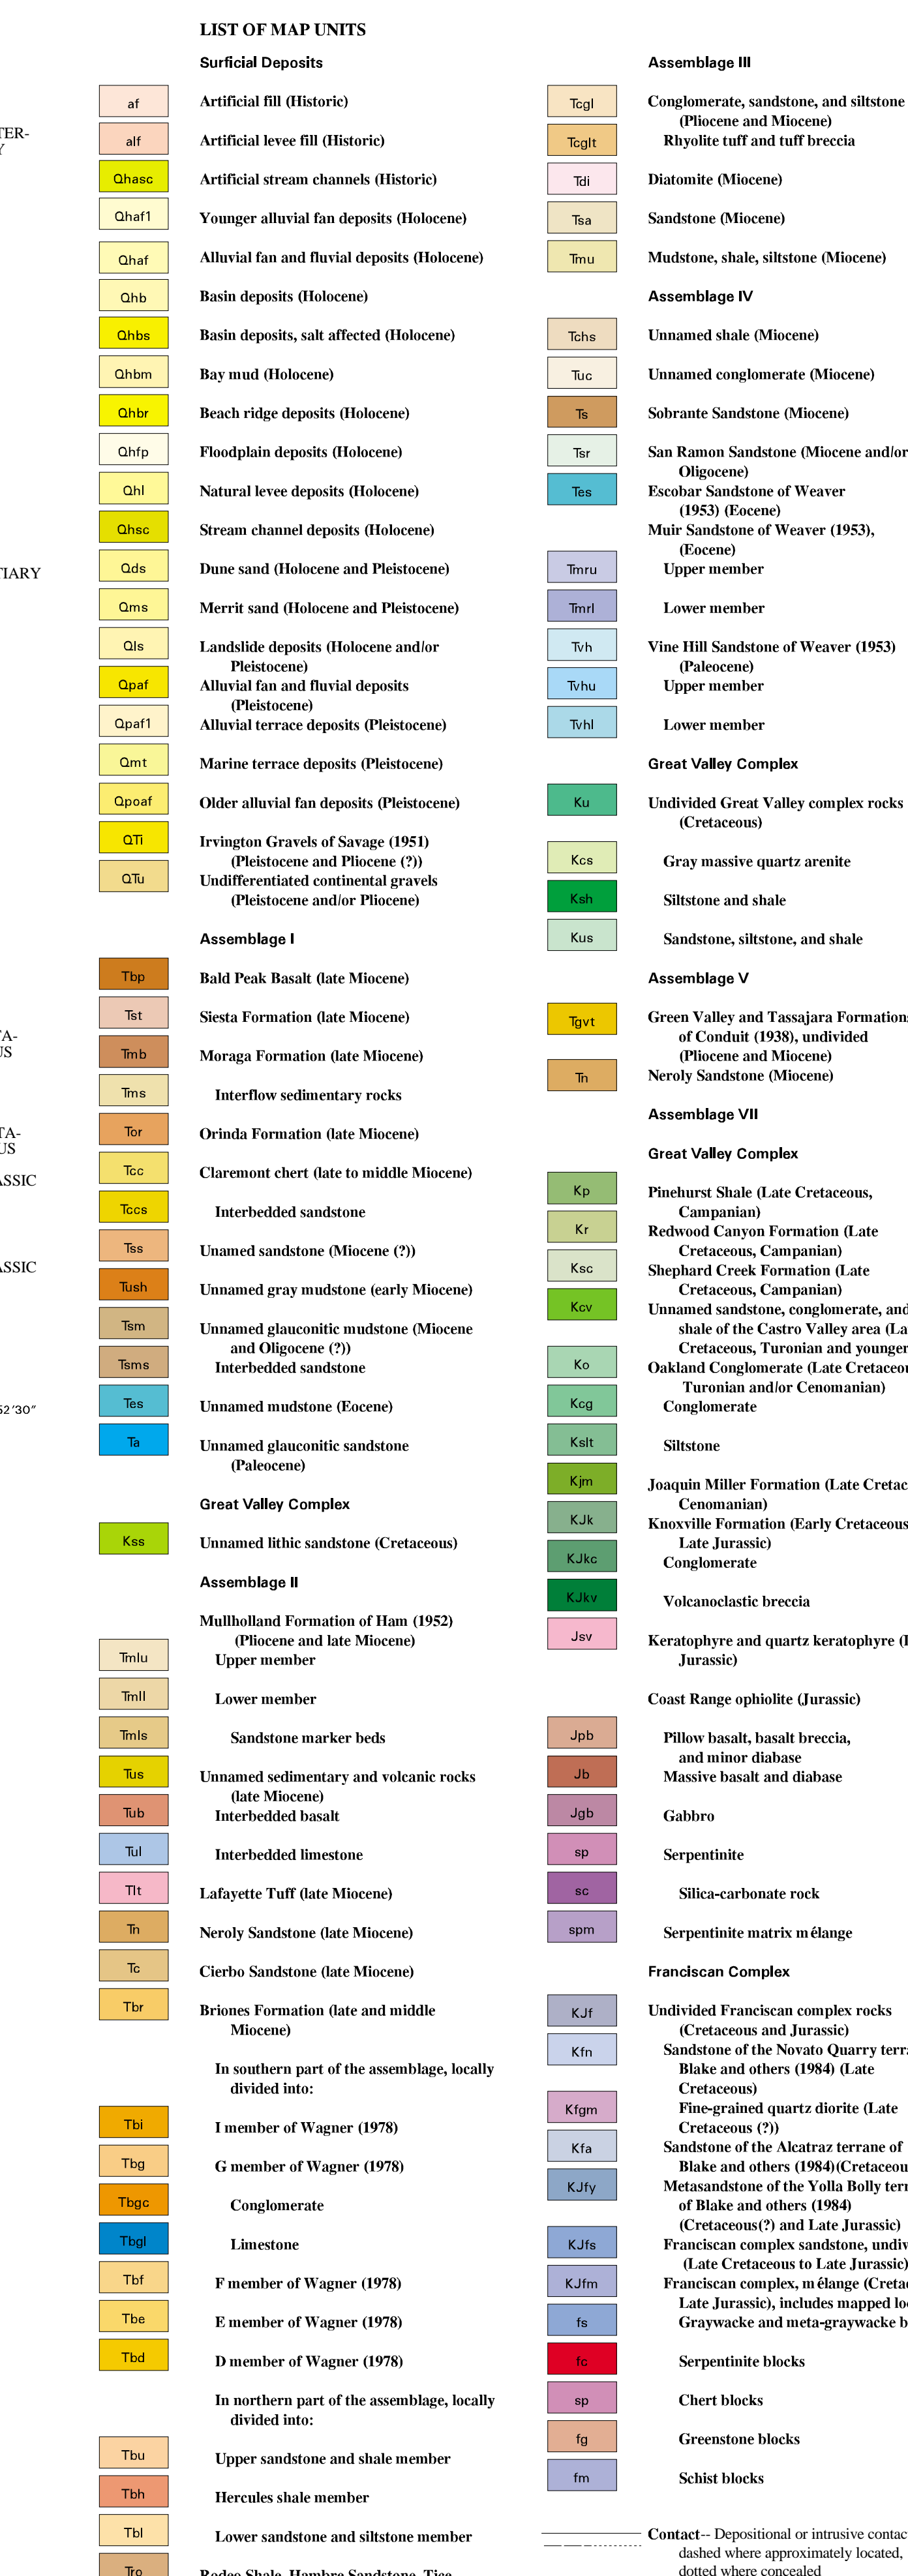
**Figure 3**

Figures from R.W. Graymer, USGS. *Geologic Map and Map Database of the Oakland Metropolitan Area, Alameda, Contra Costa, and San Francisco Counties, California*, 2000.

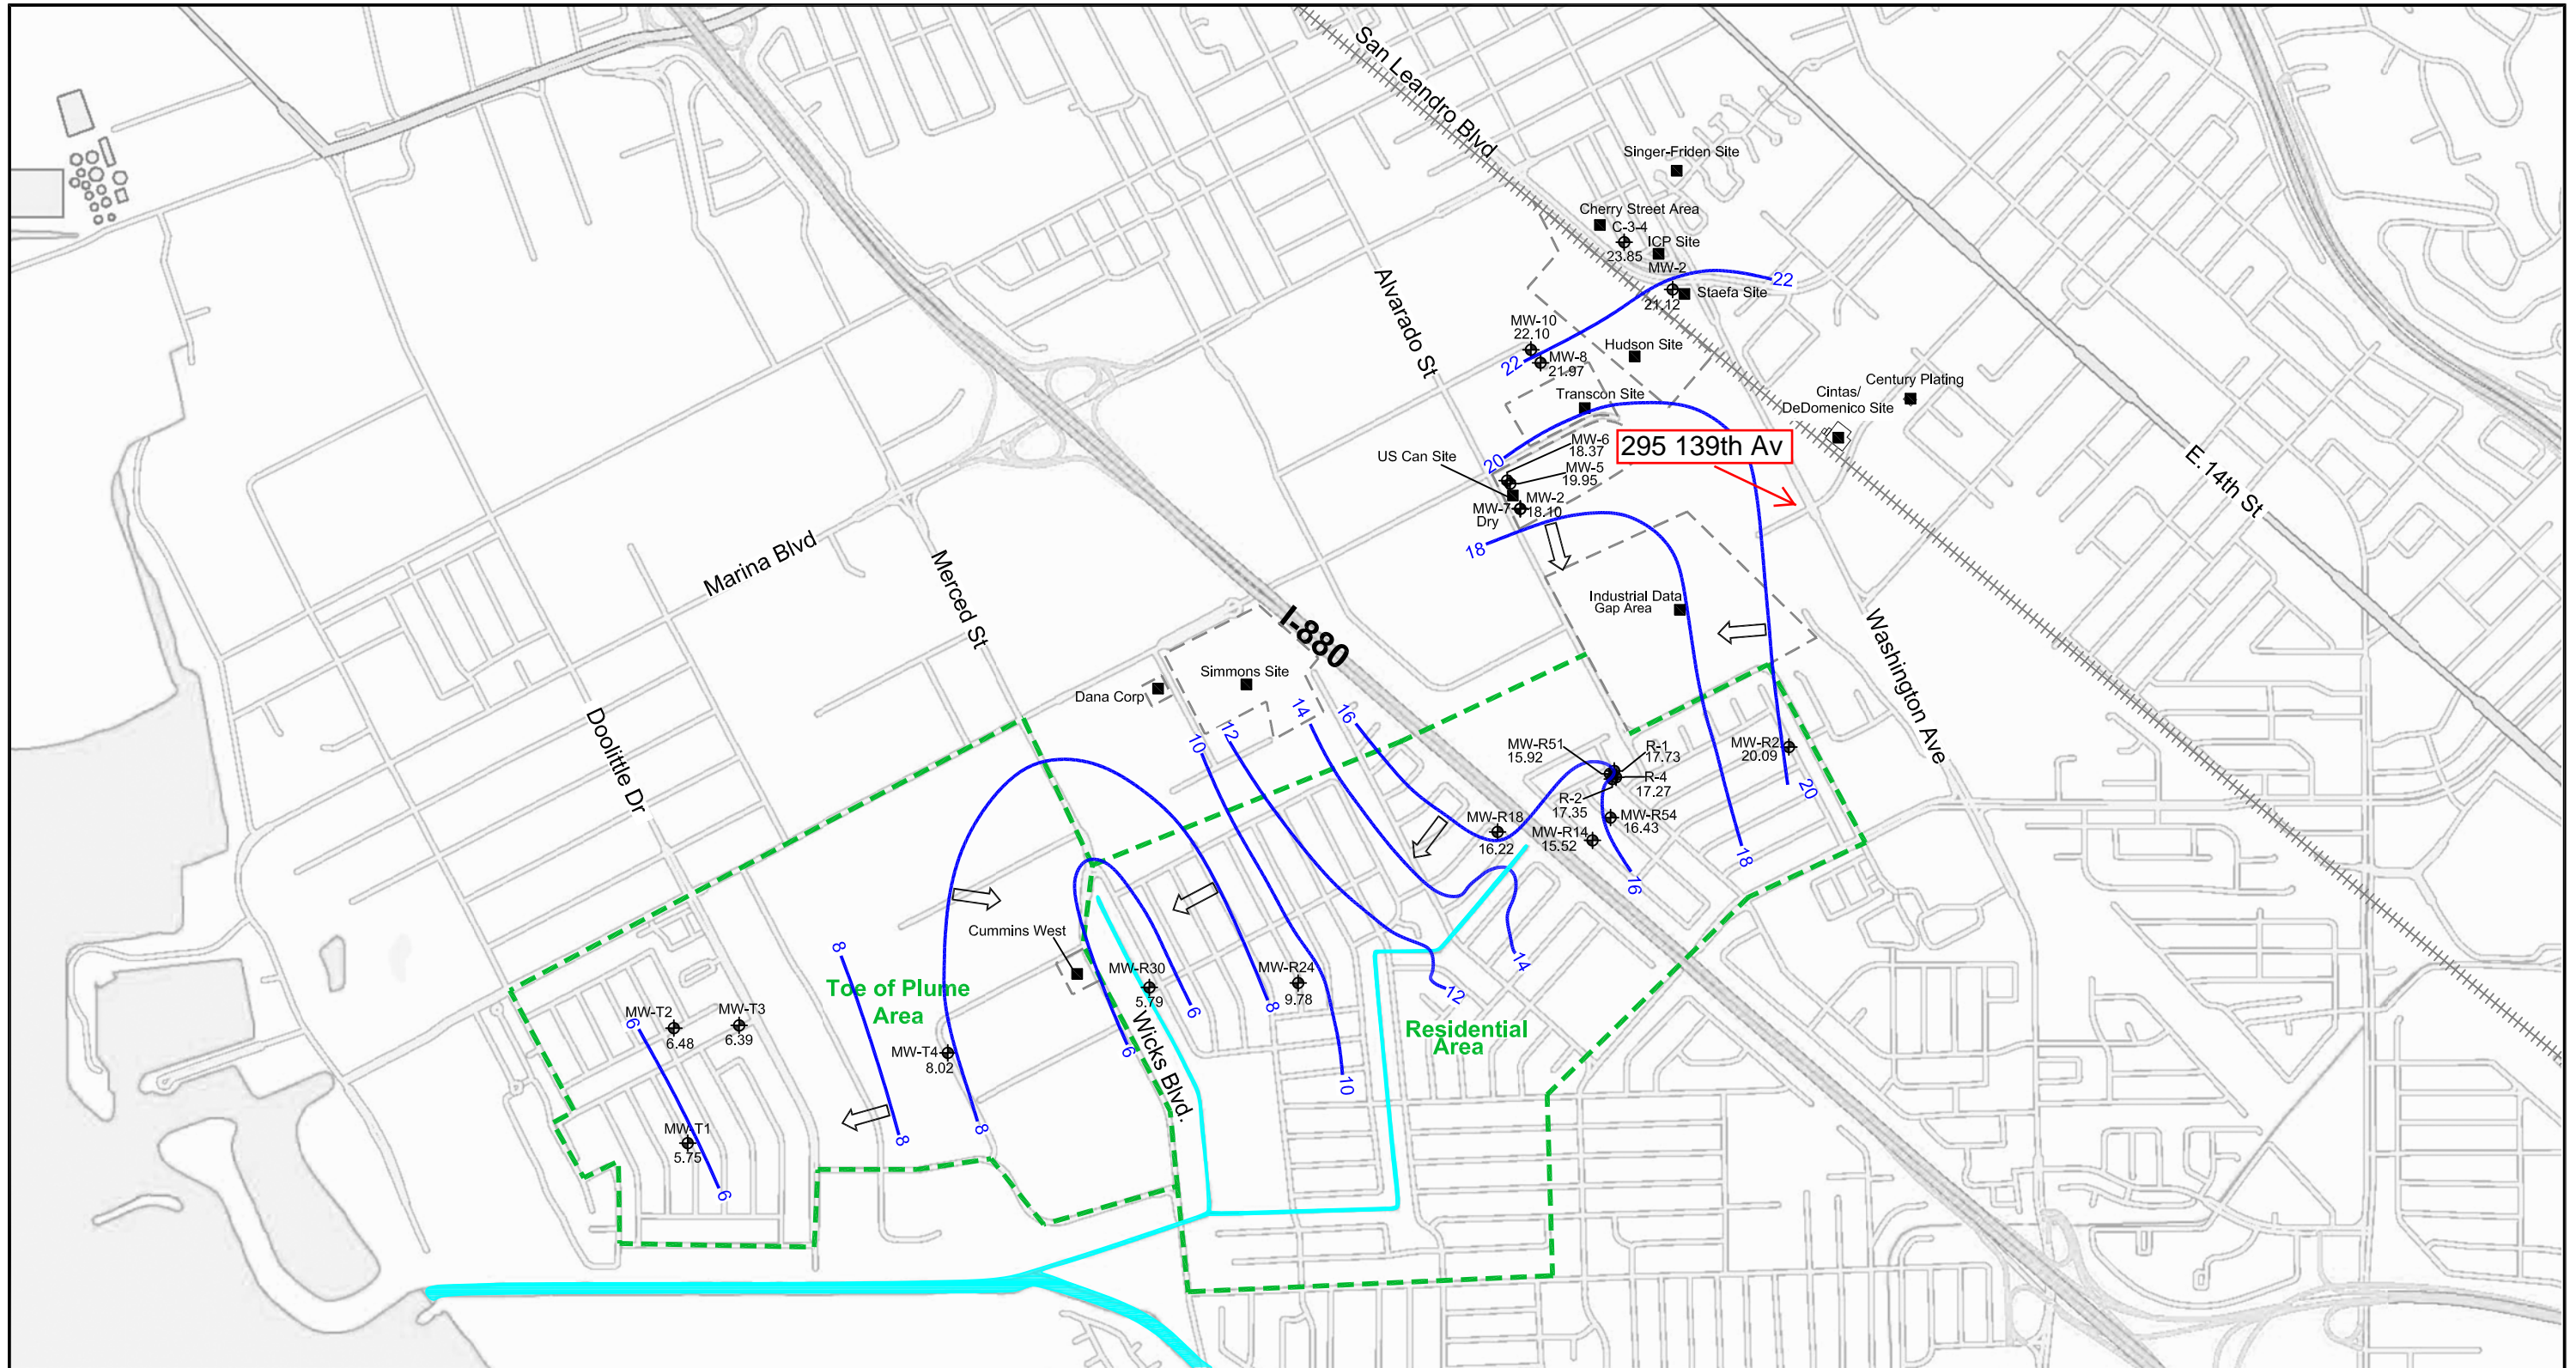
- ◆ 2014 Monitoring Well Network
- Individual Sites
- - - DWA Study Areas
- Approximate Groundwater Elevation Contour in Feet Above Mean Sea Level
- 5.35 Groundwater Elevation in Feet Above Mean Sea Level
- Surface Water Channel
- ⇒ Estimated Groundwater Flow Direction

DWA PLUME SAN LEANDRO, CALIFORNIA				<b>GROUNDWATER ELEVATION CONTOUR SEPTEMBER 2014</b>	
PROJECT NO.	DATE	DRAWN BY:	APP. BY:	<b>SGI THE SOURCE GROUP, INC.</b> <small>environmental</small> 3478 BUSKIRK AVENUE, SUITE 100 PLEASANT HILL, CA 94523	
01-DTSC-003	12/16/14	ZA	SD		
HORIZONTAL SCALE IN FEET				<b>FIGURE 3</b>

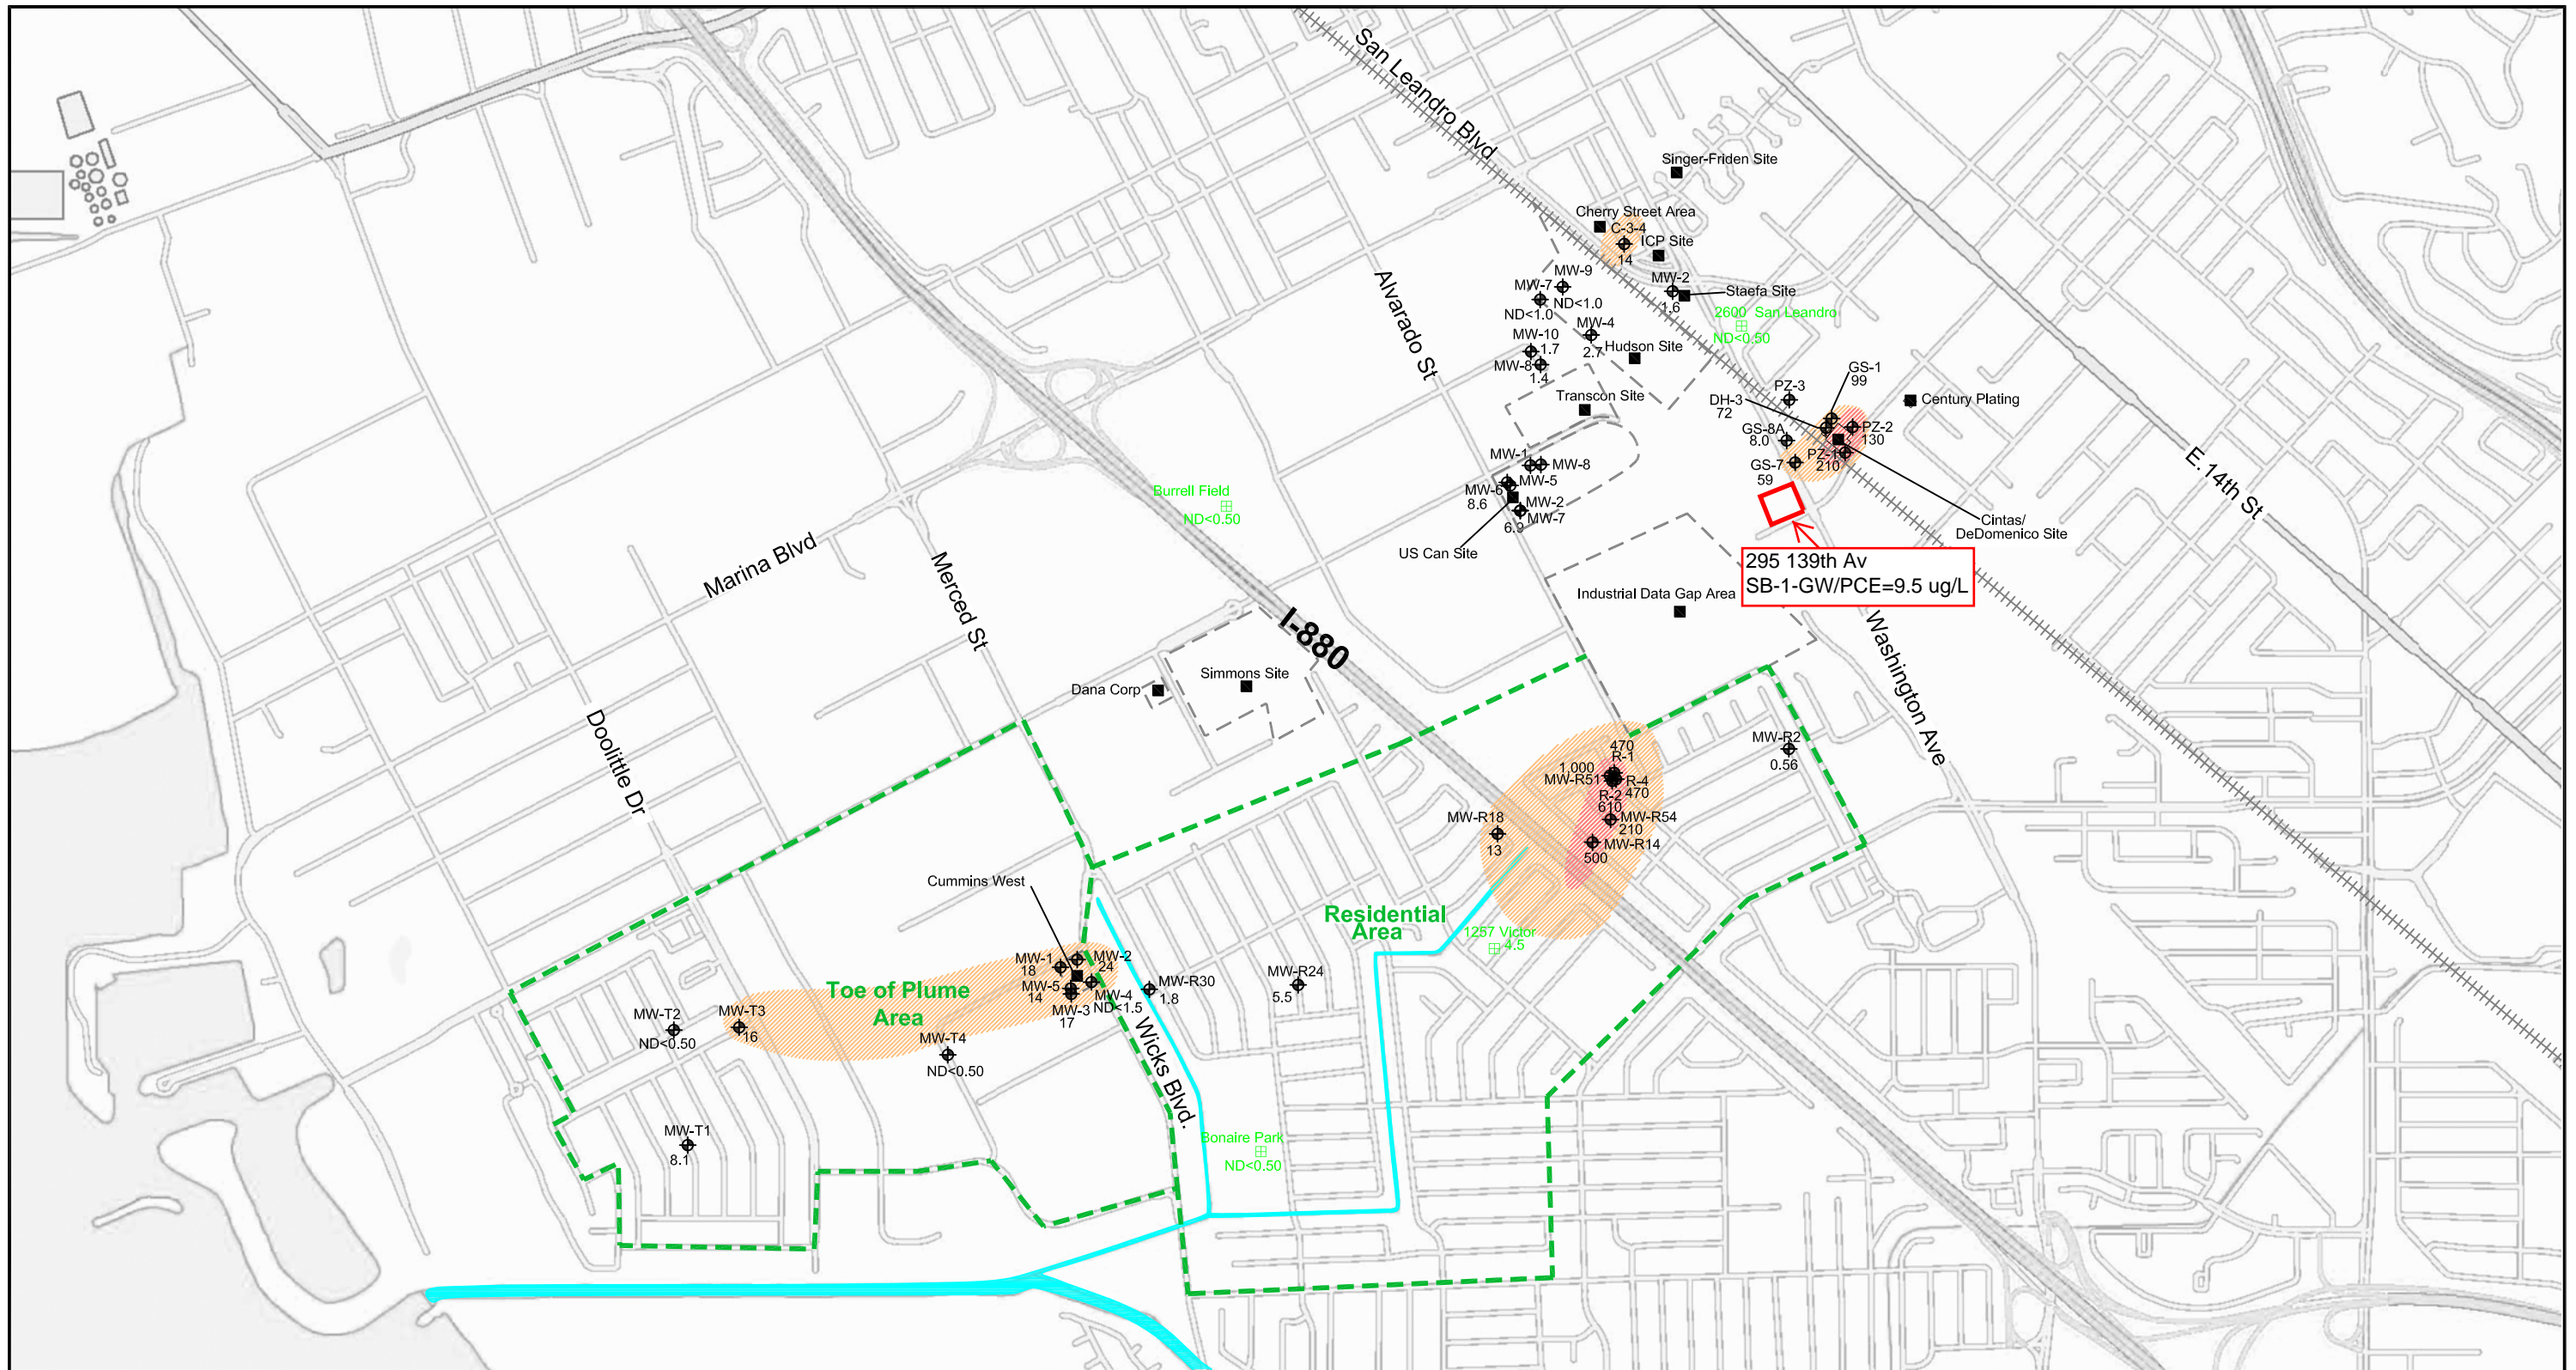
**FIGURE**  
 4

LEGEND	
	2014 Monitoring Well Network
	Private/Public Well
	Individual Sites
	DWA Study Areas
	Surface Water Channel
	PCE Concentration >10 µg/L
	PCE Concentration >100 µg/L
PCE	Tertachloroethene
µg/L	Microgram per Liter
ND	Below Noted Reported Limit

Notes:  
 1. Analytical Results from October 2014 except as noted below:  
 Cintas/DeDomenico - October 2013 Data (Environ, 2014);  
 Hudson - May 2014 Data (Professional Service Industries (2014));  
 Cummins West - July 2013 Data (Antea Group, 2013)).  
 2. Locations are approximate.

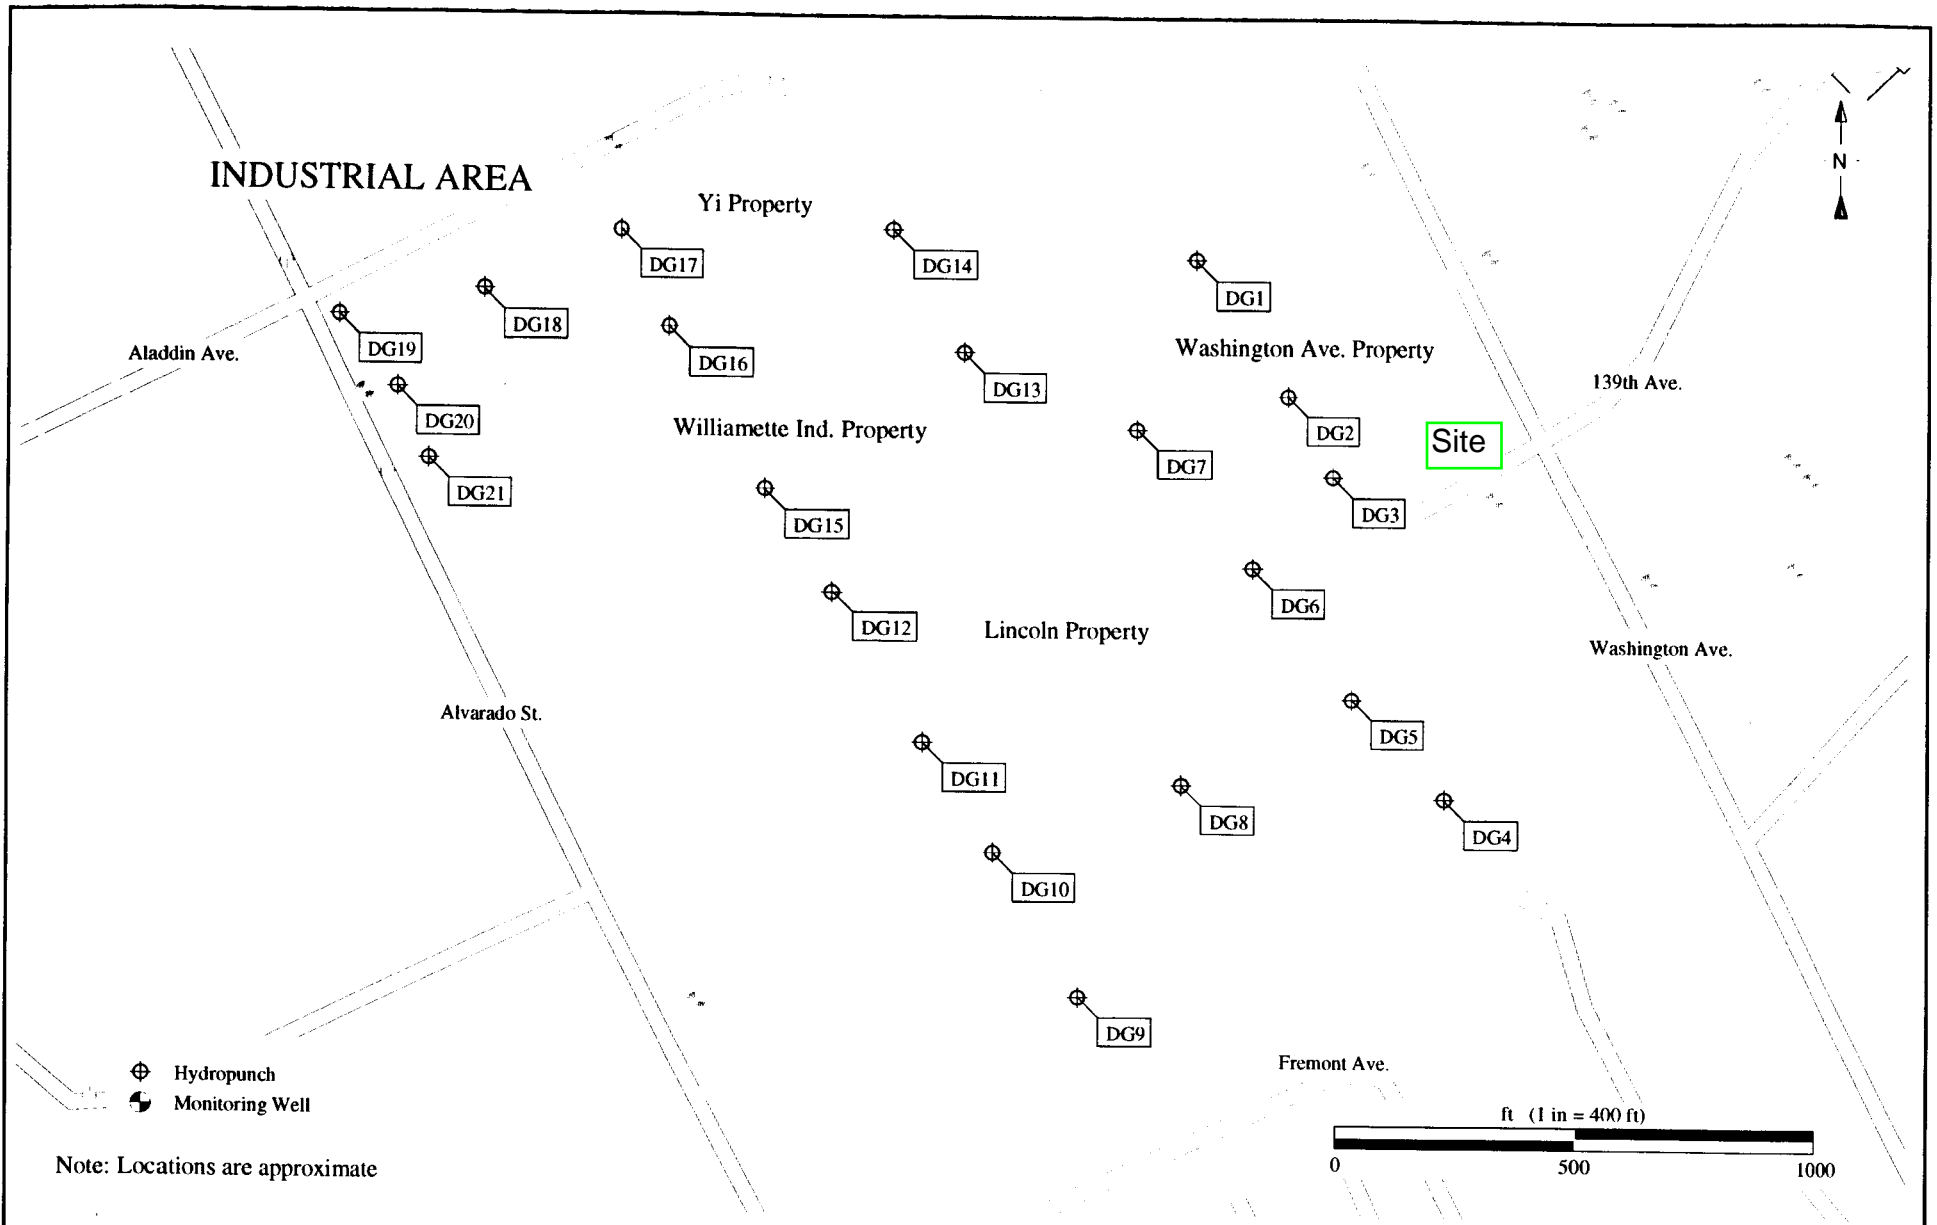
Project No. 931083NC	California EPA Department of Toxic Substances Control	Locations of CPT and Powerpunch/Hydropunch Sampling	March 1995
<b>Woodward-Clyde Consultants</b>			Figure 1

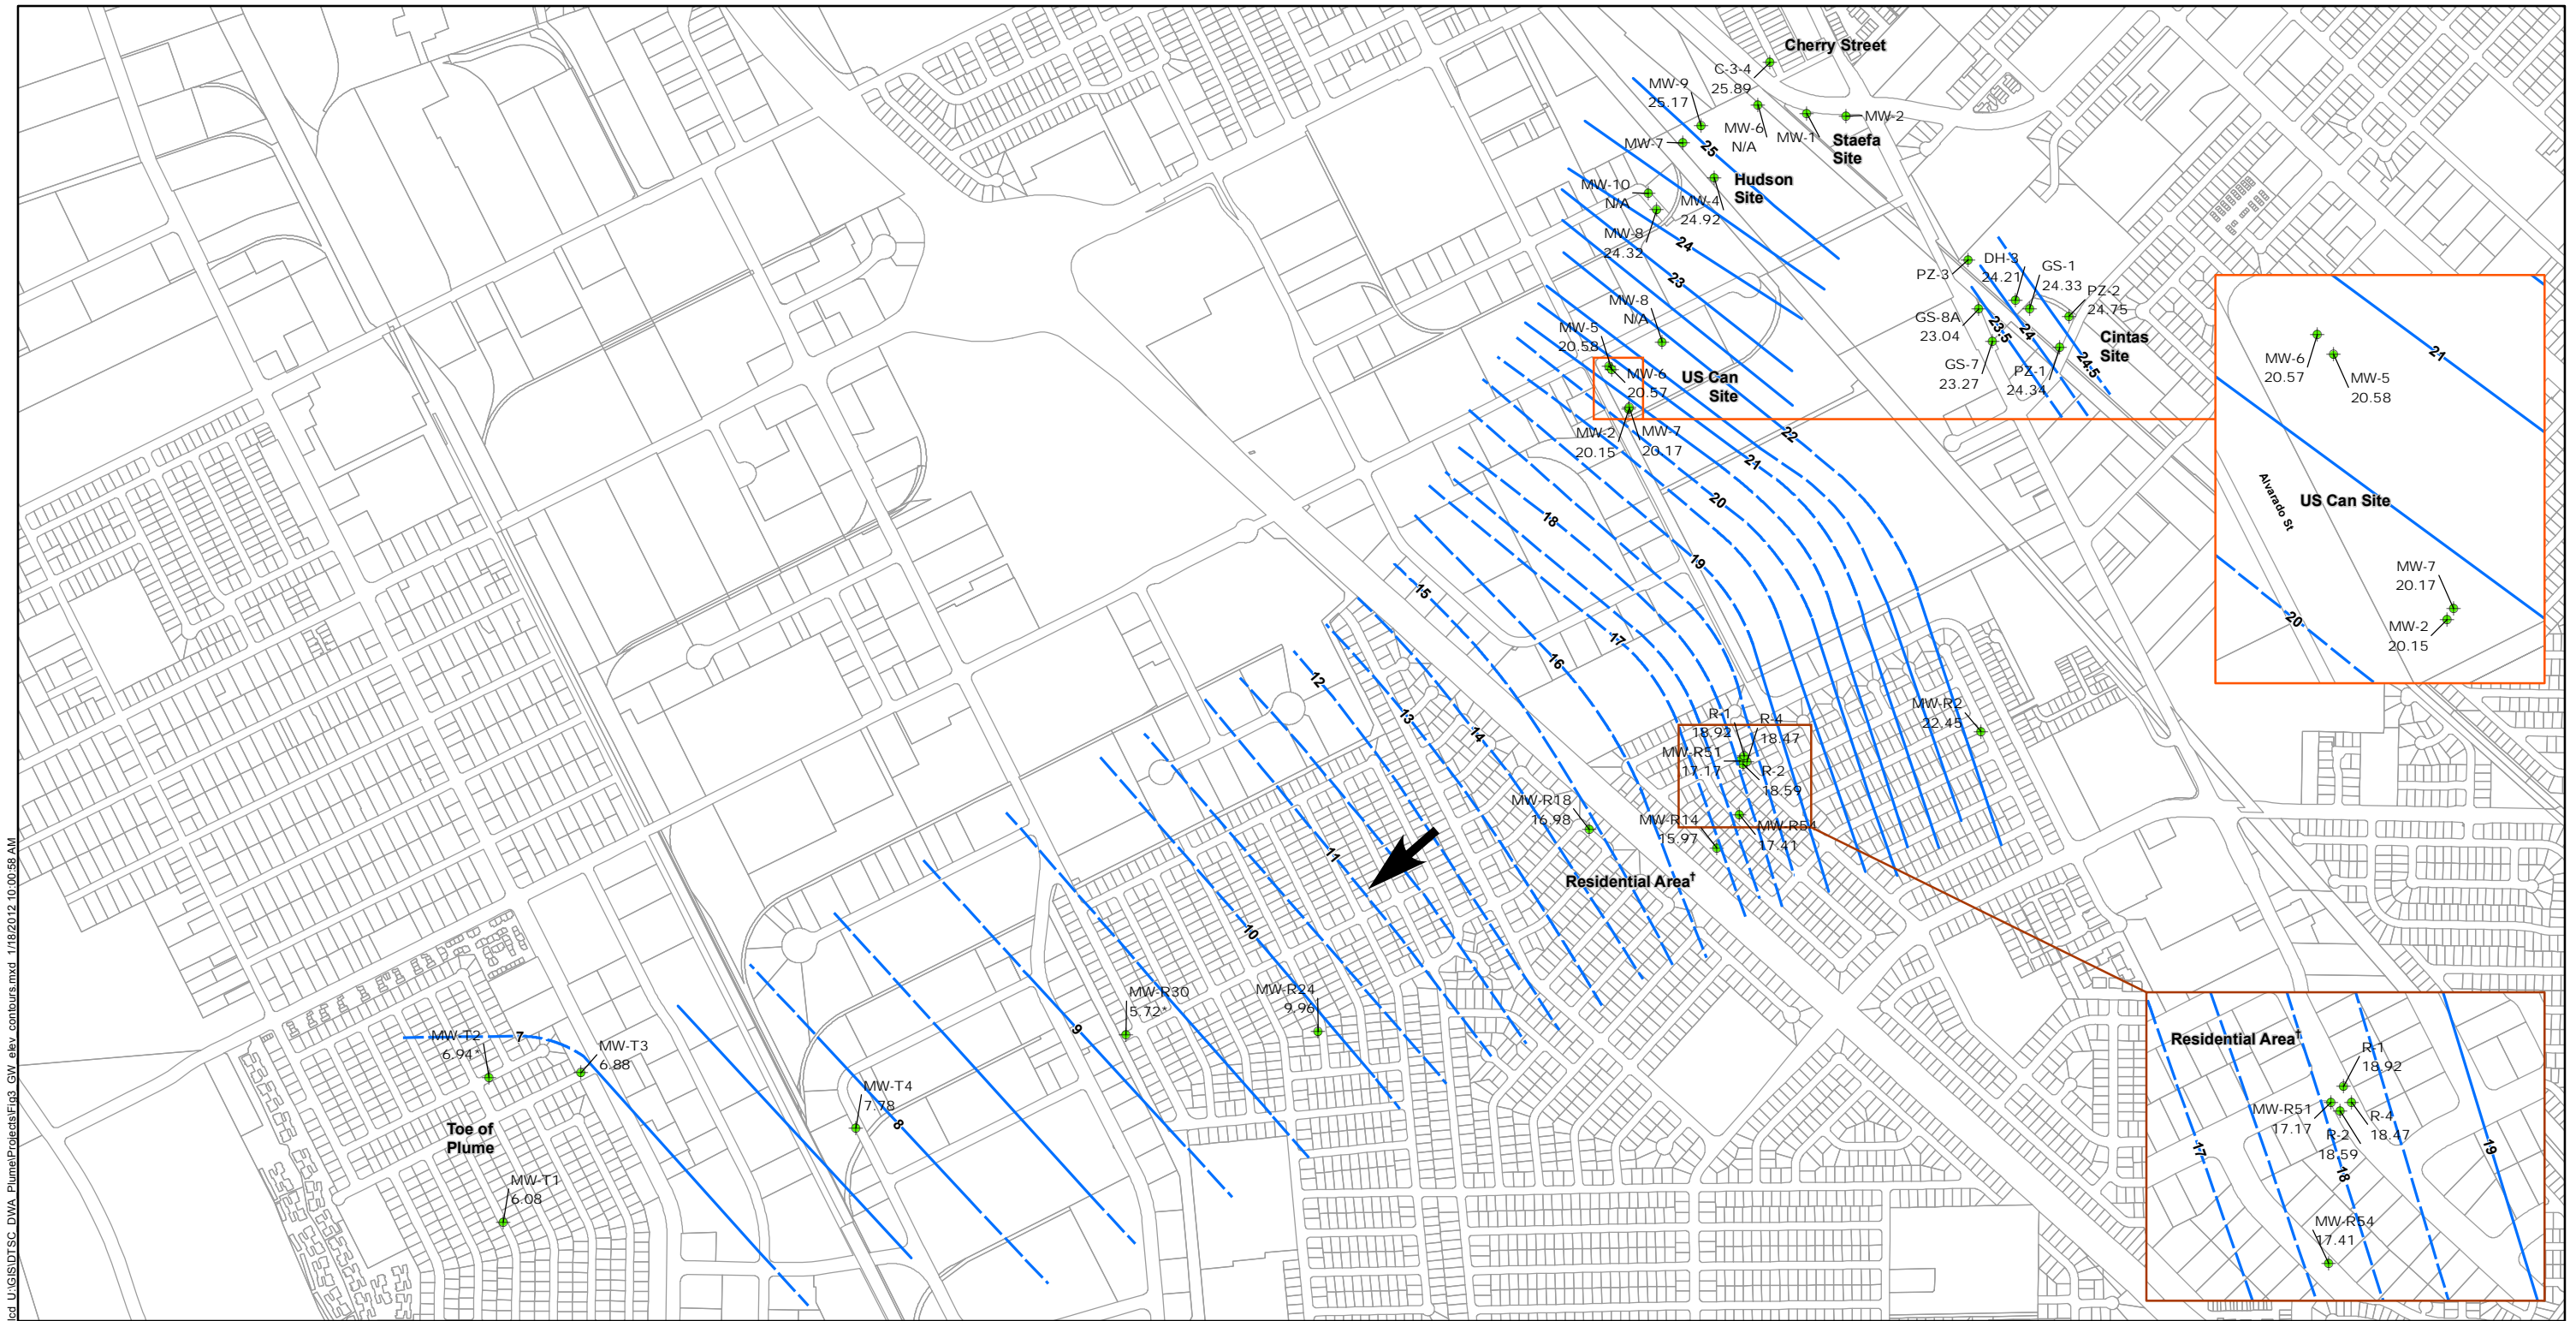
I:\GIS\DTSC\_DWA\_Plume\Projects\Fig3\_GW\_elev\_contours.mxd 1/18/2012 10:00:58 AM  
 Source: Parcels, Alameda County, 2009

- MW-T1  
6.08  
 Monitoring Well  
GW Elevation (feet mean sea level)
- 11  
 GW Elevation Contour (0.5-1.0' contours)
- Approximate Groundwater Flow Direction
