Subject: Baker Road Redevelopment  
20785 and 20957 Baker Road (Case #RO0003234)  
Castro Valley, California

Project No.  
**13255.000.000**

## **WORKPLAN FOR ADDITIONAL SITE CHARACTERIZATION**

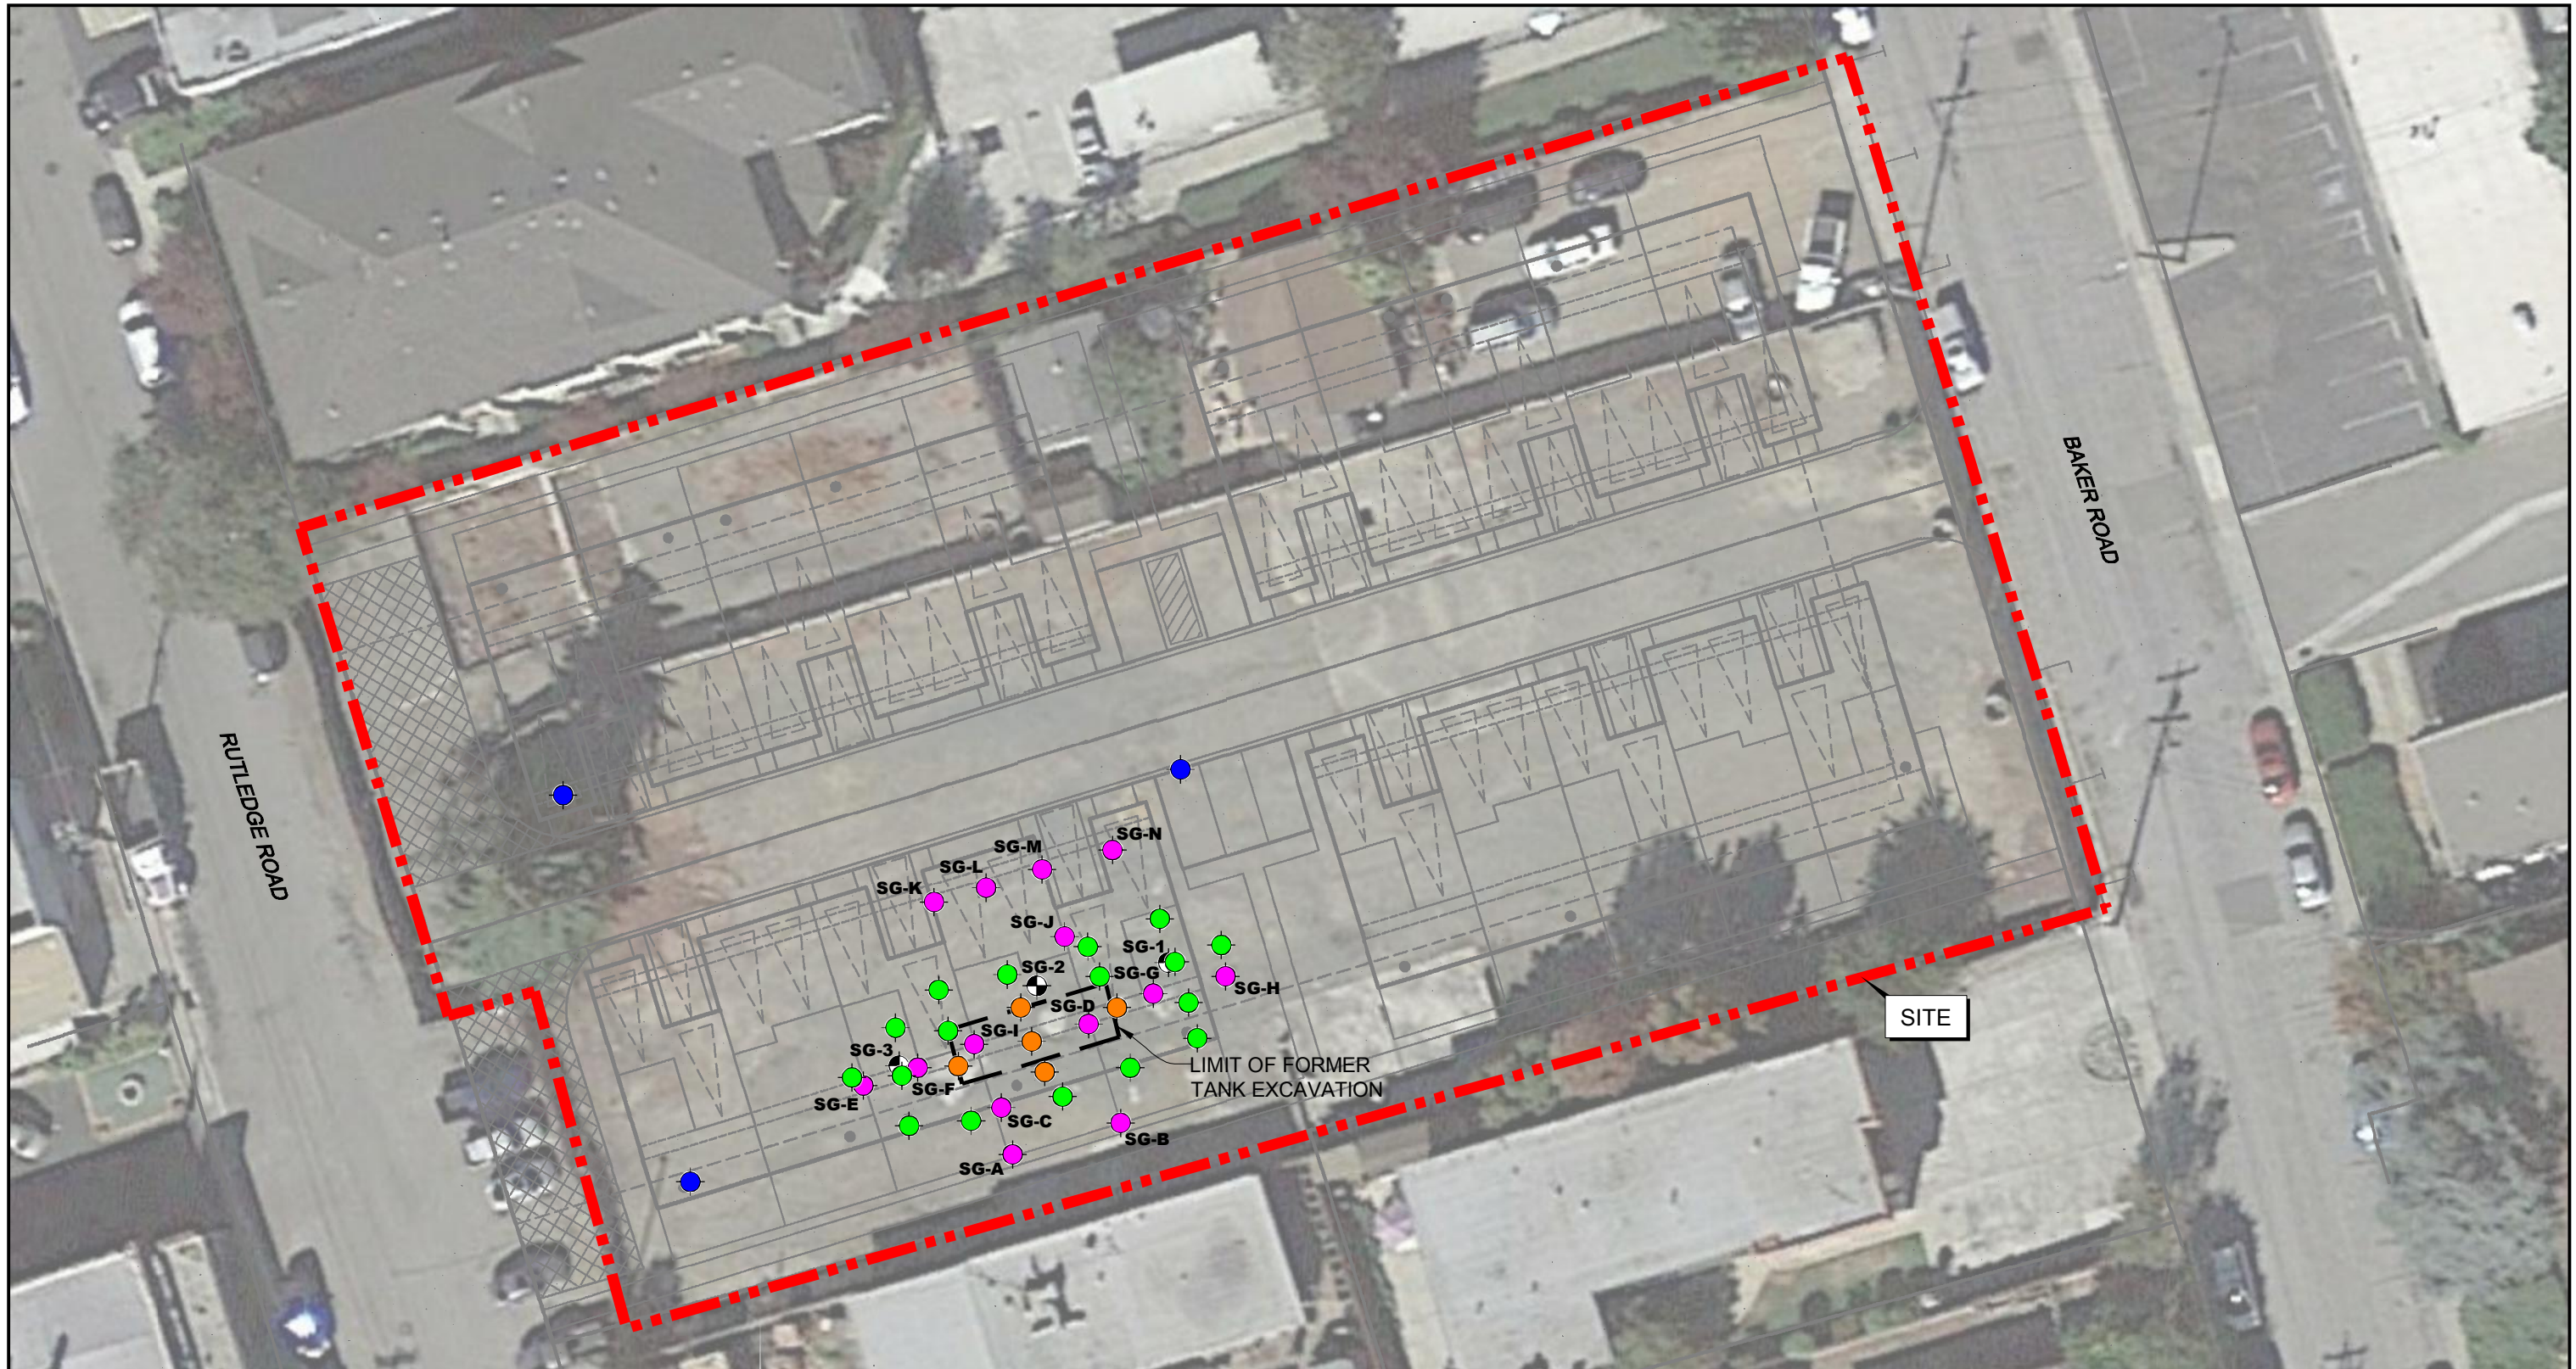
**Figure 2 – Proposed Boring Locations**

- SG-N** SOIL GAS SAMPLE (ENGEO, 2017)
- PROPOSED GRAB GROUNDWATER SAMPLE
- PROPOSED SOIL BORING TO 8 FEET
- PROPOSED SOIL BORING TO 5 FEET
- SG-3** PREVIOUS SOIL GAS SAMPLE (ENGEO, 2016)

PROPOSED BORING LOCATIONS  
20785 AND 20957 BAKER ROAD  
CASTRO VALLEY, CALIFORNIA

We will retain a C-57 licensed direct push drilling subcontractor to advance Geoprobe® borings at three locations until groundwater is encountered (anticipated to be approximately 12 feet below the ground surface) (Figure 2). The Sampling and Analysis Plan (SAP) is presented in Appendix A.

In order to further define the vertical and lateral extent of residual impact associated with the former USTs, one soil boring will be advanced within the footprint of the former tank excavation, and four borings will be advanced along the perimeter of the former tank excavation. These five borings will be advanced to depths of 10 feet below ground surface (at the base of the tank excavation), as shown in Figure 2. Two soil samples (for a total of ten soil samples) will be recovered from each boring at the following depth intervals: approximately 4½ to 5 feet below the ground surface and approximately 7½ to 8 feet below the ground surface (at the base of the former UST excavation). The SAP is presented in Appendix A.

An additional 17 soil borings will be advanced within the vicinity of the former UST excavation to assess the potential presence of a bioattenuation zone within the upper five feet of soil. One soil sample from each of the seventeen soil borings will be recovered from an approximate depth interval of 4½ to 5 feet below the ground surface.
