Re: **Remedial Design and Implementation Plan**
Bockman Road Property (East Sector)
1233 Bockman Road
San Lorenzo, California 94577
ACDEH Case # RO003239

REMEDIAL DESIGN AND IMPLEMENTATION PLAN

**Bockman Road Property (East Sector)
1233 Bockman Road
San Lorenzo, CA 94577
ACDEH Case # RO003239**

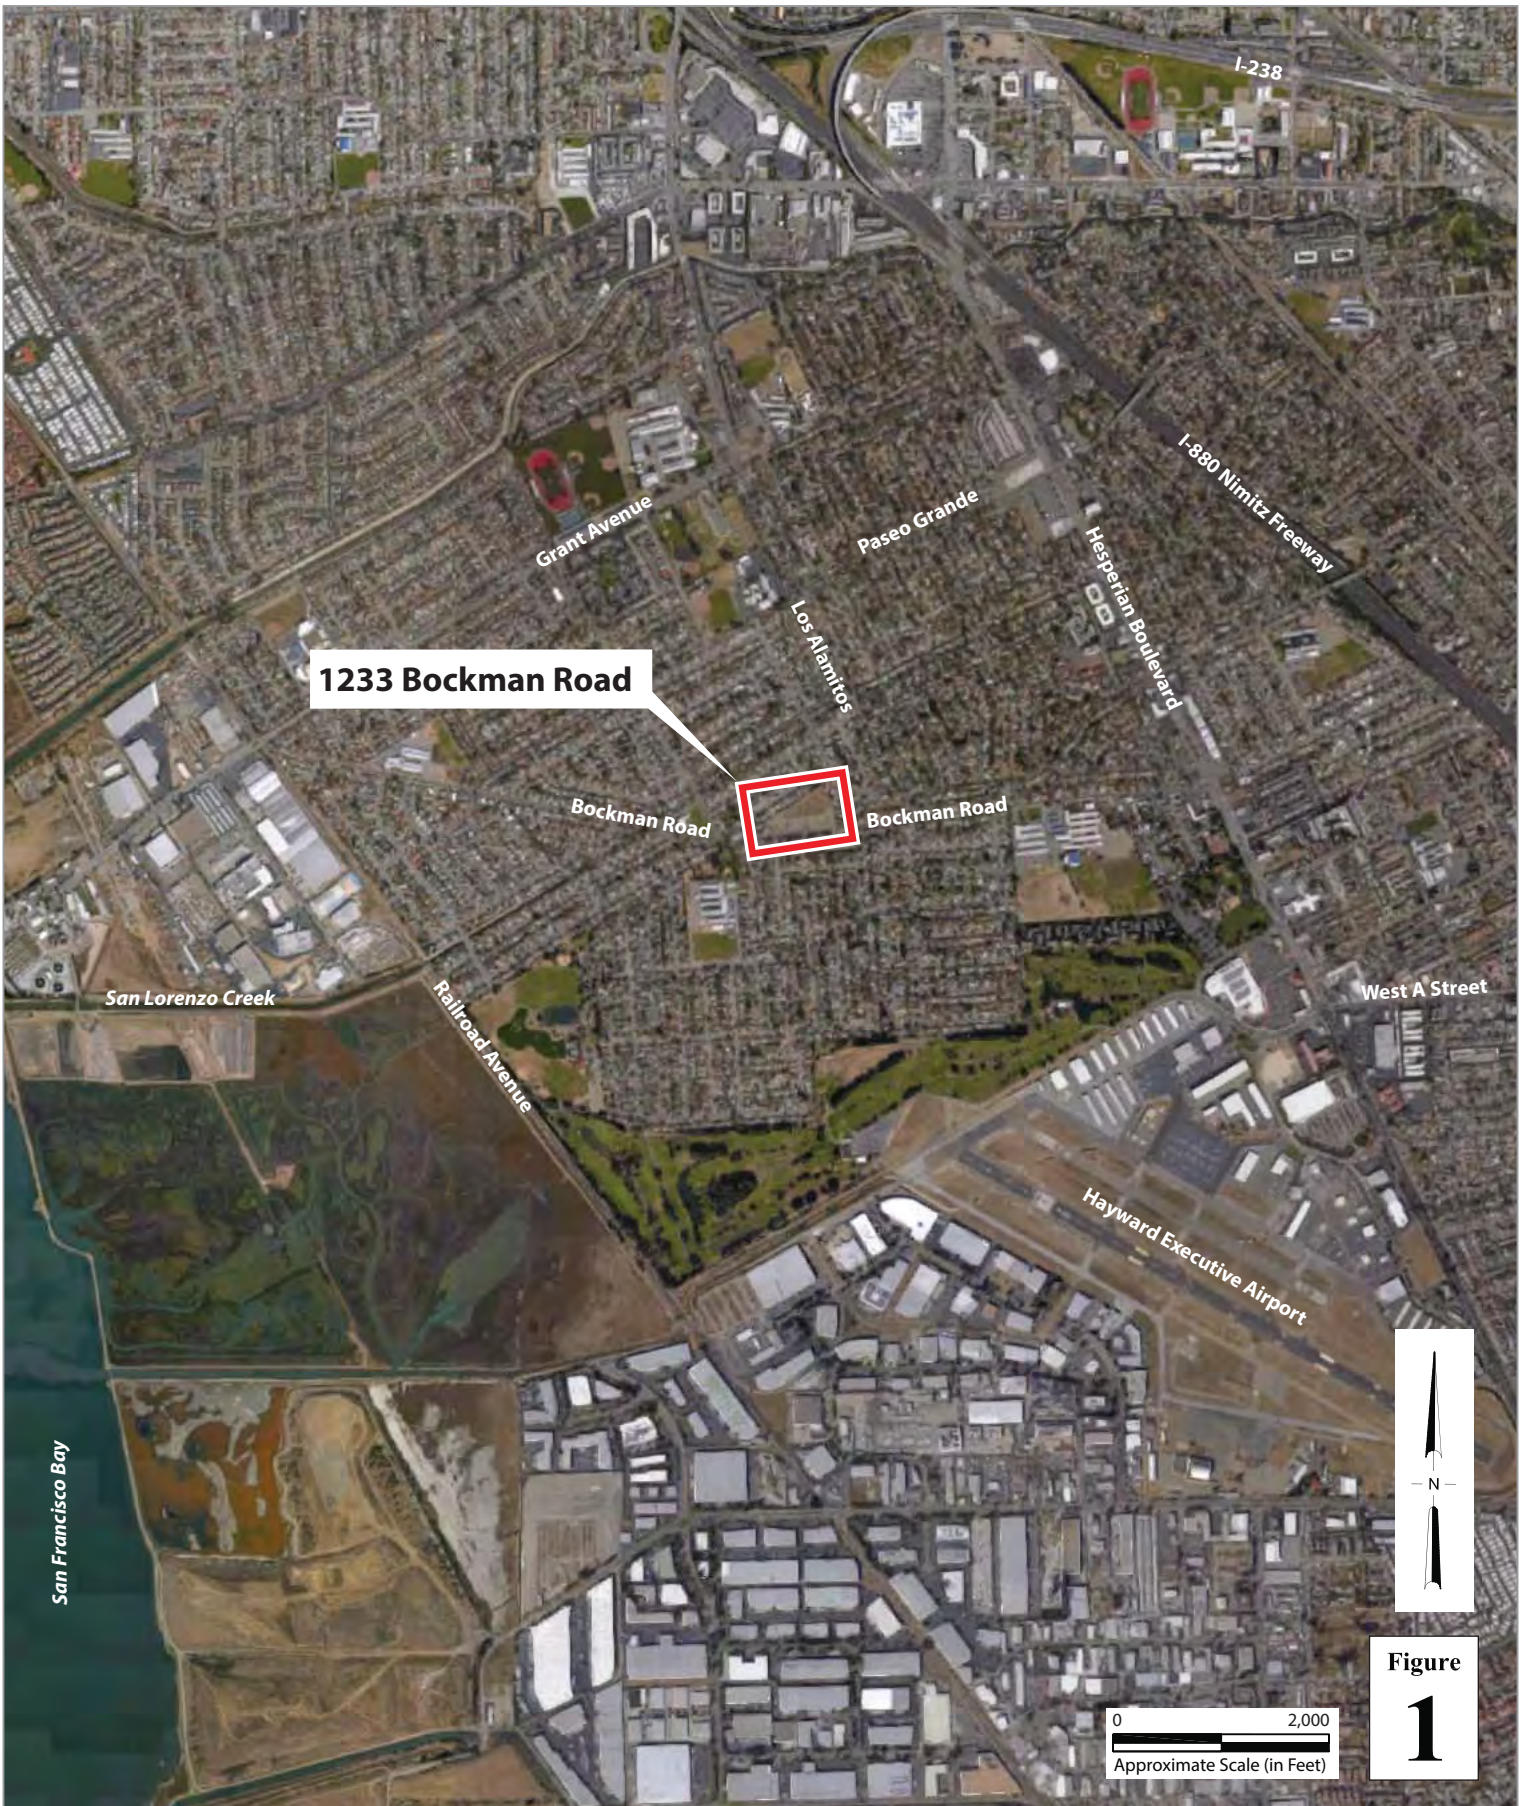
Figure
1

Vicinity Map

The relatively flat Site lies at an elevation of approximately 20 feet above mean sea level to the east of San Francisco Bay (Figure 1). Soil beneath the Site consists of sandy gravel fill (likely base rock material) to approximately 1 ft bgs underlain by 2 to 3 feet of moderately plastic clay. The clay layer is underlain by silt and a discontinuous, one-foot thick sand lens observed intermittently between 6 and 10 feet bgs. Pangea observed groundwater between 7 and 9 feet bgs, while others reported first encountered groundwater deeper. Based on data from neighboring sites, static groundwater was approximately 8 ft bgs (1201 Bockman) and groundwater flows to the northwest.
