## **SITE MANAGEMENT PLAN**

Aster Apartments  
6775 Golden Gate Drive  
Dublin, California

**Amec Foster Wheeler Environment & Infrastructure, Inc.**  
180 Grand Avenue, Suite 1100  
Oakland, California 94612

July 2017

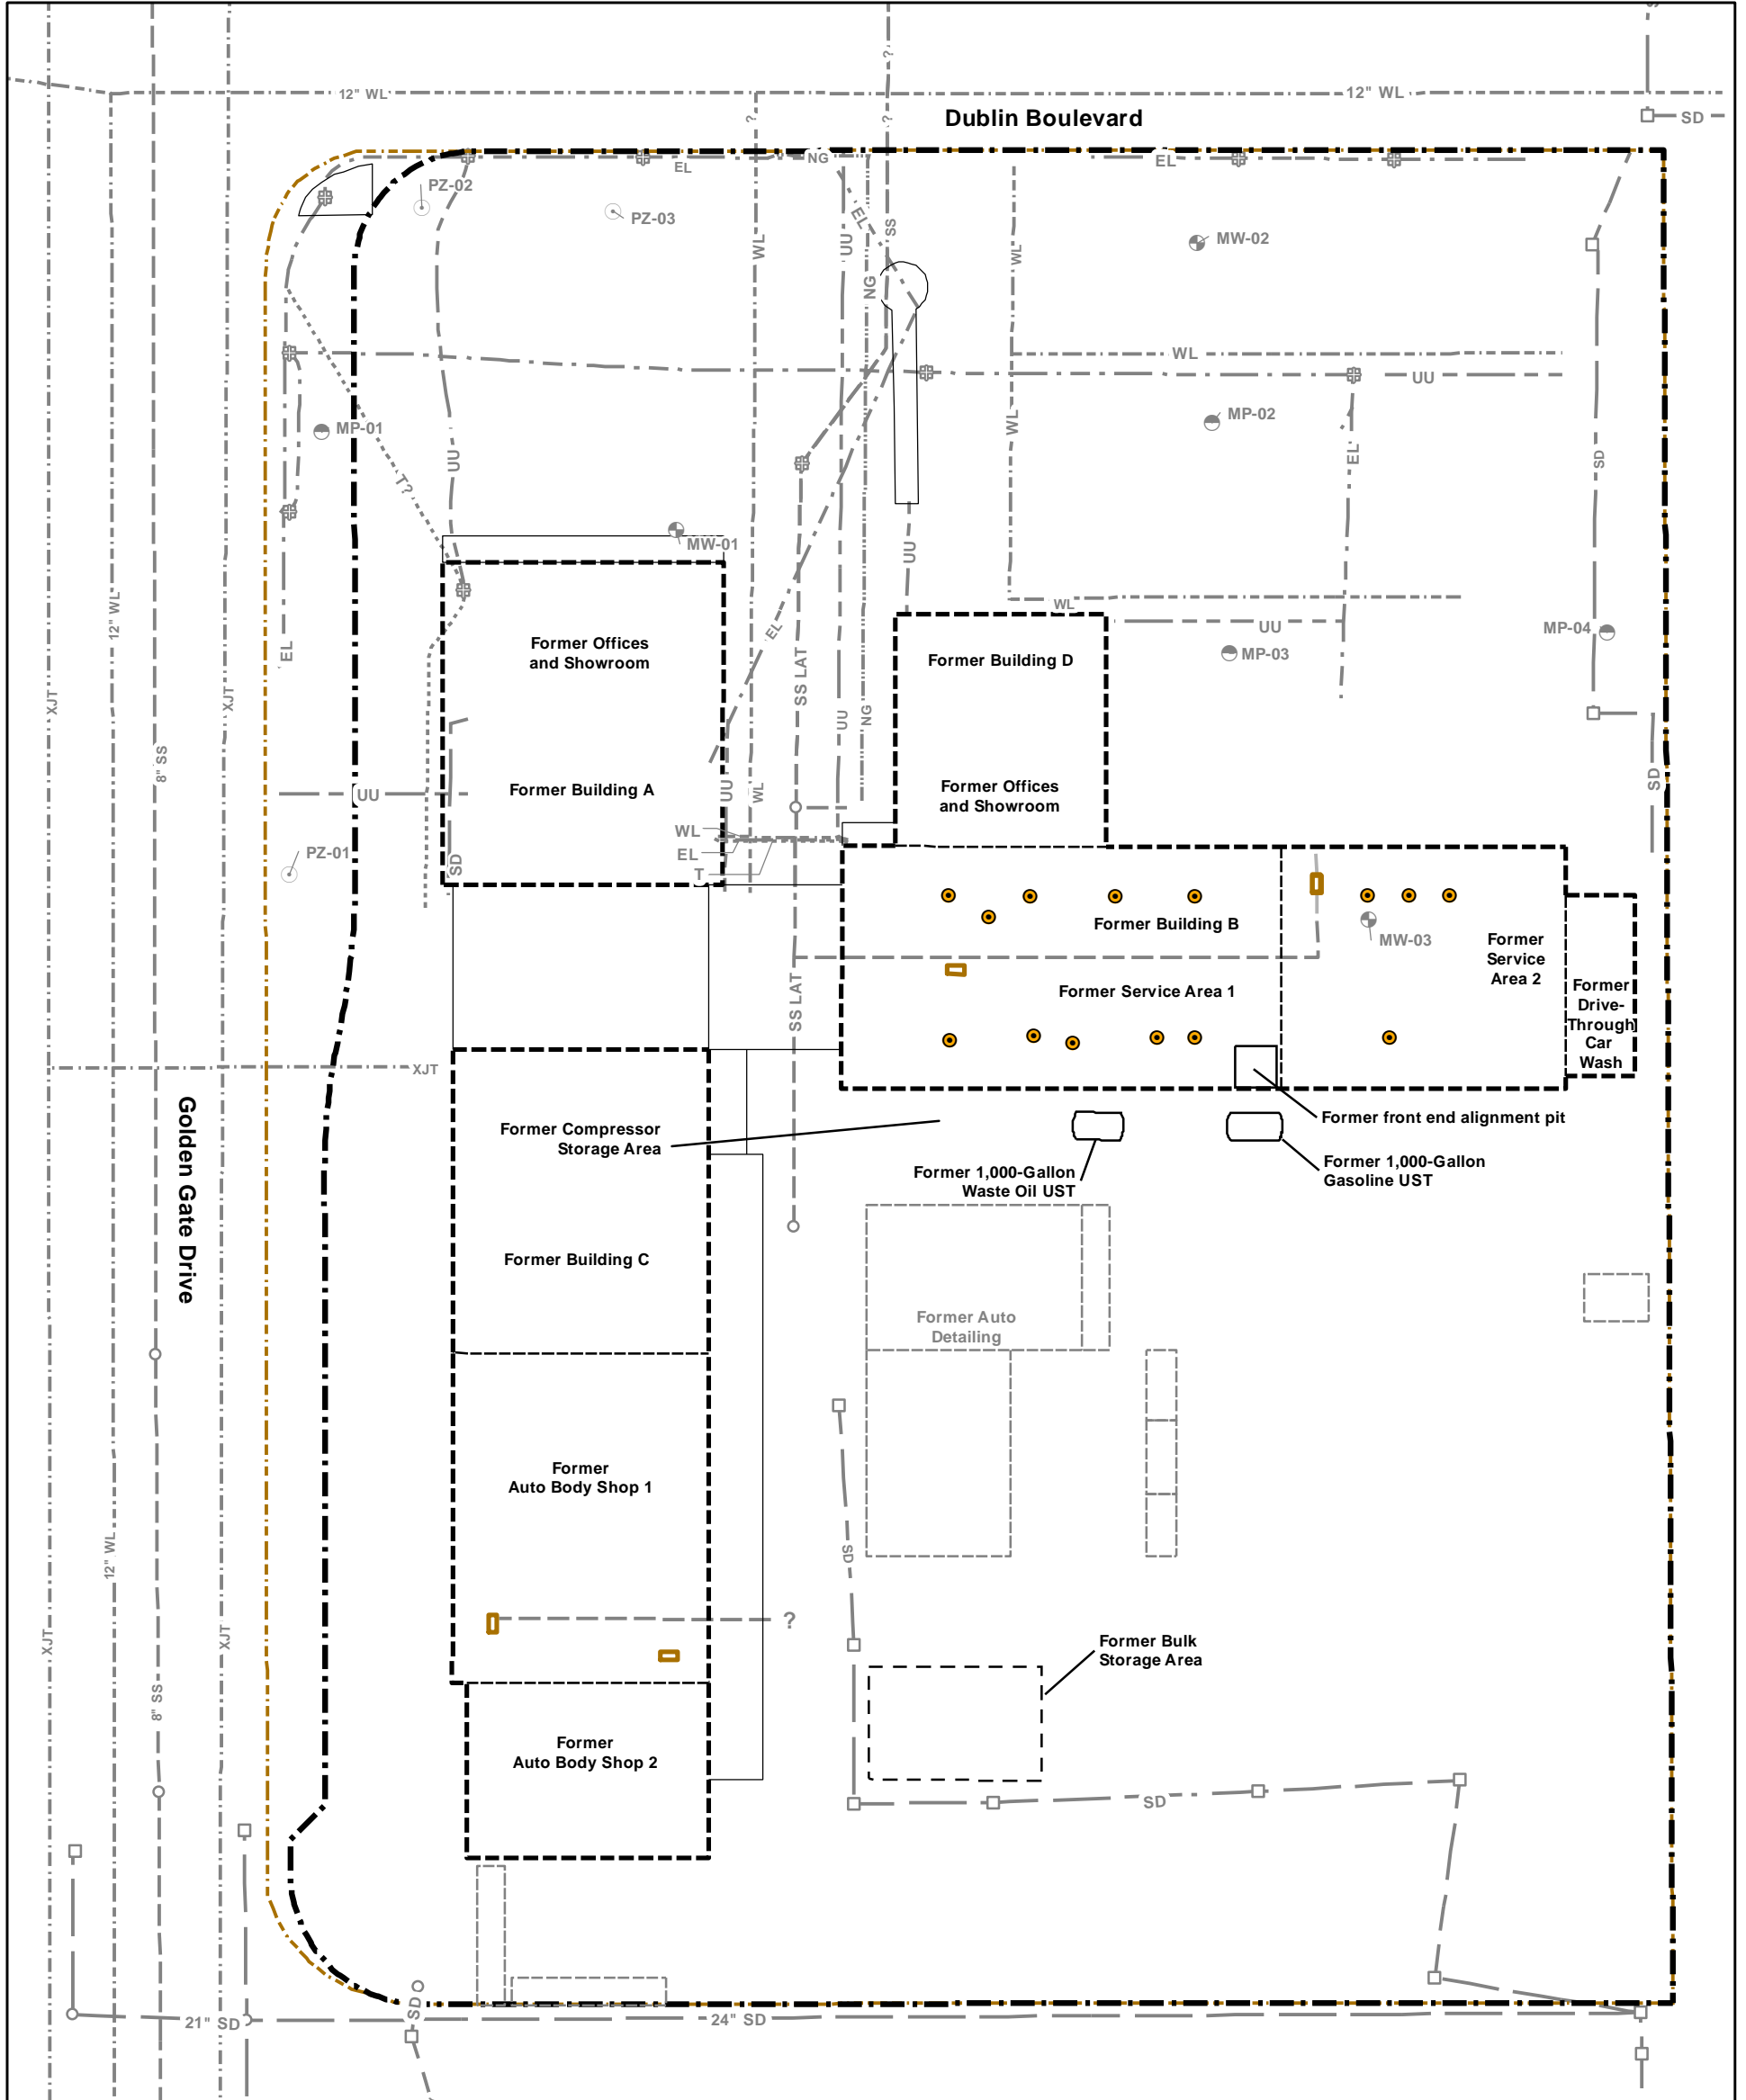
**FORMER BUILDINGS AND FEATURES**  
Aster Apartments  
6775 Golden Gate Drive  
Dublin, California

Prior to redevelopment, the site was operated as Crown Chevrolet, a car dealership, repair shop, and auto body shop, beginning in 1968 (Figure 3); all operations ceased in 2013. The property was sold in the fall of 2014, and the demolition and removal of existing parking areas, buildings, sumps, and hydraulic lifts was performed by Dublin Apartment Properties in 2014 and 2015 in preparation for redevelopment (Amec Foster Wheeler, 2015c).

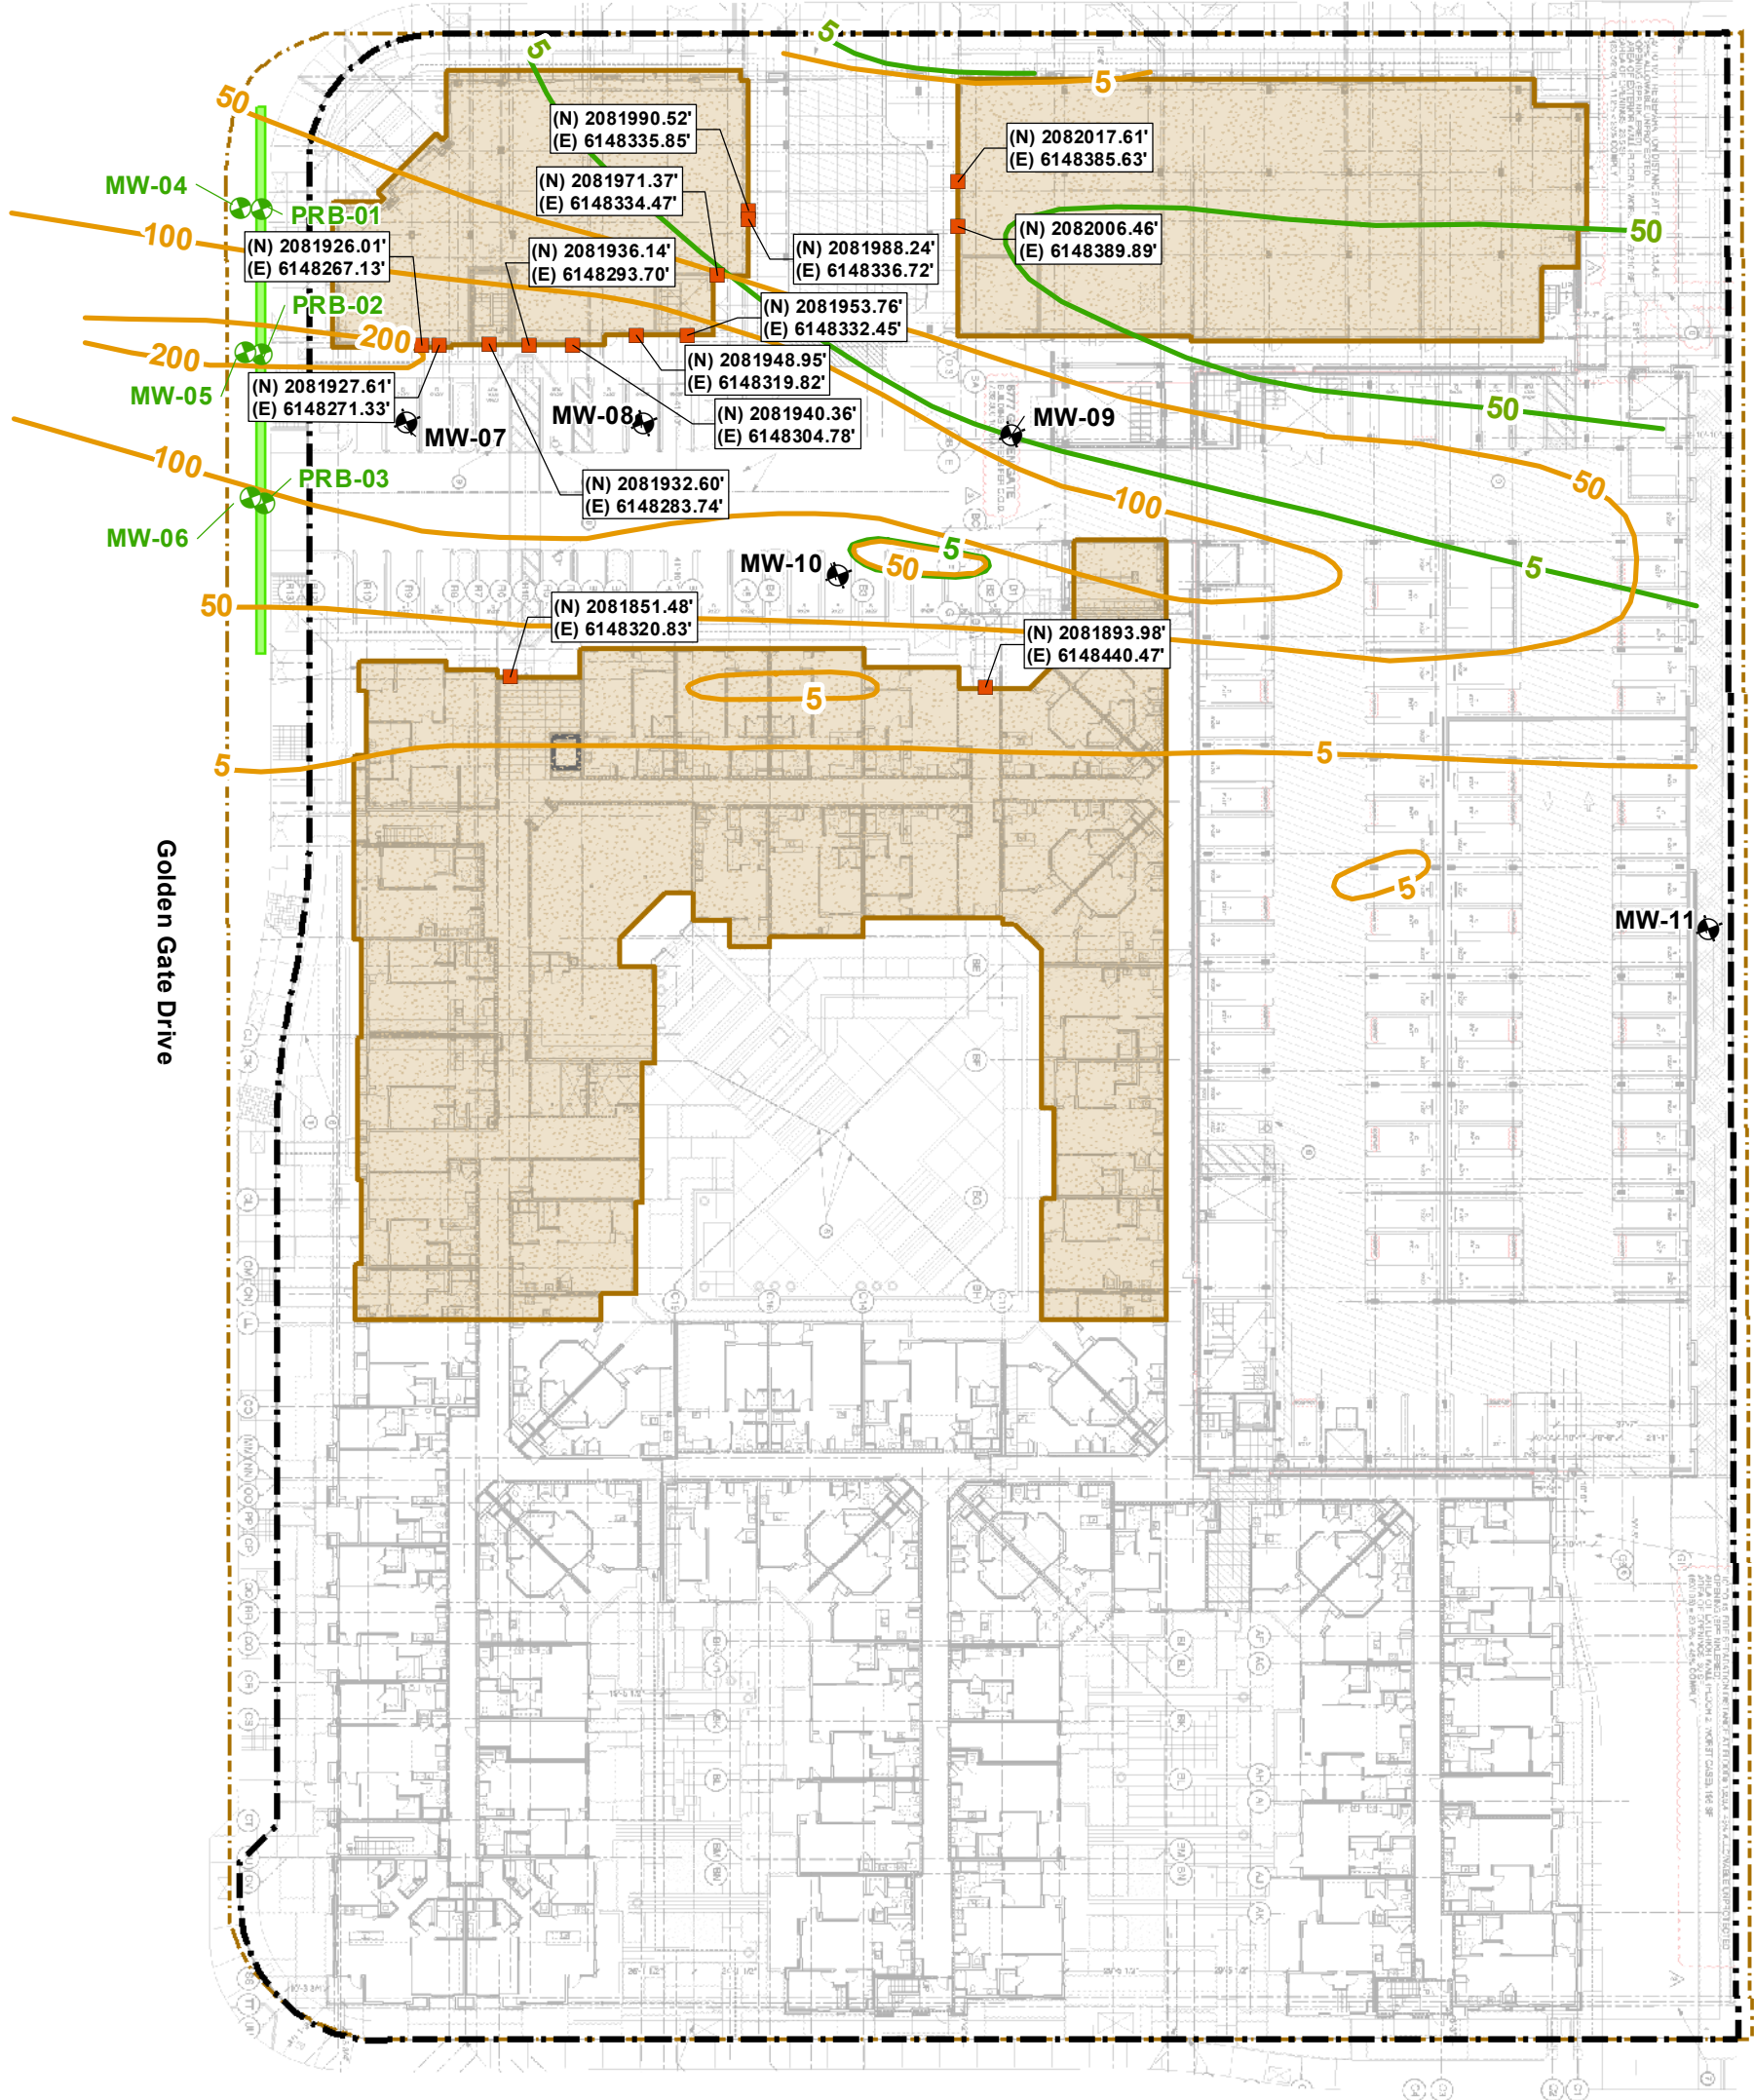
- PRB performance monitoring well location
- On-site monitoring well location
- Approximate line of equal PCE concentration in shallow groundwater (µg/L)
- Approximate line of equal TCE concentration in shallow groundwater (µg/L)
- Extent of permeable reactive barrier (PRB)
- Extent of vapor mitigation system (VMS)
- Current property line
- Former property line
- Concrete utility trench plug

PERMEABLE REACTIVE BARRIER  
 AND VAPOR MITIGATION SYSTEM  
 Aster Apartments  
 6775 Golden Gate Drive  
 Dublin, California

The PRB was installed October 2015 near the northwest corner of the site, where the impacted groundwater is entering the site (Figure 4). It was designed to passively treat the impacted groundwater as it moves beneath the site. The PRB consists of a 24-inch wide, 146-foot-long continuous trench that is backfilled with ZVI/sand treatment media. The PRB extends to approximately 29 feet below ground surface (bgs), including a 1-foot key into an existing clay layer observed from approximately 28-30 feet bgs. The upper 7-8 feet of was completed with controlled-density fill (CDF) to existing grade. The PRB does not require regular maintenance.

As part of, and supplemental to the VMS, utility trench plugs along the building foundations where utilities entered the building footprints to establish an impermeable collar (Figure 4). The trench plugs were installed to prevent preferential flow of potentially contaminated soil vapor from areas outside the building footprint to the sub-slab area, as well as a geotechnical measure (Rockridge Geotechnical, 2015) to prevent water from entering the sub-slab area. The plugs consist of a concrete sand slurry backfill material that is installed at each location over a length of 3 feet along the trench axis.

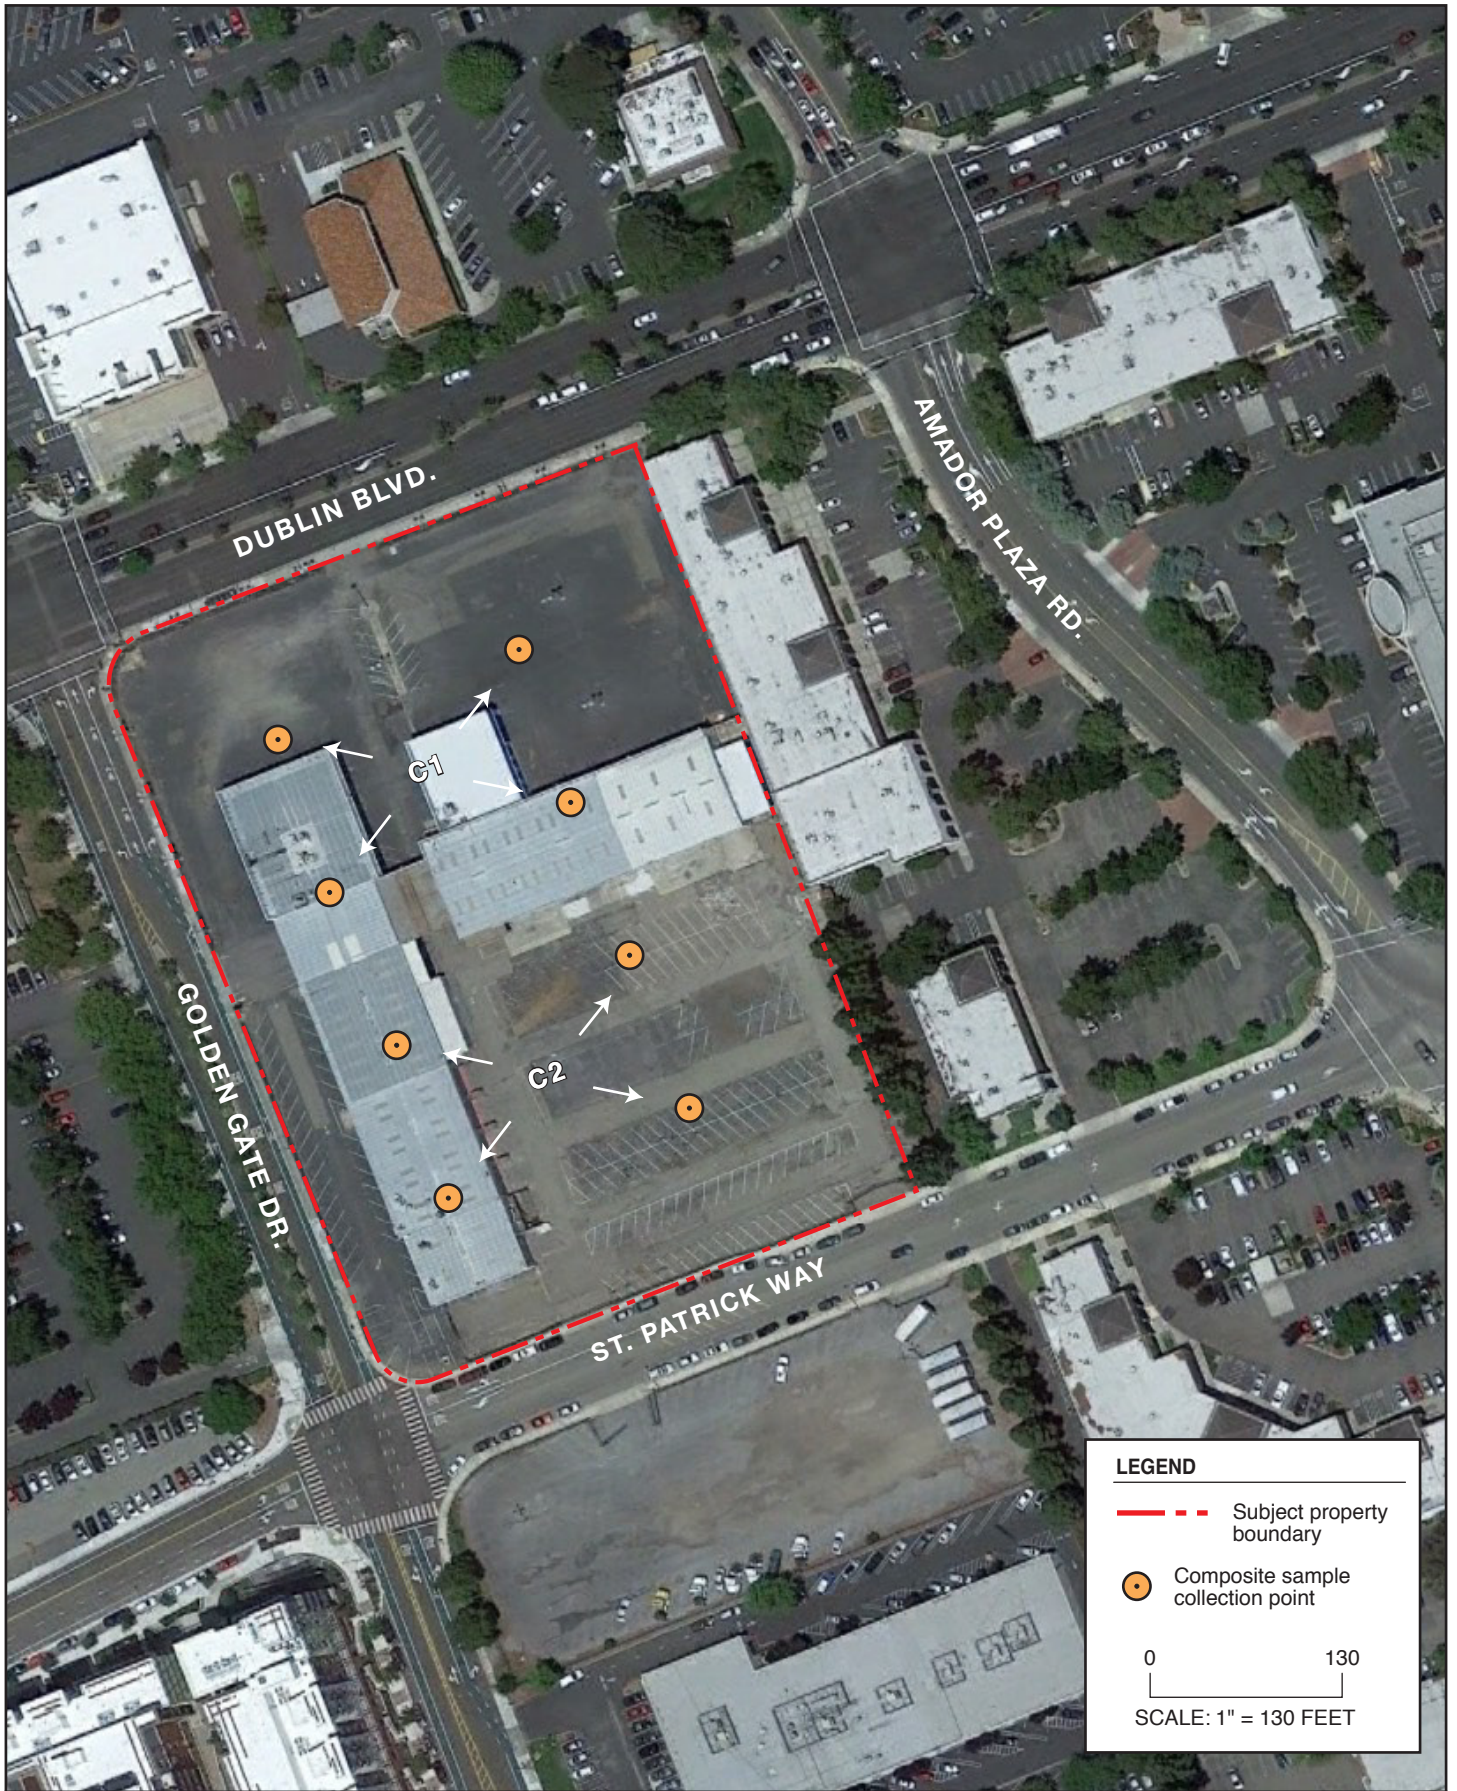
- - - Subject property boundary
- Composite sample collection point

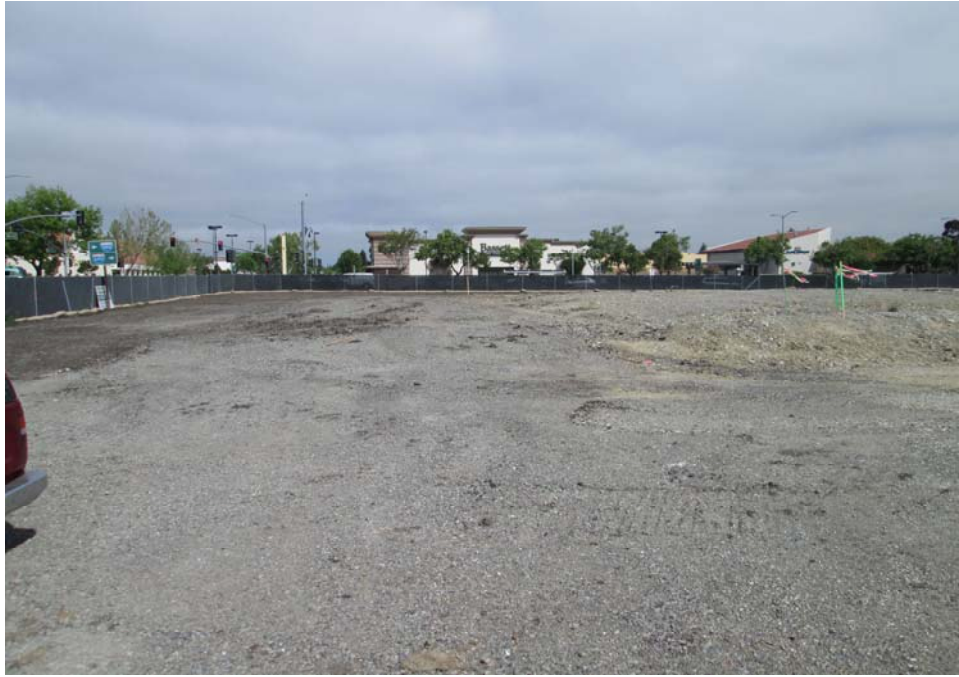
Photo No.: 01

Subject: Recently graded site

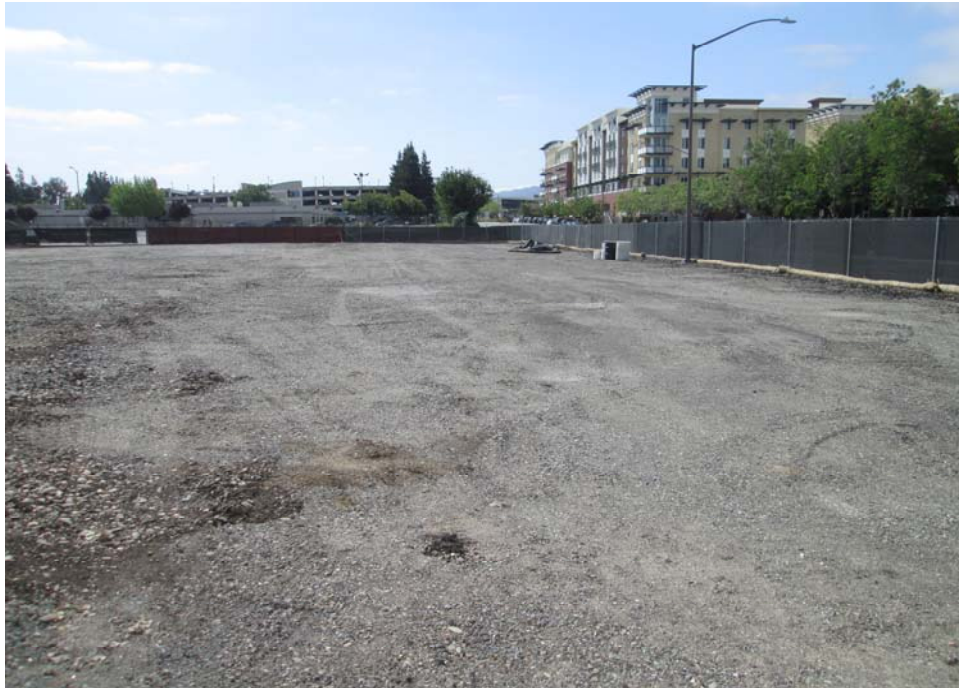
Subject: Location of composite sample point

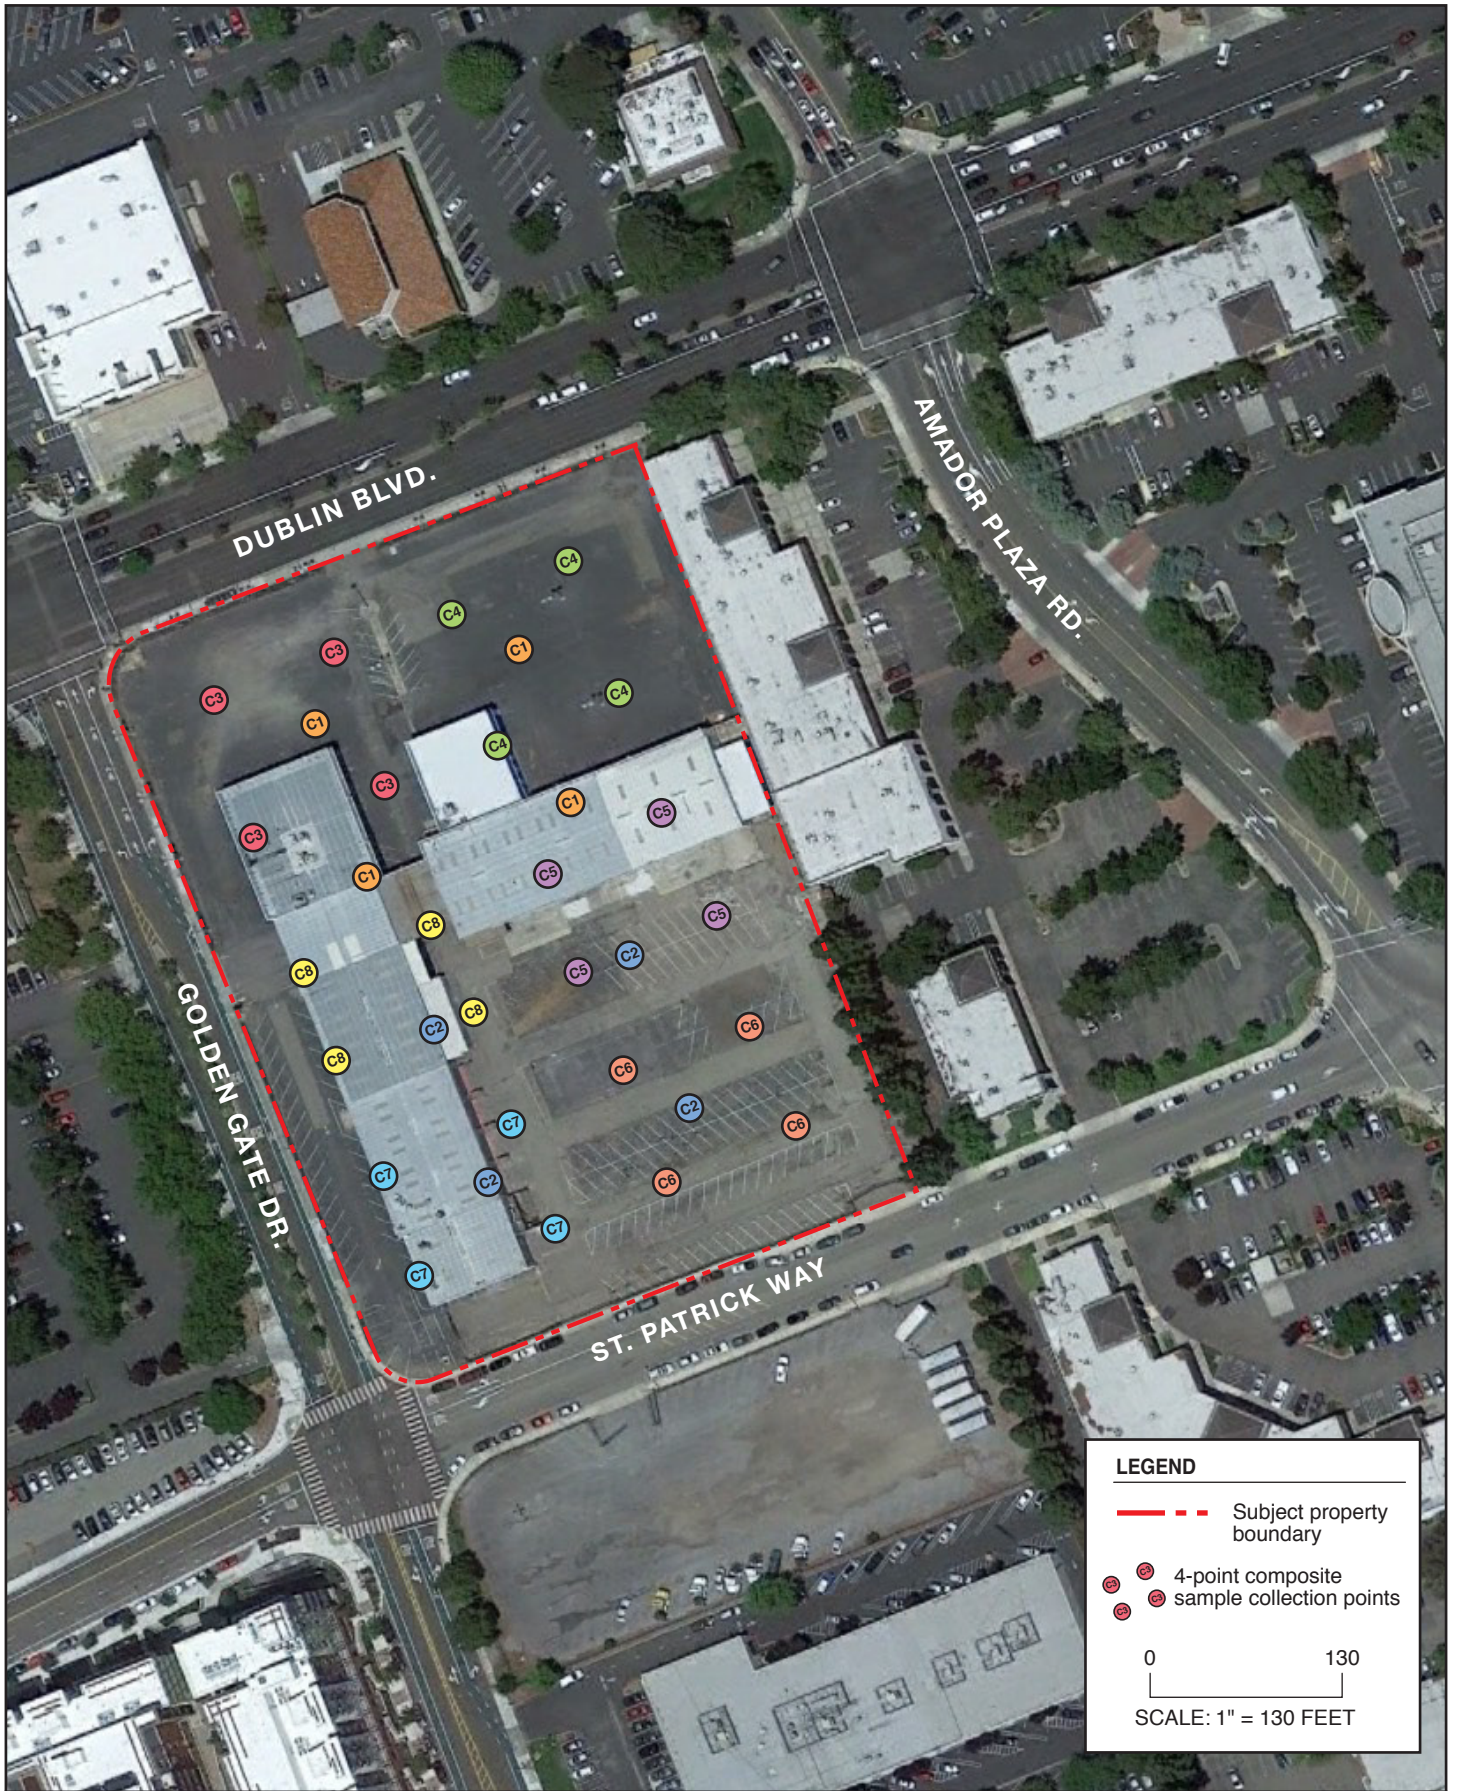
- - - Subject property boundary
- 4-point composite sample collection points

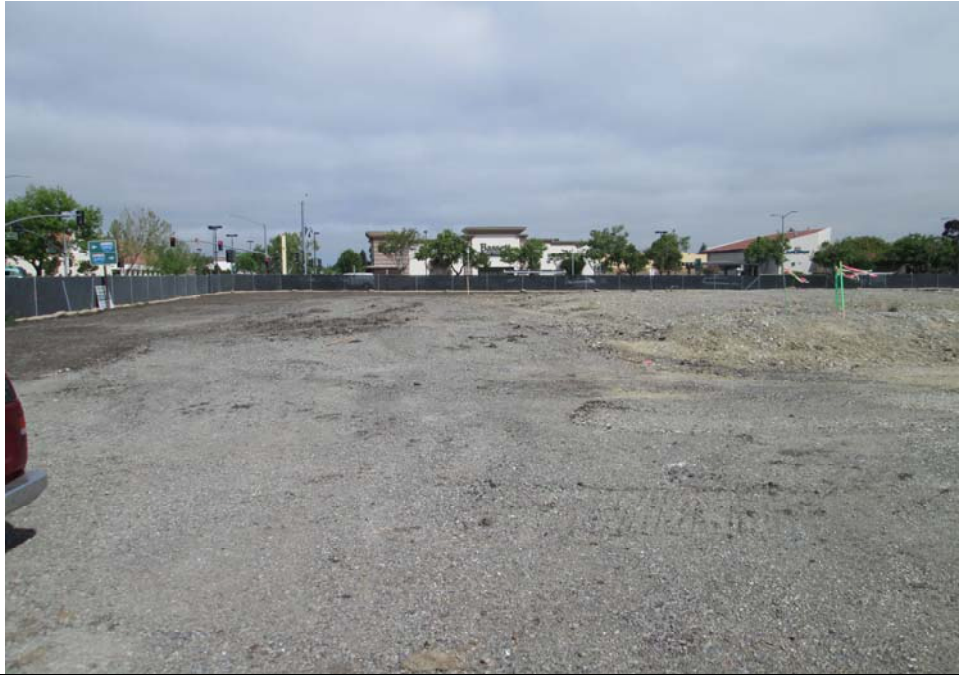
Photo No.: 01

Subject: Recently graded site

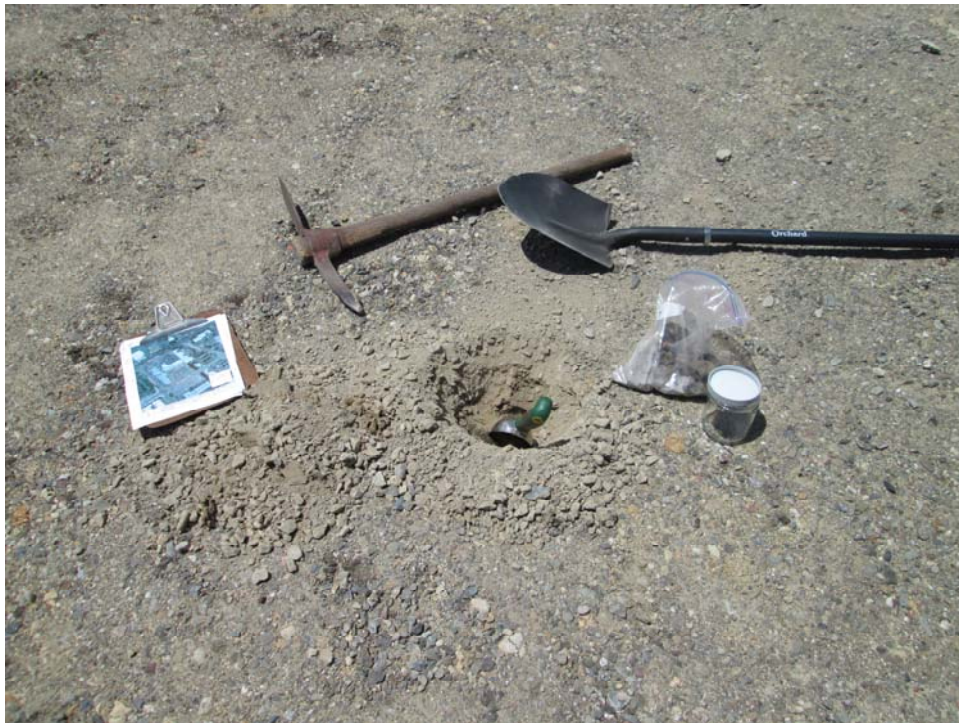
Subject: Location of composite sample point
