PHASE I  
ENVIRONMENTAL  
SITE ASSESSMENT

964 & 974-980 "A" Street  
Hayward  
California

**Subject:** Phase I Environmental Site Assessment Report  
964 & 974-980 "A" Street  
Hayward, California 94541

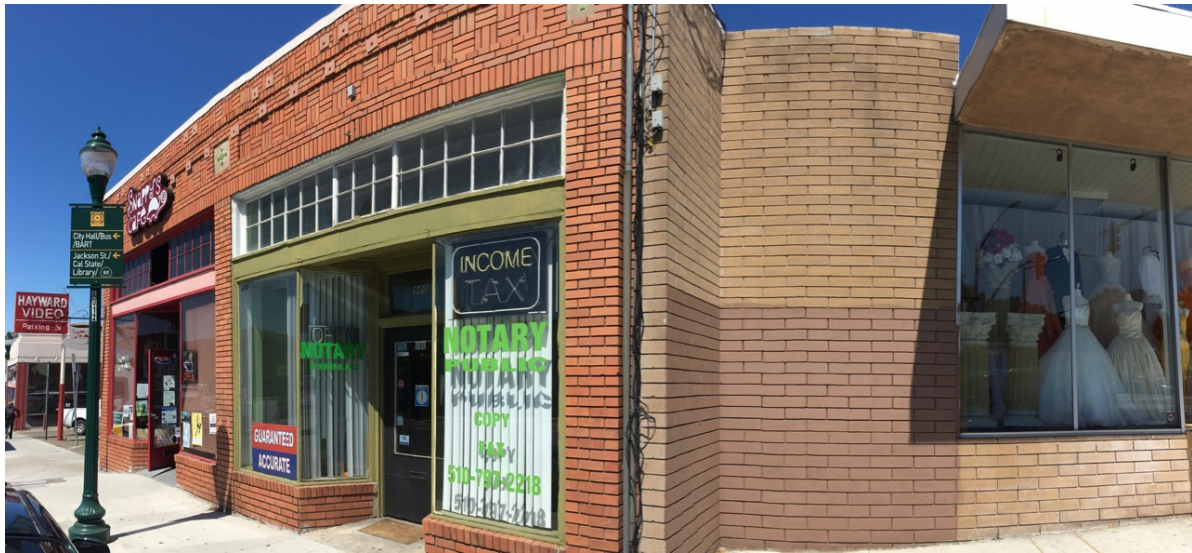
Photo 1: Subject Site (Facing West)  
One-Story Commercial Building (974-980 "A" Street)  
Along the North Side of "A" Street

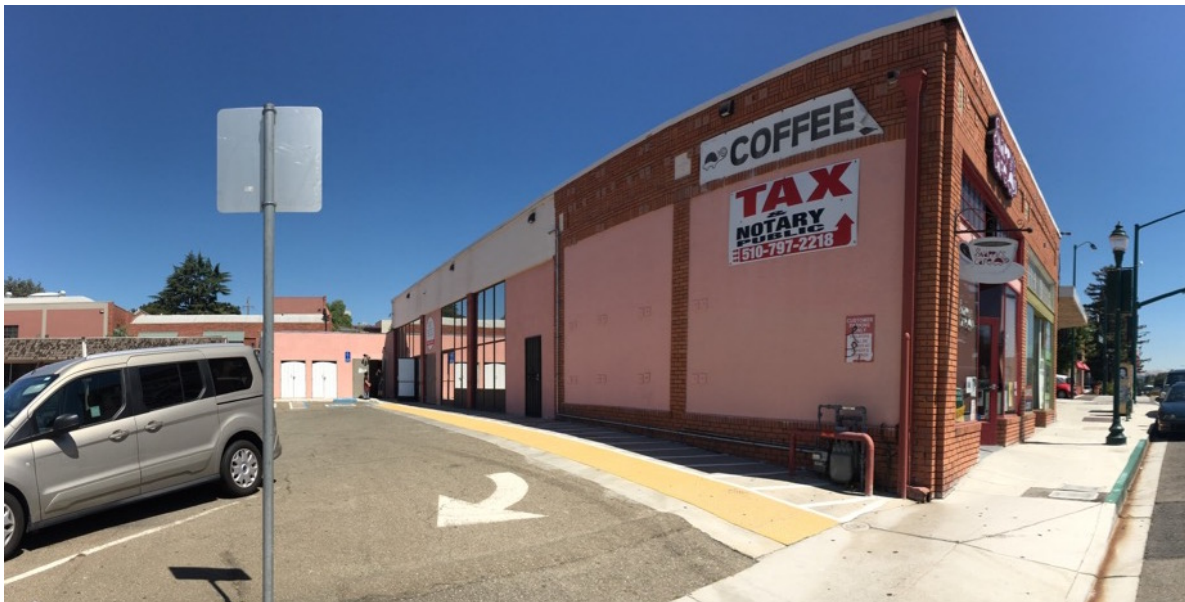
Photo 2: Subject Site (Facing North)  
One-Story Commercial Building (974-980 "A" Street)  
Along the North Side of "A" Street

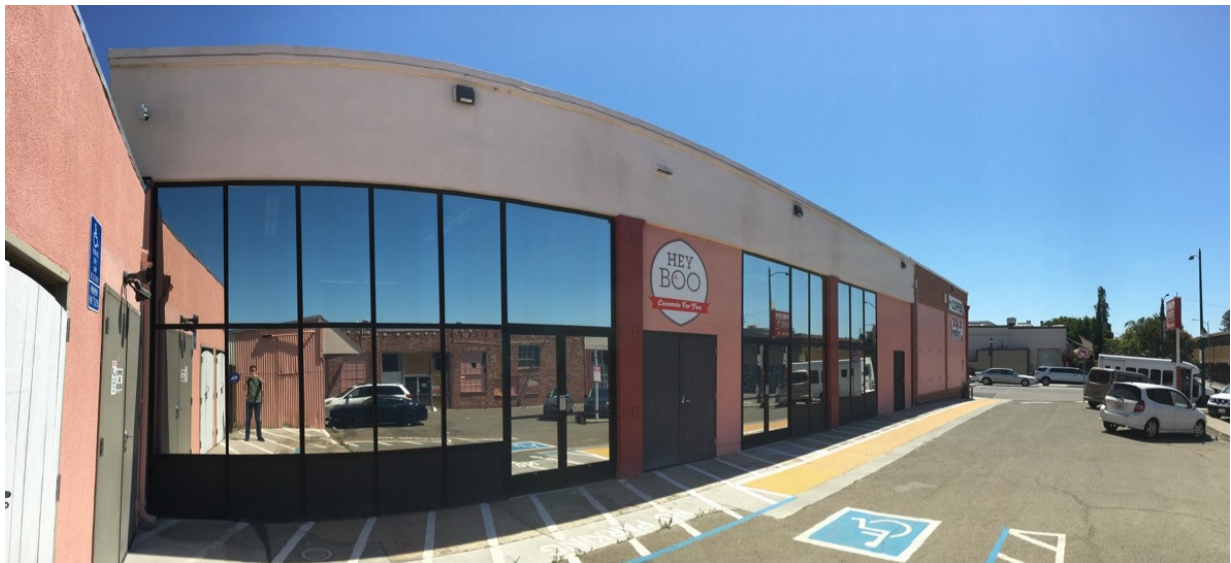
Photo 3: Subject Site (Facing East)  
One-Story Commercial Building (974–980 "A" Street)  
Along the North Side of "A" Street  
(Associated Paved Parking at Right)

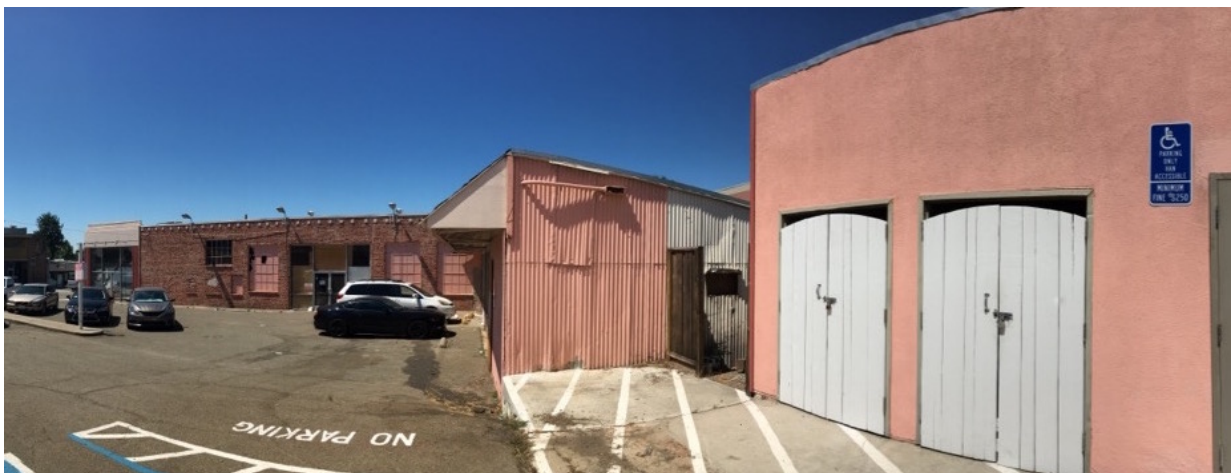
Photo 4: Subject Site (Facing Northwest)  
One-Story Commercial Building (974–980 "A" Street) + One-Story Commercial Building (964 "A" Street)  
Along the North Side of "A" Street  
(Associated Paved Parking at Left)

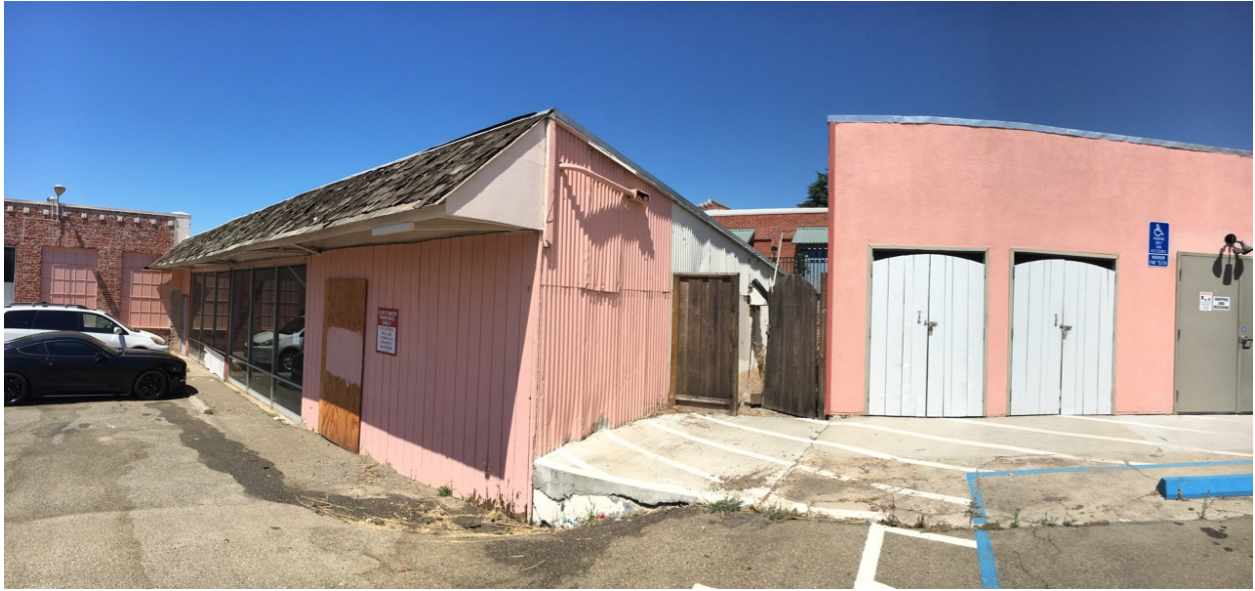
A garbage bin area is located on the northern portion of the subject site parcel, within the northwestern “arm” of the eastern building (See Photo 5). The garbage area was locked and inaccessible at the time of site reconnaissance. Limited general observations of the garbage bin area from the exterior did not reveal any obvious evidence of hazardous materials, stains or spills.

Photo 5: Subject Site (Facing Northwest)  
One-Story Commercial Building (964 "A" Street) + One-Story Commercial Building (974–980 "A" Street)  
(Drainage at Center)

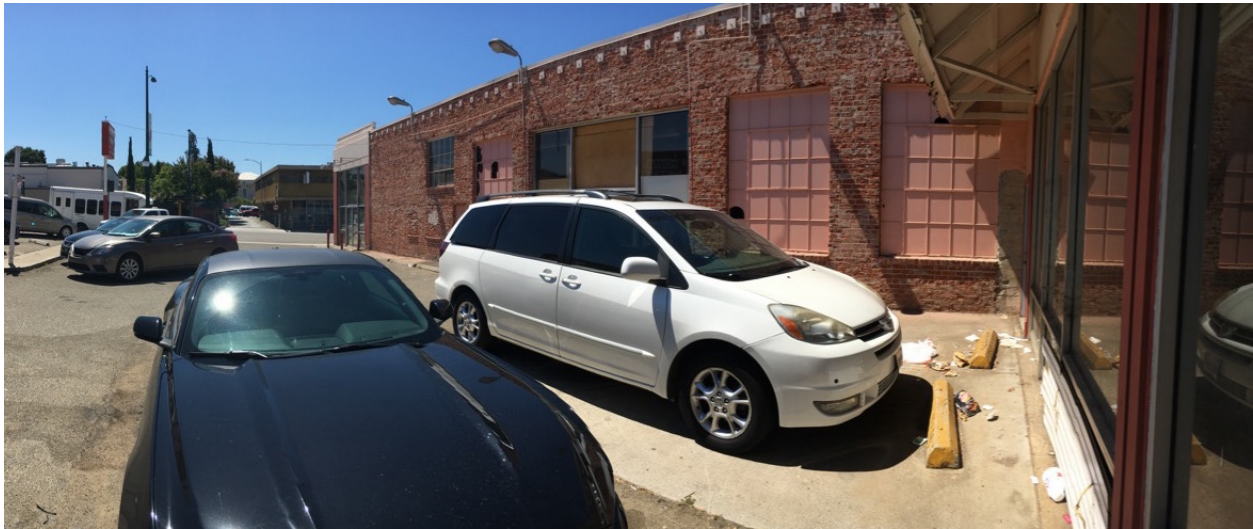
Photo 6: Subject Site (Facing Southwest)  
One-Story Commercial Building (964 "A" Street)  
Along the North Side of "A" Street  
(Associated Paved Parking at Center – No Fill Ports or Vent Pipes Identified)

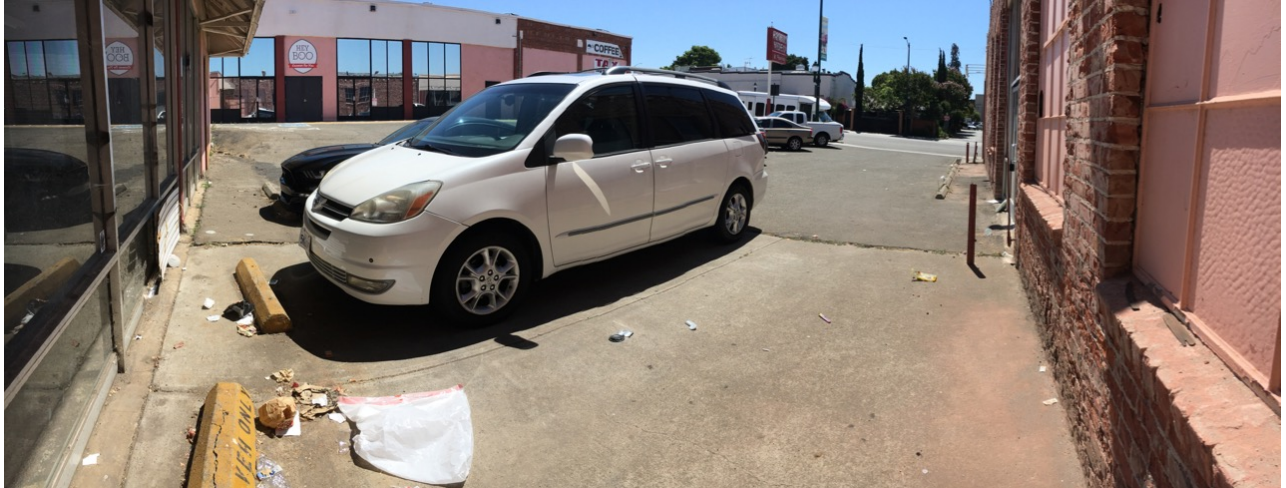
Photo 7: Subject Site (Facing Southeast)  
Associated Paved Parking Area  
(No Fill Ports or Vent Pipes Identified)

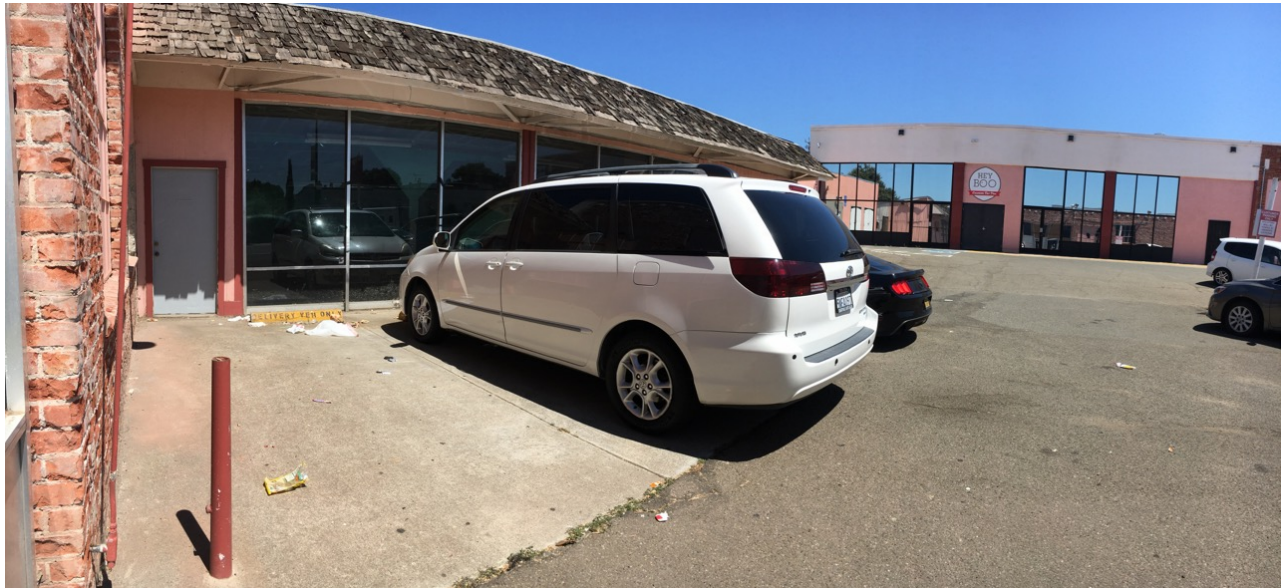
Photo 8: Subject Site (Facing North)  
One-Story Commercial Building (964 "A" Street)  
(Associated Paved Parking Area – No Fill Ports or Vent Pipes Identified)

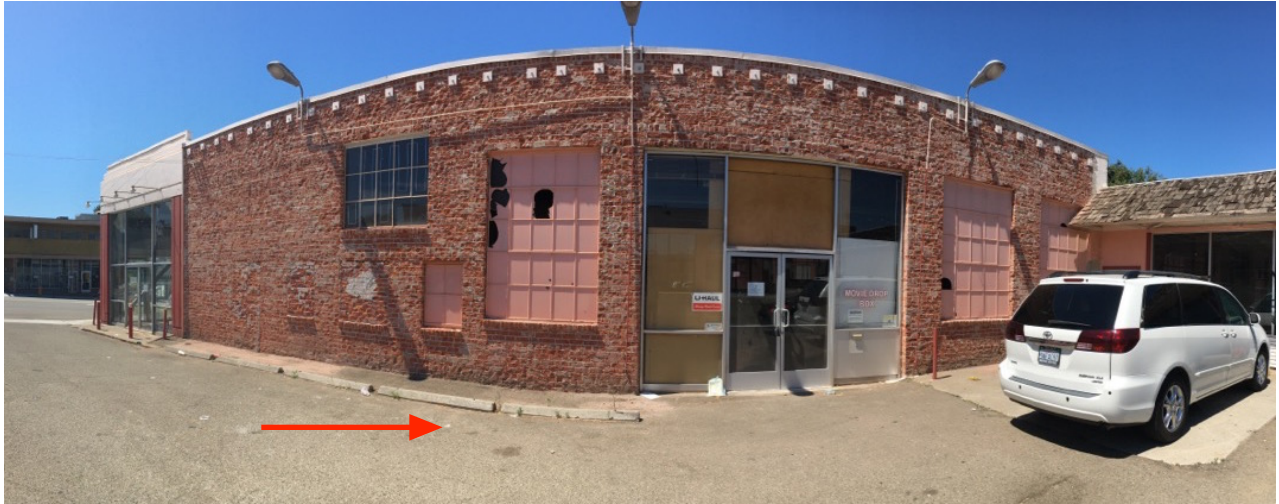
Photo 9: Subject Site (Facing West)  
One-Story Commercial Building (964 "A" Street)  
(Arrow Points to Reported Location of Abandoned UST – Circa 1997)

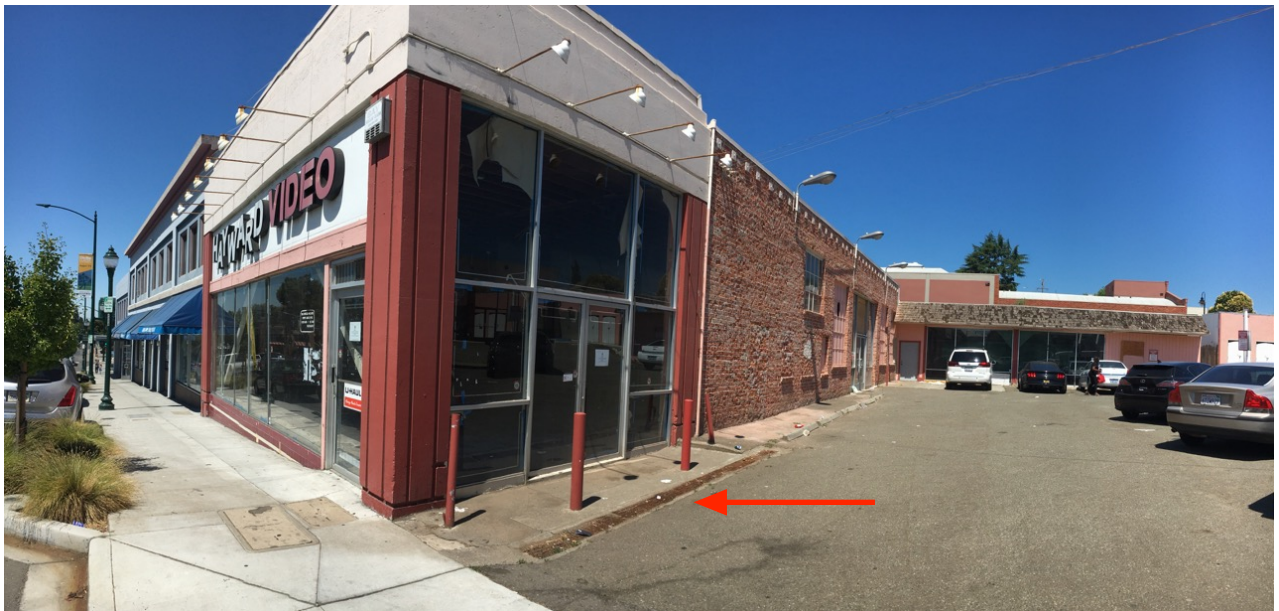
Photo 10: Subject Site (Facing Northwest)  
One-Story Commercial Building (964 "A" Street)  
(Arrow Points to Drain)

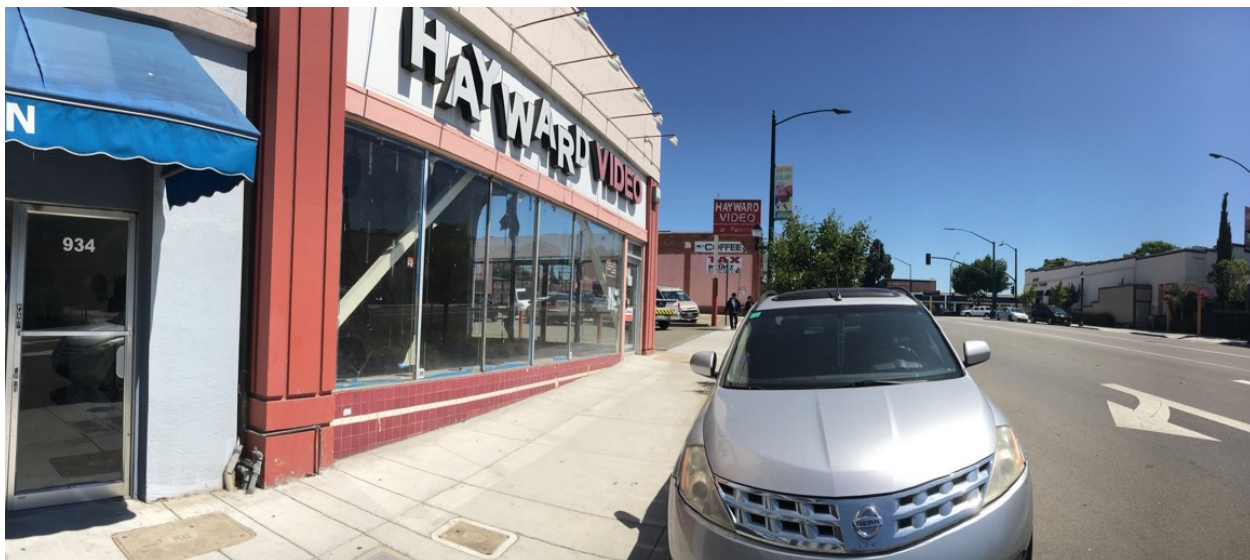
Photo 11: Subject Site (Facing Northeast)  
One-Story Commercial Building (964 "A" Street)  
Along the North Side of "A" Street

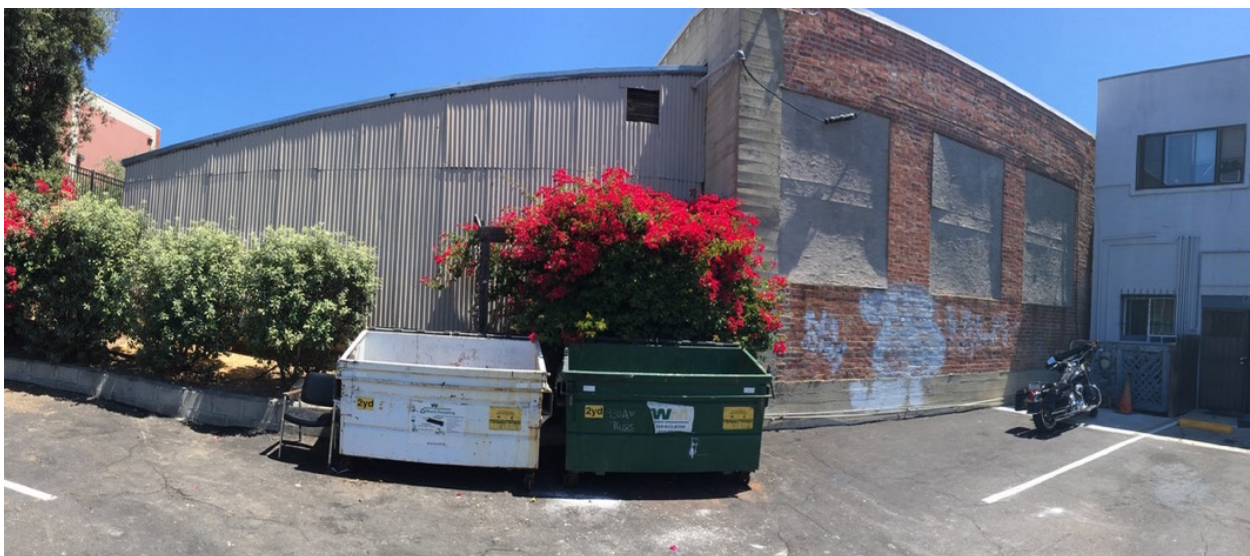
Photo 12: Subject Site (Facing East)  
One-Story Commercial Building (964 "A" Street)  
(Western Rear of Building from Adjacent Parking Lot)

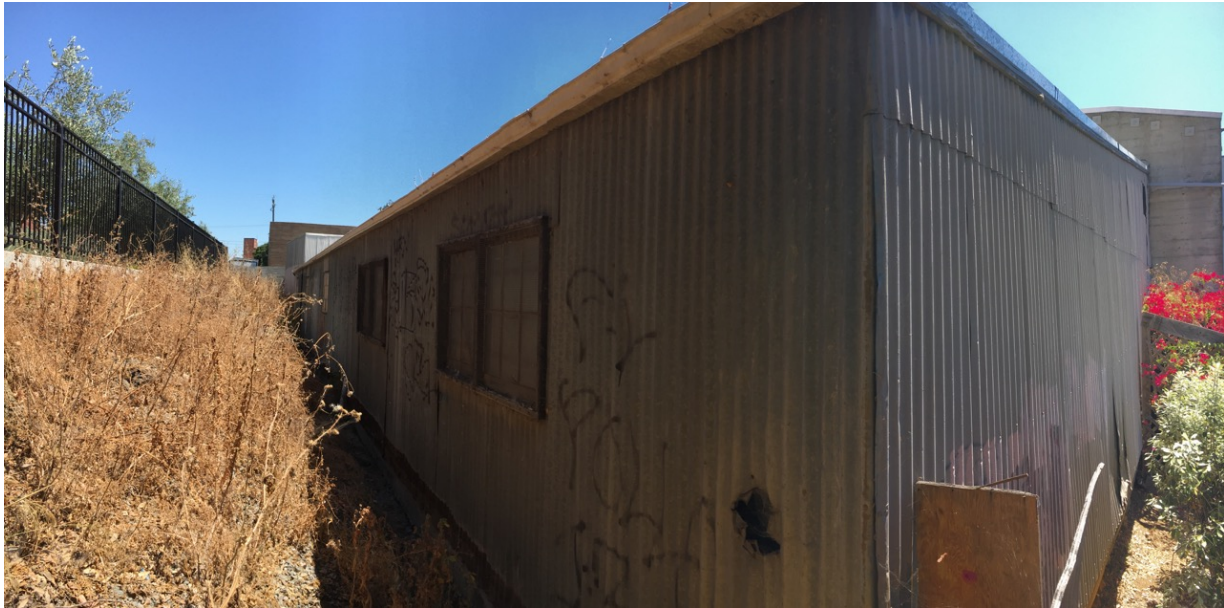
Photo 13: Subject Site (Facing East)  
One-Story Commercial Building (964 "A" Street)  
(Northwestern Rear of Building at Left)

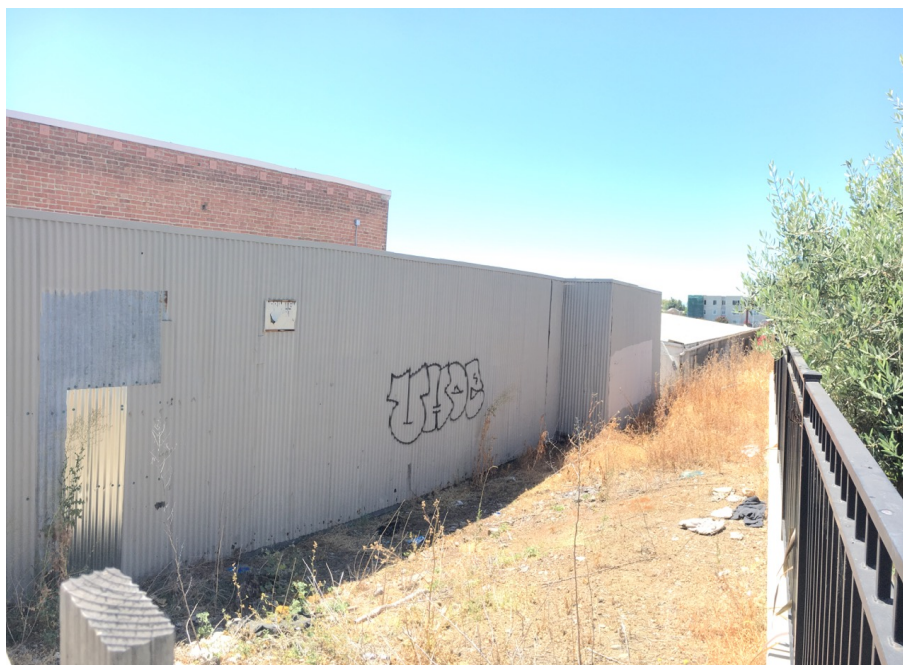
Photo 14: Subject Site (Facing West)  
One-Story Commercial Building (974–980 "A" Street)  
(Northwestern Rear of Building and Unlandscaped Inaccessible Areas)

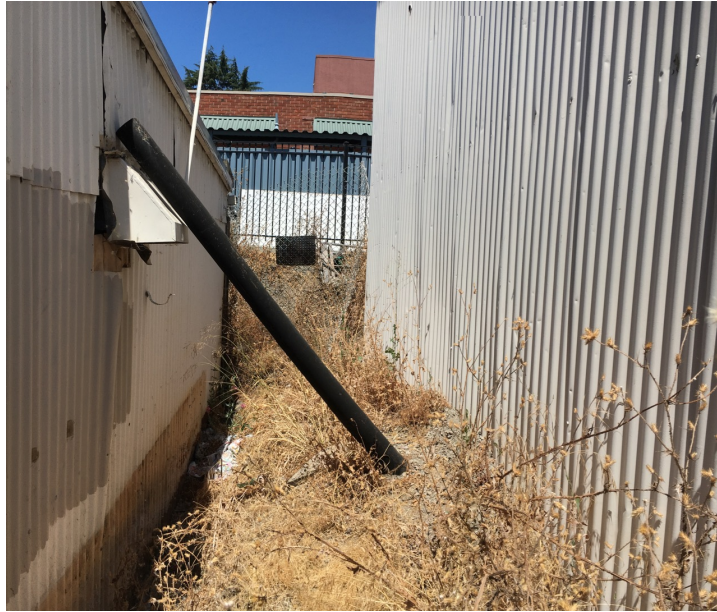
Photo 15: Subject Site (Facing Northwest)  
(Space Between Two One-Story Commercial Buildings)  
(964 & 974–980 "A" Street)

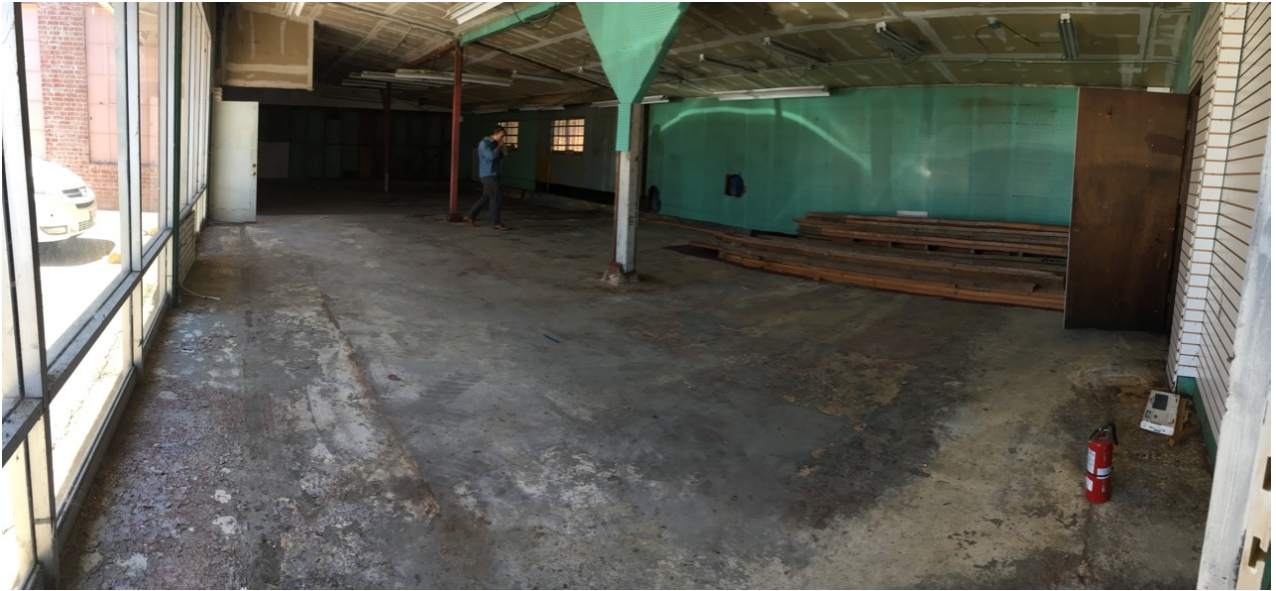
Photo 17: Subject Site (Facing Northwest)  
One-Story Commercial Building (964 "A" Street)  
(Former Video Store (2000s–2010s), Auto Parts Retail (1960s–2000s);  
Auto Service (1950s); and Auto Body & Paint Area (1940s))

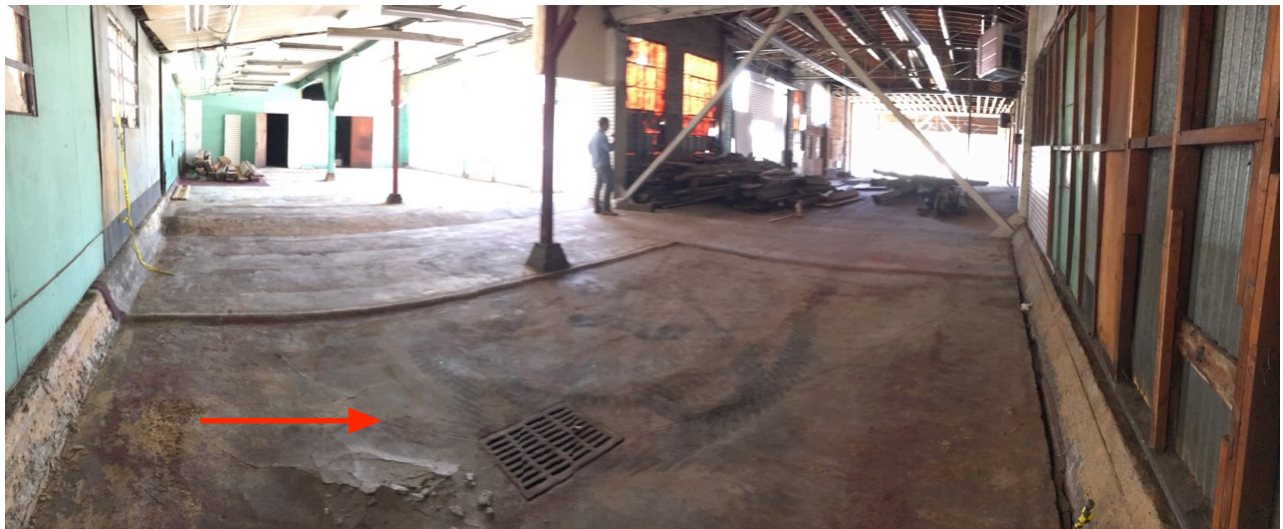
Located at the northwest corner of the building is a large “rectangular” concrete bermed (2–4-inch height) area with central large “rectangular” drain (See Photos 18 and 19). Visual observations of the small bermed concrete basin indicated uneven surfaces and cracking paint/concrete. The floor drain appeared from limited observations from the exterior to drain to a larger basin below, which may represent a sump-like area, not necessarily leading directly to sanitary sewer. This region may have been utilized as part of historical auto body and associated auto paint work (1940s). Mr. Weinstein was not familiar with the historical use of this area. Visual observations of this area did not reveal any obvious evidence of current hazardous materials, significant stains or spills. However, the previous use of this area as auto repair, and

Photo 18: Subject Site (Facing Southeast)  
One-Story Commercial Building (964 "A" Street)  
(Arrow Points to Bermed Drainage Area)

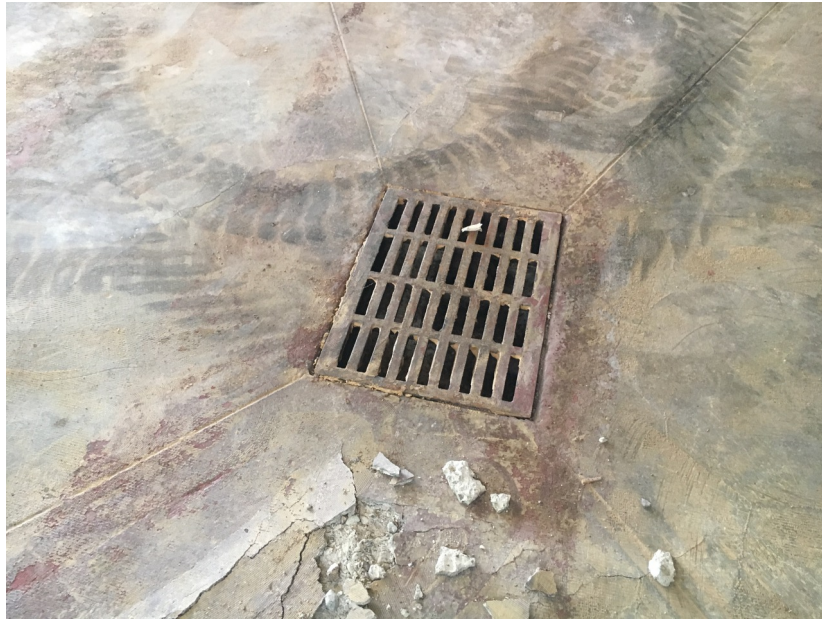
Photo 19: Subject Site (Facing South)  
One-Story Commercial Building (964 "A" Street)  
(Floor Drain in Basin at Northwestern Corner of Building)

Located at the northwest corner of the western building is a large “rectangular” concrete basin (2–4-inch berm height) area with central large “rectangular” drain (See Photos 18 and 19). Visual observations of the small concrete basin indicated uneven surfaces and cracking paint/concrete. The floor drain appeared from limited observations from the exterior to drain to a larger basin below, which may represent a sump-like area, not necessarily leading directly to sanitary sewer. This region may have been utilized as part of historical auto body and associated auto paint work (1940s). Mr. Weinstein was not familiar with the historical use of this area. Visual observations of this area did not reveal any obvious evidence of current hazardous materials, significant stains or spills. However, the previous use of this area as auto repair, and existence of large drain and berm area, represents a significant conduit to the subsurface for historical hazardous materials use onsite, and therefore an area of concern/focus for future investigation.

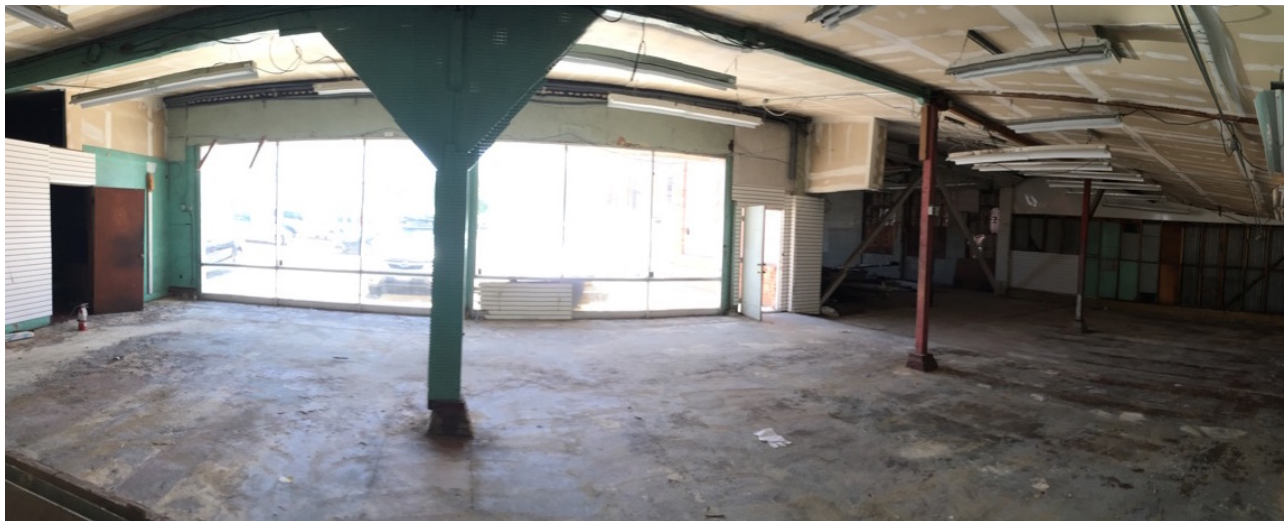
Photo 20: Subject Site (Facing Southwest)  
One-Story Commercial Building (964 "A" Street)  
(Former Video Store (2000s–2010s), Auto Parts Retail (1960s–2000s);  
Auto Service (1950s); and Auto Body & Paint Area (1940s))

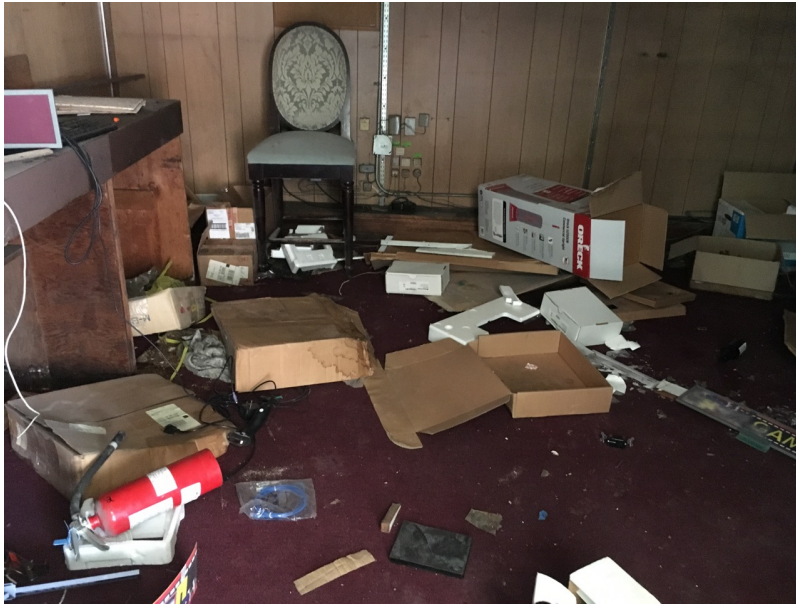
Photo 21: Subject Site (Facing East)  
 One-Story Commercial Building (964 "A" Street)  
 (Former Video Store (2000s–2010s), Auto Parts Office? (1950s–2000s);  
 Auto Radio Repair Area (1940s))

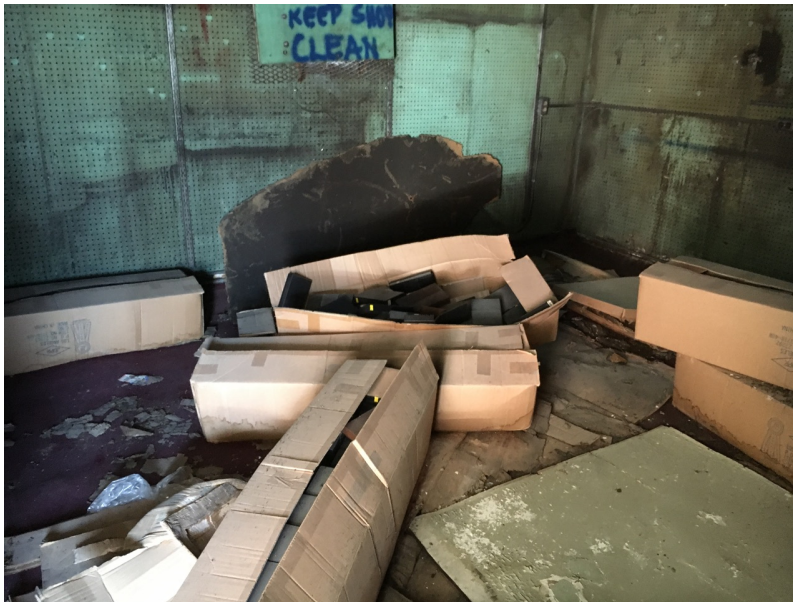
Photo 22: Subject Site (Facing Northeast)  
 One-Story Commercial Building (964 "A" Street)  
 (Northeastern Former Office Area)

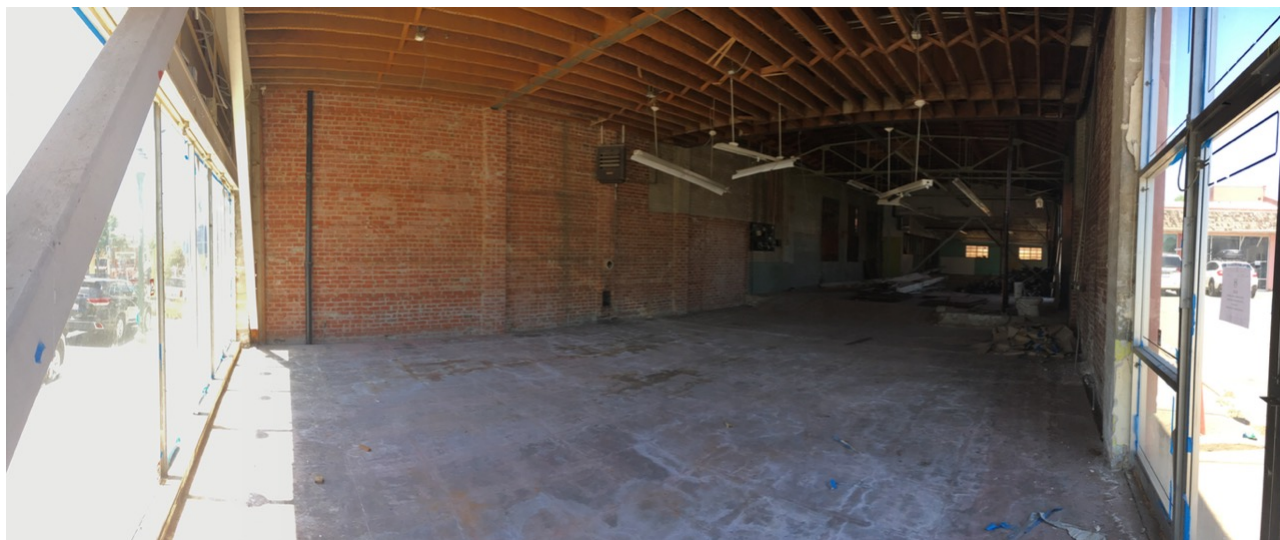
Photo 23: Subject Site (Facing Northwest)  
One-Story Commercial Building (964 "A" Street)  
(Former: Auto Sales and Service Area – Show Room (Late 1940s);  
Retail/Storefront (1950s–2000s); Video Store (2000s–2010s))

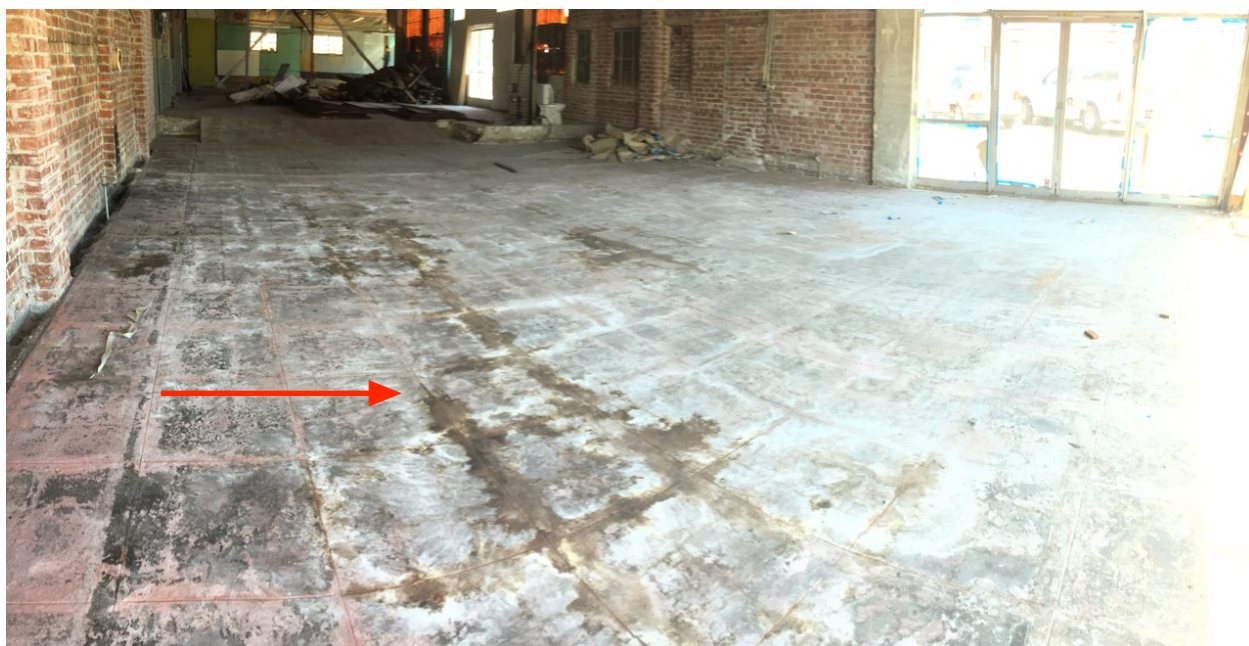
Located along the southwest corner of the subject building, within the former auto show room and, later, video retail area, is brownish staining of the floor surface, arranged in a linear fashion – trending northwest to southeast (See Photo 24). Visual observations of this area did not reveal any obvious evidence of hazardous materials or spills. Visual observations of the floor of the this area did not reveal any obvious evidence of collection drains, sumps or other conduits to the subsurface. However, the staining is indicative to a potential past spillage in this area, which was unlikely to have occurred as part of demolition activities or previous commercial retail use for video store. However, the extent of staining was small, time since staining long, and no nearby conduits to the subsurface were identified.

Photo 24: Subject Site (Facing Northeast)  
One-Story Commercial Building (964 "A" Street)  
(Former: Auto Sales and Service Area – Show Room (Late 1940s);  
Retail/Storefront (1950s–2000s); Video Store (2000s–2010s))  
(Arrow Points to Potential Oil Staining)

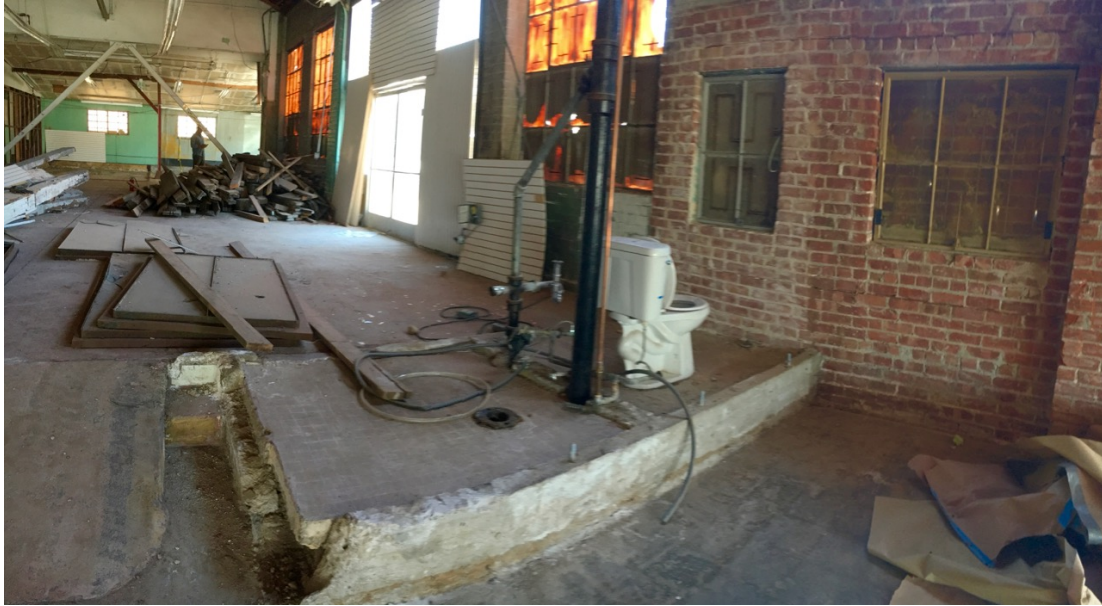
Photo 25: Subject Site (Facing North)  
One-Story Commercial Building (964 "A" Street)  
(Former Restroom Area – Drain at Center)

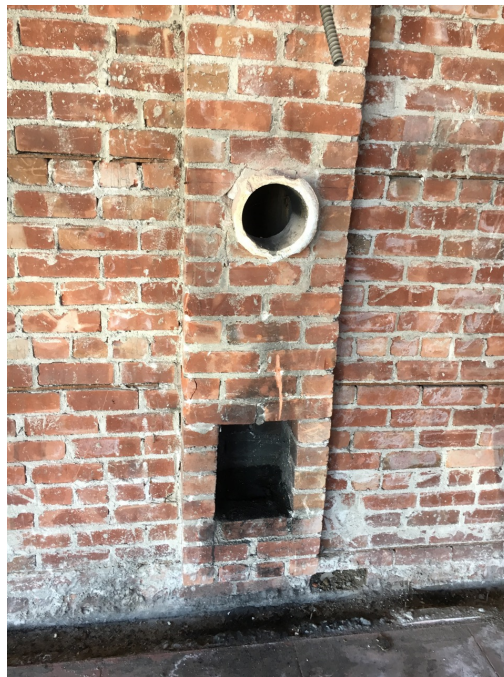
Visual observations of the rest of the open former retail areas indicated the presence of a former restroom (See Photo 25) along the east, and a former chimney (See Photo 26) along the west, with all other areas being primarily empty or utilized for dry construction demolition debris storage. In addition, located along the eastern side of the building, within the brick exterior walls, were several former windows as well as a single former doorway. These areas were filled with bricks, but suggest alternate entryways to the subject building. One exposed drain was located near the former restroom area. Visual observations of the rest of the area did not reveal any obvious evidence of hazardous materials, stains or spills. Visual observations of the floors of the open areas did not reveal any obvious evidence of collection drains, sumps or other conduits to the subsurface outside of the two drains (former restroom + bermed area) previously described.

Photo 26: Subject Site (Facing West)  
One-Story Commercial Building (964 "A" Street)  
(Former Chimney Area at West-Central Portion of Building)

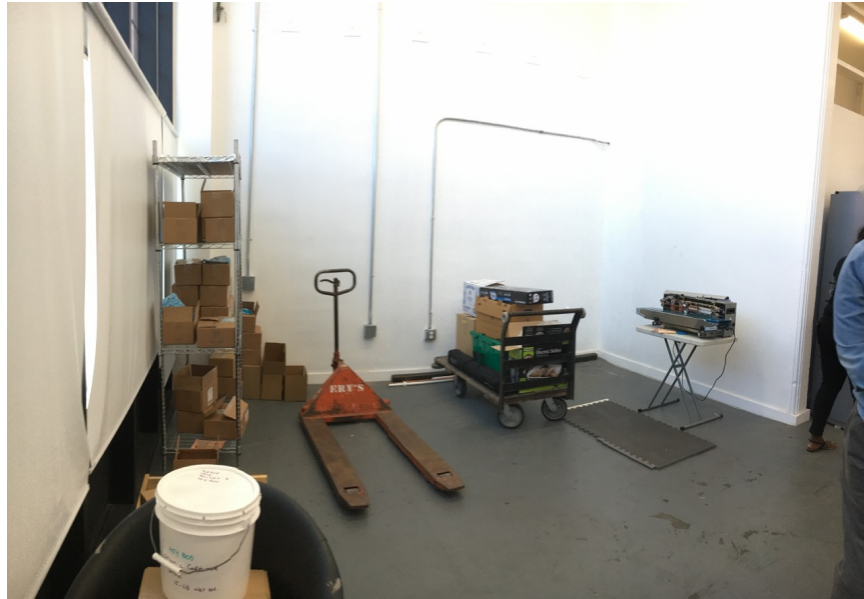
Located within the central entryway/small warehouse areas were various shelving units, carts, and tables of typical office and kitchen furnishings and supplies (See Photo 27). In addition, a food-processing unit (e.g., for cutting, with conveyance system) was located in the center of this area, indicating it was partly utilized as a kitchen. In addition, one restroom with floor drain was located in this area (See Photo 28). Visual observations of these areas, including the restroom and associated floor drain, did not reveal any obvious evidence of hazardous materials, stains or spills. Visual observations of the floor of these areas did not reveal any obvious evidence of collection drains, sumps or other conduits to the subsurface other than the one restroom floor drain.

Photo 27: Subject Site (Facing North)  
One-Story Commercial Building (974–980 "A" Street)  
(974 "A" Street – Entrway/Warehouse Area)

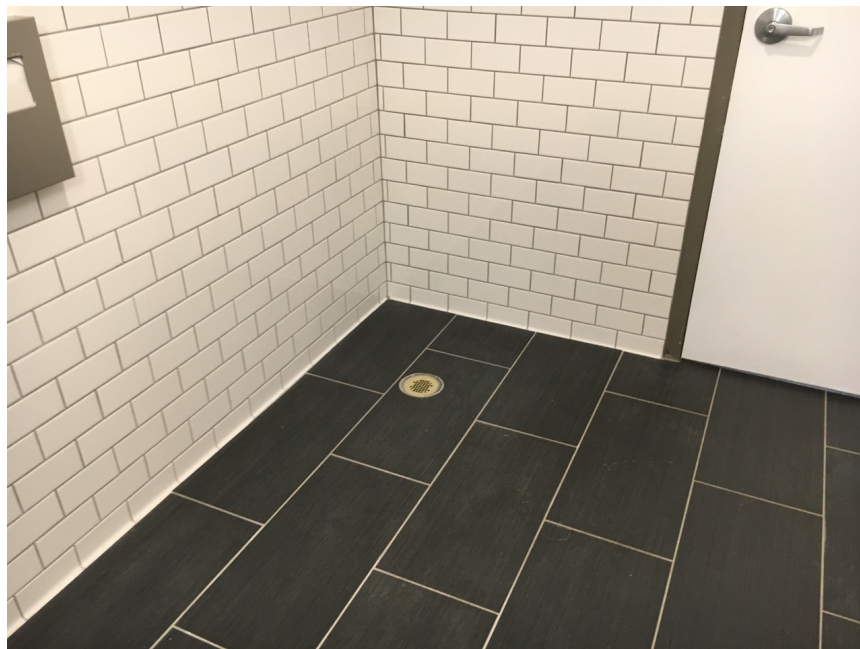
Photo 28: Subject Site (Facing North)  
One-Story Commercial Building (974–980 "A" Street)  
(974 "A" Street – Restroom Floor Drain)

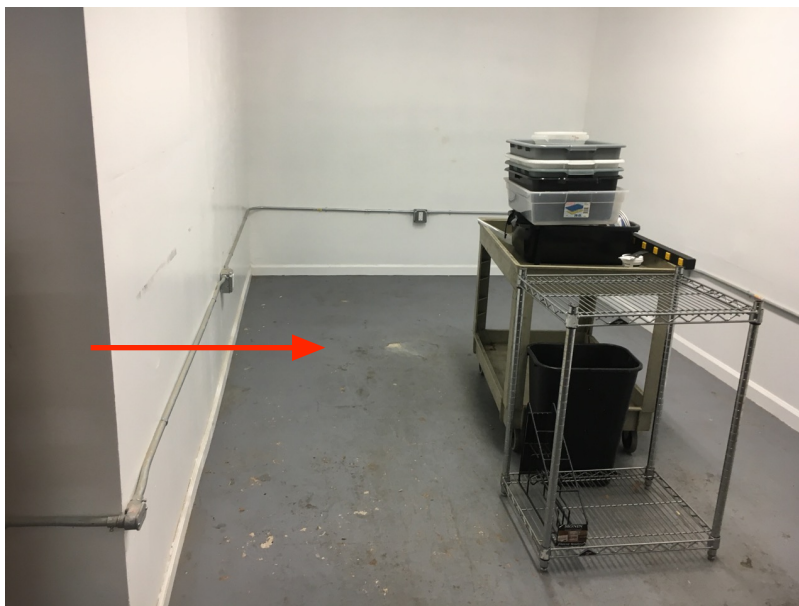
unit is a small elevated circular uneven depression in the treated concrete floor surface that resembles an abandoned fill port or former soil boring (approximately 10-inches in diameter) (See Photos 29 & 30). The depression is located in the center of the western “head” of the northern arm of the building, in what was historically a storage and “old tire warehouse” area (Circa 1966). According to the subject representatives, no sampling had been completed within this unit (e.g., Phase II subsurface investigation), and so it is likely that the surface depression is a filled former conduit to the subsurface. As such, this area represents an area of the concern/focus for future investigation. However, visual observations of the room indicated that it was largely unfurnished and appeared to have been recently renovated and in good current condition. Visual observations of the rear storage did not reveal any other obvious evidence of hazardous materials, stains or spills. Visual observations of the concrete floors of the rest of the unit did not reveal any obvious evidence of collection drains, sumps or other active conduits to the subsurface.

Photo 29: Subject Site (Facing West)  
One-Story Commercial Building (974–980 "A" Street)  
(974 "A" Street – Rear Storage Area)  
(Former: Nondescript Storage (1940s–1950s); "Old Tire Warehouse" (Late 1960s))

Located along the northwestern corner of the unit is a small elevated circular uneven depression in the treated concrete floor surface that resembles an abandoned fill port or former soil boring (approximately 10-inches in diameter) (See Photos 29 & 30). The lack of circular metallic ring (from exposed portions through concrete) suggests it is a former soil boring location. The elevated depression is located in the center of the western “head” of the northern arm of the building, in what was historically a storage and “old tire warehouse” area (Circa 1966). According to the subject representatives, no sampling had been completed within this unit (e.g., Phase II subsurface investigation), and so it is conceivable that the surface depression is a filled former conduit to the subsurface. As such, this area represents an area of the concern/focus for future investigation. However, visual observations of the room indicated that it was largely unfurnished and appeared to have been recently renovated and in good current condition. Visual observations of the rear storage did not reveal any other obvious evidence of hazardous materials, stains or spills. Visual observations of the concrete floors of the rest of the unit did not reveal any obvious evidence of collection drains, sumps or other active conduits to the subsurface.

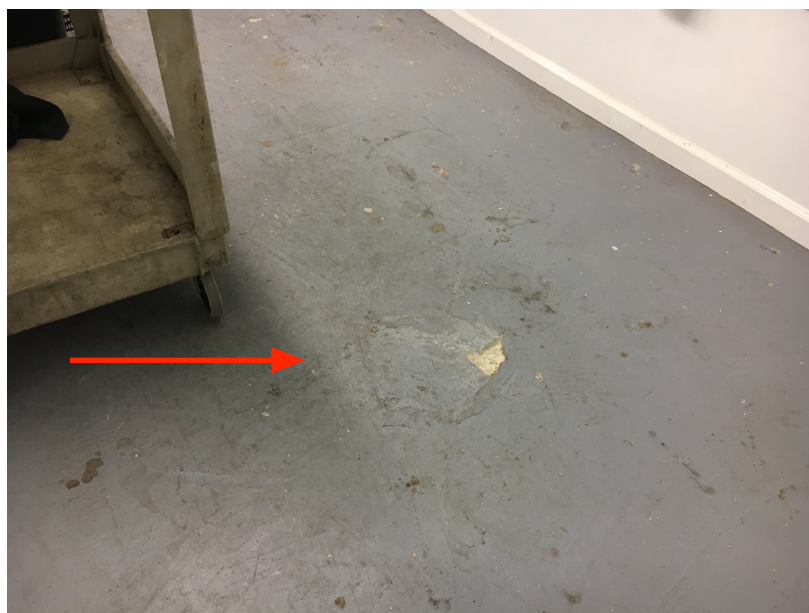
Photo 30: Subject Site (Facing West)  
One-Story Commercial Building (974–980 "A" Street)  
(974 "A" Street – Rear Storage Area)  
(Former: Nondescript Storage (1940s–1950s); "Old Tire Warehouse" (Late 1960s))  
(Arrow Points to Elevated Former Burning or Suspect Fill Port Location)

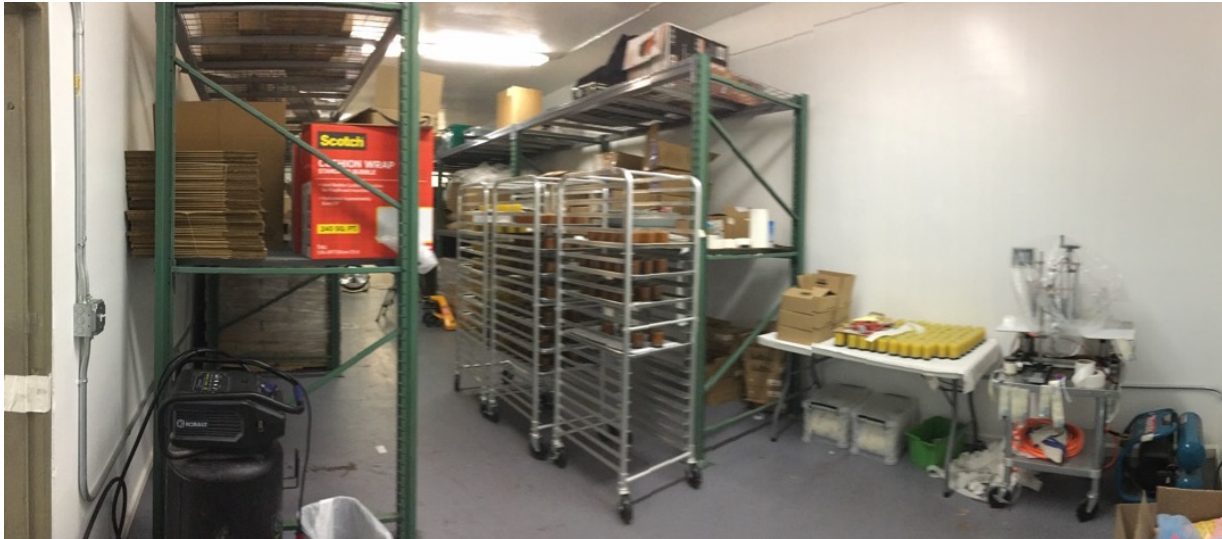
Photo 31: Subject Site (Facing Northwest)  
One-Story Commercial Building (974–980 "A" Street)  
(974 "A" Street – Rear Storage Area)
