PHASE I  
ENVIRONMENTAL  
SITE ASSESSMENT

964 & 974-980 "A" Street  
Hayward  
California

**Subject:** Phase I Environmental Site Assessment Report  
964 & 974-980 "A" Street  
Hayward, California 94541

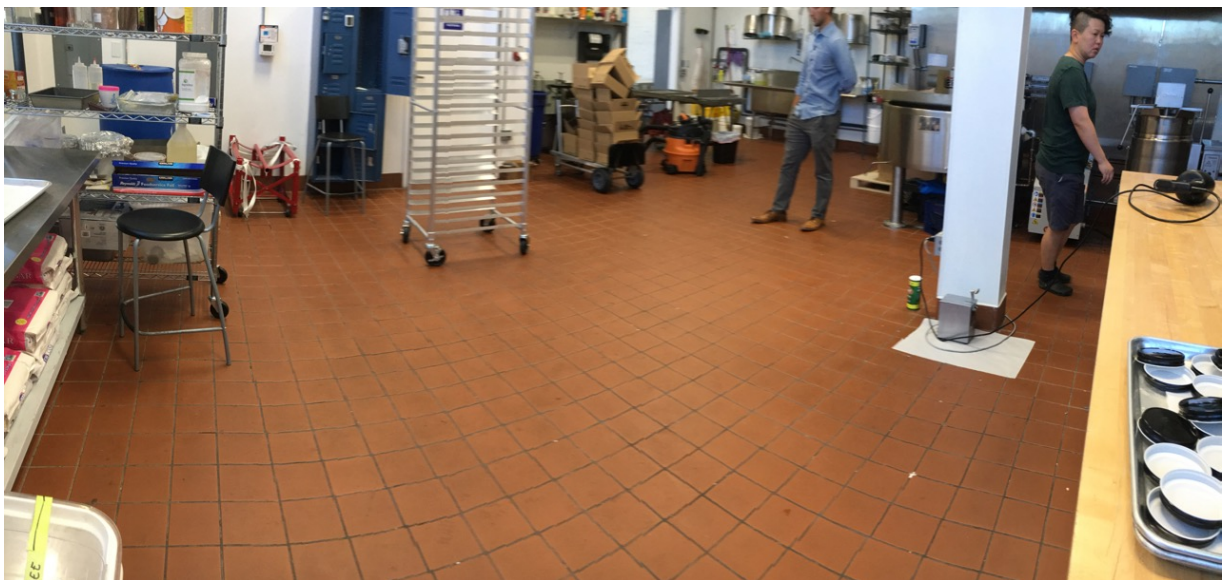
Photo 32: Subject Site (Facing North)  
One-Story Commercial Building (974–980 "A" Street)  
(974 "A" Street – Kitchen)  
(Former: Nondescript Storage (Late 1940s–1950s); Auto Service Area (Late 1960s);  
Storage Areas (1990s–2000s))

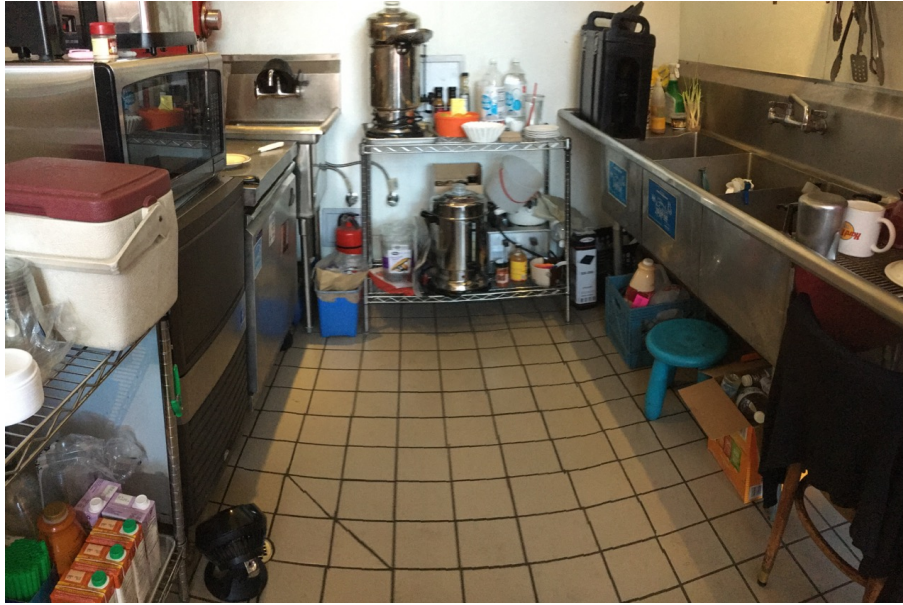
Photo 33: Subject Site (Facing North)  
One-Story Commercial Building (974–980 "A" Street)  
(978 "A" Street – Kitchen Area)

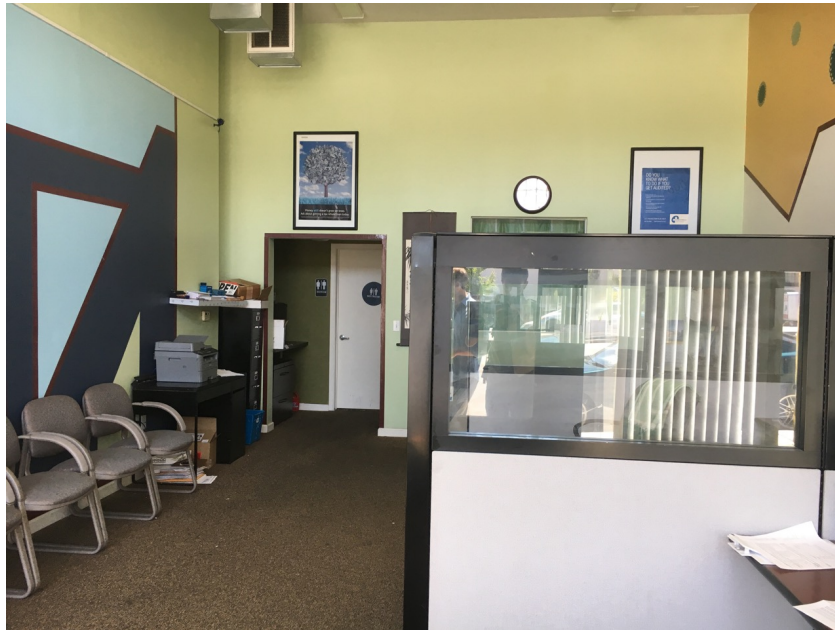
*Tax Magic (980 "A" Street)* – The 980 "A" Street unit is located on the southeast side of the subject building and consists of an open administrative office space with rear restroom facilities (See Photo 34). The unit was locked and inaccessible at the time of site reconnaissance. However, limited observations of the unit made from the adjacent paved sidewalk areas indicated that the unit contained typical office furnishings and supplies. Limited visual observations of

Photo 34: Subject Site (Facing North)  
One-Story Commercial Building (974–980 "A" Street)  
(980 "A" Street – Office Space)
