Subject: Underground Storage Tank Overspill Cleanup Report
Emeryville Marina
3310 Powel Street, Emeryville, CA 94608

This report documents the removal of contaminated soil surrounding a 25,000-gallon underground storage tank (UST) at the Emeryville Marina located at 3310 Powel Street in Emeryville, California (**Figure 1**). The site operator is SHM Emeryville LLC. Cook Environmental Services, Inc. acted as the general contractor on this project and collected confirmation soil samples upon completion of remedial activities. Soils were excavated, transported and disposed of by Fremouw Environmental Services, Inc. (FES). A representative from Armour Petroleum Services (APS) was onsite to ensure that buried electrical conduit and petroleum product lines were not damaged during remedial activities. Steven Plunkett of Alameda County Environmental Health (ACEH) was present to witness activities on behalf of the county CUPA. The site is an active marina. No permits were required to complete these activities. Underground Service Alert (USA Norcal) was notified 48 hours prior to excavation activities.

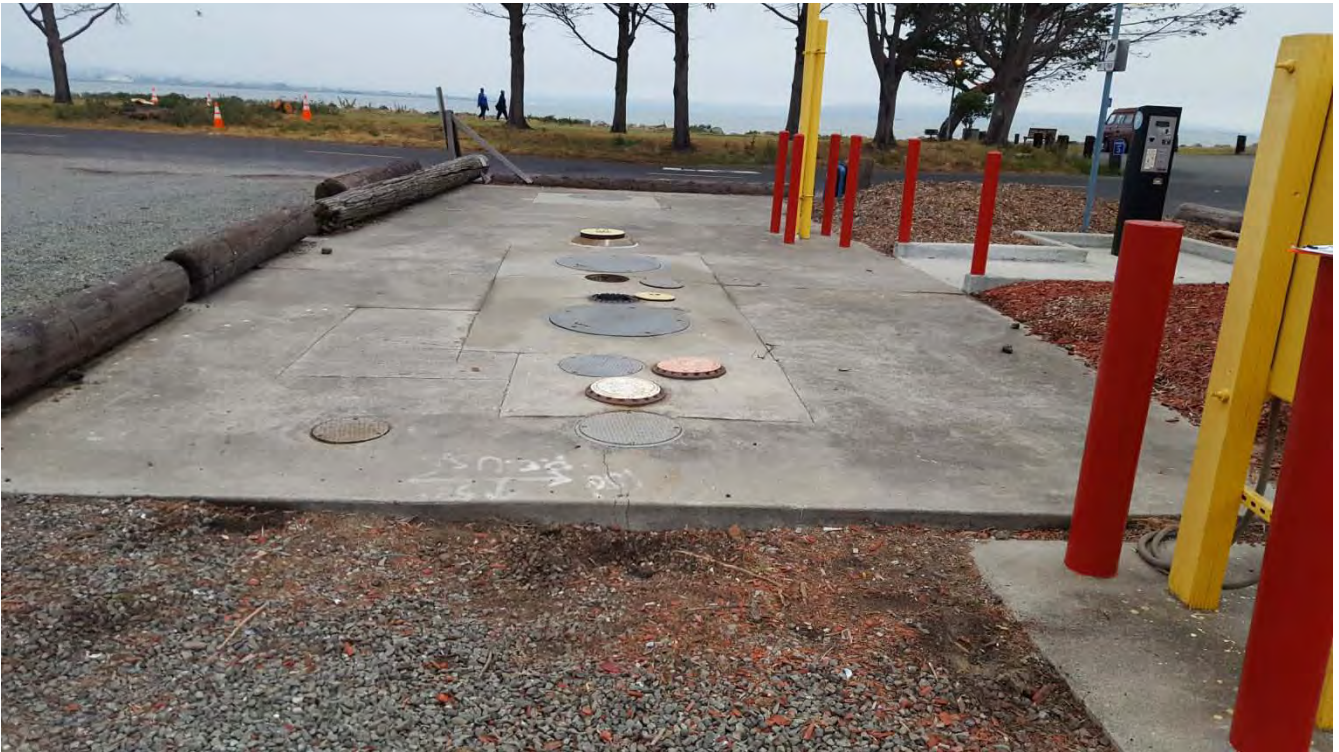
25,000-gal UST, looking west toward roadway, contaminated soil visible in left foreground (Area E-2)

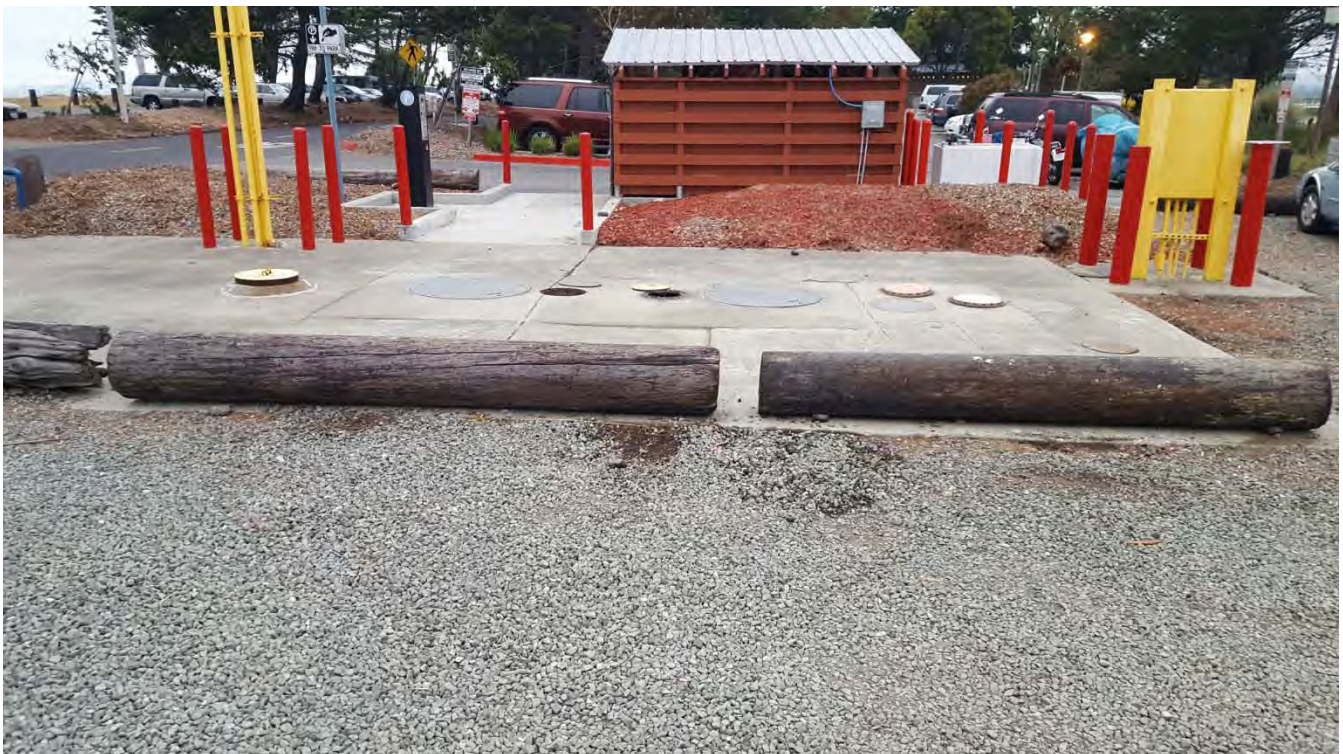
UST looking north, stained soil in foreground between logs (Area E-1)

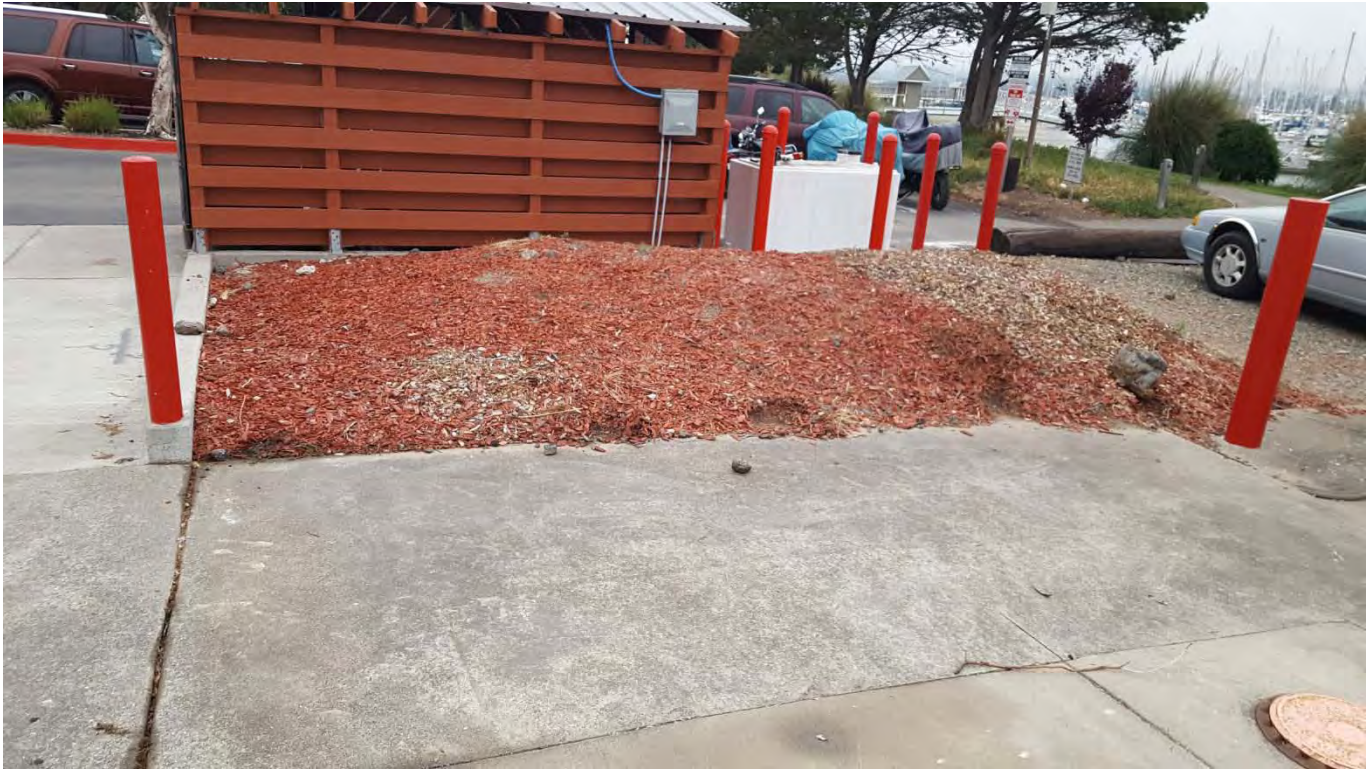
Stained soil at intersection of UST pad and sidewalk (Area E-3)

Additional excavation in E-3 was not possible since pea-gravel from the UST excavation ran into this excavation at a depth of 4 feet bg. We recommend no further action with regard to the remedial effort at this site.

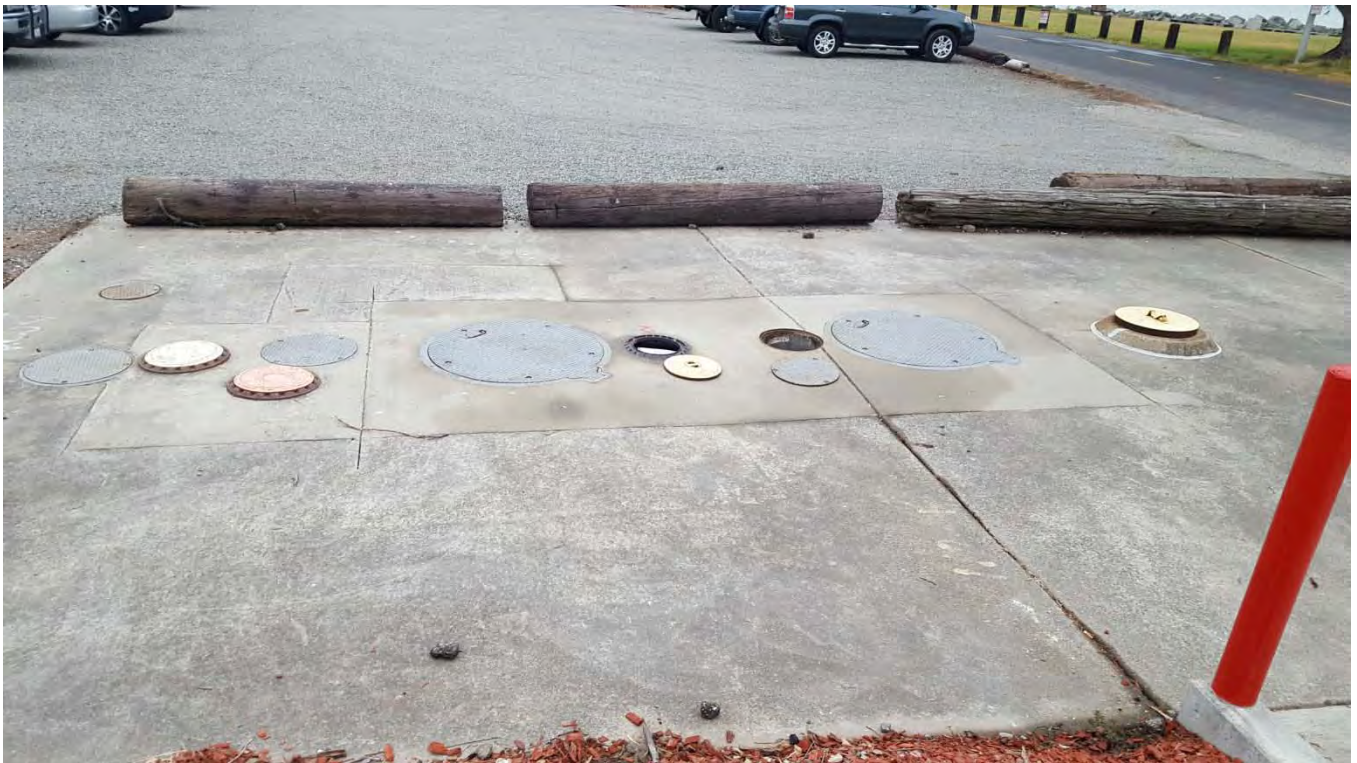
Note hydrocarbon stain in expansion joint leading off concrete pad

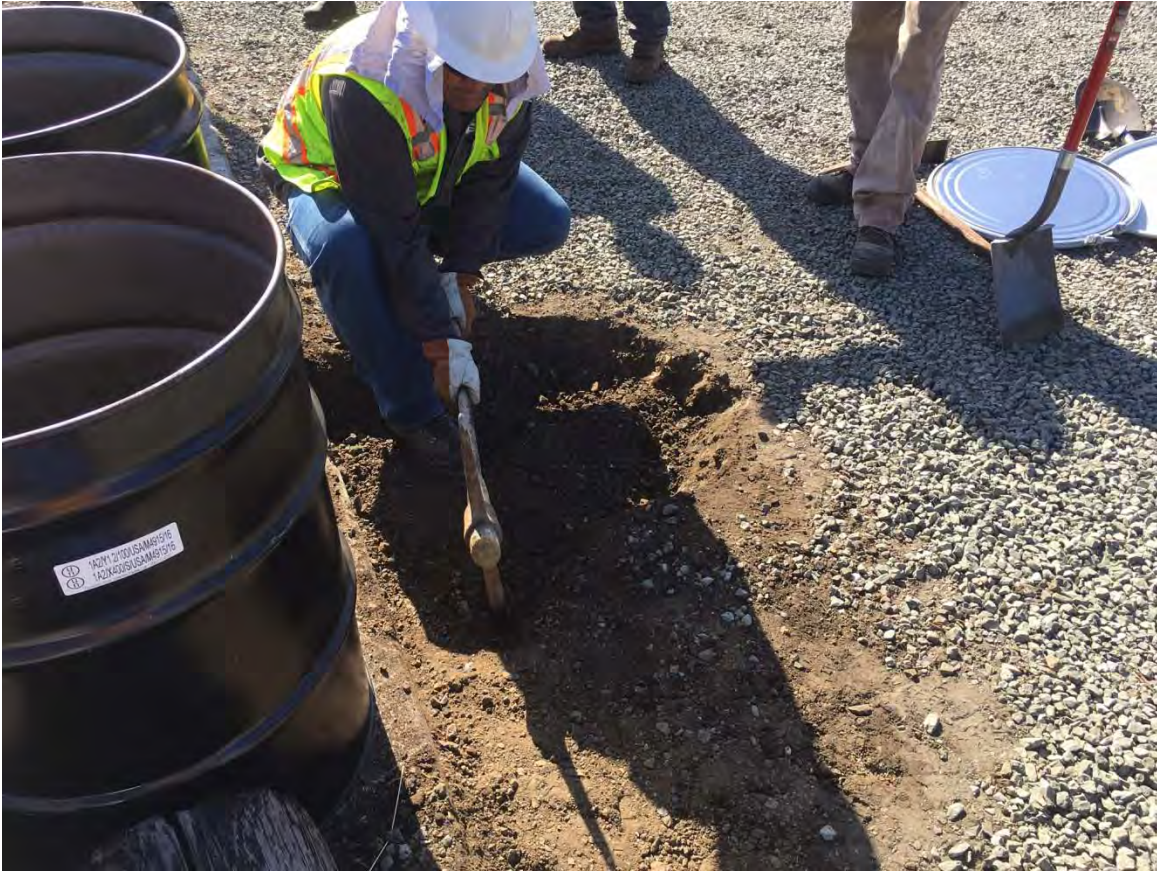
Excavating in Area E-1, south of UST

Soils were excavated from E-1 and E-2 until soils at the base of the excavation exhibited no hydrocarbon odor. Sample E-1 was collected from the base of the excavation at a depth of approximately 8 inches below grade (bg). Sample E-2 was collected from the base of the excavation at a depth of approximately 9 inches bg. Excavation E-3 was located in close proximity to an expansion joint in the concrete pad overlying the UST. This expansion joint was a preferential pathway for the diesel spill. A concrete sidewalk is also located immediately west of E-3. This area was significantly impacted by the spill as evidenced by very strong hydrocarbon odor down to a depth of 4 feet bg. A buried 2-inch diameter gray electrical conduit is located approximately one foot north of the edge of the concrete pad. Sample E-3 was collected from the bottom of the excavation at 4 feet bg. Excavation E-4 was dug to depth of 5 inches bg. Photographs of the UST pad and the four excavations are included in **Attachment A**.

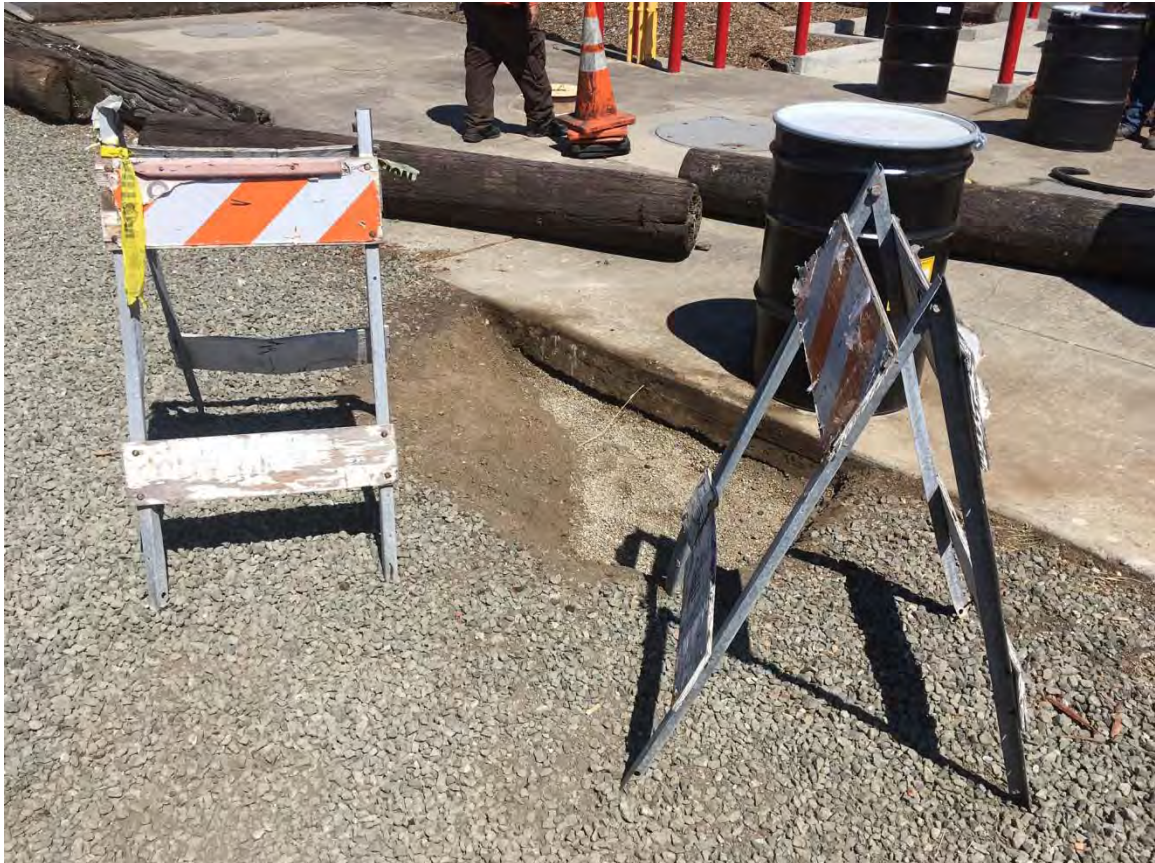
Another view of E-1

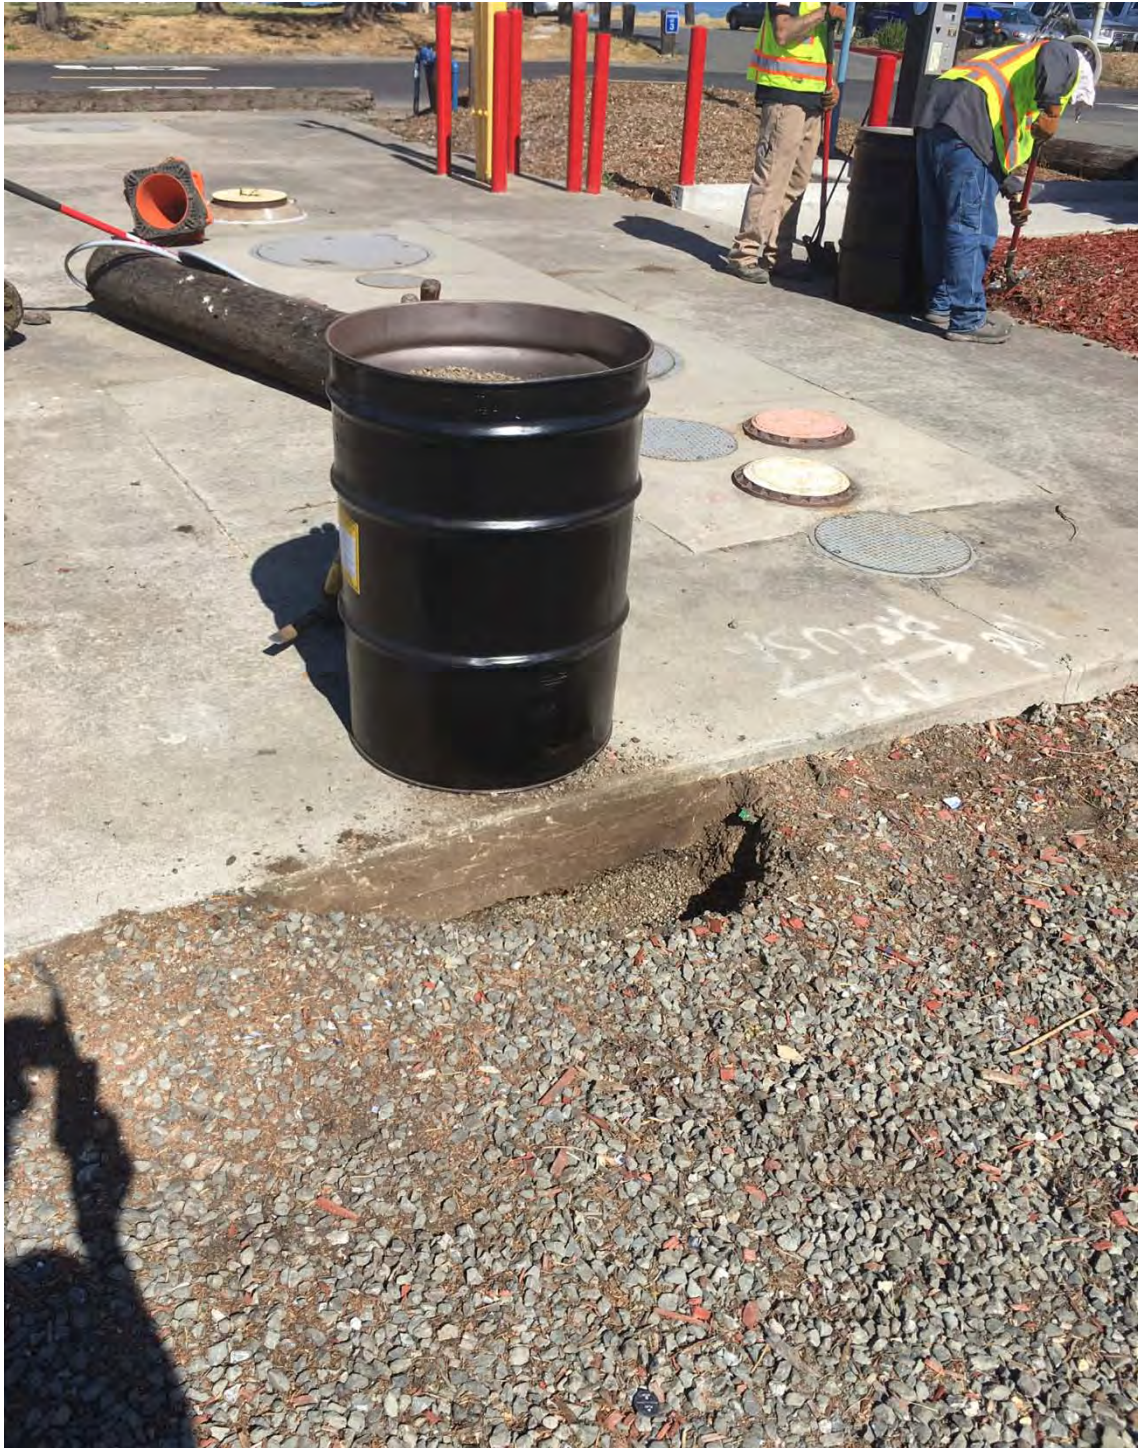
Excavation E-2, east of UST

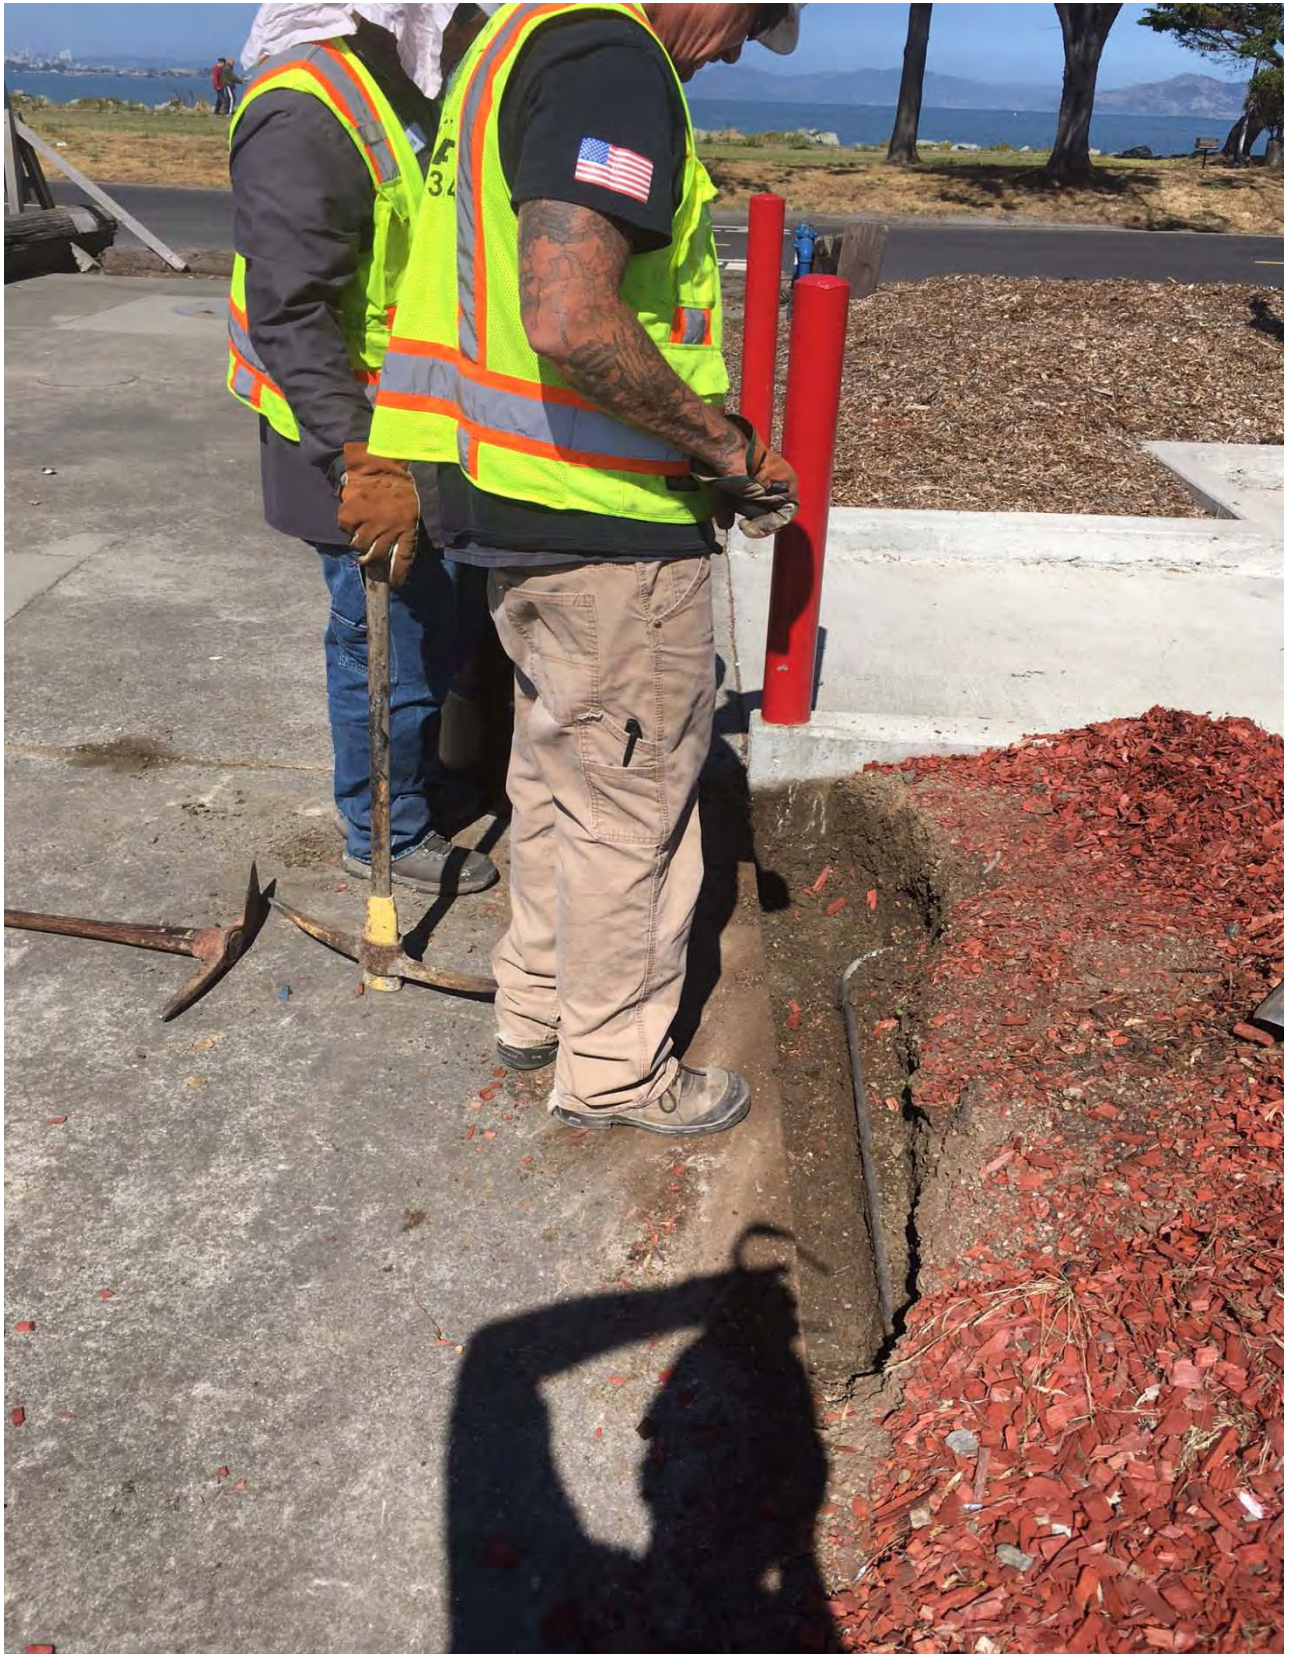
Excavation E-3 on north side of UST, note 2" conduit in sidewall at 18" bg

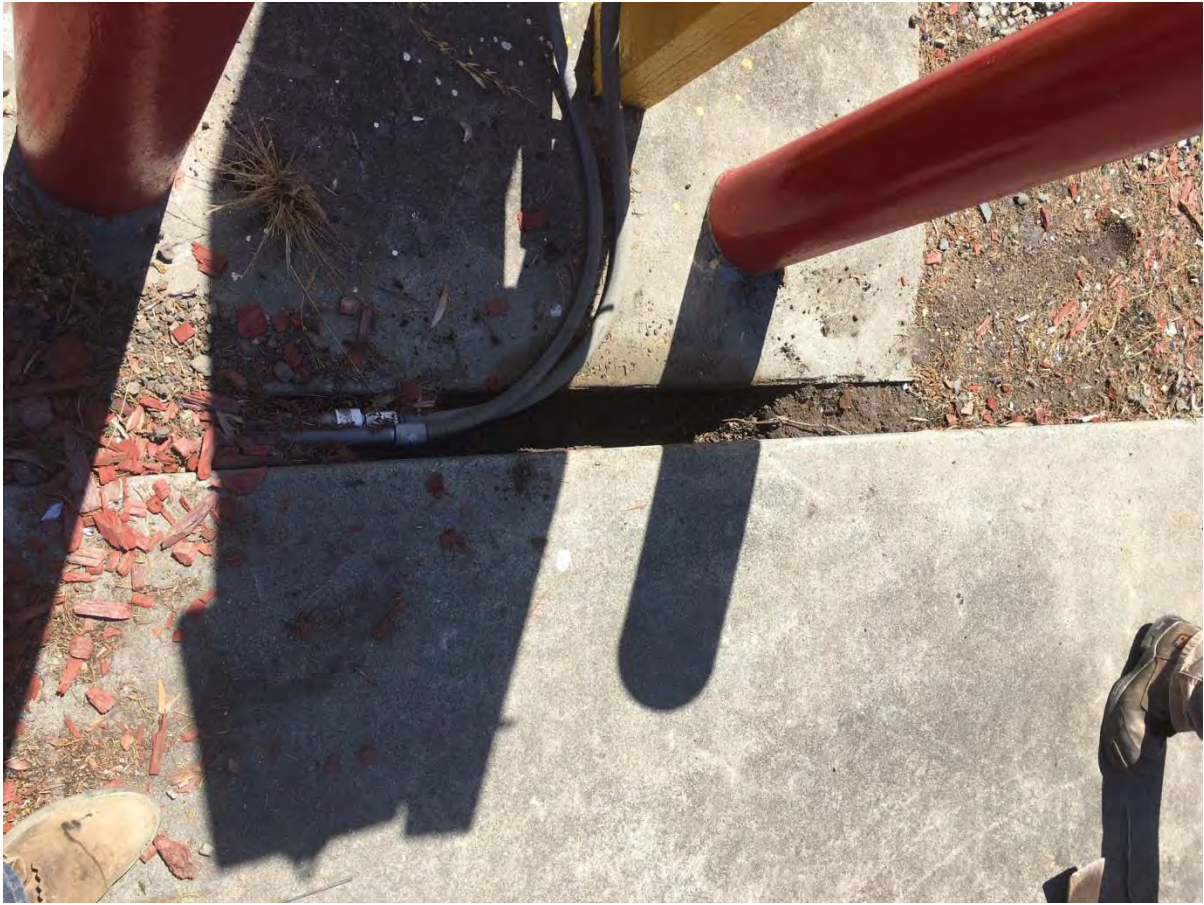
a narrow area between the concrete pad overlying the UST and a small concrete pad supporting an electrical panel. Shovels were not used in Excavation E-4. A digging bar and a shop vacuum were used to remove contaminated soil.

Excavation E-4 between concrete pads, note flexible electrical conduits in trench

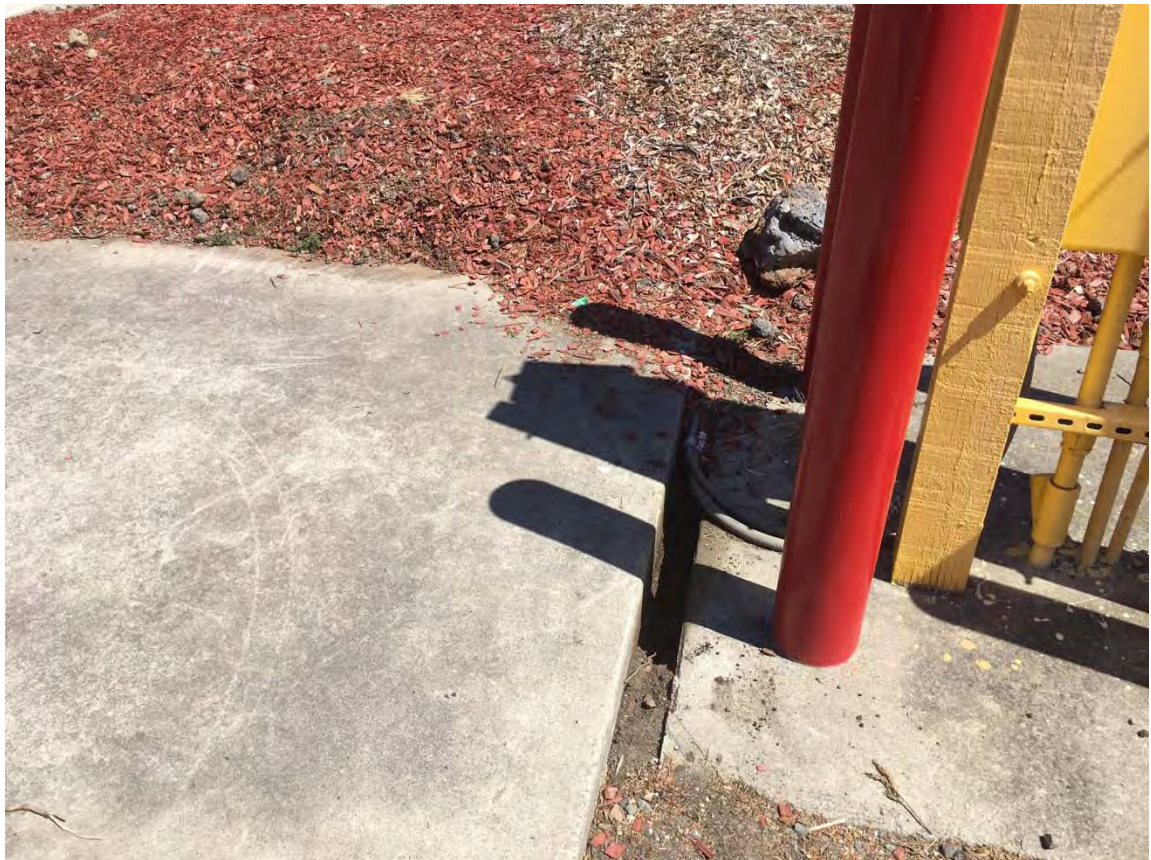
Another view of E-4
