THIRD QUARTER
GROUND WATER MONITORING

Harcros Pigments Plant
4650 Shellmound Street
Emeryville, California

October 29, 1992

Doc #HP19801W.3.3

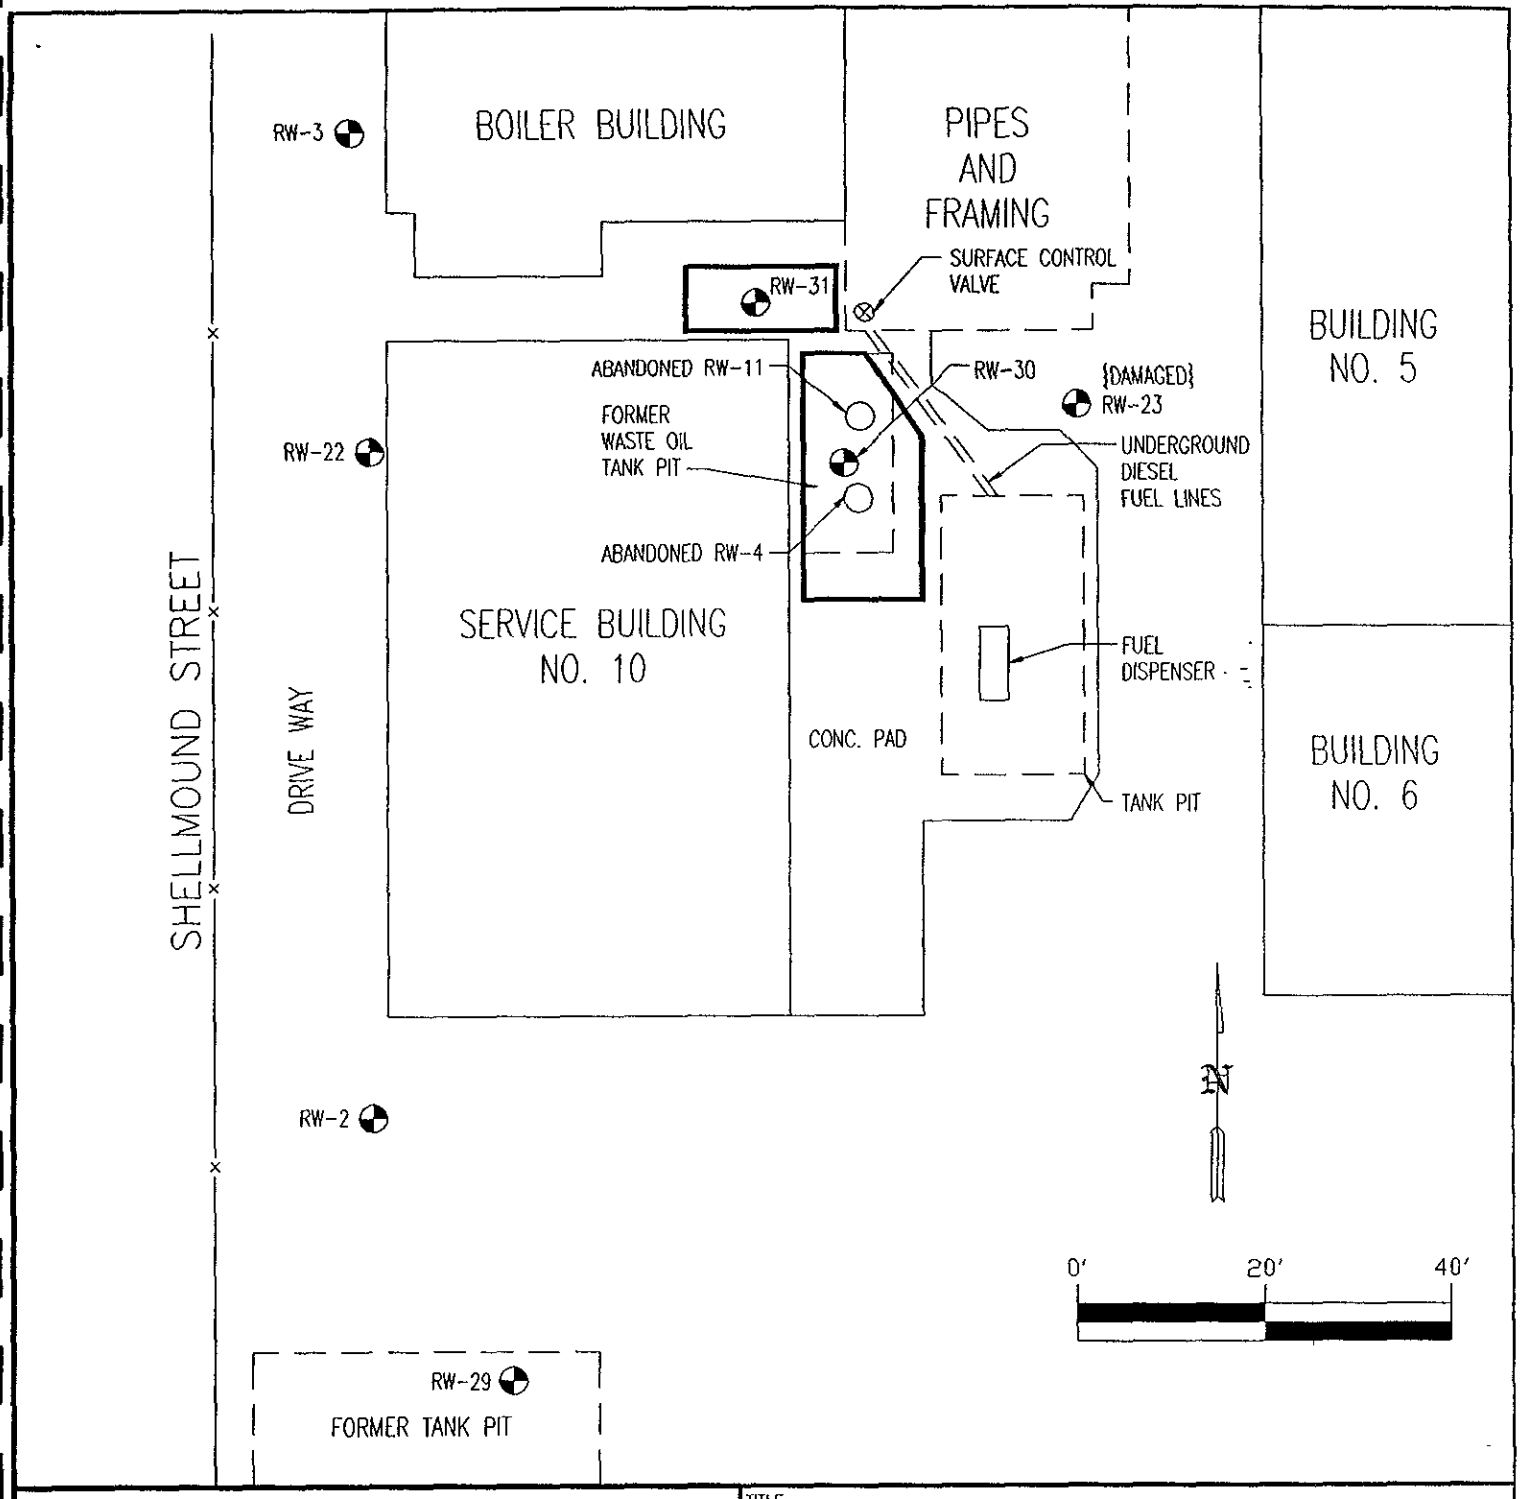
FIGURE 3

In January, 1990, Roux staff discovered diesel fuel floating on top of the water column in monitoring wells RW-4 and RW-11 (Roux, 1990b). Wells RW-4 and RW-11 were located near the northeastern corner of Service Building No. 10 (Figure 3). The monitoring wells were within a former waste oil tank pit and were adjacent to the two recently installed USTs and their associated pipelines.

LOCATION OF MONITORING WELLS AND FORMER TANK PITS

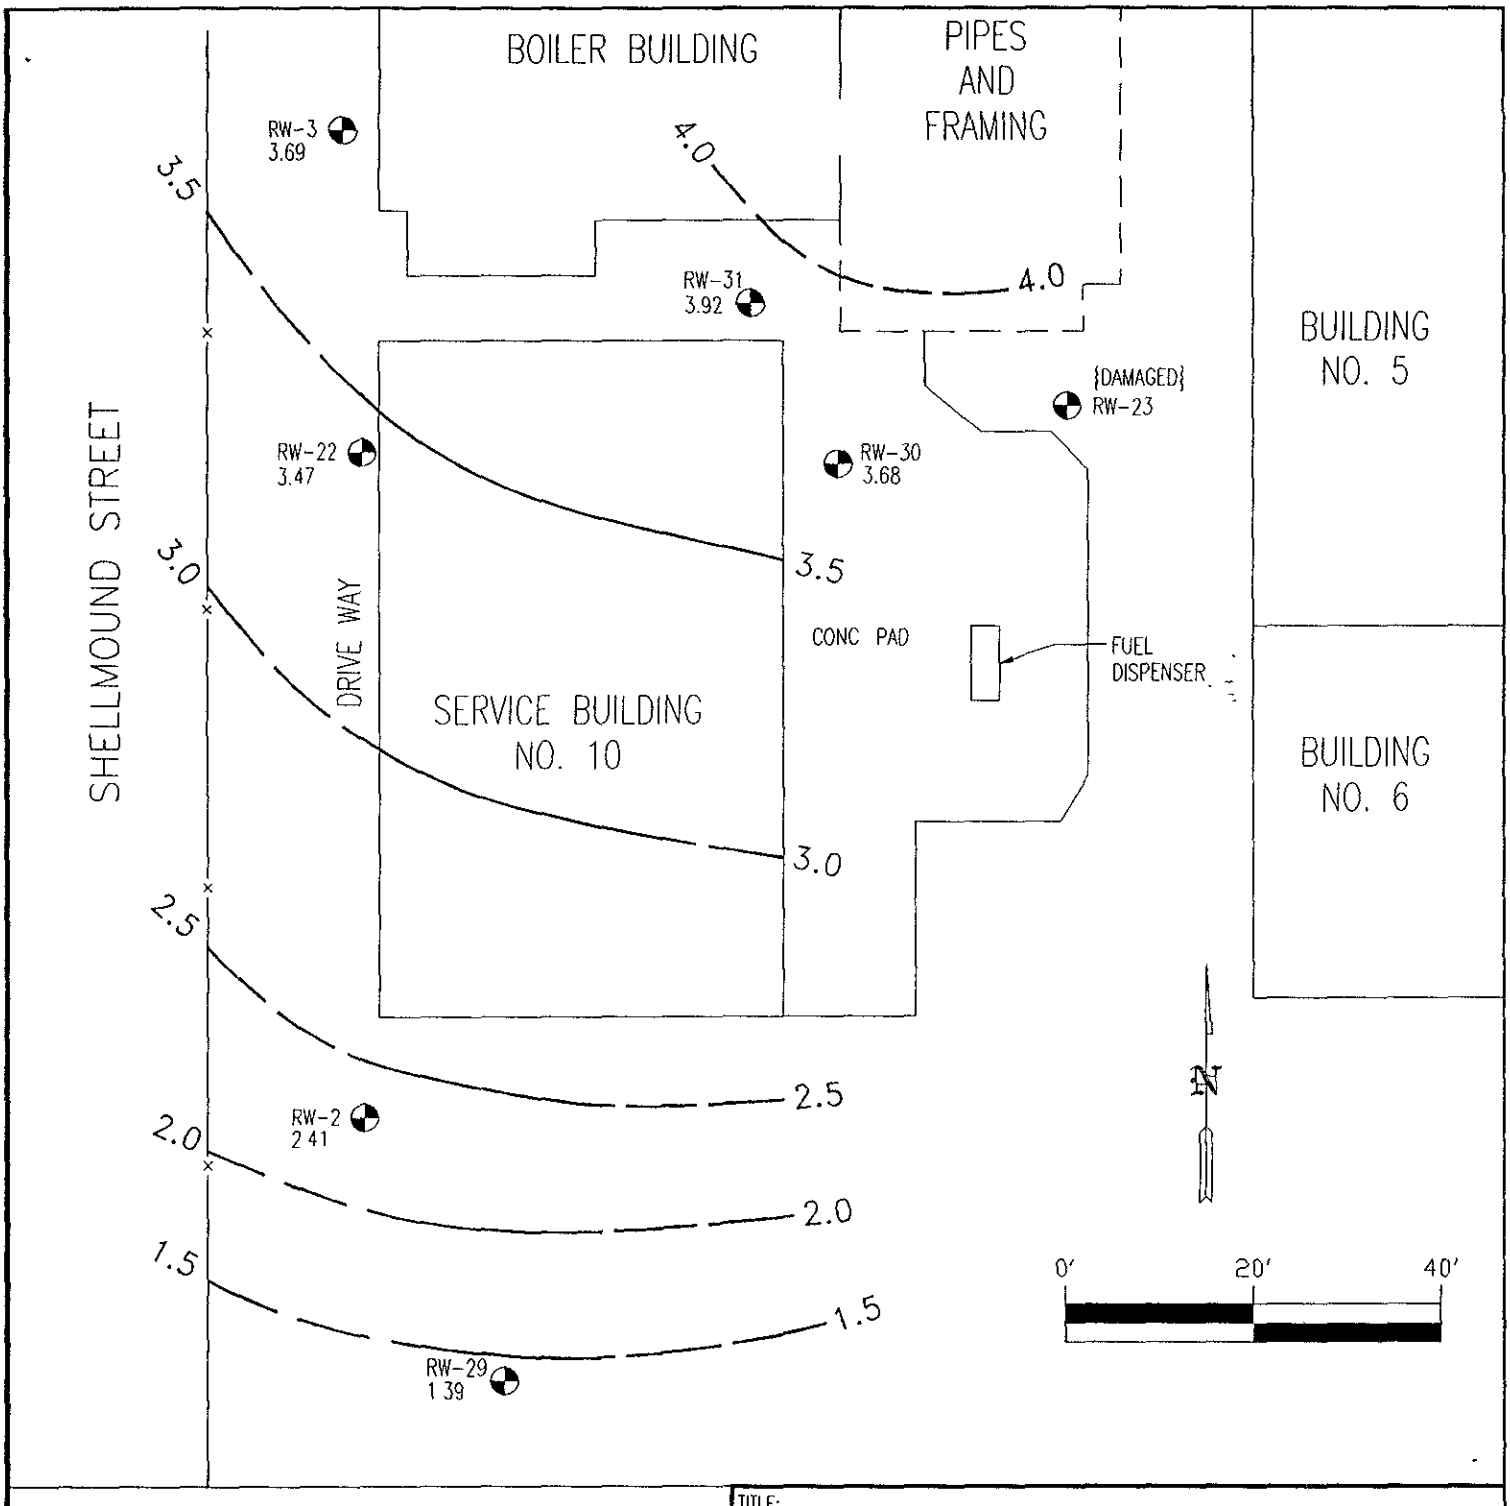
FIGURE 4

Water levels were measured on August 28, 1992, in six on-site monitoring wells. The depth to ground water at the Site has historically been about two to five feet below ground surface (bgs). The depth to ground water measured on August 28, 1992 ranged from 3.16 to 5.62 ft. bgs. Ground water elevations calculated from these water levels indicated the direction of ground water movement at the Site was to the south at a gradient of about 0.02 (Figure 4). This flow direction and gradient is generally consistent with historical measurements. The local flow direction towards the south differs from the regional flow direction to the west, possibly due to the influence of Temescal Creek, located about 170 ft. south of Service Building No. 10.

ELEVATION OF GROUND WATER AUGUST 28, 1992
