FOURTH QUARTER
GROUND WATER MONITORING

Harcros Pigments Plant
4650 Shellmound Street
Emeryville, California

February 25, 1993

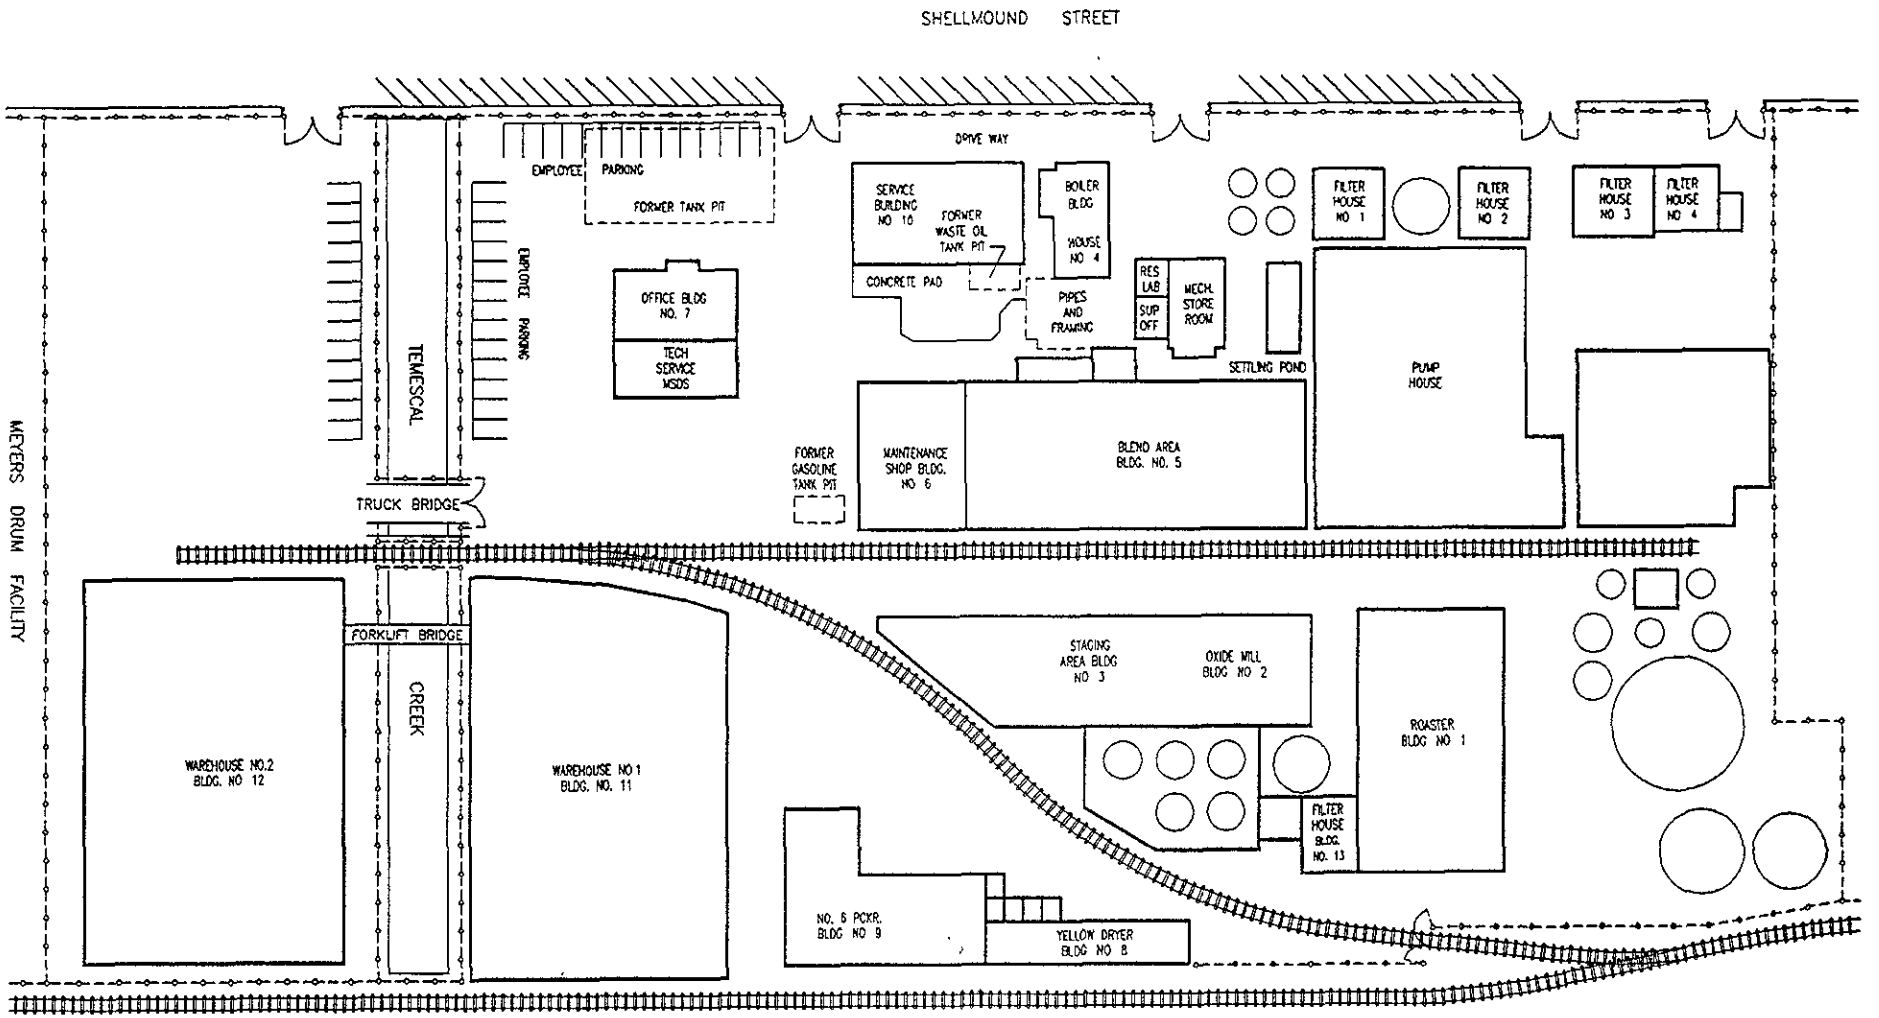
FIGURE 1

LOCATION OF SITE

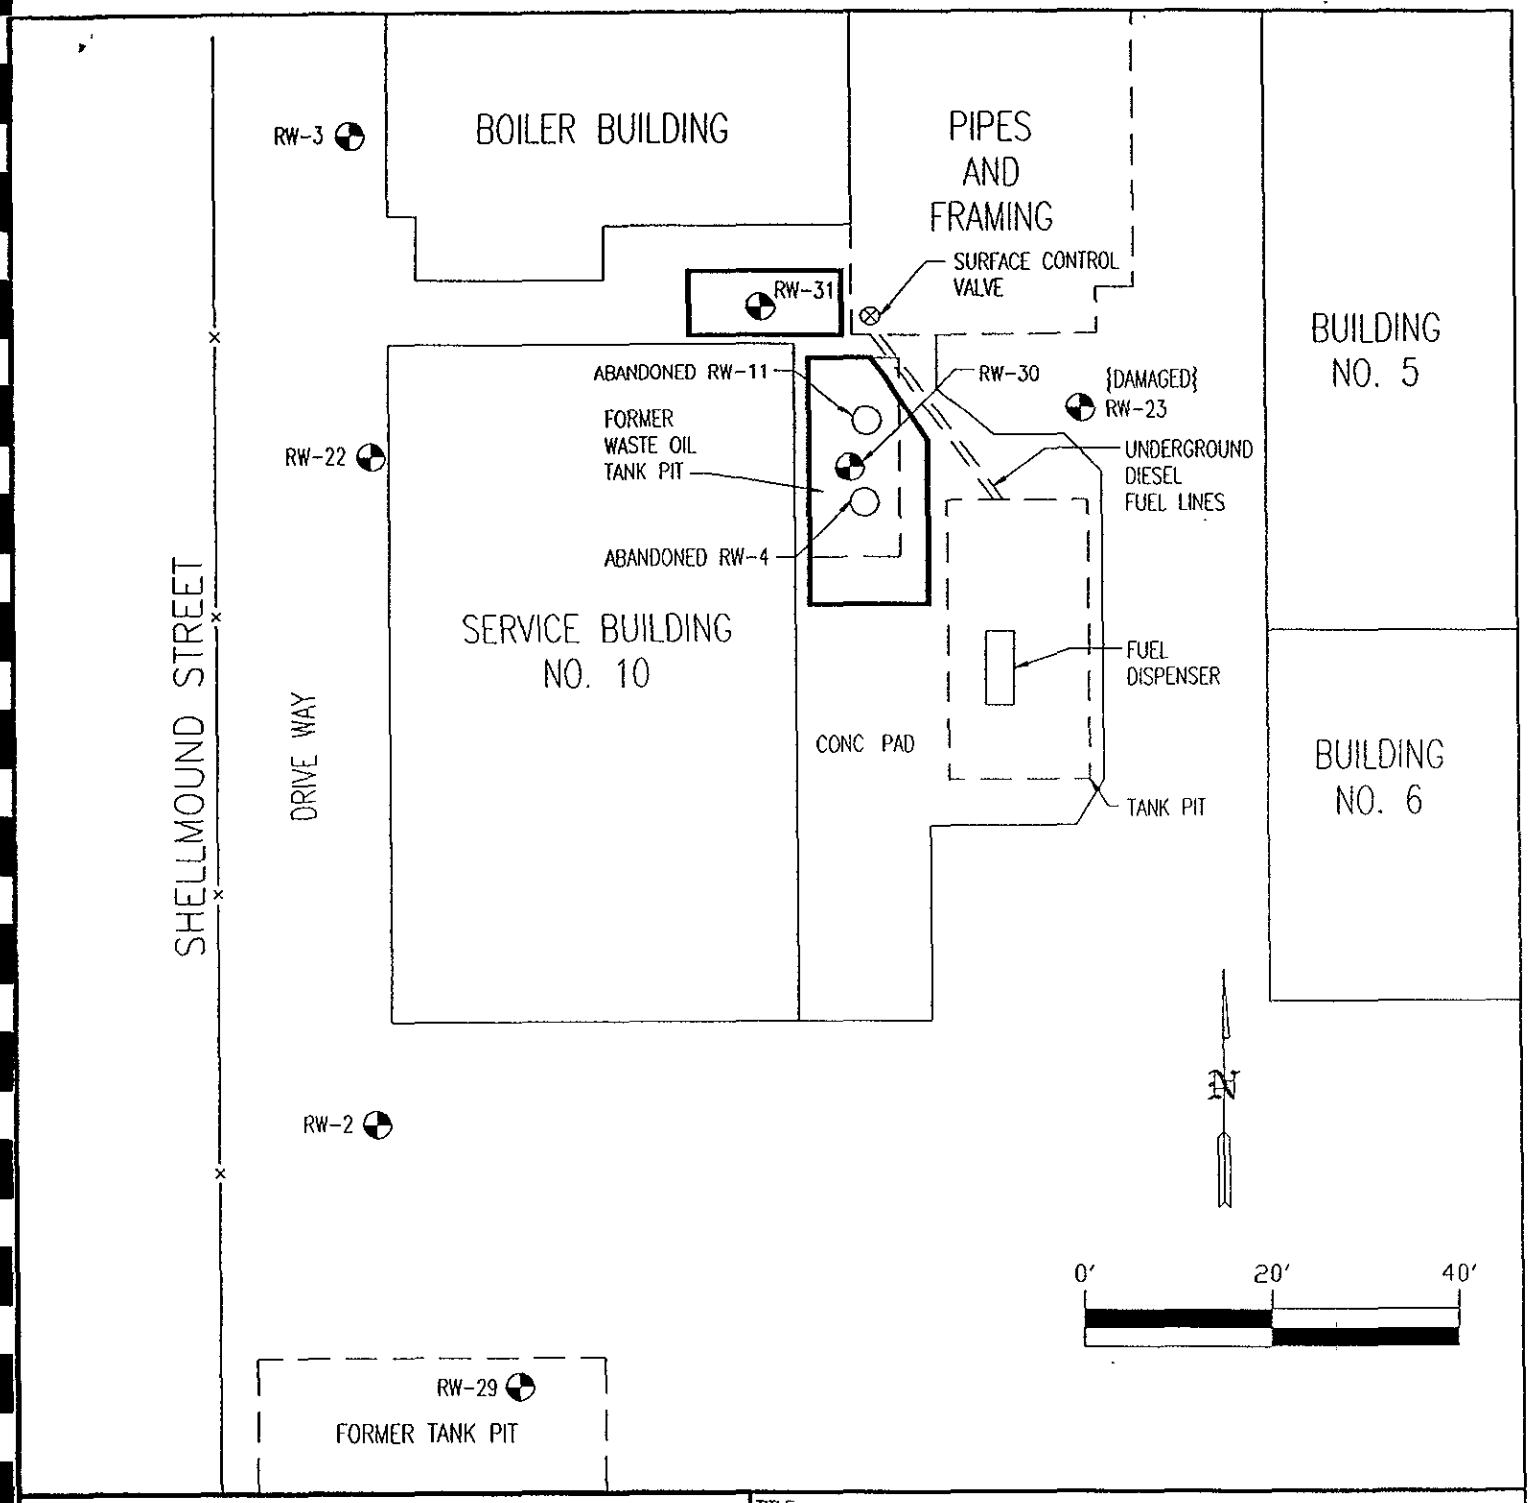
FIGURE
2

TITLE:
SITE PLAN
EMERYVILLE, CA

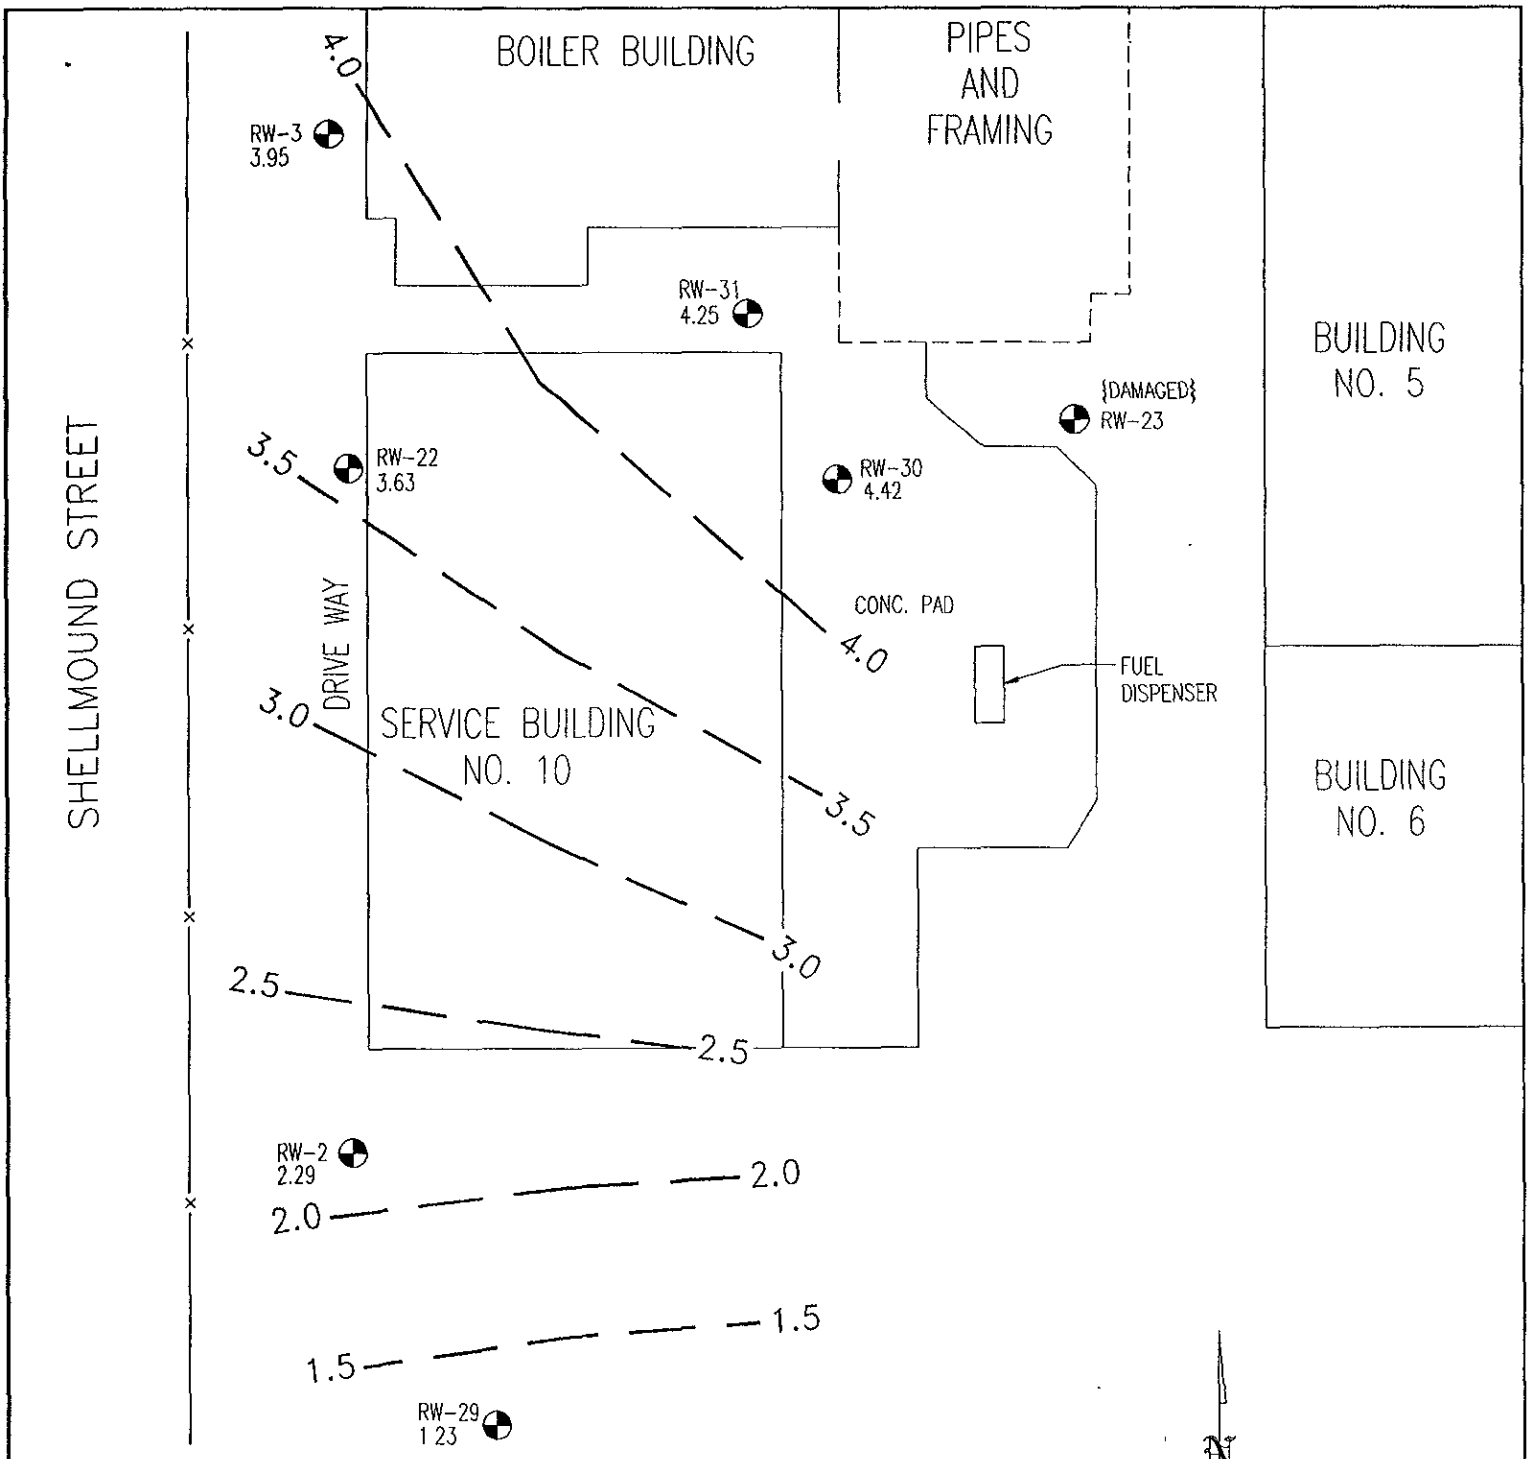
FIGURE 3

In January, 1990, Roux staff discovered diesel fuel floating on top of the water column in monitoring wells RW-4 and RW-11 (Roux, 1990b). Wells RW-4 and RW-11 were located near the northeastern corner of Service Building No. 10 (Figure 3). The monitoring wells were within a former waste oil tank pit and were adjacent to the two recently installed USTs and their associated pipelines.

LOCATION OF MONITORING WELLS AND FORMER TANK PITS
