SUBJECT: DRAFT - PEA REPORT
Thomas A. Short Company (TASCO)
3430 Wood Street
Oakland, CA 94662

PRELIMINARY ENDANGERMENT ASSESSMENT REPORT (PEA)

THOMAS A. SHORT COMPANY (TASCO)
3430 WOOD STREET
OAKLAND, CALIFORNIA 94608

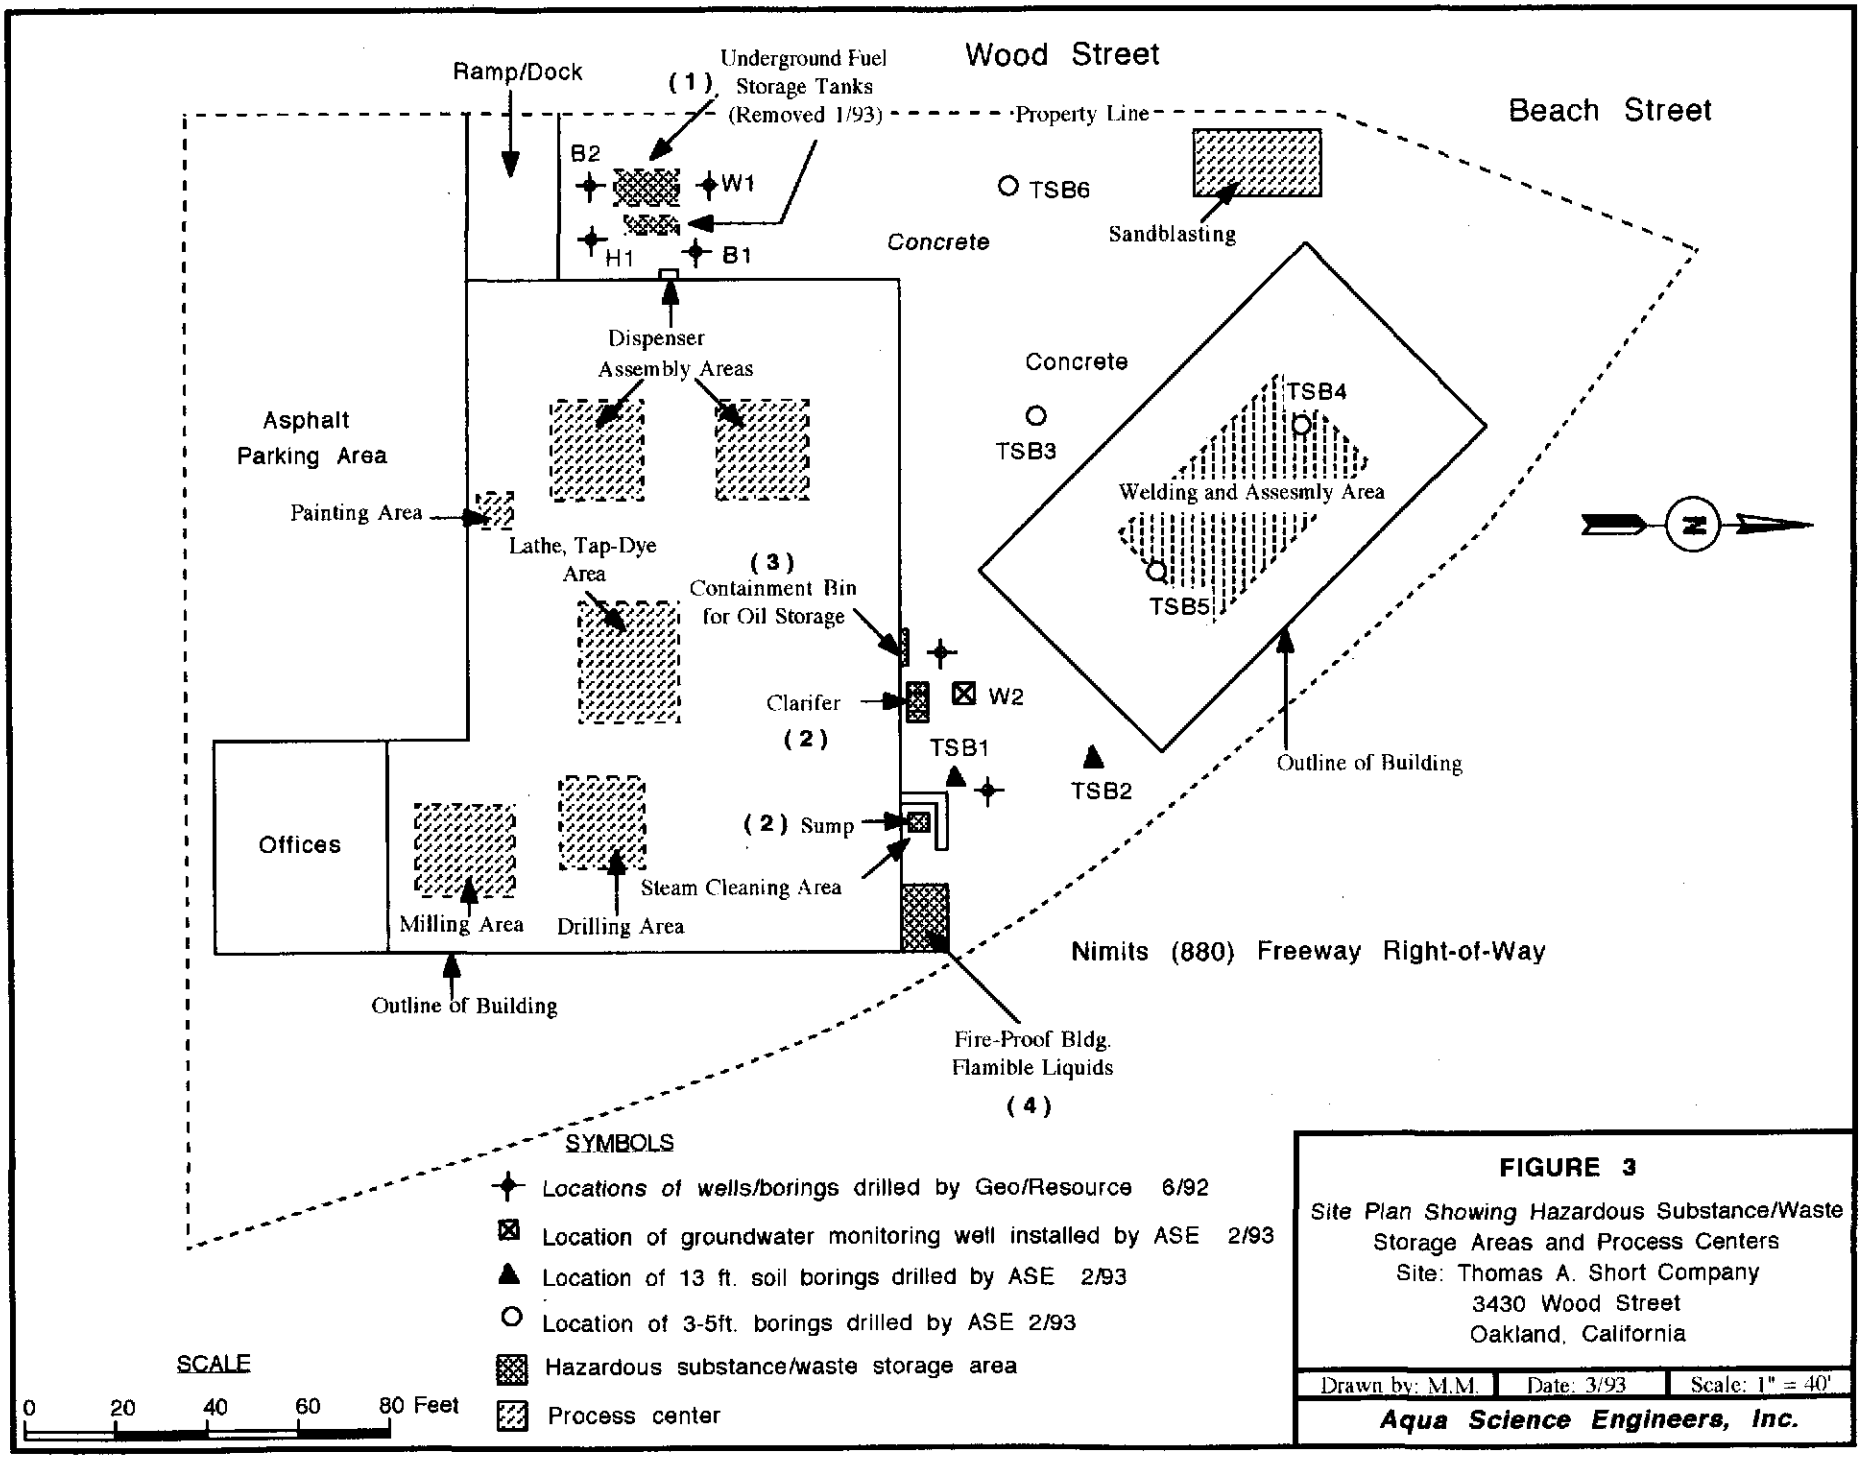
FIGURE 3

Prior to repair of many valves and associated parts, a steam cleaner unit is used to remove built-up layers of oil and grease. (see Figure 3 for location of steam cleaning unit). This steam cleaning unit is housed above an oil-water separator/clarifier with the capacity of approximately 300 gallons. The steam cleaning unit sprays extremely hot water onto the parts; the residual water is then separated from the oil and grease via the clarifier. The clarifier is connected to the local sanitary sewer. Sump cleaning and sludge disposal records were not available.

The locations of current and former hazardous substances/wastes storage units at the TASCO site are provided on Figure 3. A total of four locations were identified by ASE. The locations numbered on Figure 3 correspond with the following description:

Site Plan Showing Hazardous Substance/Waste Storage Areas and Process Centers
Site: Thomas A. Short Company
3430 Wood Street
Oakland, California

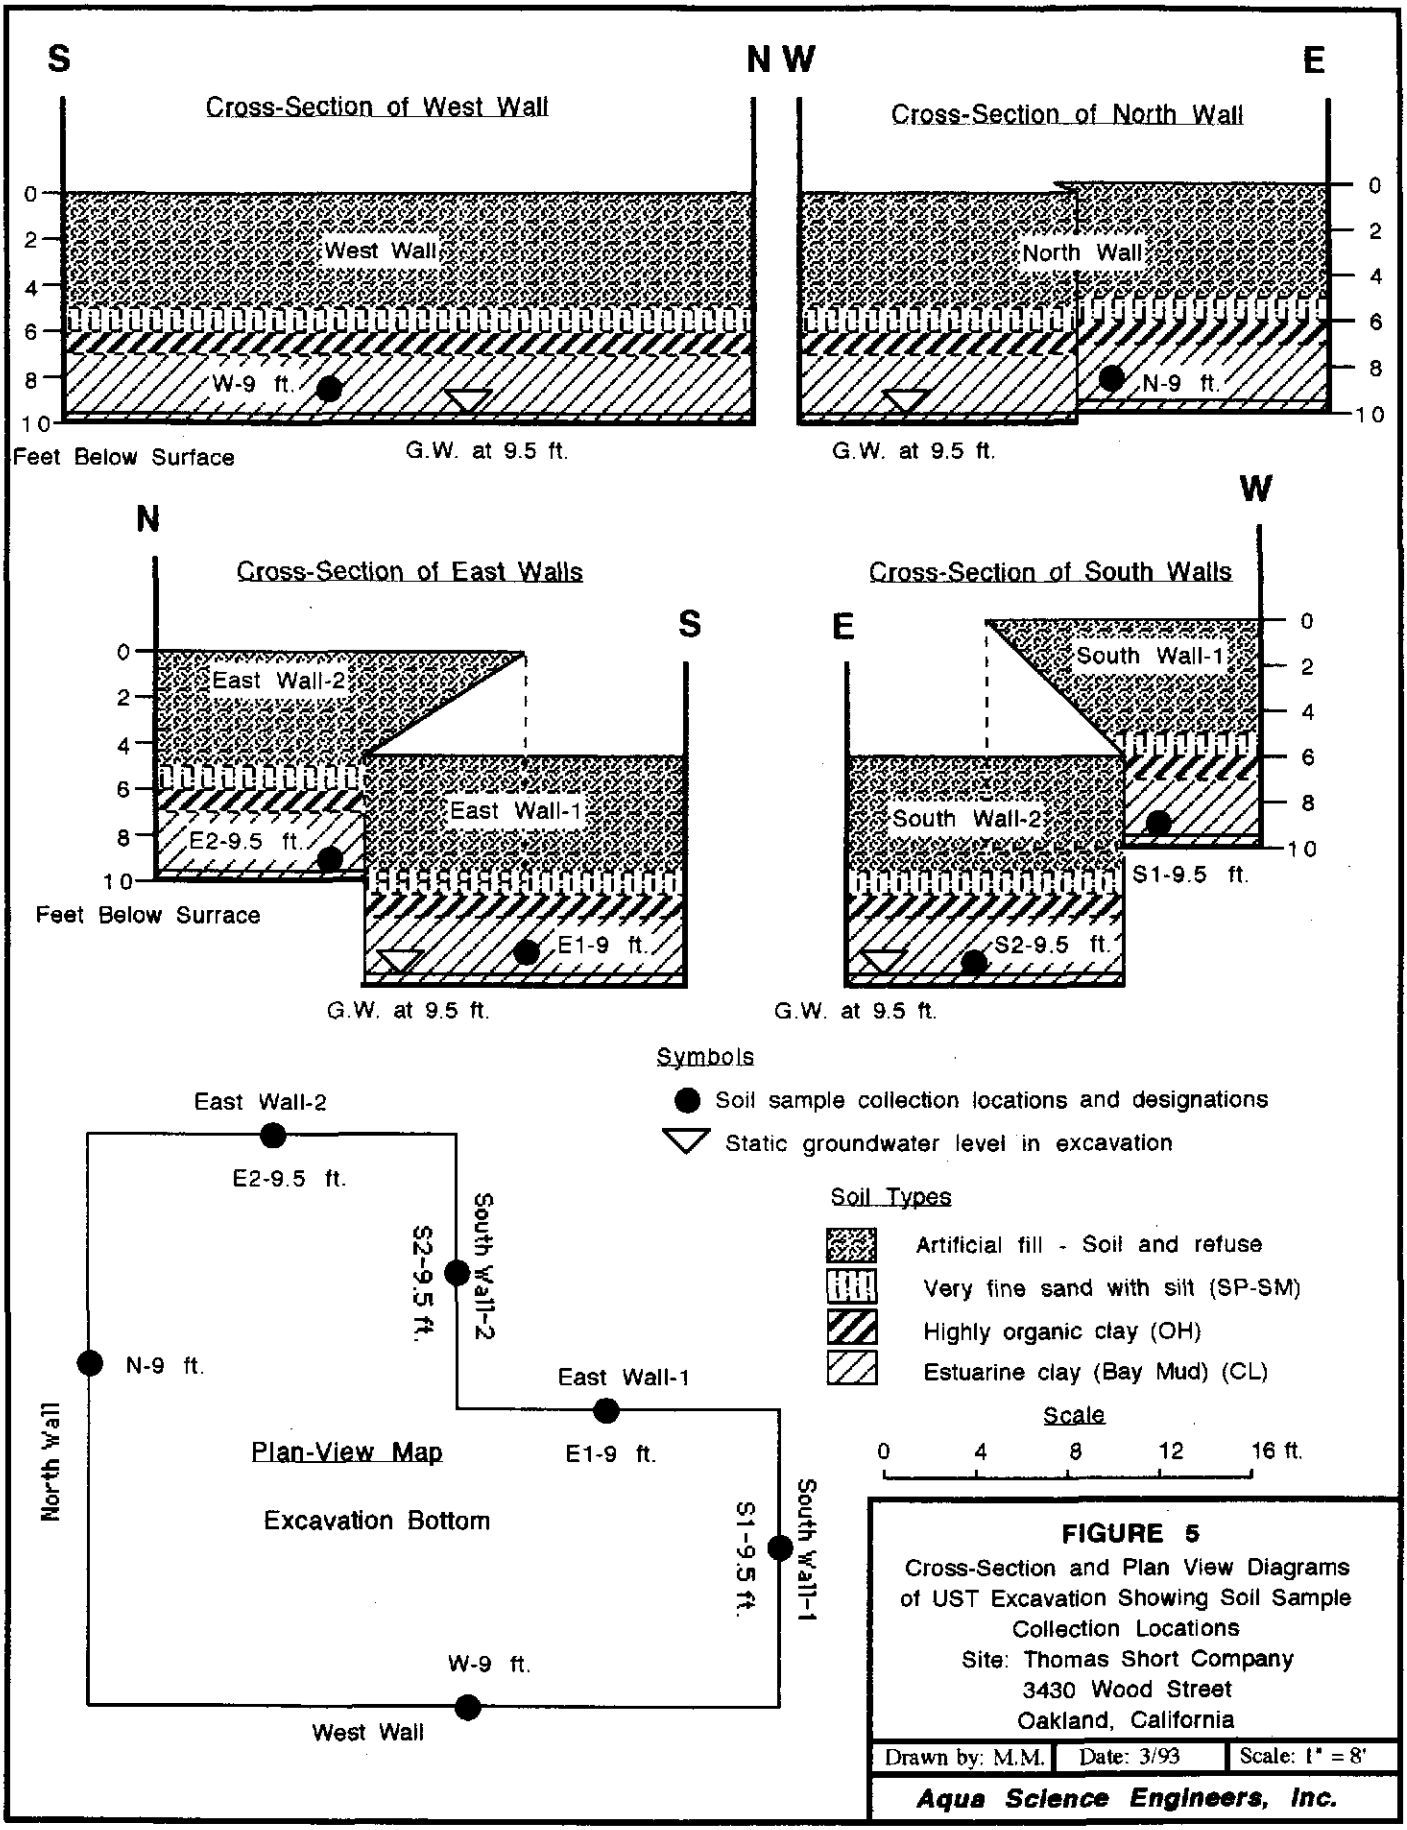
FIGURE 5

Soil excavation continued laterally until the sample screening using the Photovac PID indicated low levels of residual volatile organic carbon. At that time, confirmation soil samples were collected from the excavation under the supervision of Ms. Jennifer Eberle of the ACHCSA, and Mr. Michael Marello, R.G. #5339 of Aqua Science Engineers. The samples were collected from backhoe scoops of soil taken from the side-walls of the excavation approximately six to ten inches above groundwater level. Precleaned six inch length by two inch diameter stainless steel tubes were driven into the scoops of soil until completely full. A total of six confirmation soil samples were collected. These samples were designated E-1, E-2, N, S-1, S-2 and W. Grab soil samples were also collected from the excavated soil stockpile. These samples were designated STKP-E and STKP-W. The ends of the tubes were secured with double-thickness aluminum foil, plastic end-caps and tape. The sample tubes were subsequently numbered and placed in an ice chest for temporary cold storage. A diagram showing the dimensions of the excavation and soil sample collection locations is provided as Figure 5.

Cross-Section and Plan View Diagrams of UST Excavation Showing Soil Sample Collection Locations

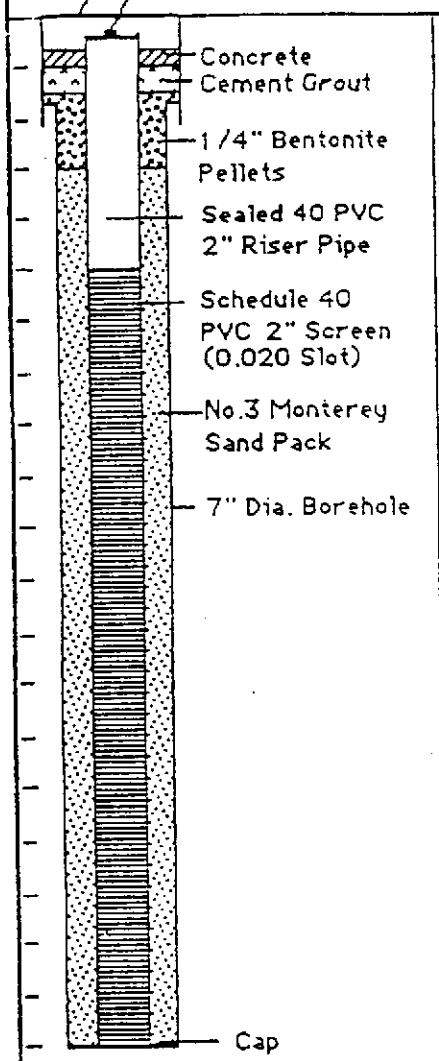
Depth (ft.)	Sample pnts.	Blows/ft.	Hnu Readings (ppm)	
0		32	2	SILTY CLAY (CL) light brown, damp, medium dense, rock fragments, debris (concrete)
5		3	2	color changes to dark brown, very soft
		3	6	color changes to black, wet, very soft
10		8	4	Fill
		30	7	color changes to light brown, some rock fragments, very stiff
15				
20				Boring terminated @ 20.0 feet. No free standing groundwater was encountered during drilling.
25				
30

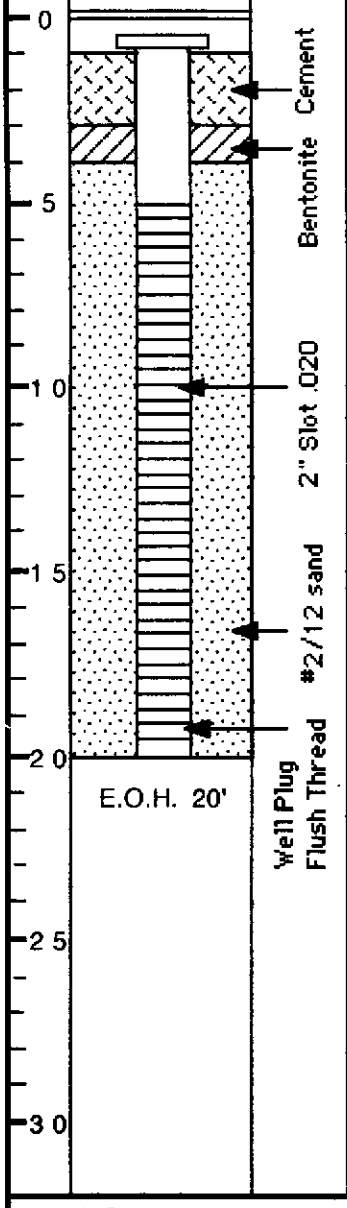
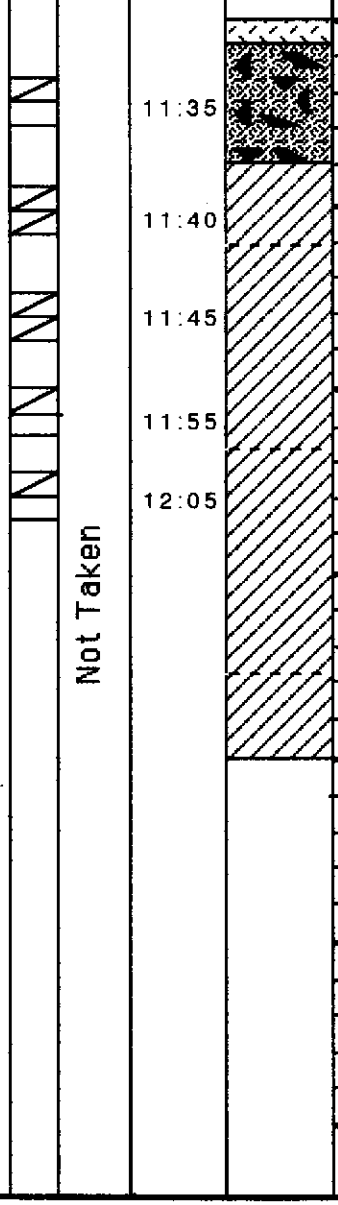
Sand, clay, gravel & silt (Fill), black to dark gray, moist, oil odor, oil staining

Clay some silt (OL), black, highly organic, H_2S odor, moist

Clay with silt (CL), olive gray to olive green mottled, moist to wet, H_2S odor

Clay, some silt (CL), olive-gray and olive-green mottled, moist, sticky, mod. stiff

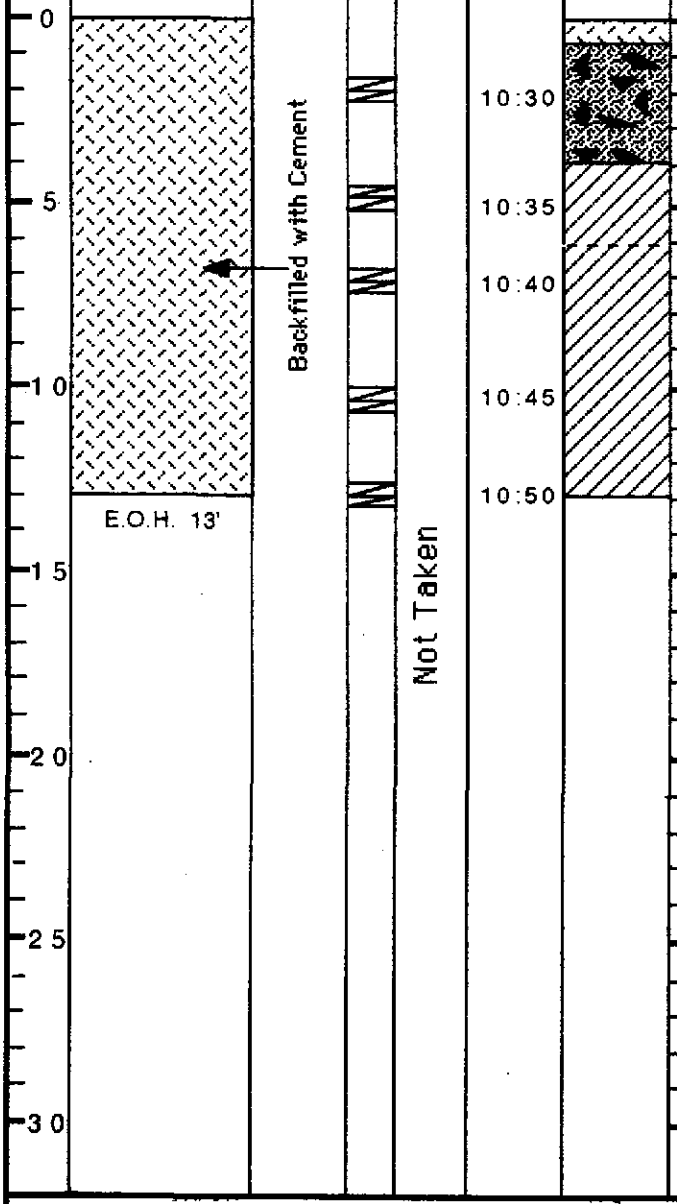
Silt with clay, sand & gravel (Fill), dark gray to black, moist, sl. odor

Clay, some silt (OL), black, highly organic, moist, some odor (oil sheen?)

Clay and silt (CL), olive to olive-gray, moist, some humus, no odor

Clay (CL), olive-gray to olive green mottled, mod. stiff, moist, no odor

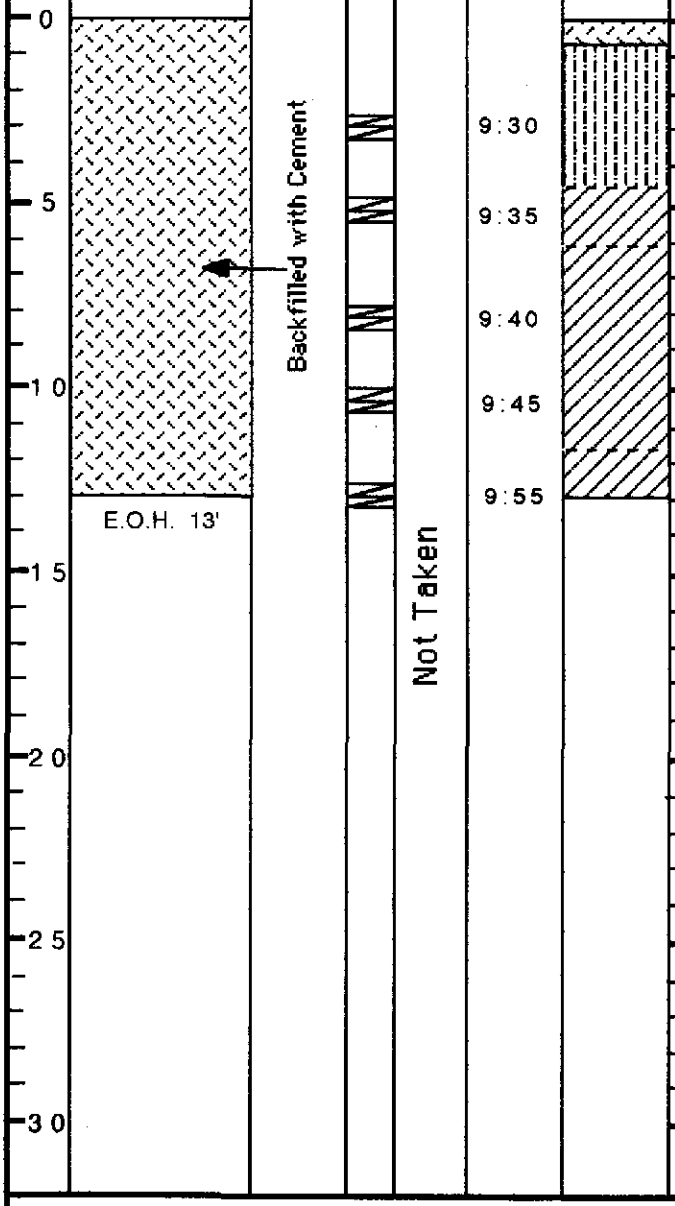
Silt with gravel & sand (Fill) olive-brown, sl. moist, no odor

Clay (OL), black, highly organic, moist, H_2S odor

Clay (CL), olive-gray, moist, no odor

Clay (CL), olive, sticky, moist, no odor

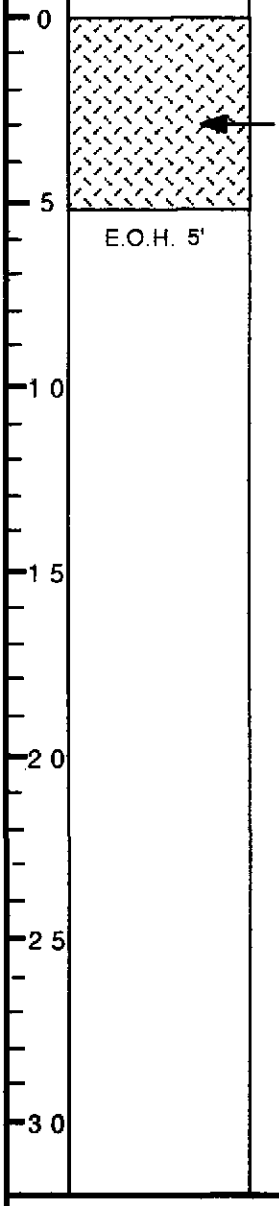
Silt with clay, some sand, abundant brick,asphalt, wire, concrete (Fill). Dark gray to black, sl. moist, H_2S odor

Clay, some silt, highly organic (OL), dark gray to black, moist H_2S odor

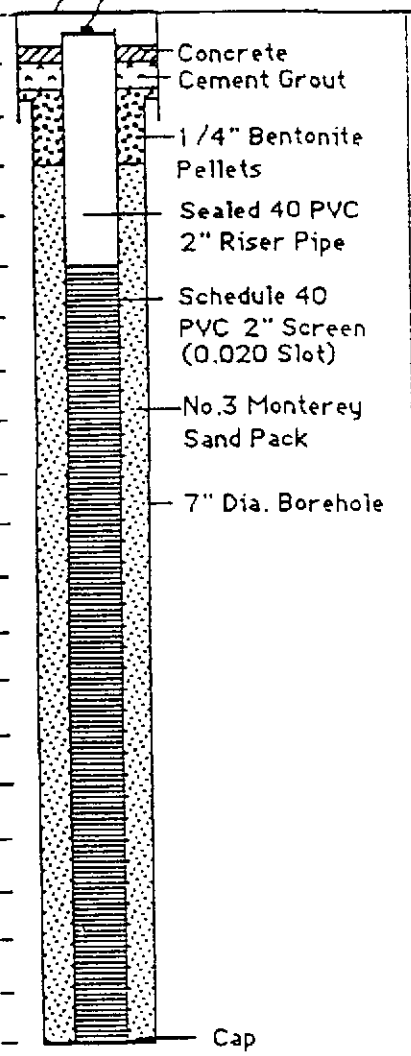
Depth (ft.)	Sample pnts.	Blows/ft.	Hnu Readings (ppm)	
0		32	2	SILTY CLAY (CL) light brown, damp, medium dense, rock fragments, debris (concrete)
5		3	2	color changes to dark brown, very soft
		3	6	color changes to black, wet, very soft
10		8	4	Fill
		30	7	color changes to light brown, some rock fragments, very stiff
15				
20				Boring terminated @ 20.0 feet. No free standing groundwater was encountered during drilling.
25				
30
