SUBJECT: BEACON STATION NO. 721, 44 LEWELLING BLVD., SAN LORENZO, CALIFORNIA

ENVIRONMENTAL PROJECT QUARTERLY STATUS REPORT

Subject: *Quarterly Ground Water Monitoring Report, Third Quarter 1997*
Beacon Station No. 721
44 Lewelling Boulevard
San Lorenzo, California
Delta Project No. D093-936

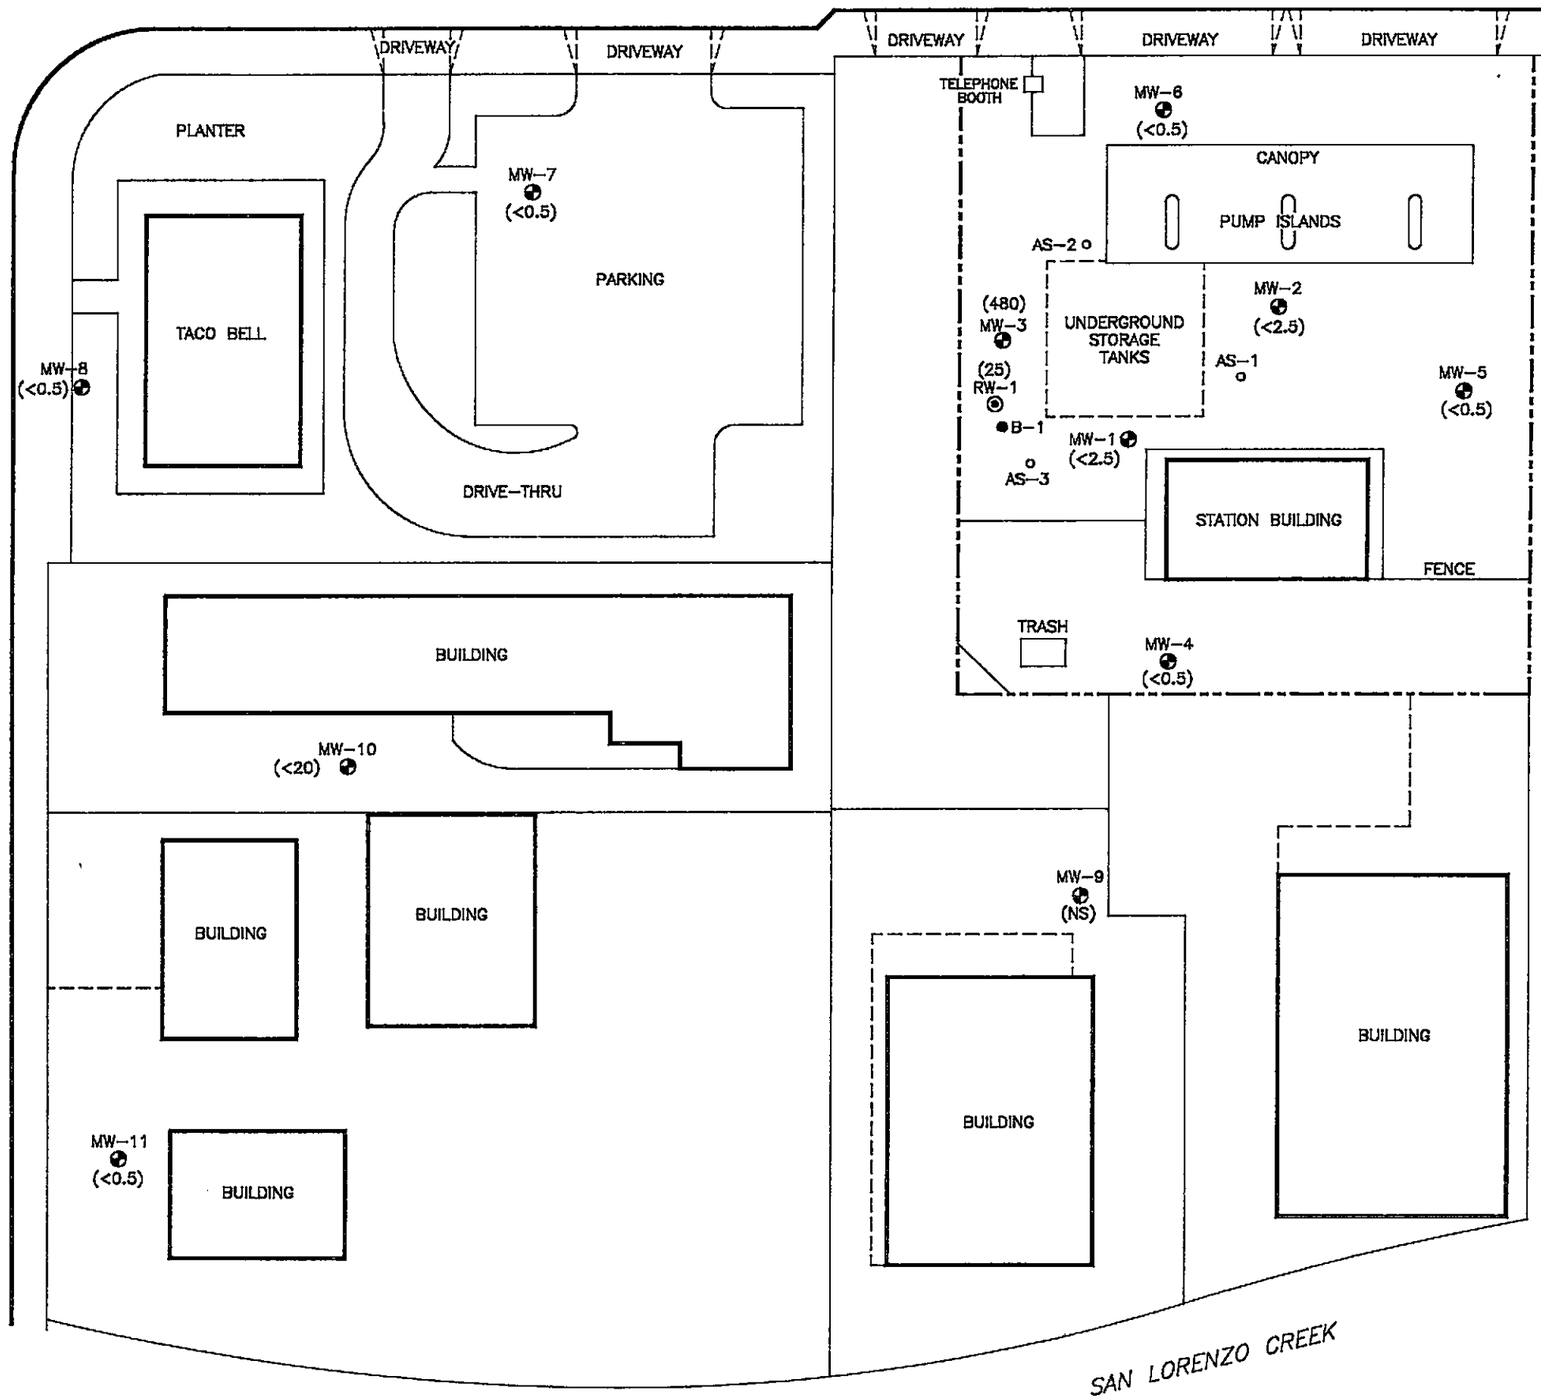
FIGURE 3
GROUND WATER ELEVATION CONTOUR MAP
8/18/97
BEACON STATION NO. 721
44 LEWELLING BOULEVARD
SAN LORENZO, CA.

Depth to ground water was measured in wells MW-1 through MW-8, MW-10, MW-11, and RW-1 at depths ranging from 14.95 (MW-7) to 18.84 (MW-11) feet below the top of well casings. Ground water monitoring well MW-9 was not accessible during this sampling event due to a parked automobile over the well. Ground water measurements were not recorded during the September 29, 1997 visit. Ground water elevations have decreased an average of approximately 1.93 feet since the previous quarterly event in May 1997. Cumulative ground water elevation measurements at the site are compiled in Table 1. Based on the ground water table measurements, the inferred ground water flow is generally toward the west with a gradient of less than 0.01. The ground water recovery system was not operating during this monitoring event. A ground water table contour map prepared from the current event data is included as Figure 3.
