SUBJECT: Verdese Carter Park
Site Characterization Report

Re: Site Characterization Report
Verdese Carter Park Site Characterization Project
98th and Bancroft Avenues, Oakland

SITE CHARACTERIZATION REPORT
VERDESE CARTER PARK

OAKLAND, CALIFORNIA

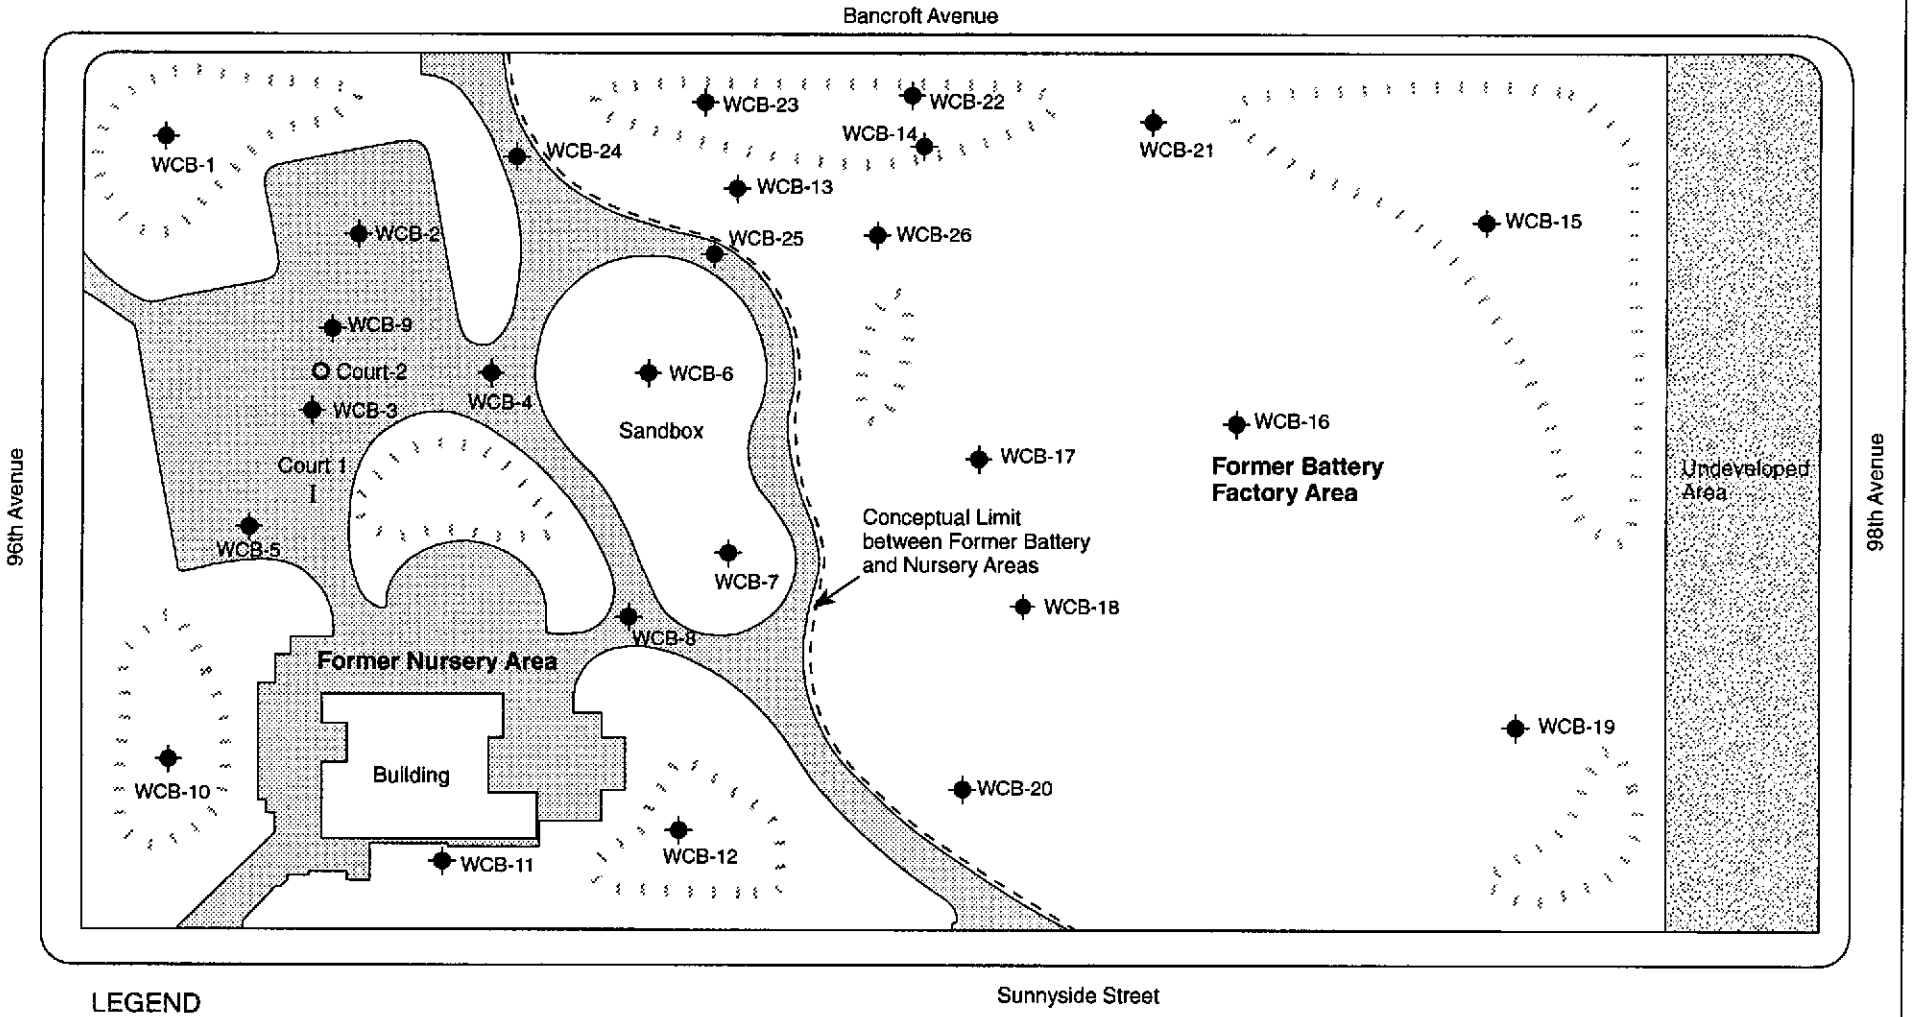
Project No. 93C0243A	Verdese Carter Park Oakland, California	SITE AND SOIL SAMPLE LOCATION PLAN	Figure 1
Woodward-Clyde Consultants

Twelve soil borings were advanced in the Nursery Area as shown on Figure 1. While some of the proposed boring locations within the Nursery Area were selected to provide general area coverage, WCB-2, -3, -5, and -9 were located in the area where a precipitate-like substance was observed in cracks in the basketball court pavement. WCB-6 and -7 were

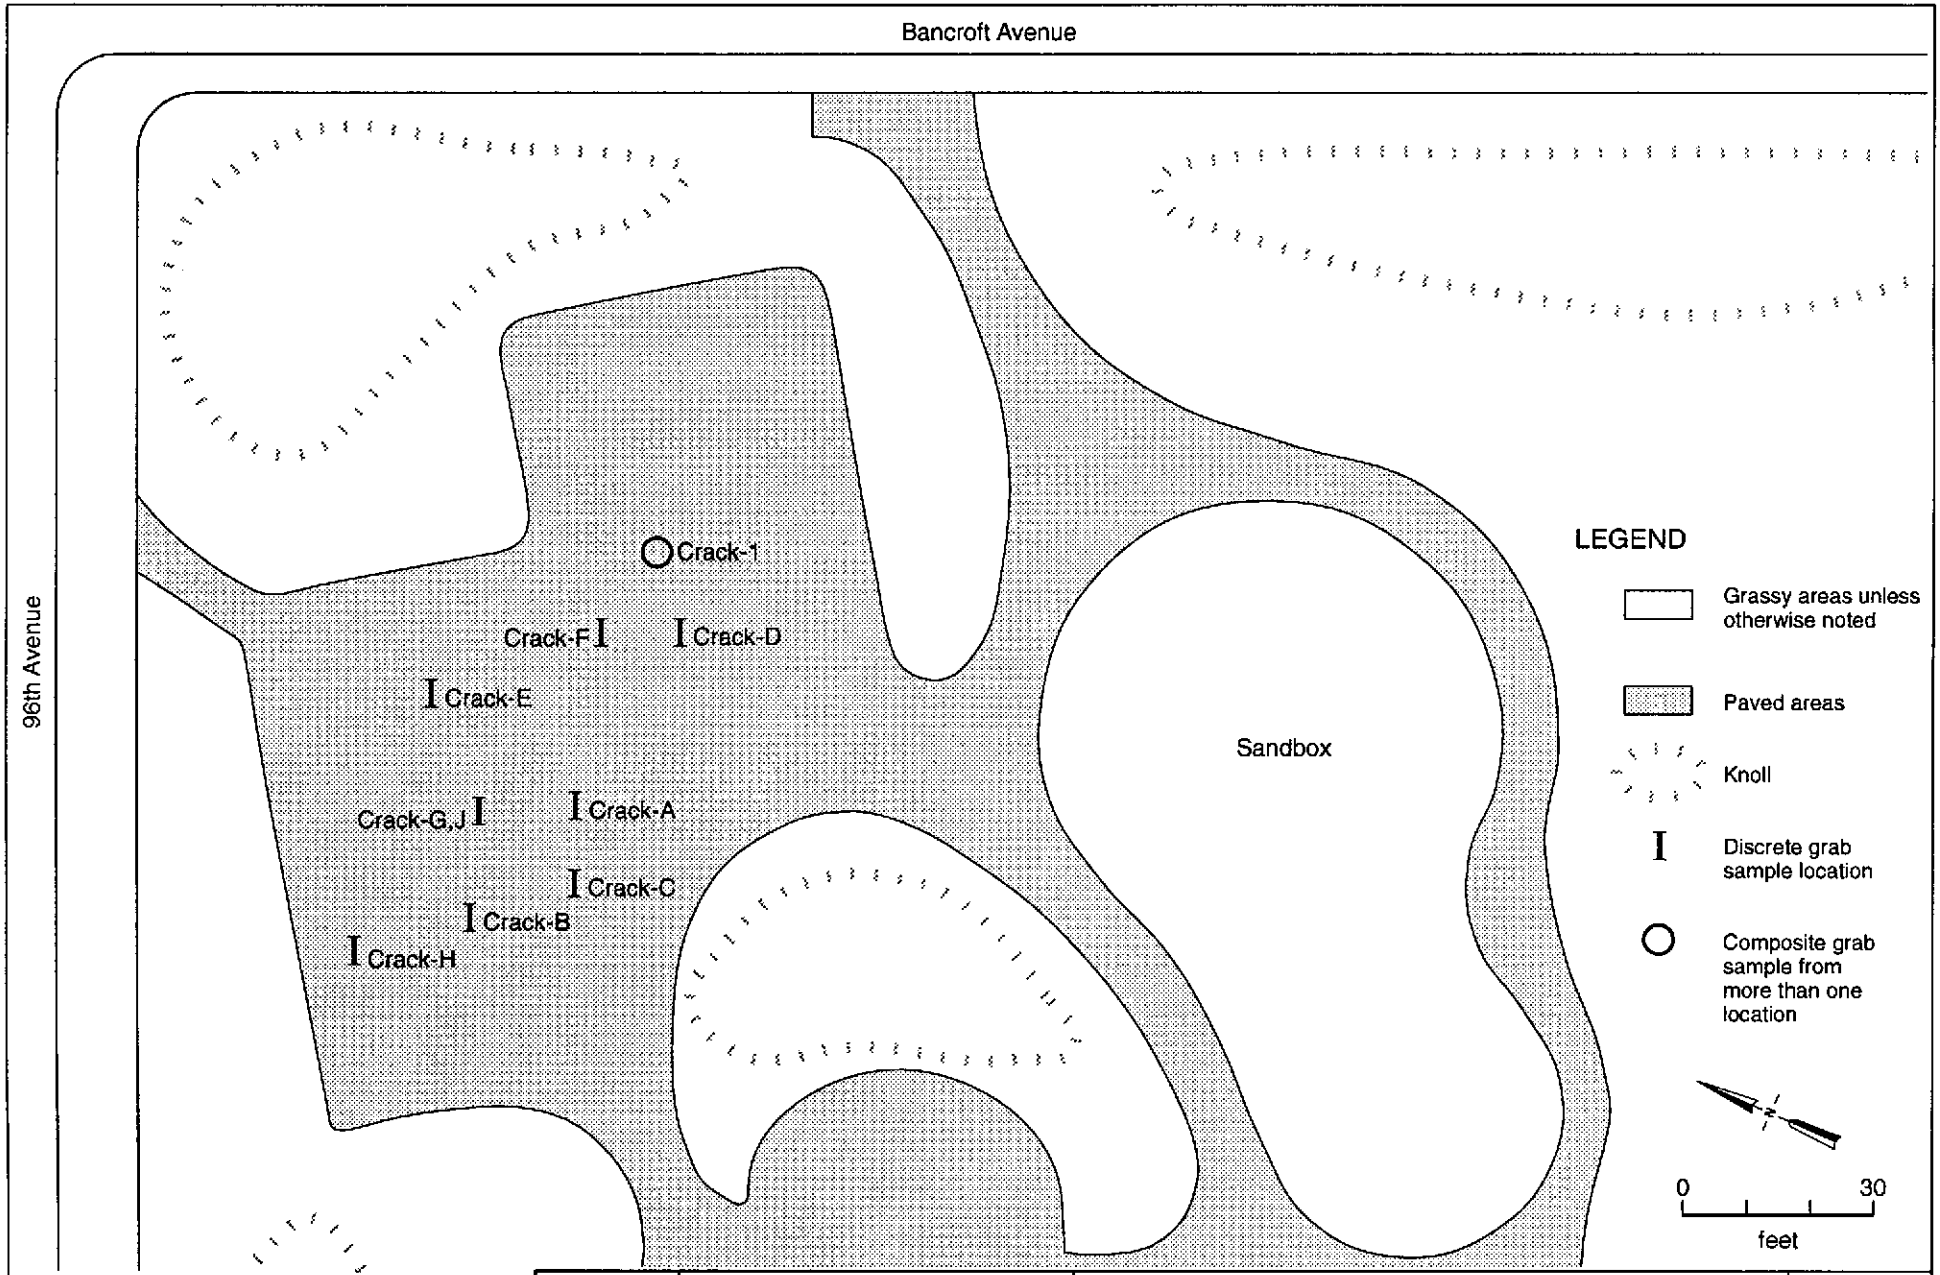
Project No. 93C0243A	Verdese Carter Park Oakland, California	PAVEMENT CRACK PRECIPITATE SAMPLE LOCATION PLAN	Figure 2
Woodward-Clyde Consultants

The selective removal of pavement was performed by WCC personnel on June 28, 1993. The purpose was to expose more of the precipitate-like substance in some of the pavement cracks and the soil staining observed in the aggregate base material penetrated by soil borings in pavement areas. A grab sample (Court 1) of the aggregate base material was obtained that day and forwarded to ATI Laboratory in San Diego, a California certified laboratory for a wide range of analyses. On July 8, a composite sample of the aggregate base material (Court 2) and of the precipitate substance (Crack 1) from various locations at the play court area was obtained and forwarded to ATI for a variety of total and soluble metals analyses. The location of aggregate base samples Court 1 and 2 are shown on Figure 1. The location of precipitate sample Crack 1 is shown on Figure 2.

The precipitate-like substance found in pavement cracks contains elevated concentrations of arsenic (sample concentrations of 7 mg/kg to 33 mg/kg) but at concentrations significantly below those found in the underlying aggregate base.

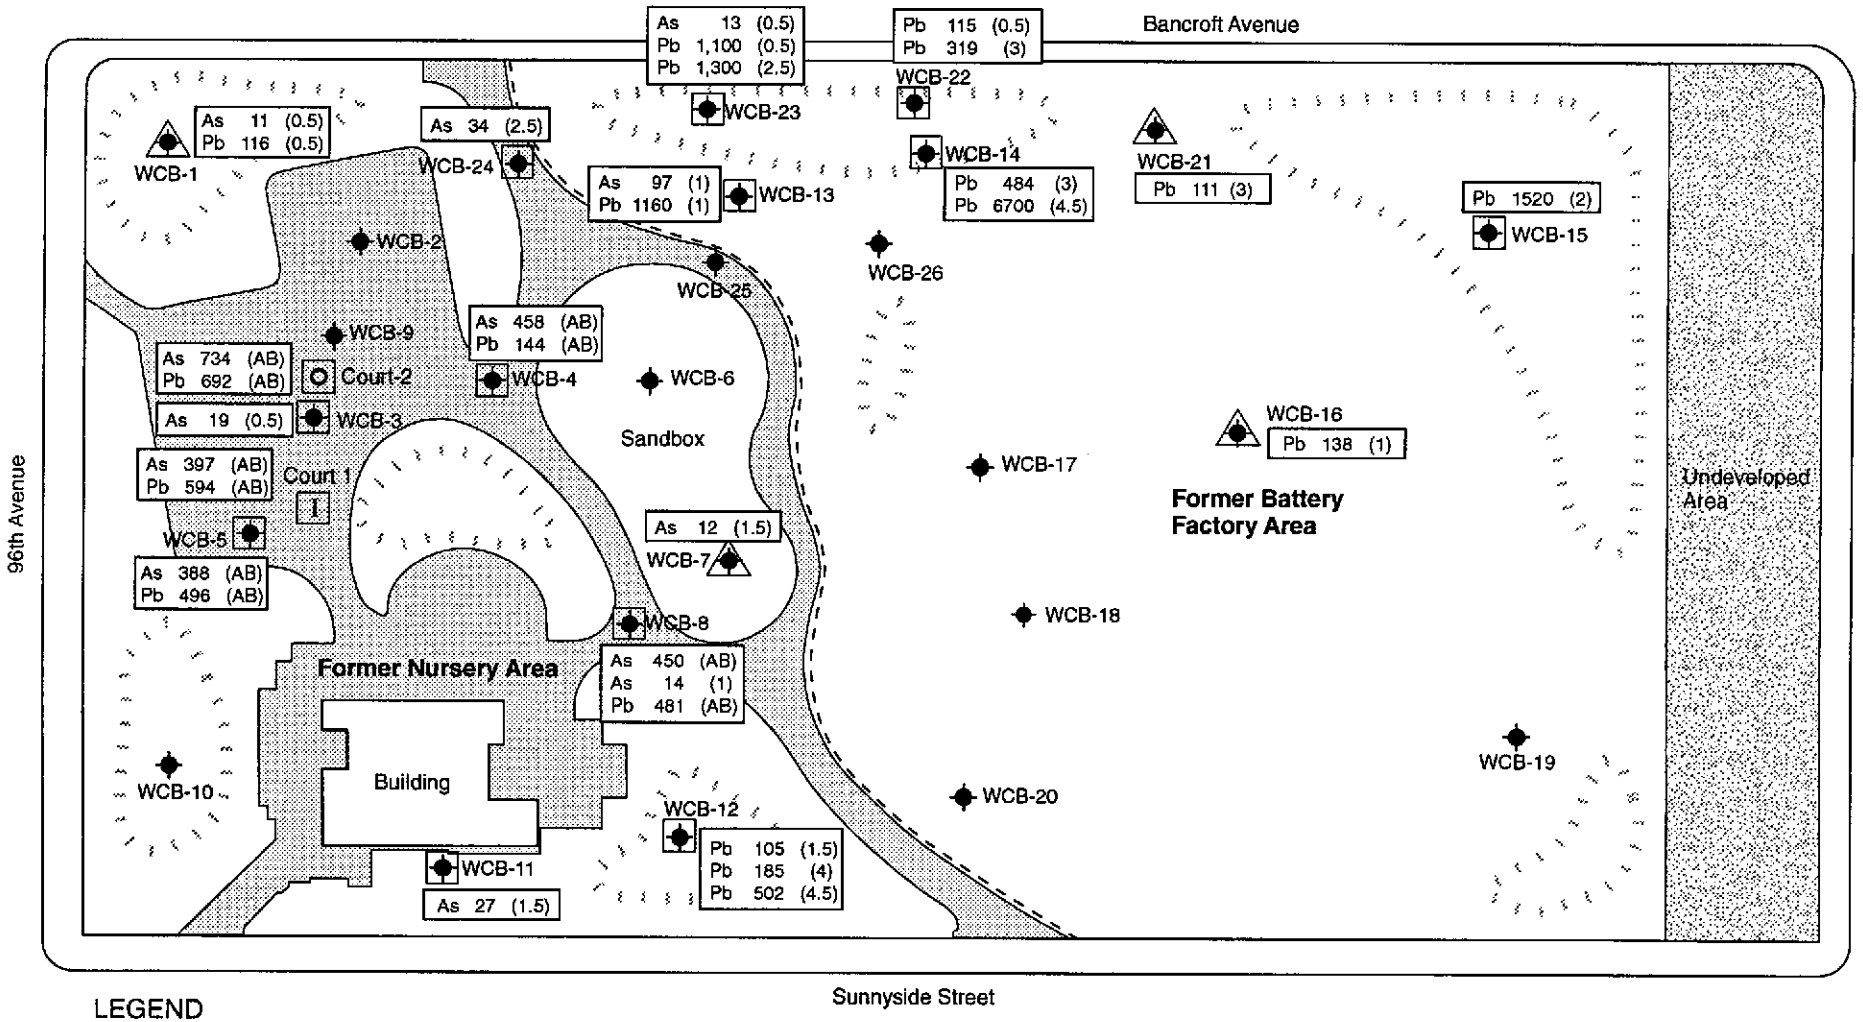
Project No. 93C0243A	Verdese Carter Park Oakland, California	SUMMARY OF ELEVATED SOIL ARSENIC AND LEAD CONCENTRATIONS	Figure 3
	Woodward-Clyde Consultants

Highly elevated arsenic concentrations, typically on the order of 400 to 500 mg/kg were found in the imported aggregate base material beneath the asphalt pavement of play courts and pathways. The arsenic levels in the underlying soil generally decrease to near background levels within 6 to 12 inches beneath the bottom of the aggregate base layer. The slightly elevated arsenic concentration in the pre-park soil beneath the sandbox at WCB-7 (12 mg/kg at a depth of 18 inches) may be due to leachable arsenic in water runoff from the aggregate base material into the sandbox, the possible presence of this aggregate base material in subdrains beneath the sandbox, or may be an isolated occurrence. Arsenic concentrations in this boring returned to background levels within a depth of 3 feet. Elevated arsenic levels are a secondary contaminant at the lead "hot spot" around WCB-13, which appears to be associated with the former battery factory. Elevated arsenic concentrations in this area appear to be limited to a depth of 3 feet or less. The elevated arsenic concentration of 27 mg/kg at a depth of 18 inches WCB-11 appears to be an isolated occurrence.

The third pattern is lead contamination in the pre-park soil zone along a portion of Bancroft Avenue under the former battery factory area. This area corresponds to the former location of aboveground acid tanks and railroad spur noted in historic Sanborn maps and aerial photos. This area is now occupied by the knoll in the vicinity of Borings WCB-13, -14, -22, and -23, and apparently was not included in the 1978 soil removal activities. The contamination here is typified by elevated lead, slightly elevated arsenic and zinc, and normal soil pH. The extent of contamination below the park fill and pre-park soil interface is apparently only a few feet.

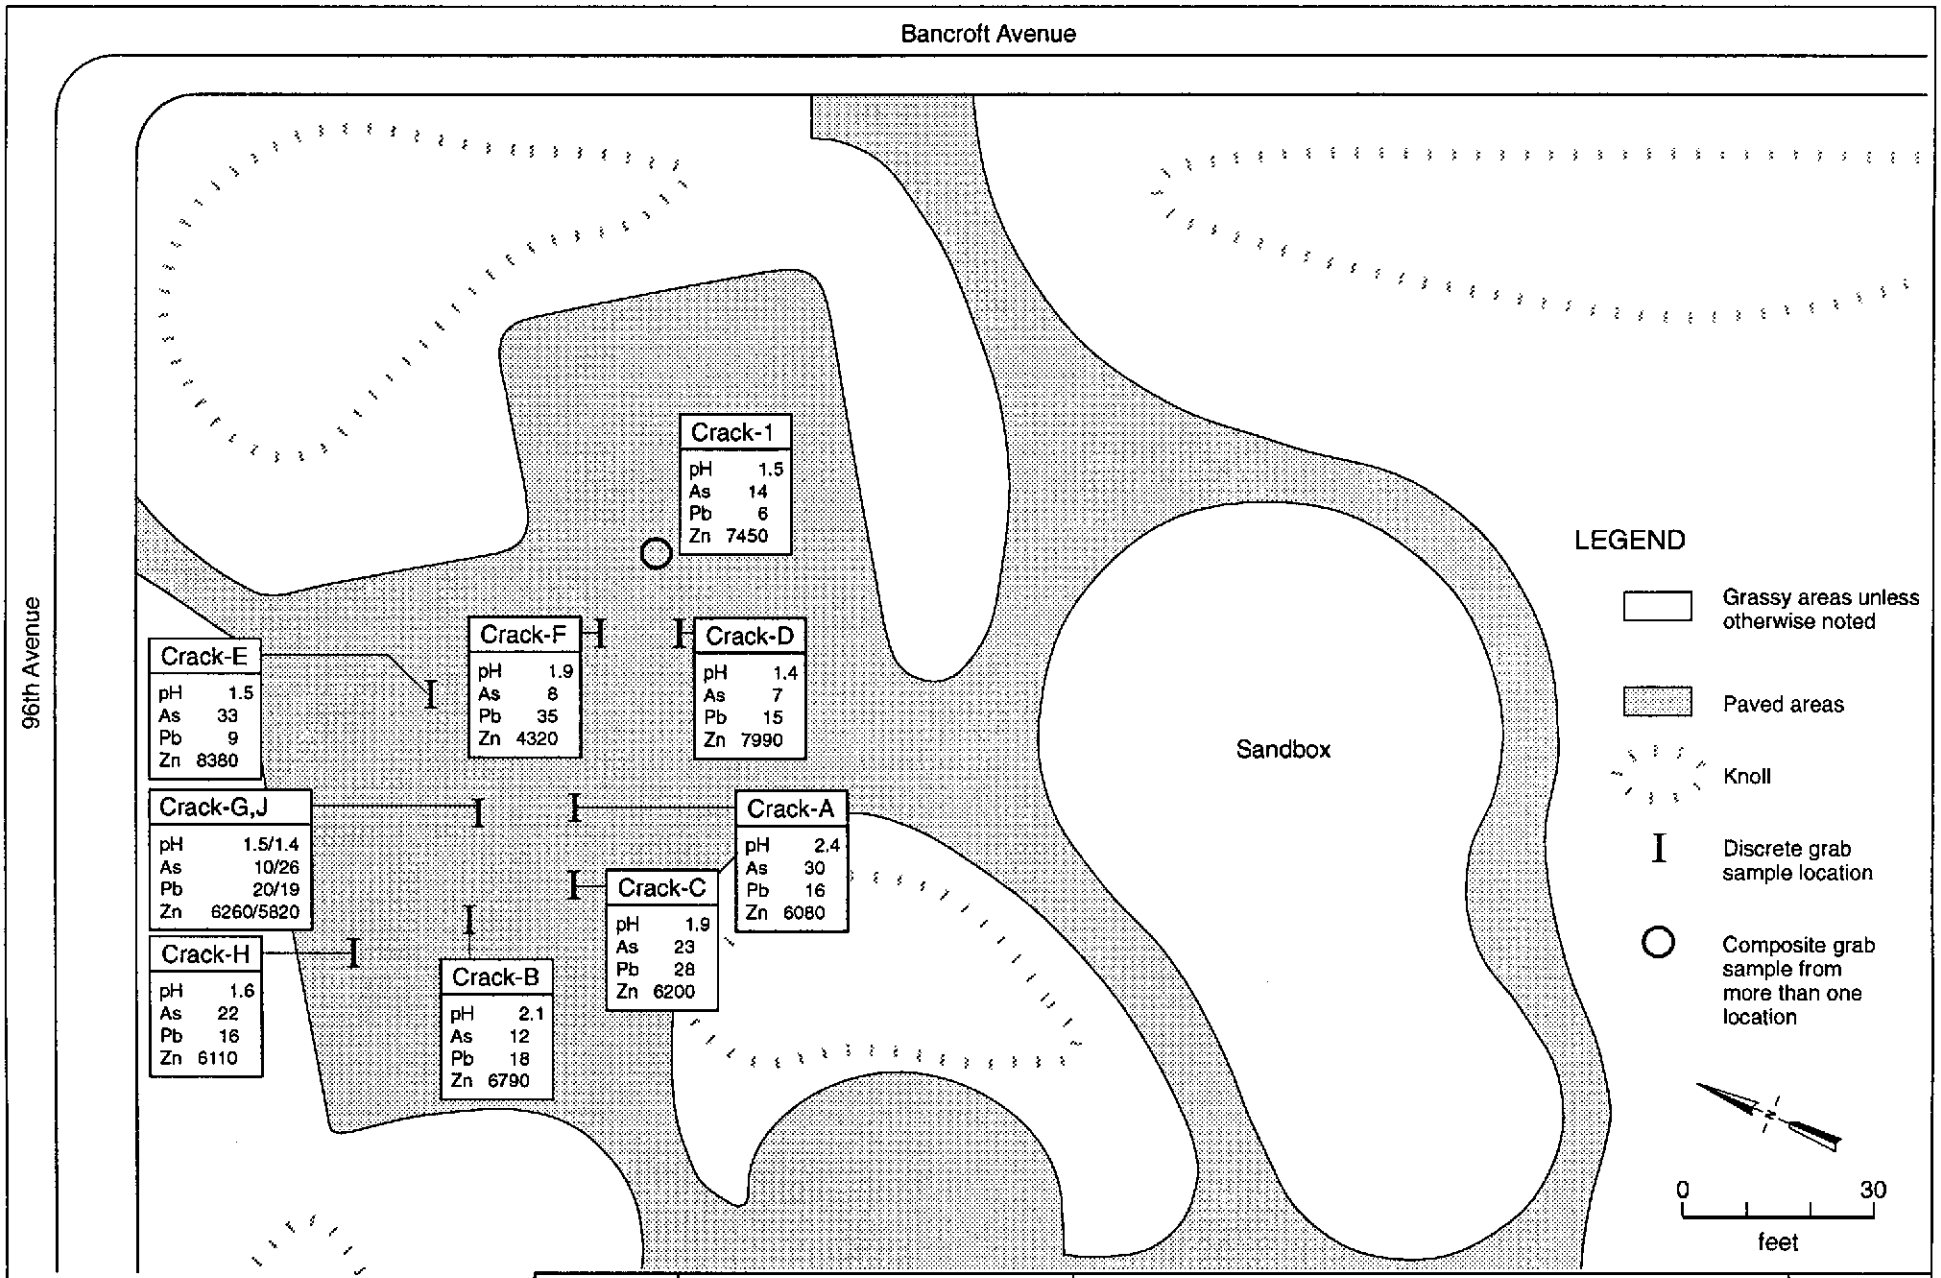
Project No. 93C0243A	Verdese Carter Park Oakland, California	SUMMARY OF PRECIPITATE pH, ARSENIC, LEAD, AND ZINC CONCENTRATIONS (mg/kg)	Figure 4
Woodward-Clyde Consultants

The precipitate-like substance found in the pavement cracks does not contain significant concentrations of lead (sample concentrations of 6 mg/kg to 35 mg/kg).

The precipitate-like substance found in some of the pavement cracks contains high levels of zinc generally in the range of 6,000 to 8,000 mg/kg.

The pH of the precipitate material in the pavement cracks was very low i.e., acidic, with measured pHs as low as 1.4 and generally below 2. The regulatory hazardous criteria for corrosivity for transport and disposal is pH 2 or below.
