Subject: **2011 THIRD QUARTER GROUNDWATER SAMPLING RESULTS FOR FORMER RPMS (E-Z SERVE) SITE 100877 LOCATED AT: 525 West A Street in Hayward, California**

2011 THIRD QUARTER GROUNDWATER MONITORING REPORT
for
FORMER RPMS (E-Z SERVE) SITE 100877
525 WEST A STREET IN HAYWARD, CALIFORNIA.

GALLARDO & ASSOCIATES, INC. PROJECT NO. 001.11

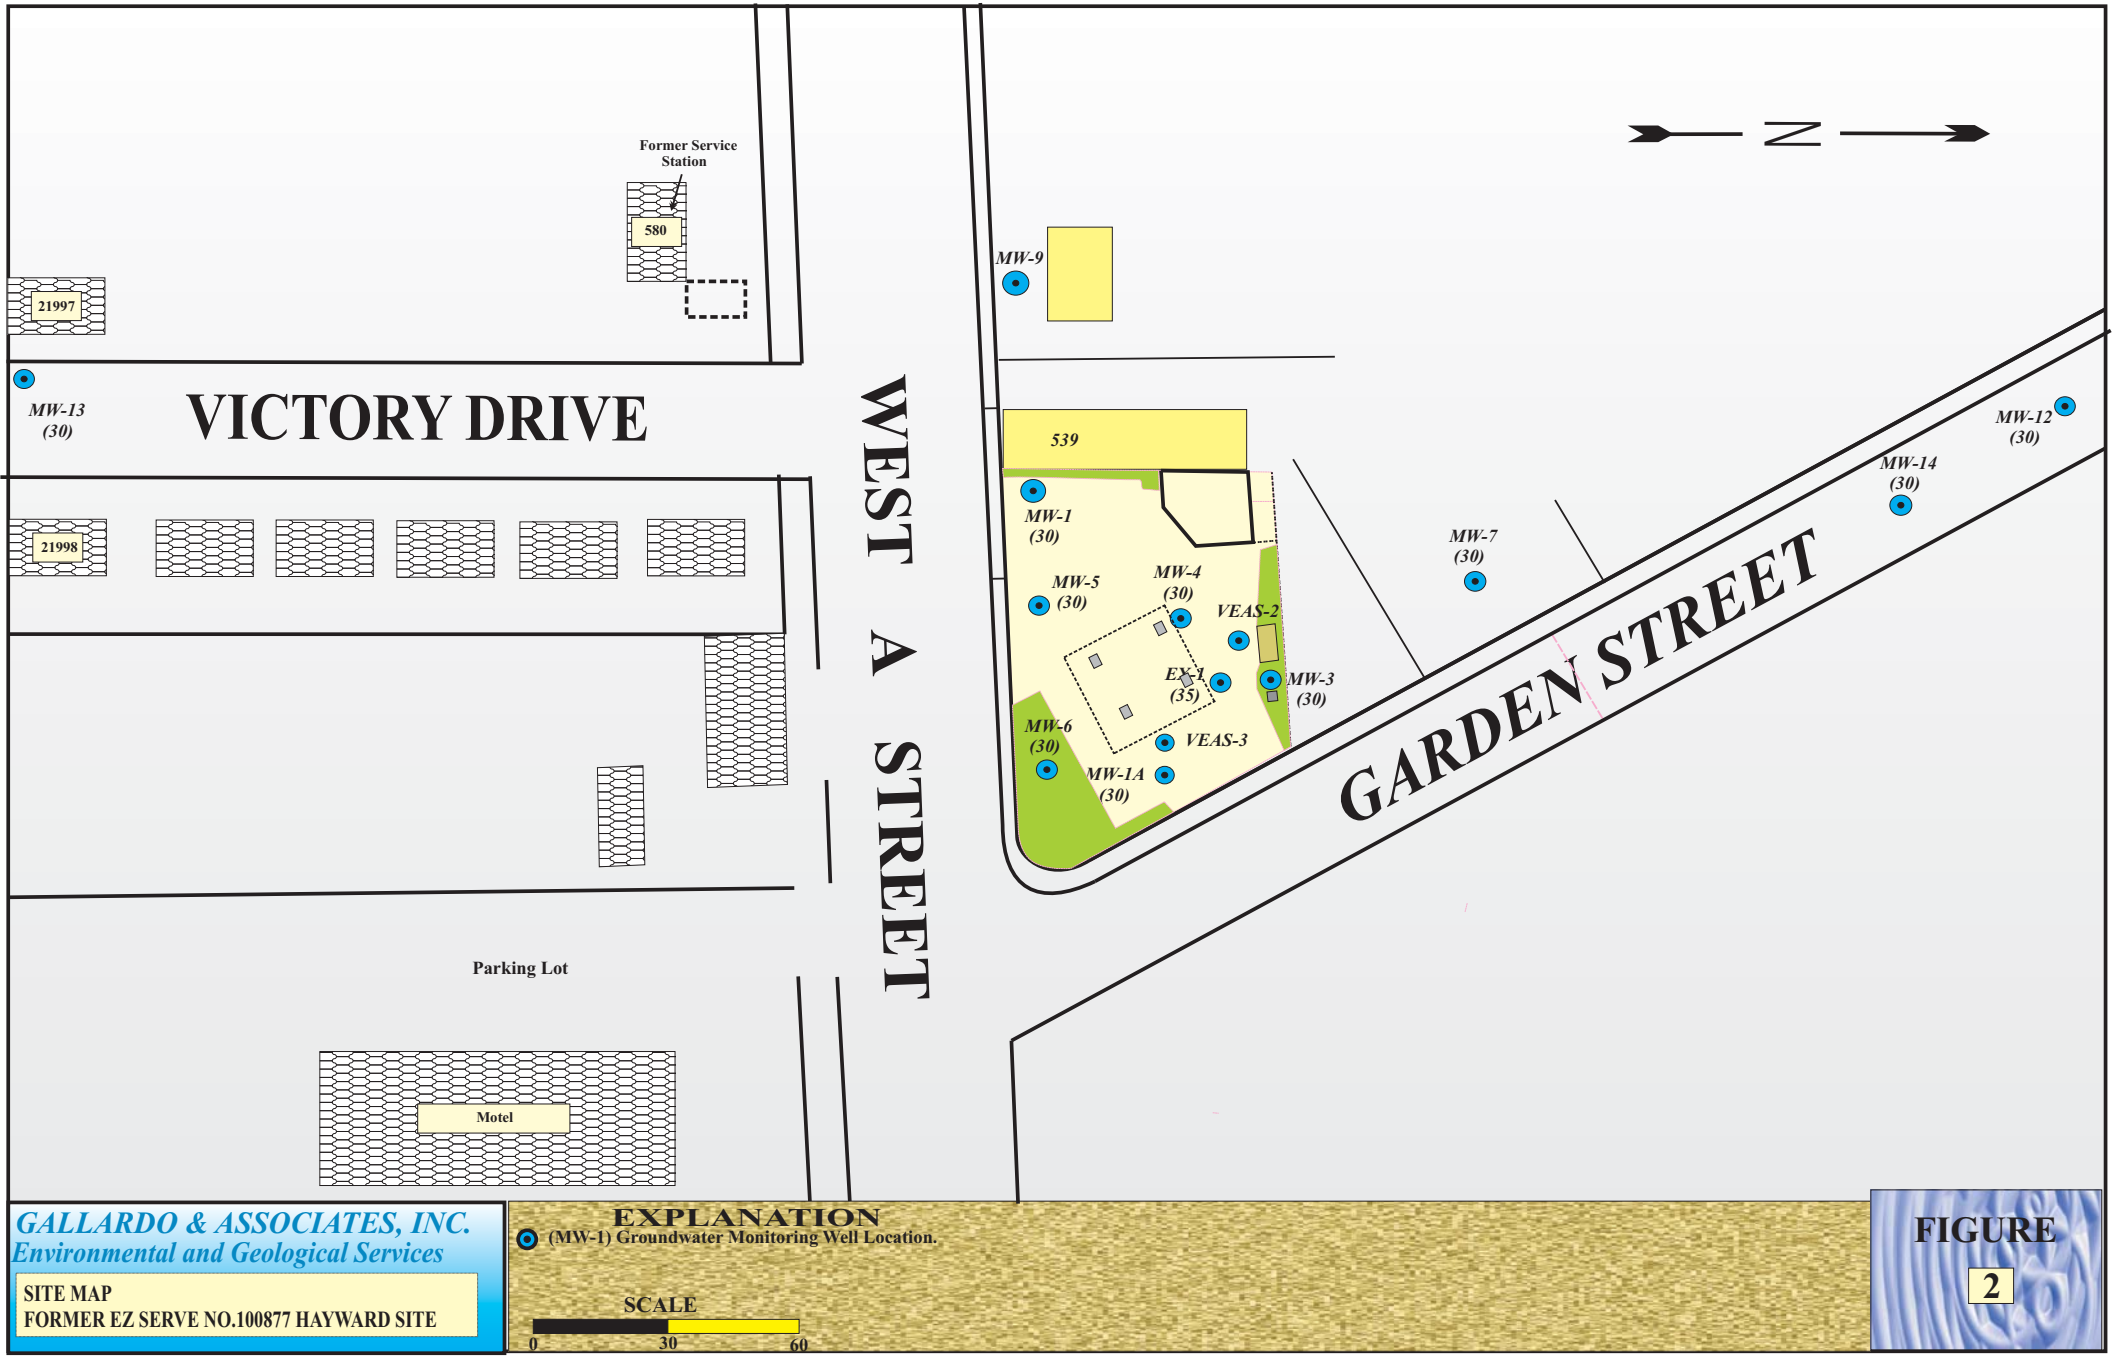
The site is located at 525 West A Street in Hayward, California, (**See Figure 1**). The property is an active gasoline station and convenience store bordered along the south side by West A Street and along the east side by Garden Street. The west side of the property is bordered by retail and commercial property, while the north side is bordered by a small trailer park. The site is relatively flat and the surface consists of natural ground planters, concrete and asphalt. According to previous consultants, the former owner (EZ-Serve) removed four UST's in 1990. The site remained an empty lot until the current Vallero station was constructed in 2008. the site currently contains two active underground fuel storage tanks (UST's), containing gasoline and diesel fuel, and one UST for bio-diesel fuel storage. which were removed in August 1989. The site currently contains ten on-site and eight off-site groundwater monitoring wells. However, four have been covered over and cannot be found (MW-8, MW-10, MW-15, and MW-16). According to the USGS Topographic map and Virgil Chavez Land Surveying the site rests at an approximate elevation of between 46.28 and 48.26 feet, **(See Figure 2**).

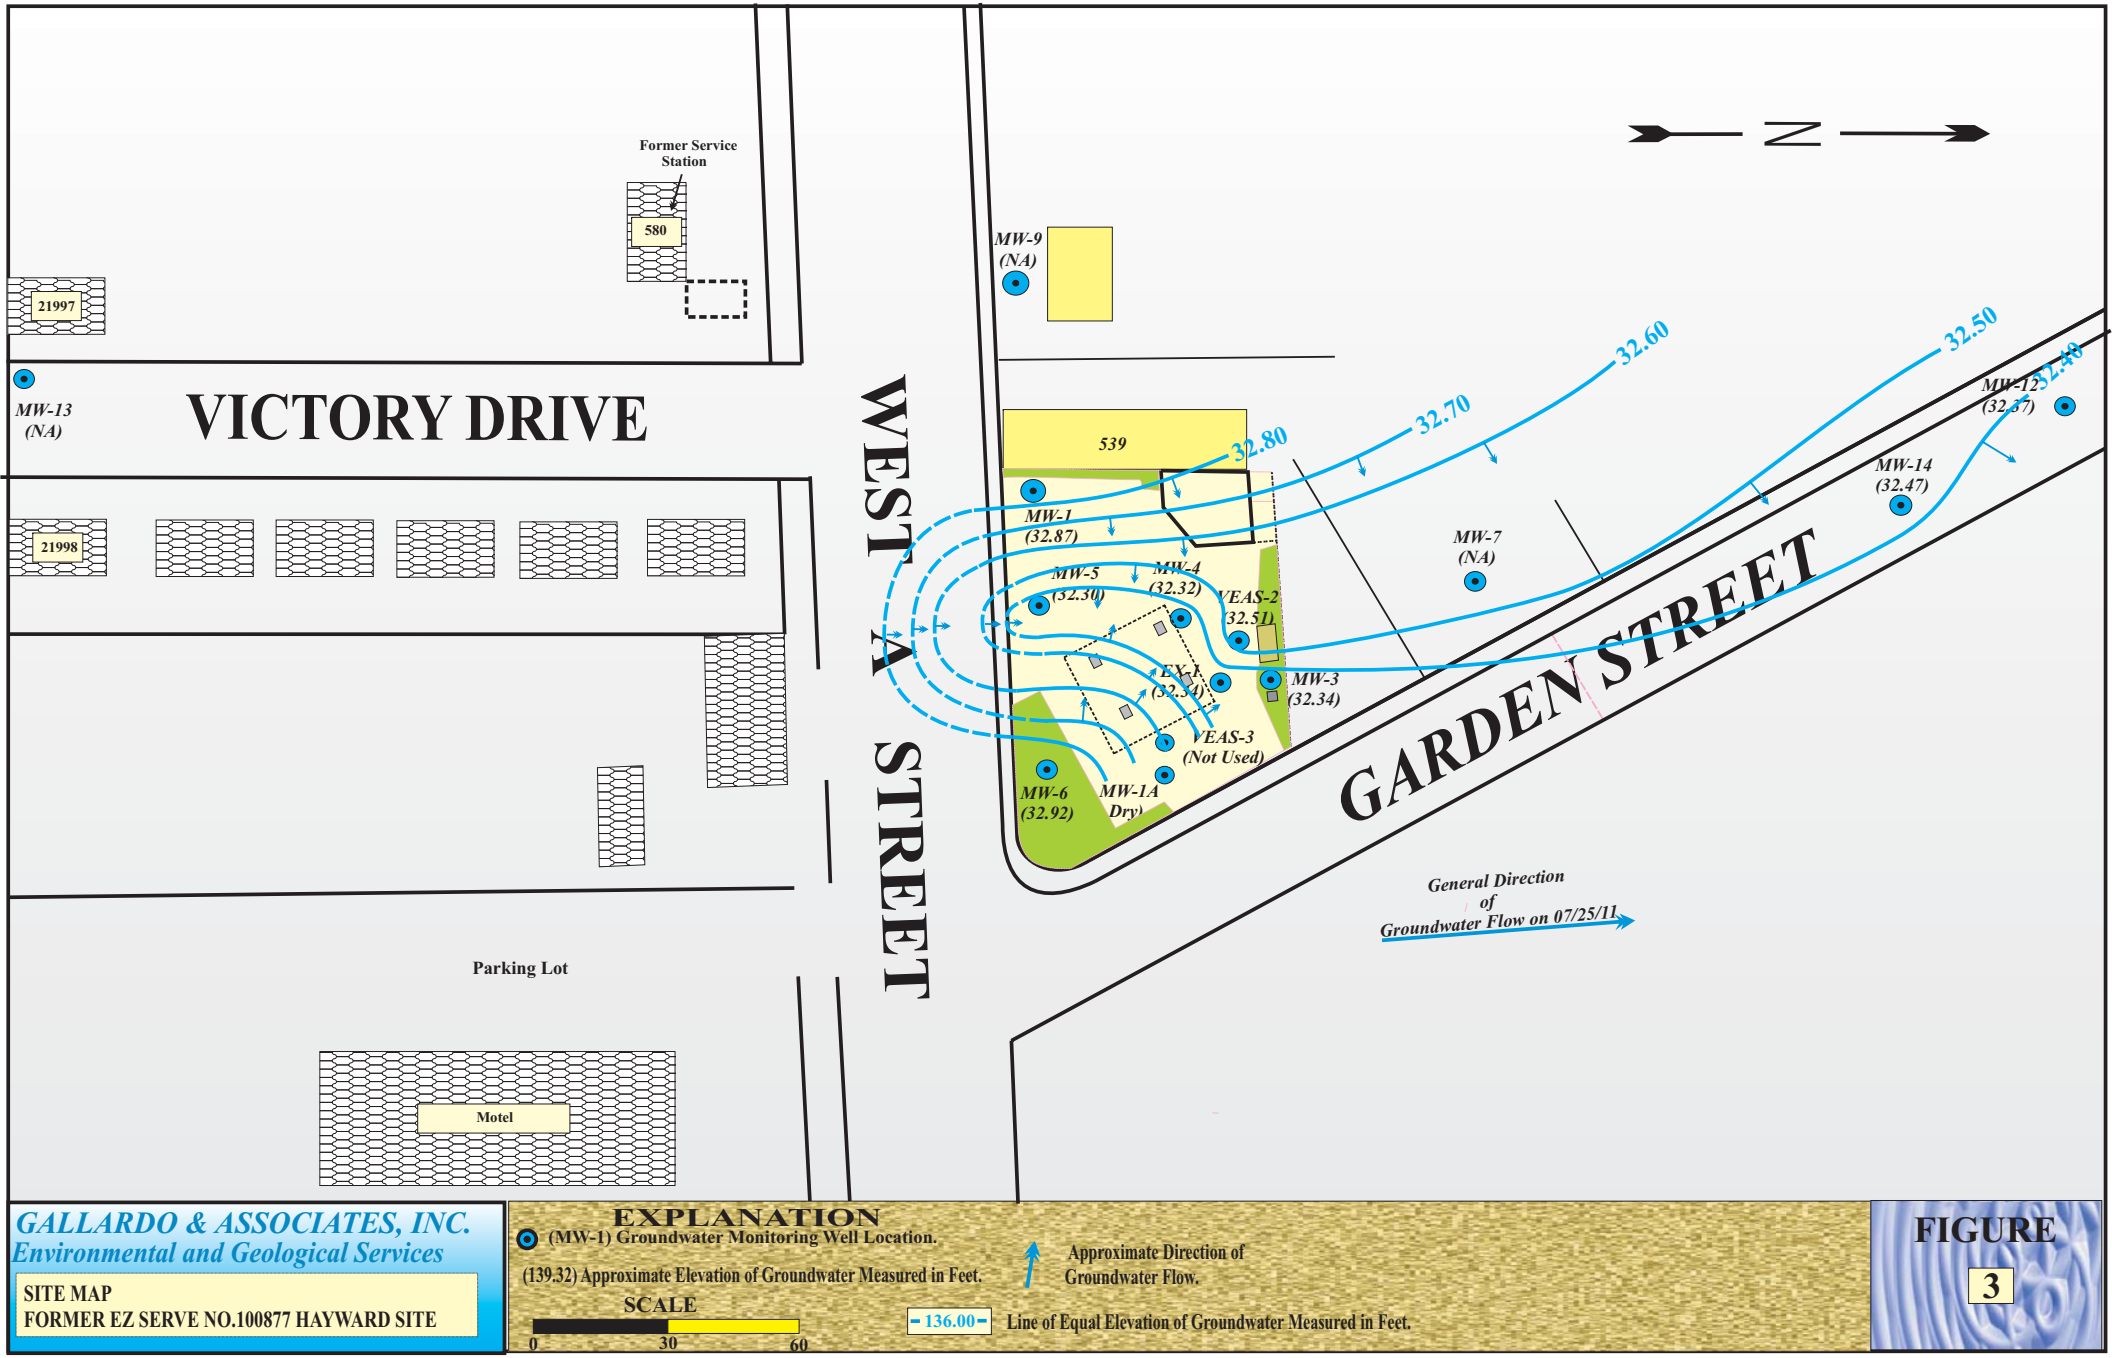
FIGURE 3

The groundwater flow direction was calculated from the **July 25, 2011** measurements. The groundwater elevation data is shown on **Figure 3**. Groundwater flow beneath the property for this quarter was generally to the Northwest, with a hydraulic gradient was approximately 0.008 ft/ft. However, a groundwater depression was observed around wells MW-3, MW-4, MW-5, and EX-1.

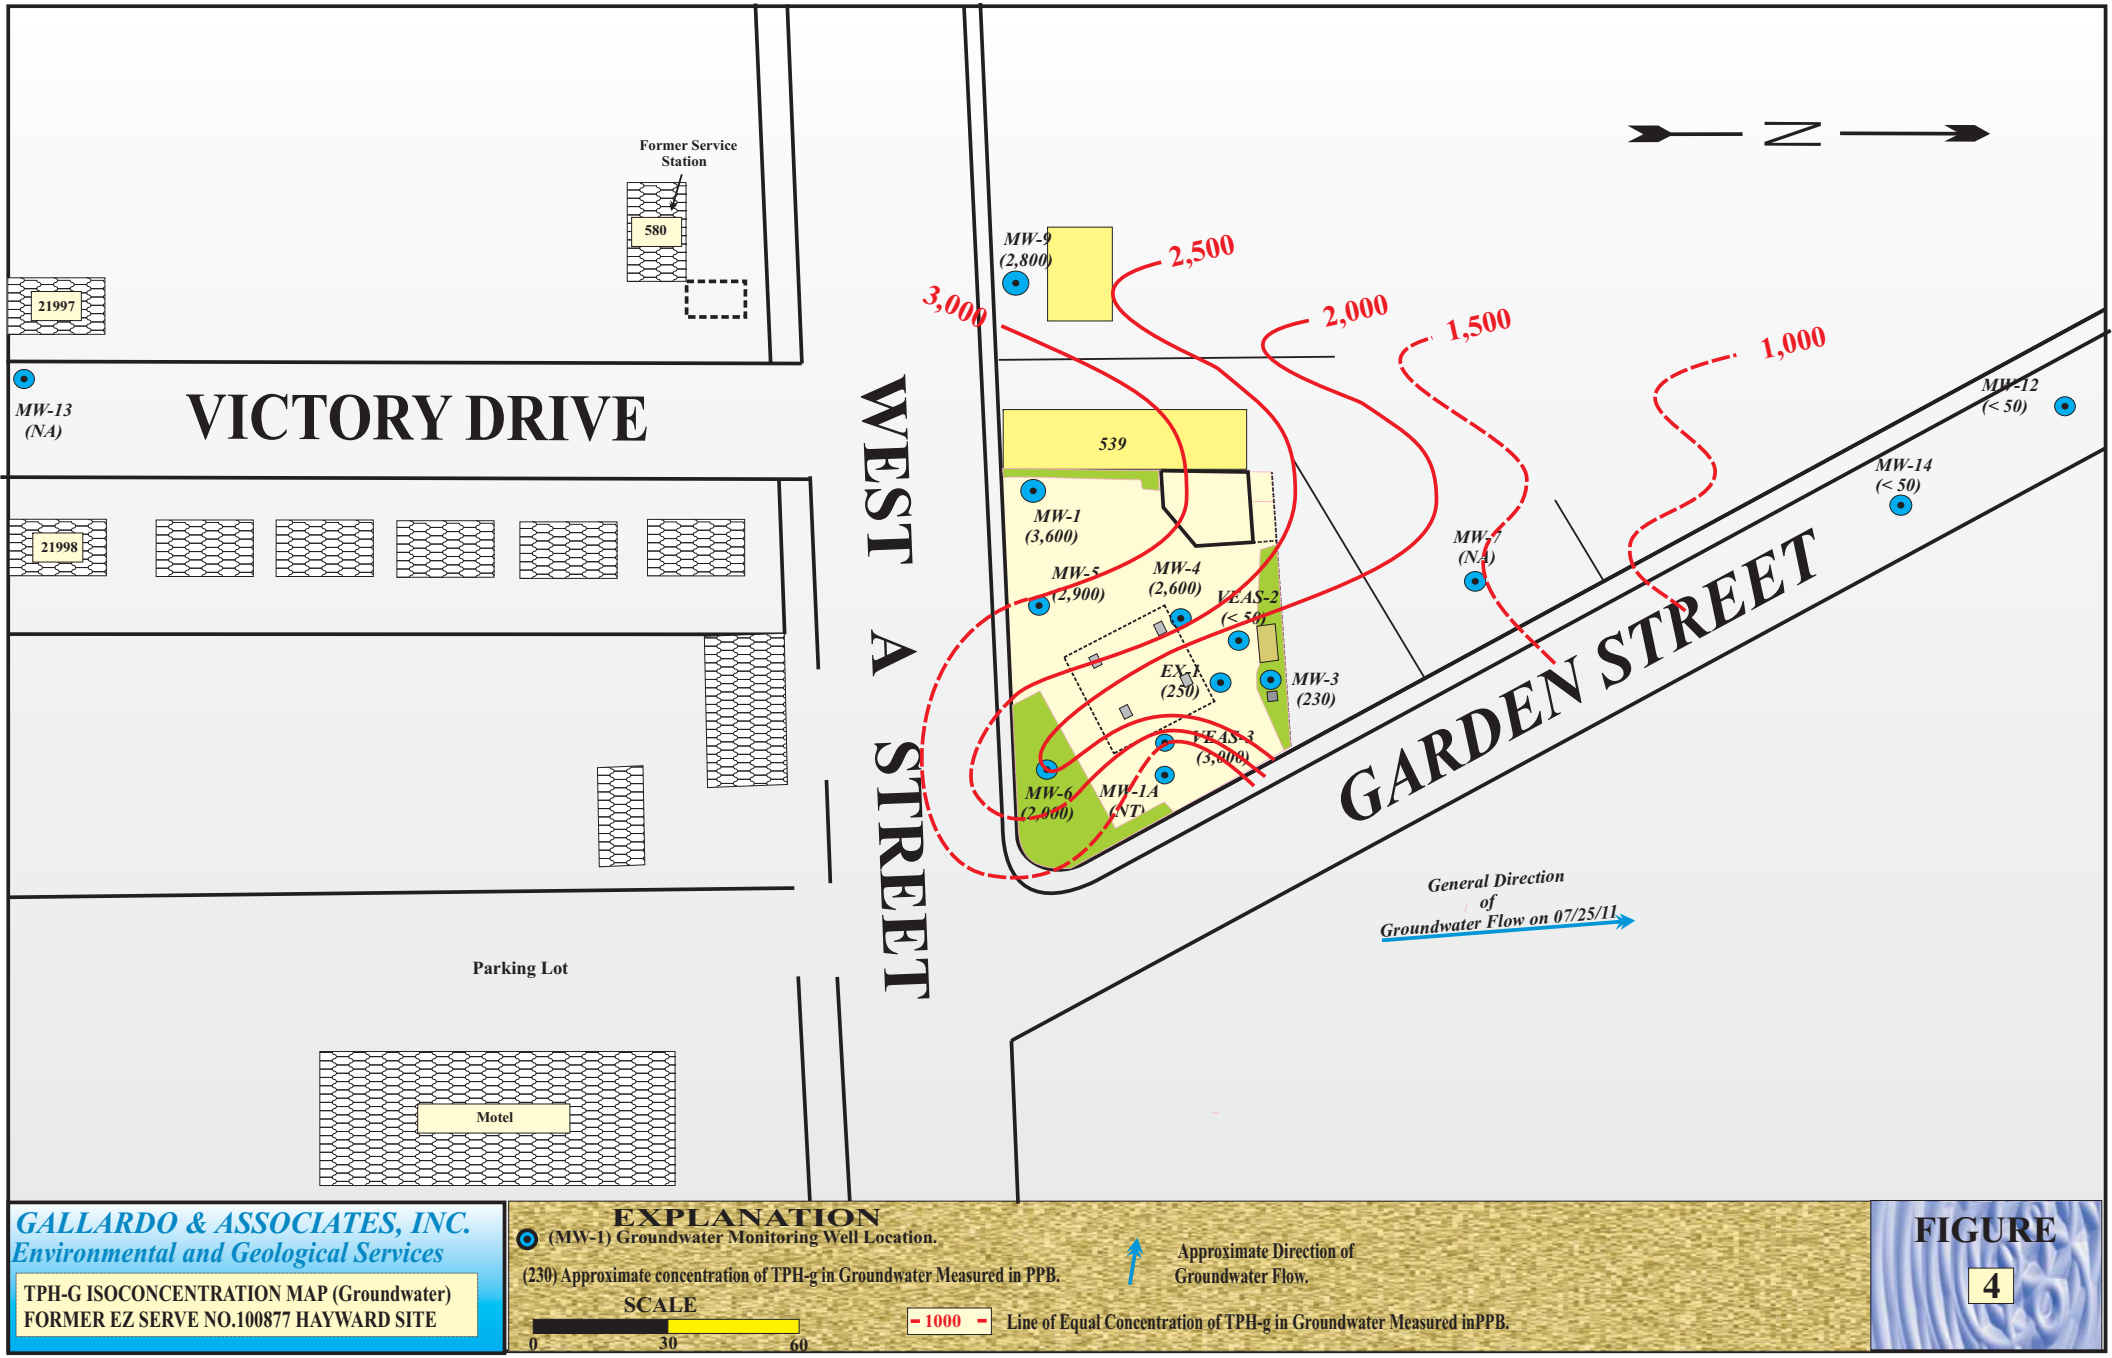
TPH-G ISOCONCENTRATION MAP (Groundwater)
FORMER EZ SERVE NO.100877 HAYWARD SITE

Based upon the current groundwater flow calculations, ***Gallardo & Associates, Inc.*** concludes that groundwater flow beneath the property for this quarter was generally to the northwest, with a hydraulic gradient was approximately 0.008 ft/ft. However, a groundwater depression was observed around wells MW-3, MW-4, MW-5, and EX-1. Current analytical results reveal increasing concentrations of TPH-g within wells MW-1, MW-4, and MW-5. Increased concentrations of benzene were also detected within well MW-4. The center of the TPH-g groundwater plume rests within MW-1, while the center of the benzene groundwater plume rests within MW-4. The center of the MTBE groundwater plume rests within wells MW-4 and EX-1. The off-site extent of the groundwater plume appears to extend across West A street and Garden Street. Additional wells will need to be placed in these areas to define the lateral extent of the groundwater plumes.

- Continuation of bi-annual sampling of wells EX-1,VEAS-2, MW-1A, MW-12, MW-13, and MW-14. However, quarterly groundwater sampling of wells MW-1, MW-3, MW-4, MW-5, MW-6, MW-9, and VEAS-3 is highly recommended so that plume definition and the groundwater flow pattern can be better established.
