Re: Subsurface Investigation
800 Franklin, Oakland, CA

REPORT ON SUBSURFACE INVESTIGATION AND REMEDIATION OF CONTAMINATED SOIL

SITE LOCATION:
800 FRANKLIN ST., OAKLAND, CALIFORNIA

November 3, 1989

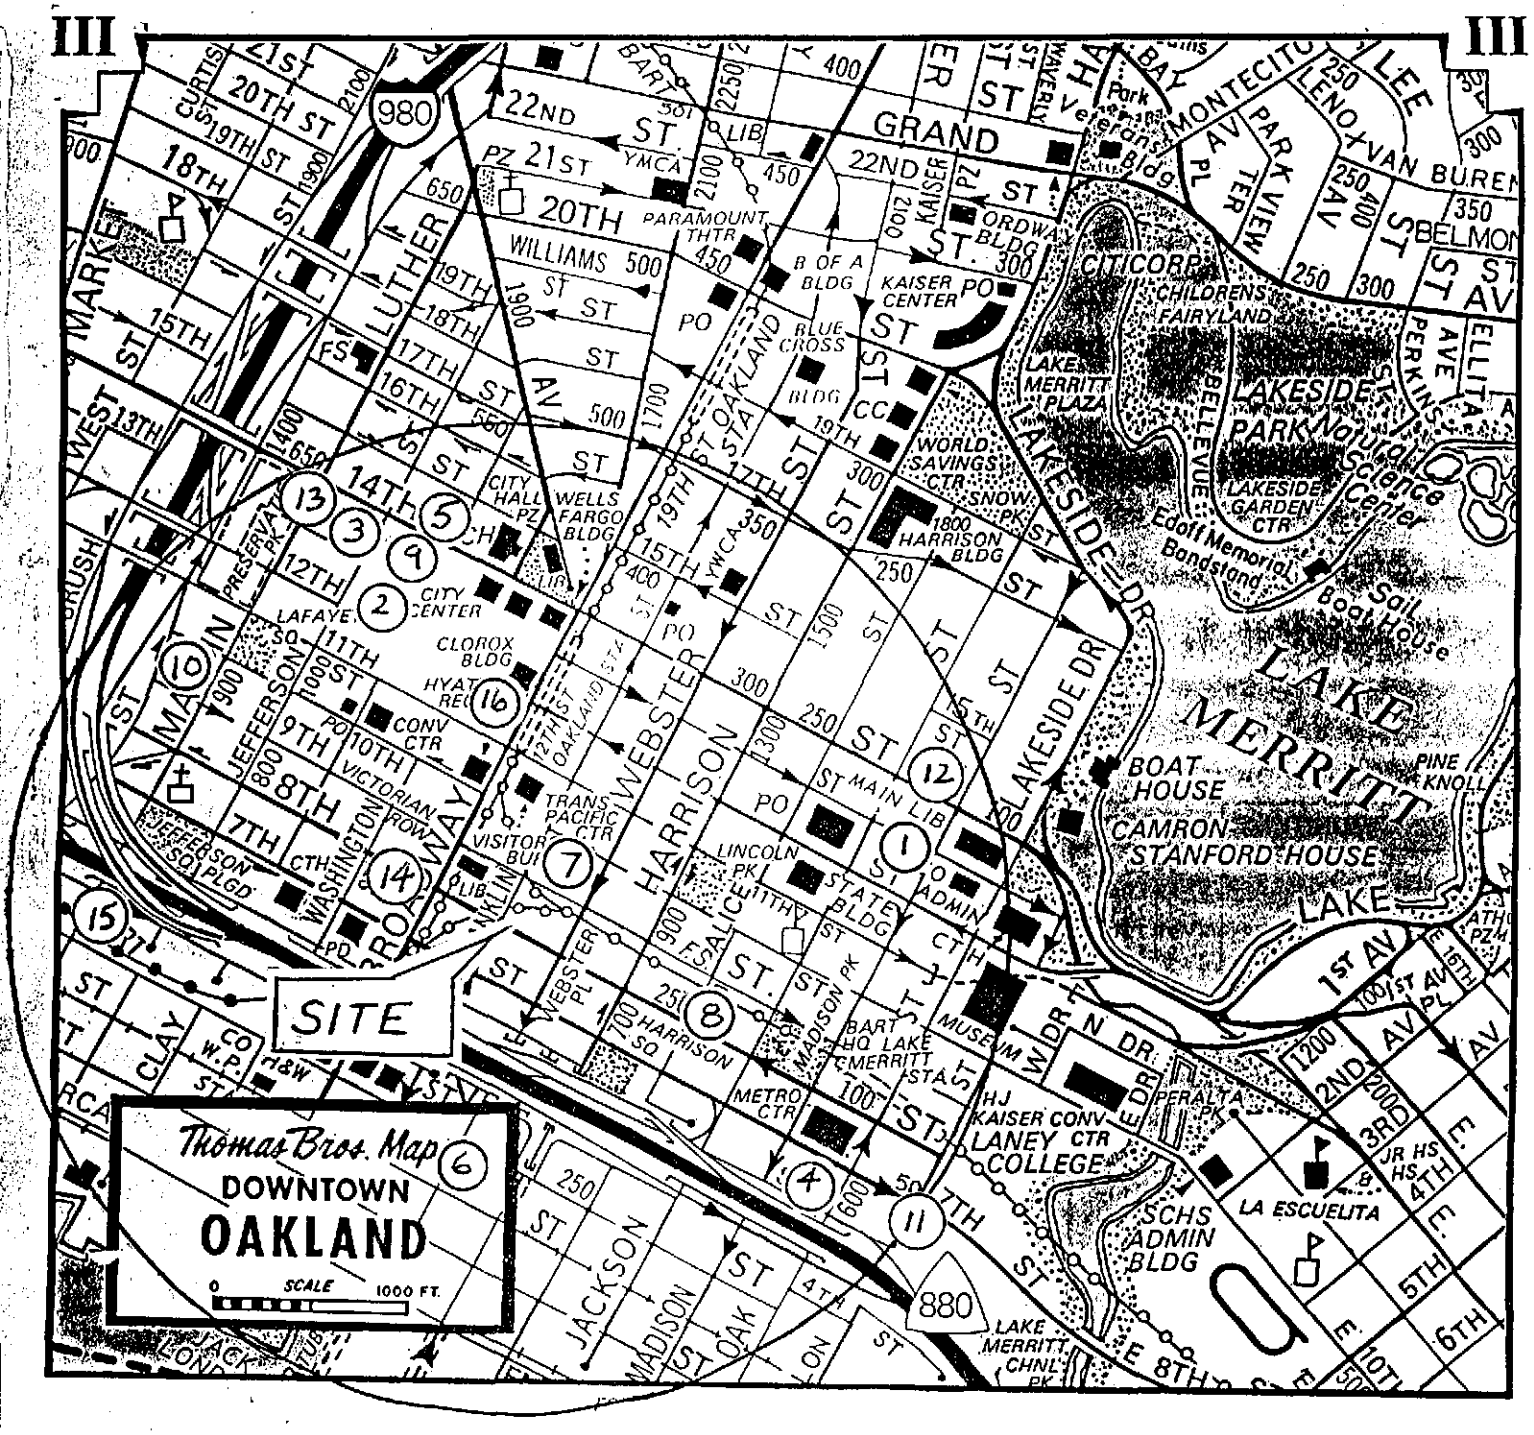
FIGURE 1
SITE LOCATION MAP SHOWING SUBSURFACE CONTAMINATION SITES WITHIN 1/2-MILE RADIUS OF SITE

Miller Environmental has reviewed the records of underground fuel leak cases on file at the RWQCB. A number of ground water contamination problems were found to exist in the nearby area. Within a 1/2 mile radius of the 800 Franklin Street site there are sixteen (16) reported cases of petroleum hydrocarbon releases to the subsurface, with half of these being classified as ground water problems. The locations of these releases are shown by number on Figure 1. The sites corresponding to these numbers are listed in Table 5.

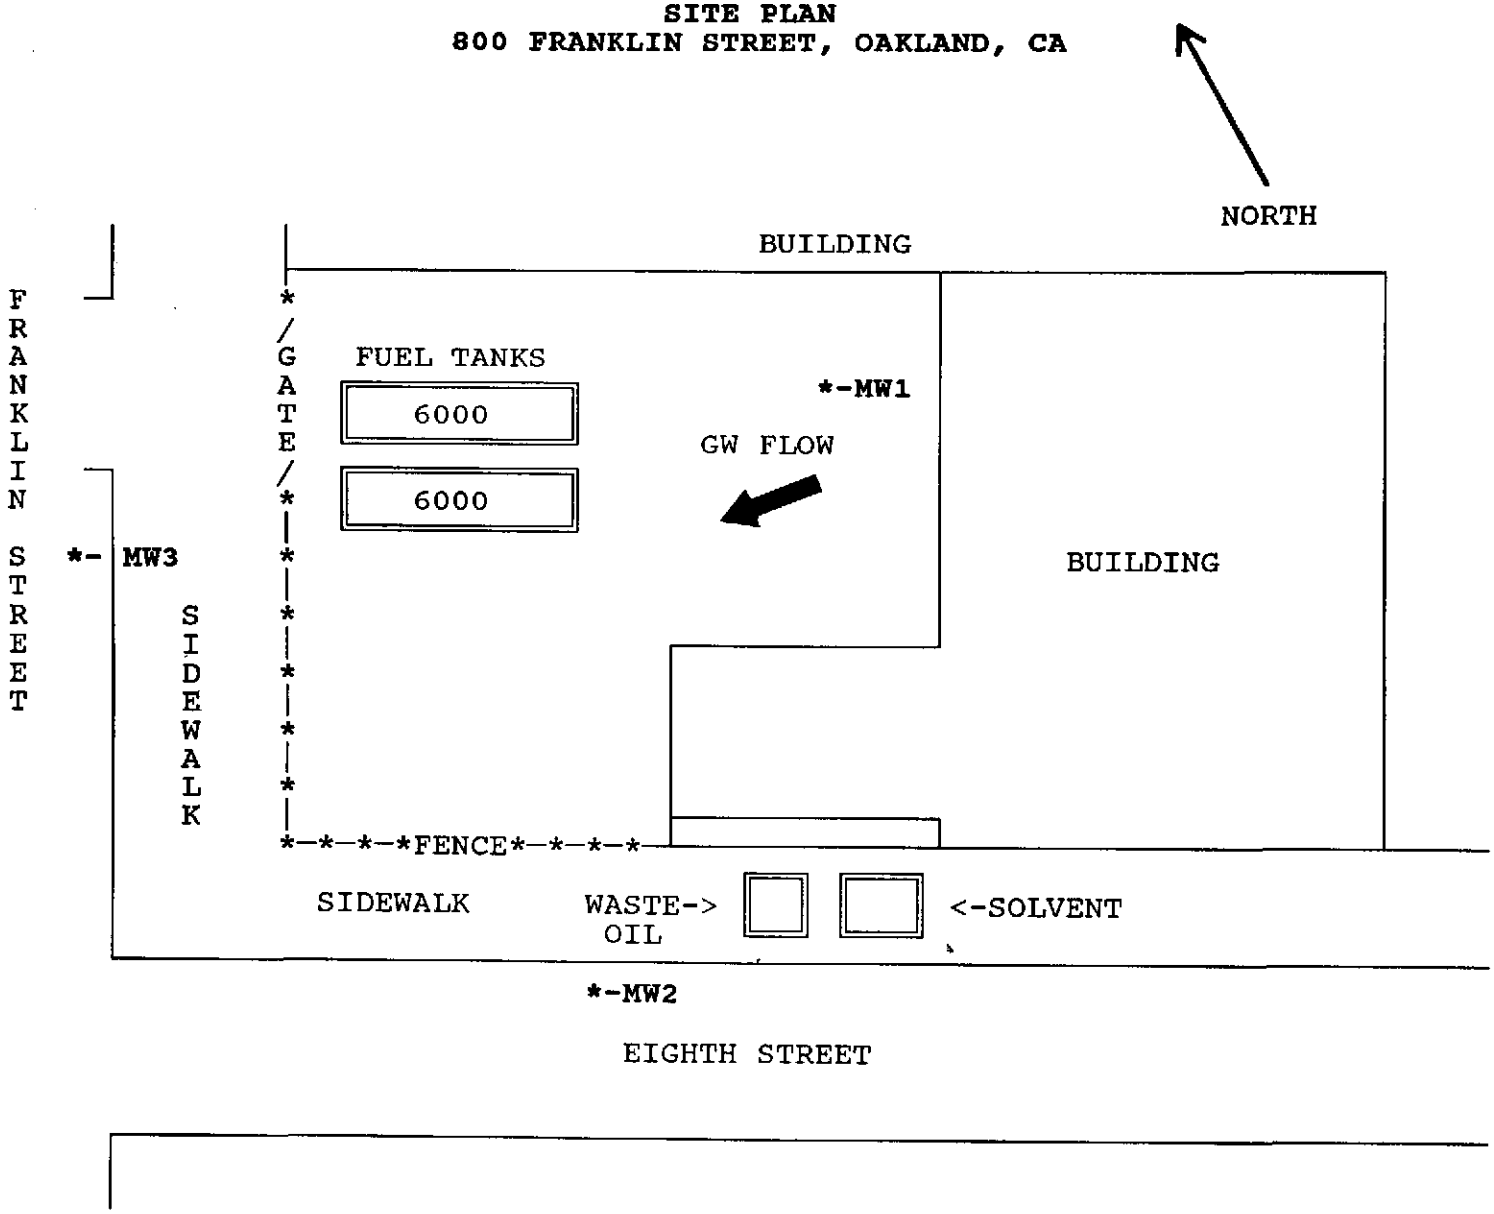
FIGURE 2
SITE PLAN
800 FRANKLIN STREET, OAKLAND, CA

Prior to 1989 the site operated as a service station. Five underground tanks are known to have existed at the site. At some time prior to August, 1988 one of the tanks was removed. Available records do not indicate who pulled the tank, the contents of the tank, or the exact date of removal. It is believed that this tank was located close to the current location of monitoring well MW1 (see Figure 2).

Three borings were drilled to describe the geology, locate the water table, and install the monitoring wells. Figure 2 shows the location of the wells in relation to the site. Each of the monitoring wells were drilled to the water table with hollow stem augers, logged and sampled.

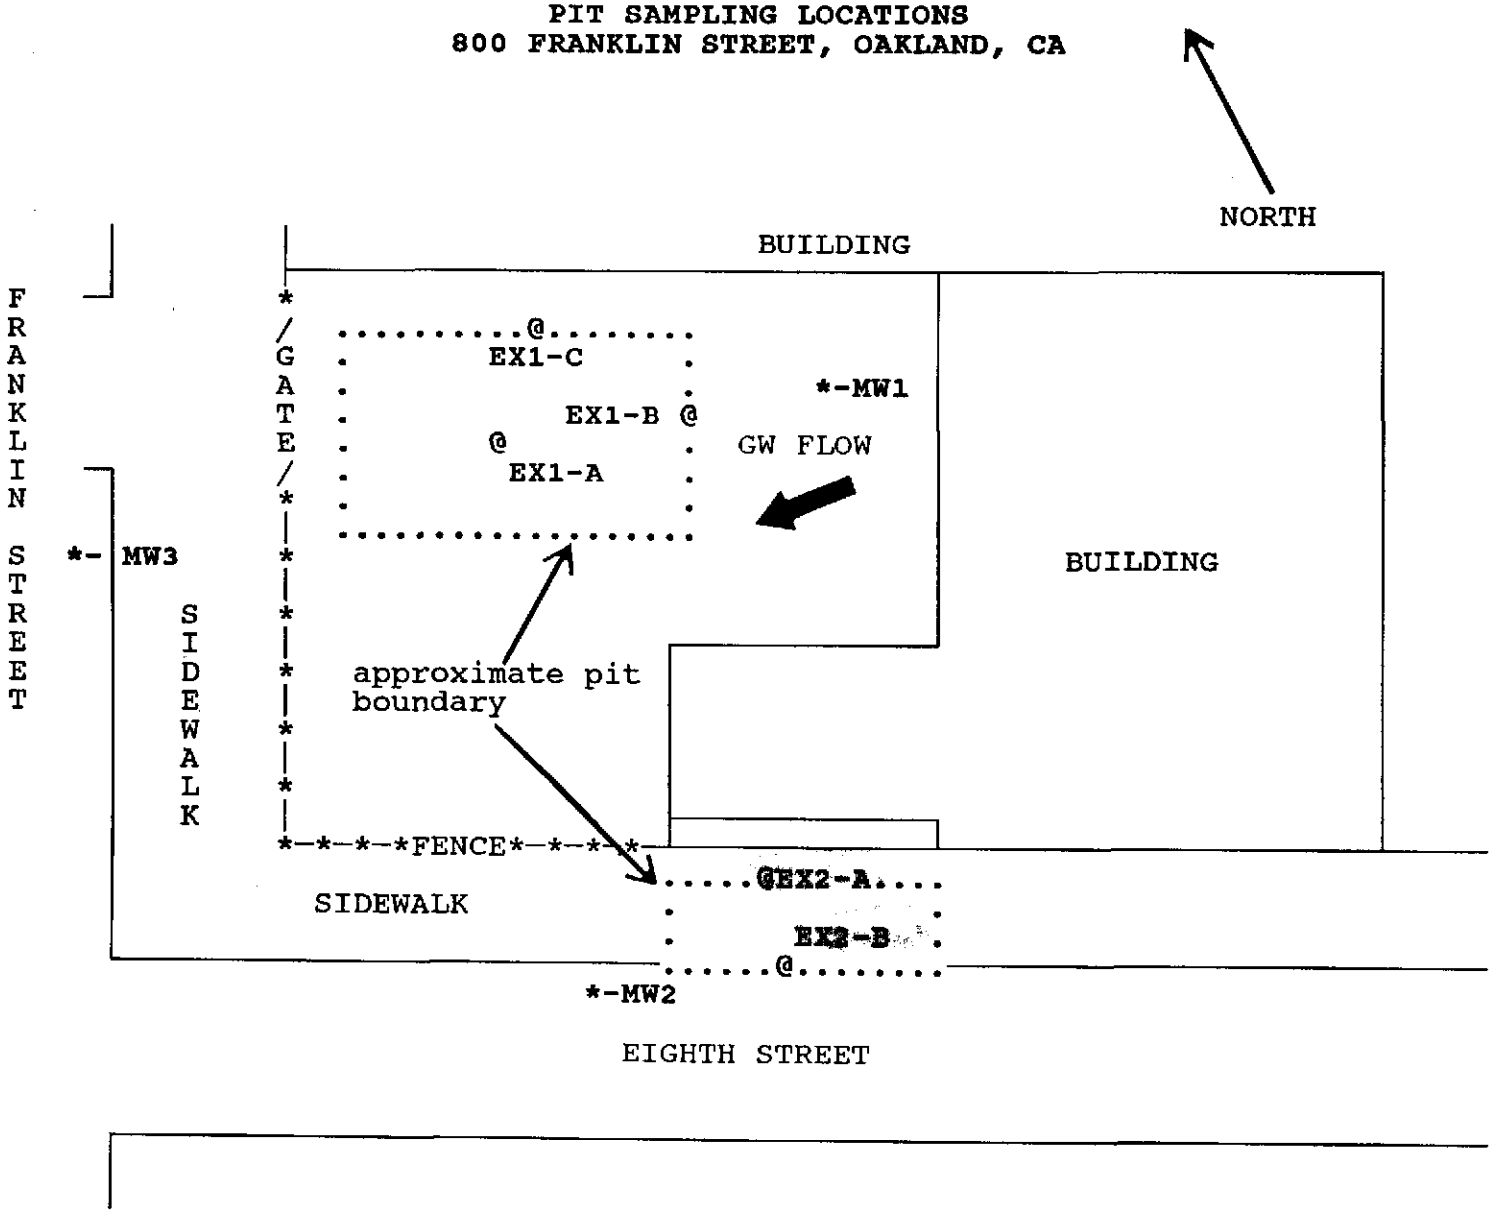
FIGURE 3
PIT SAMPLING LOCATIONS
800 FRANKLIN STREET, OAKLAND, CA

Discrete soil samples were collected from the sidewalls and bottom of the pits following re-excavation. The sampling locations are indicated on Figure 3. **All samples were collected at an approximate depth of fifteen (15) feet.** The results of laboratory analysis are summarized in Table 1.

Analytical results indicate that soil contaminated with petroleum hydrocarbons has been effectively removed from the interior of the property where the gasoline tanks were formerly located. The highest levels detected in this re-excavated pit (EX1 samples) were 2.3 ppm TPH as gasoline, none detected for TPH as diesel, 80 ppm TPH as waste oil, none detected for benzene and ethylbenzene, 0.05 ppm toluene, and 0.14 ppm xylene.

Analytical results for the samples collected from the pit in the sidewalk (EX2 samples) indicate that the re-excavation was not successful in removing all highly contaminated soil. Detected levels in **EX2-A, collected from the sidewall toward 8th Street**, were 10,000 ppm TPH as gasoline, 250 ppm TPH as diesel, and 400 ppm TPH as waste oil. **The extent of excavation was limited in this case to machinery capabilities and the proximity of 8th Street along the southern edge of the excavation.**

map shows EX2-A as being towards site, not 8th ST.

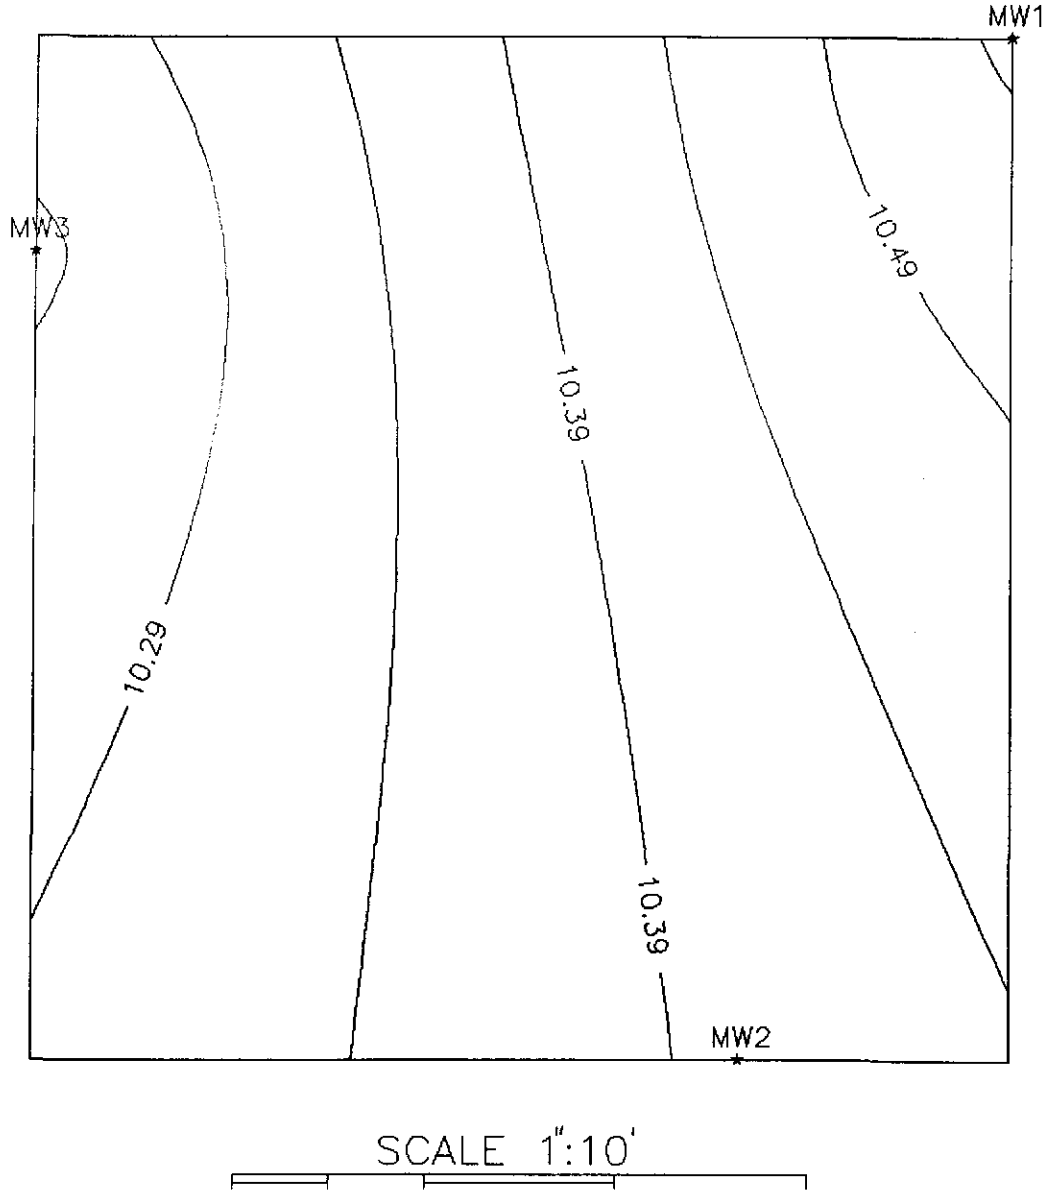
FIGURE 4–GROUNDWATER ELEVATIONS–800 FRANKLIN

The ground water gradient and flow direction have been estimated using this data with a computer model. Ground water elevation contours generated by the model are presented in Figure 4, which shows ground water is flowing in a west-northwest direction at the Shaw site. The calculated gradient based on this data is approximately 0.006 ft/ft.

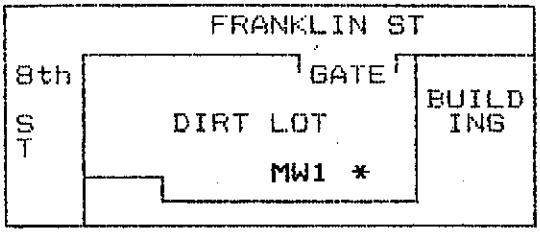
BORING # MW1

DEPTH	SAMPLE #	RECOVERY	TIME	BLOWS	DESCRIPTION	USCS	SYMBOL
0					BROWN CLAYEY FINE SAND WITH PEBBLES; BRICK DEBRIS.	SC	
5	MW1A	18"	9:45	3-2-2	LIGHT BROWN CLAYEY FINE SAND; LOOSE; DRY; WELL-SORTED.	SC	
10	MW1B	18"	9:55	7-6-7	BROWN SILTY CLAY; SLIGHTLY PLASTIC; DRY.	CL	
15	MW1C	18"	10:00	8-12-17	VERY LIGHT BROWN-GRAY CLAYEY FINE SAND.	SC	
20	MW1D	18"	10:10	8-10-12	VERY LIGHT BROWN FINE SAND; LOOSE; DRY. ▽	SM	
25	MW1E	18"	10:15	14-25-22

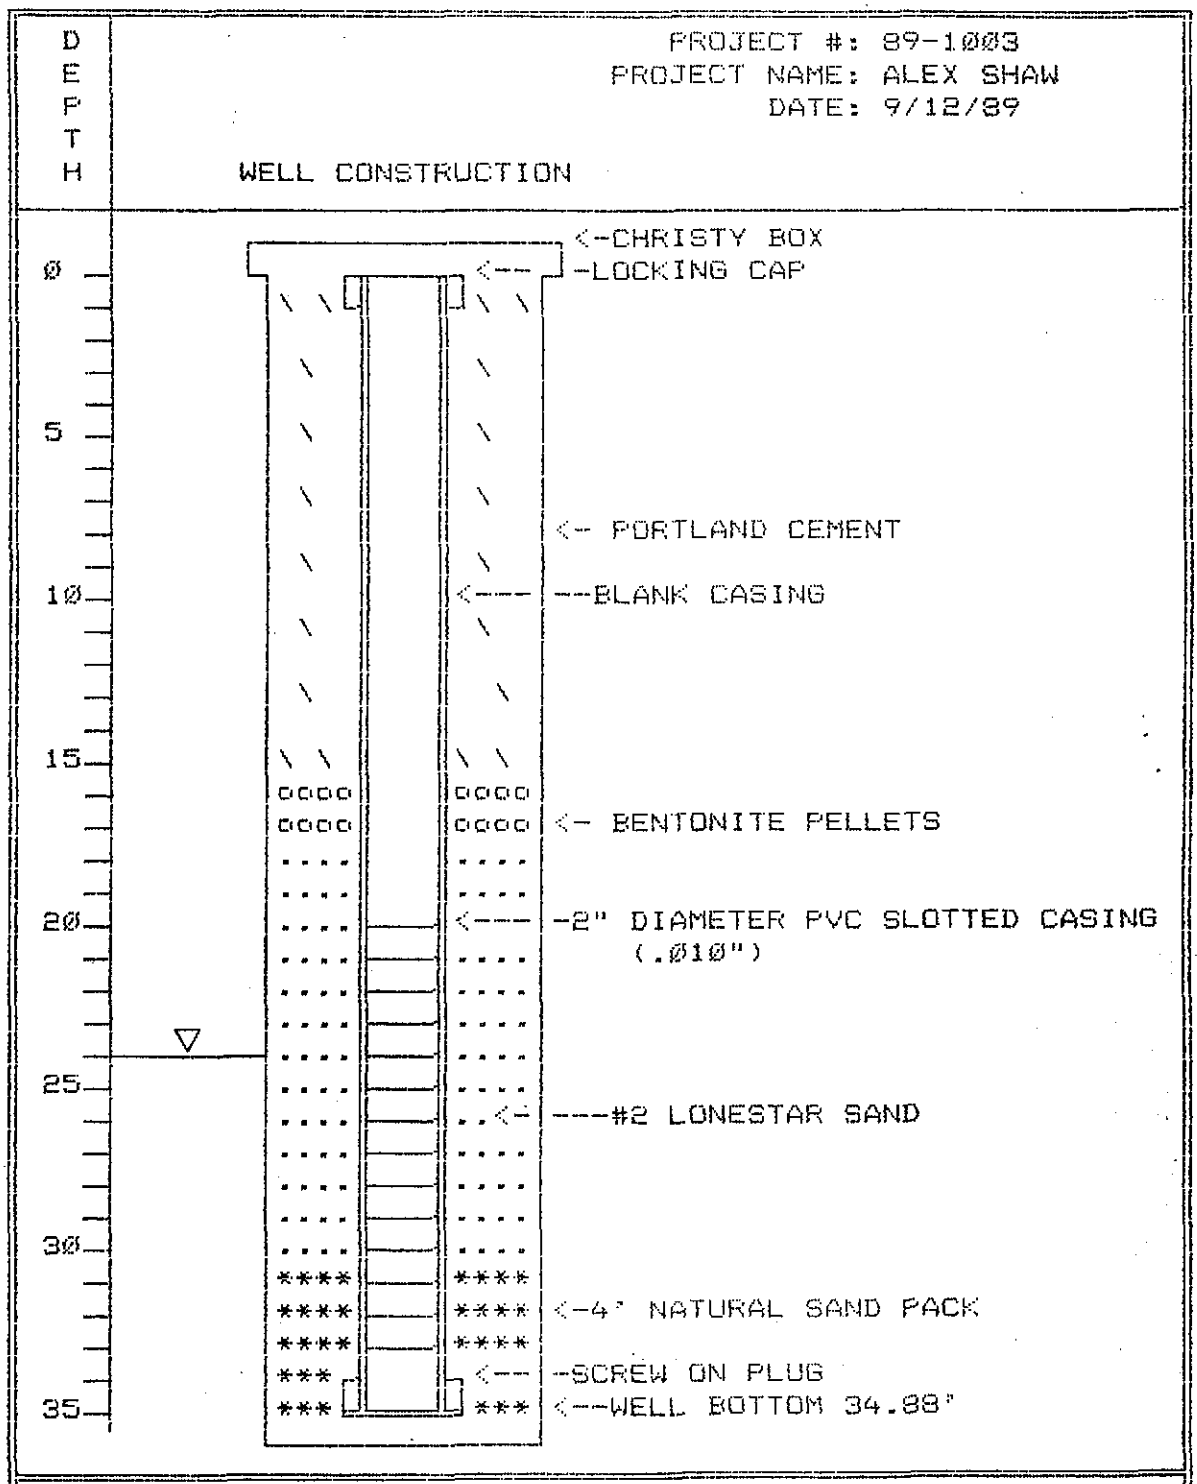
WELL CONSTRUCTION LOG
BORING # MW1

FLOWING SANDS WERE ENCOUNTERED

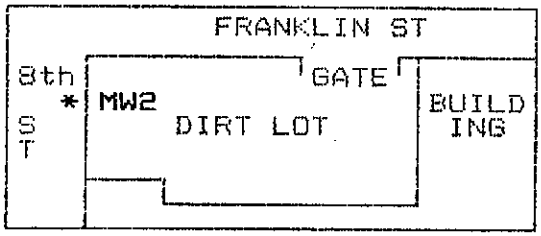
BORING # MW2

DEPTH	SAMPLE #	RECOVERY	TIME	BLOWS	DESCRIPTION	USCS	SYMBOL
0					CONCRETE		
					BROWN FINE SAND; WELL-SORTED; LOOSE; DRY.	SP	
					BROWN CLAYEY FINE SAND.	SC	
5	MW2A	18"	1:15	9-10-14			
					GRAY CLAYEY FINE SAND.	SC	
10	MW2B	18"	1:30	7-7-8			
15	MW2C	18"	1:40	7-7-14			
					GRAY SILTY CLAY.	CL	
20	MW2D	18"	1:50	8-13-14	BROWN CLAYEY FINE SAND; DRY.	SC	
					OLIVE GREEN-GRAY CLAYEY FINE SAND.	SC	
25	MW2E	18"	1:55	15-25-28

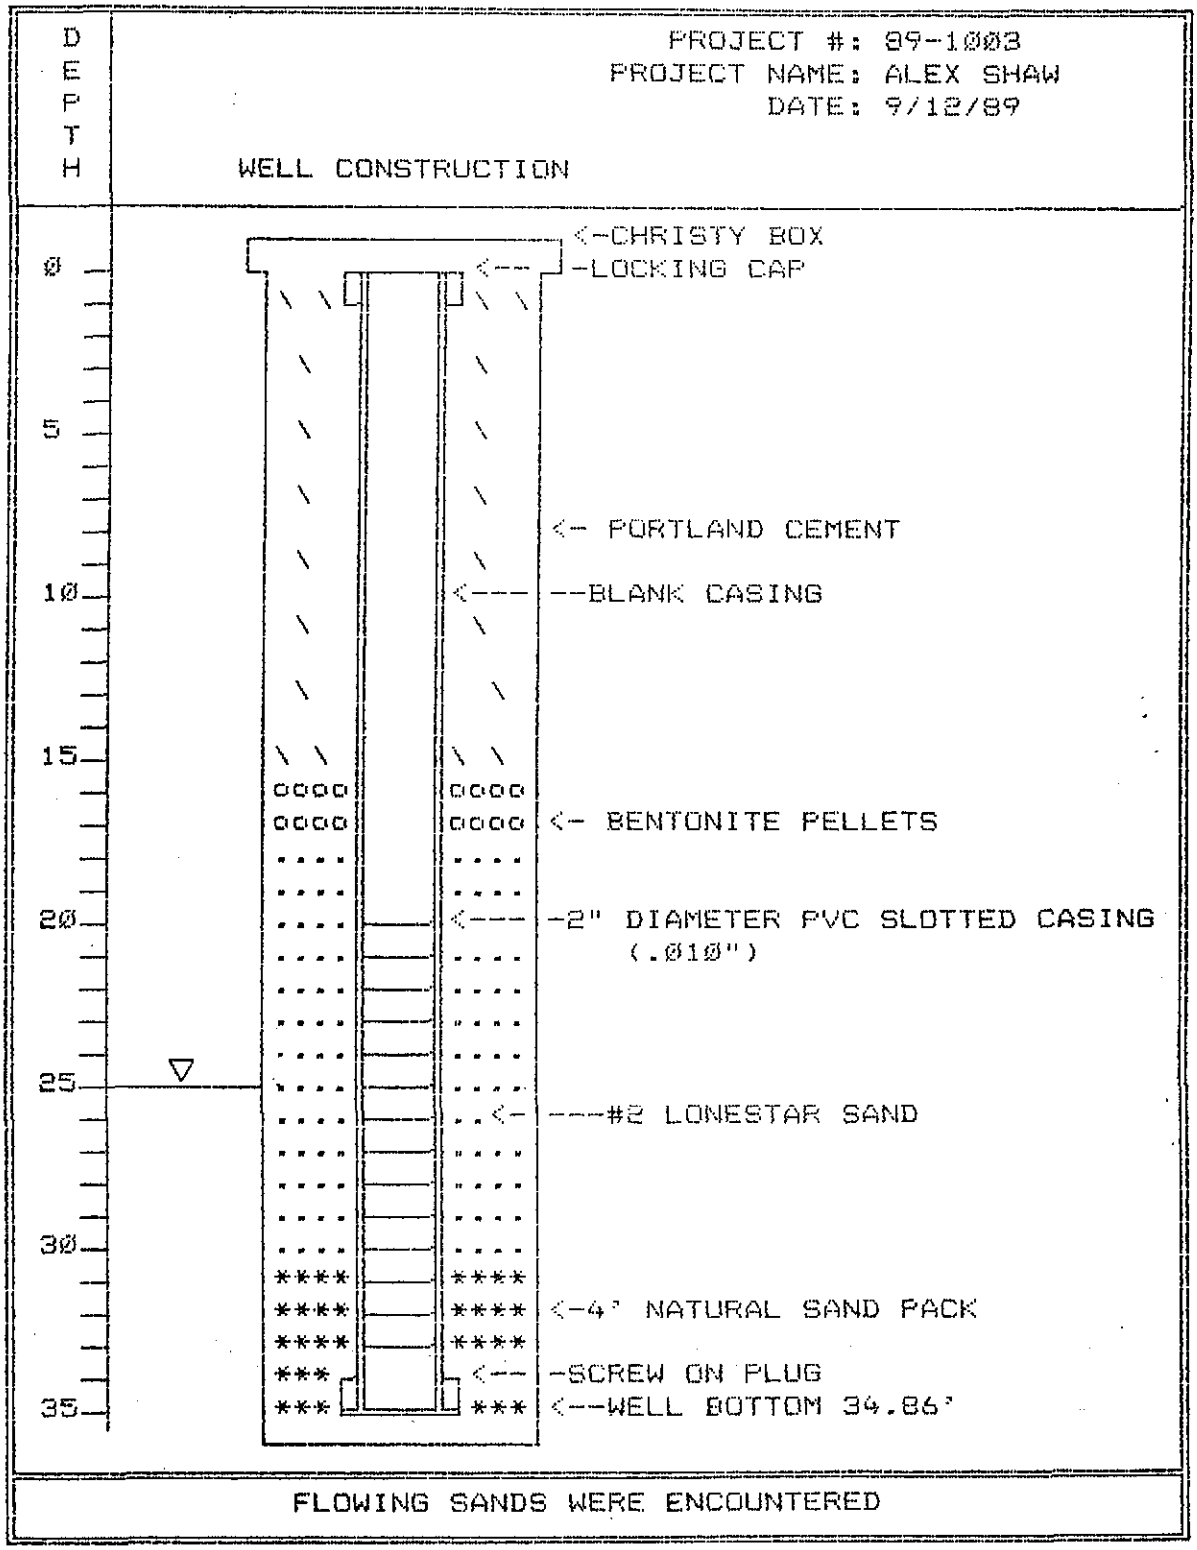
WELL CONSTRUCTION LOG
BORING # MW2

FLOWING SANDS WERE ENCOUNTERED

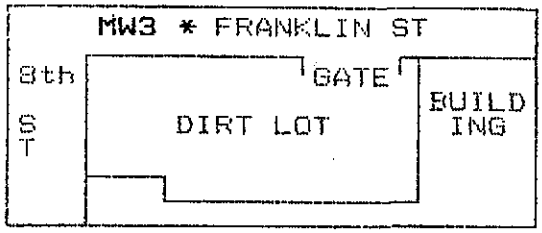
BORING # MW3

DEPTH	SAMPLE #	RECOVERY	TIME	BLOWS	DESCRIPTION	USCS	SYMBOL
0					CONCRETE		
					BROWN FINE SAND; WELL-SORTED; LOOSE; DRY.	SP	
5	MW3A	18"	9:20	2-7-12	LIGHT BROWN CLAYEY FINE SAND.		
						SC	
10	MW3B	18"	9:30	5-5-6	OLIVE GREEN-GRAY CLAYEY FINE SAND.		
					GRAY SILTY CLAY; DRY.		
15	MW2C	18"	1:40	7-7-14	BROWN CLAY; SLIGHTLY PLASTIC; STIFF.		
					BROWN SANDY CLAY.	CL	
20	MW3D	18"	9:50	10-18-21	LIGHT BROWN-TAN FINE SAND; DRY; WELL-SORTED.		
						SP	
					GRAY FINE SAND; LOOSE; MOIST.	▽	
25	MW2E	18"	1:55	15-25-28
