Re: Kerry & Associates – Palace Garage
14336 Washington Avenue
San Leandro, California
ACEH Case No. RO0000208

Subject: **First Quarter 2013 Groundwater Monitoring Report**
Palace Garage
14336 Washington Avenue
San Leandro, California
ACEH Case No. RO0000208
SFRWQCB LUFT Case No. 01-1133

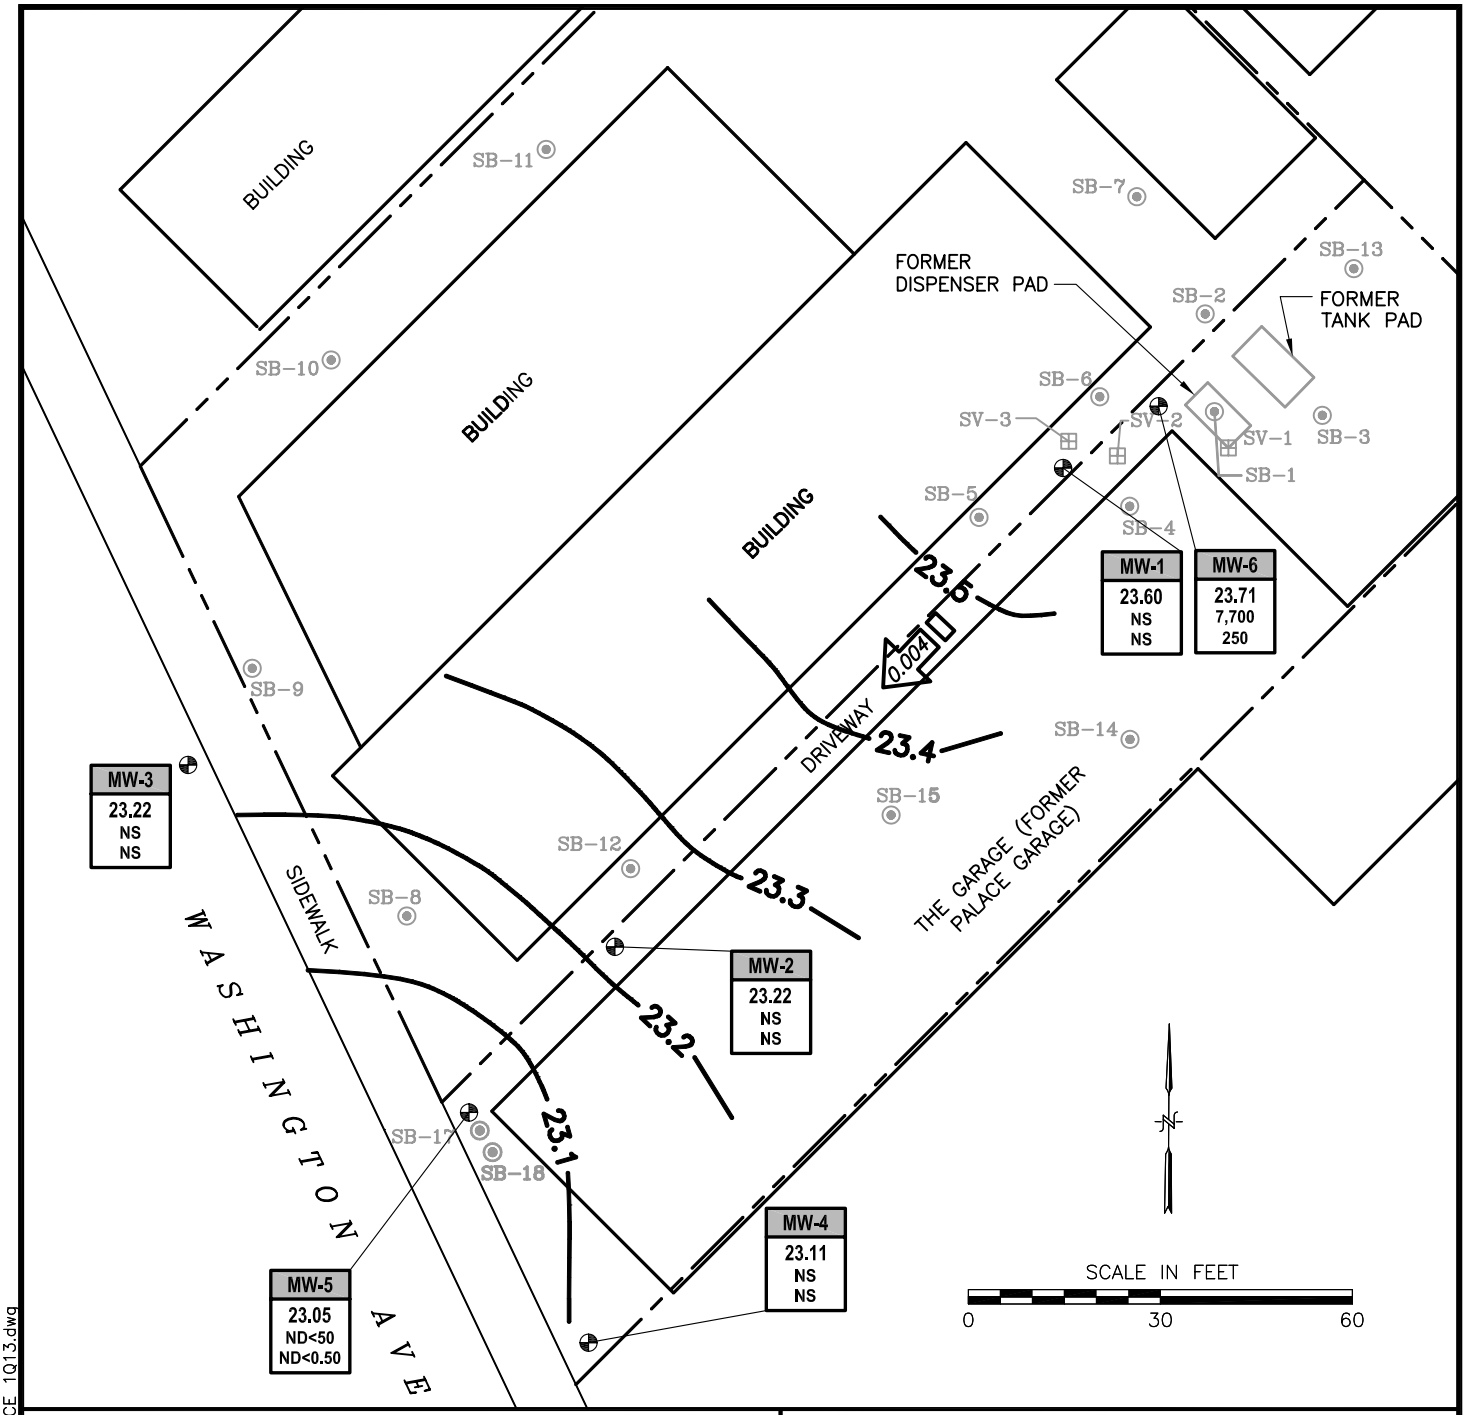
FIGURE 2

Average Depth to Groundwater (in feet bgs):	13.87
Groundwater Elevation (in feet above mean sea level)	23.05 (MW-5) to 23.71 (MW-6)
Groundwater Gradient (direction):	Southwest
Groundwater Gradient (magnitude):	0.004 feet per foot
GRO detected concentration:	7,700 µg/L (MW-6)
Benzene detected concentration:	250 µg/L (MW-6)
Toluene detected concentration:	240 µg/L (MW-6)
Ethylbenzene detected concentration:	2,800 µg/L (MW-6)
Xylenes detected concentration:	4,790 µg/L (MW-6)
Naphthalene detected concentration:	1,100 µg/L (MW-6)

FIRST QUARTER 2013
GROUNDWATER MONITORING
& SAMPLING RESULTS

GROUNDWATER CONTOUR MAP
FEBRUARY 7, 2013
