October 23, 1987
87117-1
Revised Date:
December 20, 1987

Subject: Letter report No. 87117-1 on tank inspection and laboratory analyses of soil samples collected beneath gasoline storage tanks Mobil service station No. 10LVW, 5425 Grove Street, Oakland, California

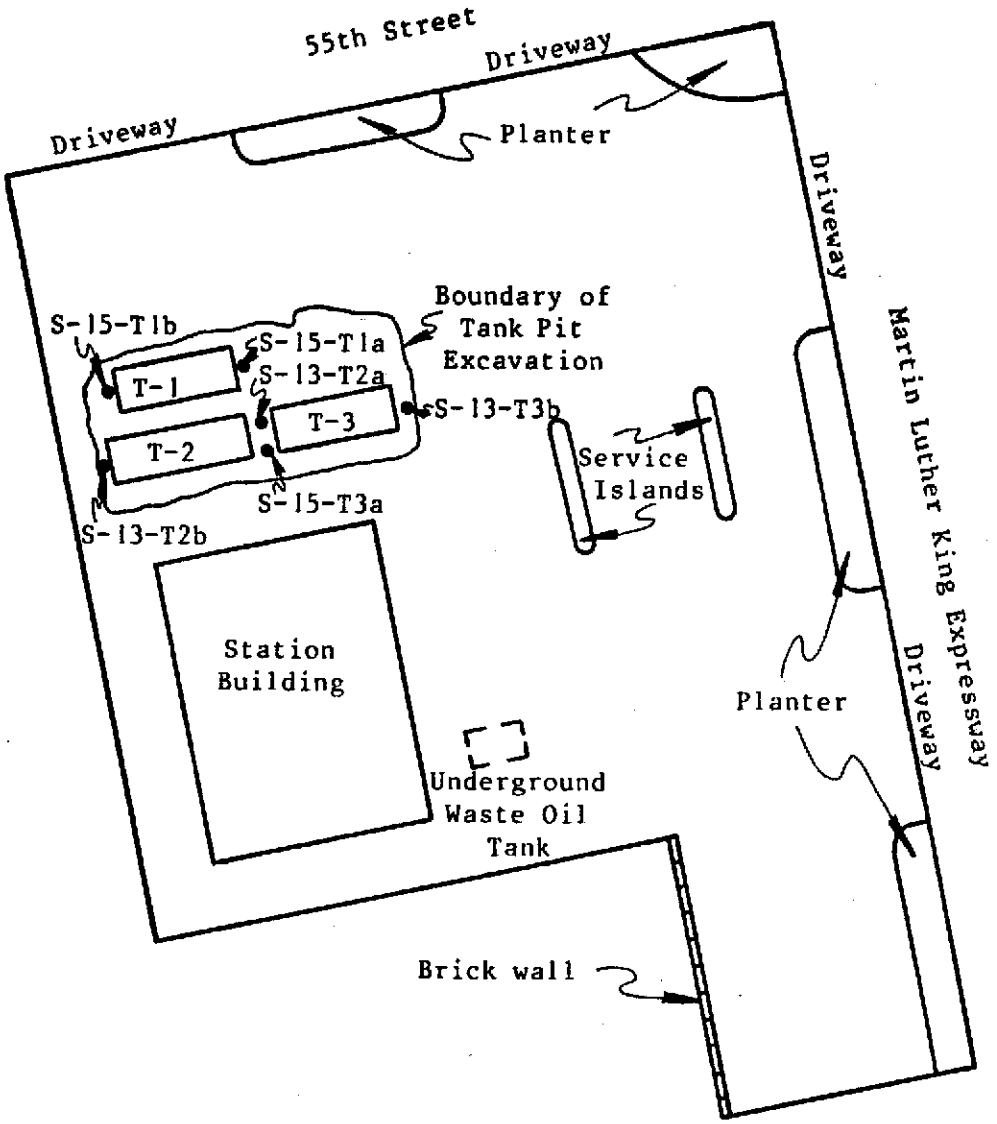
P-2

The backfill material in the gasoline storage tank pit was poorly-graded medium-grained sand. Subjective evidence of hydrocarbon contamination was found in the backfill material located adjacent to the fill ports of the tanks. This contamination was probably caused by one or more overfill events. The soil samples for analysis were collected from native soil at a depth of approximately 12 to 15 feet (approximately 2 to 3 feet below the tanks' bottoms). Sample locations are shown on the enclosed Generalized Site Plan.
