THIRD QUARTER 2005
SITE MONITORING REPORT

REDWOOD REGIONAL PARK
SERVICE YARD
OAKLAND, CALIFORNIA

EAST BAY REGIONAL PARK DISTRICT
OAKLAND, CALIFORNIA

October 2005

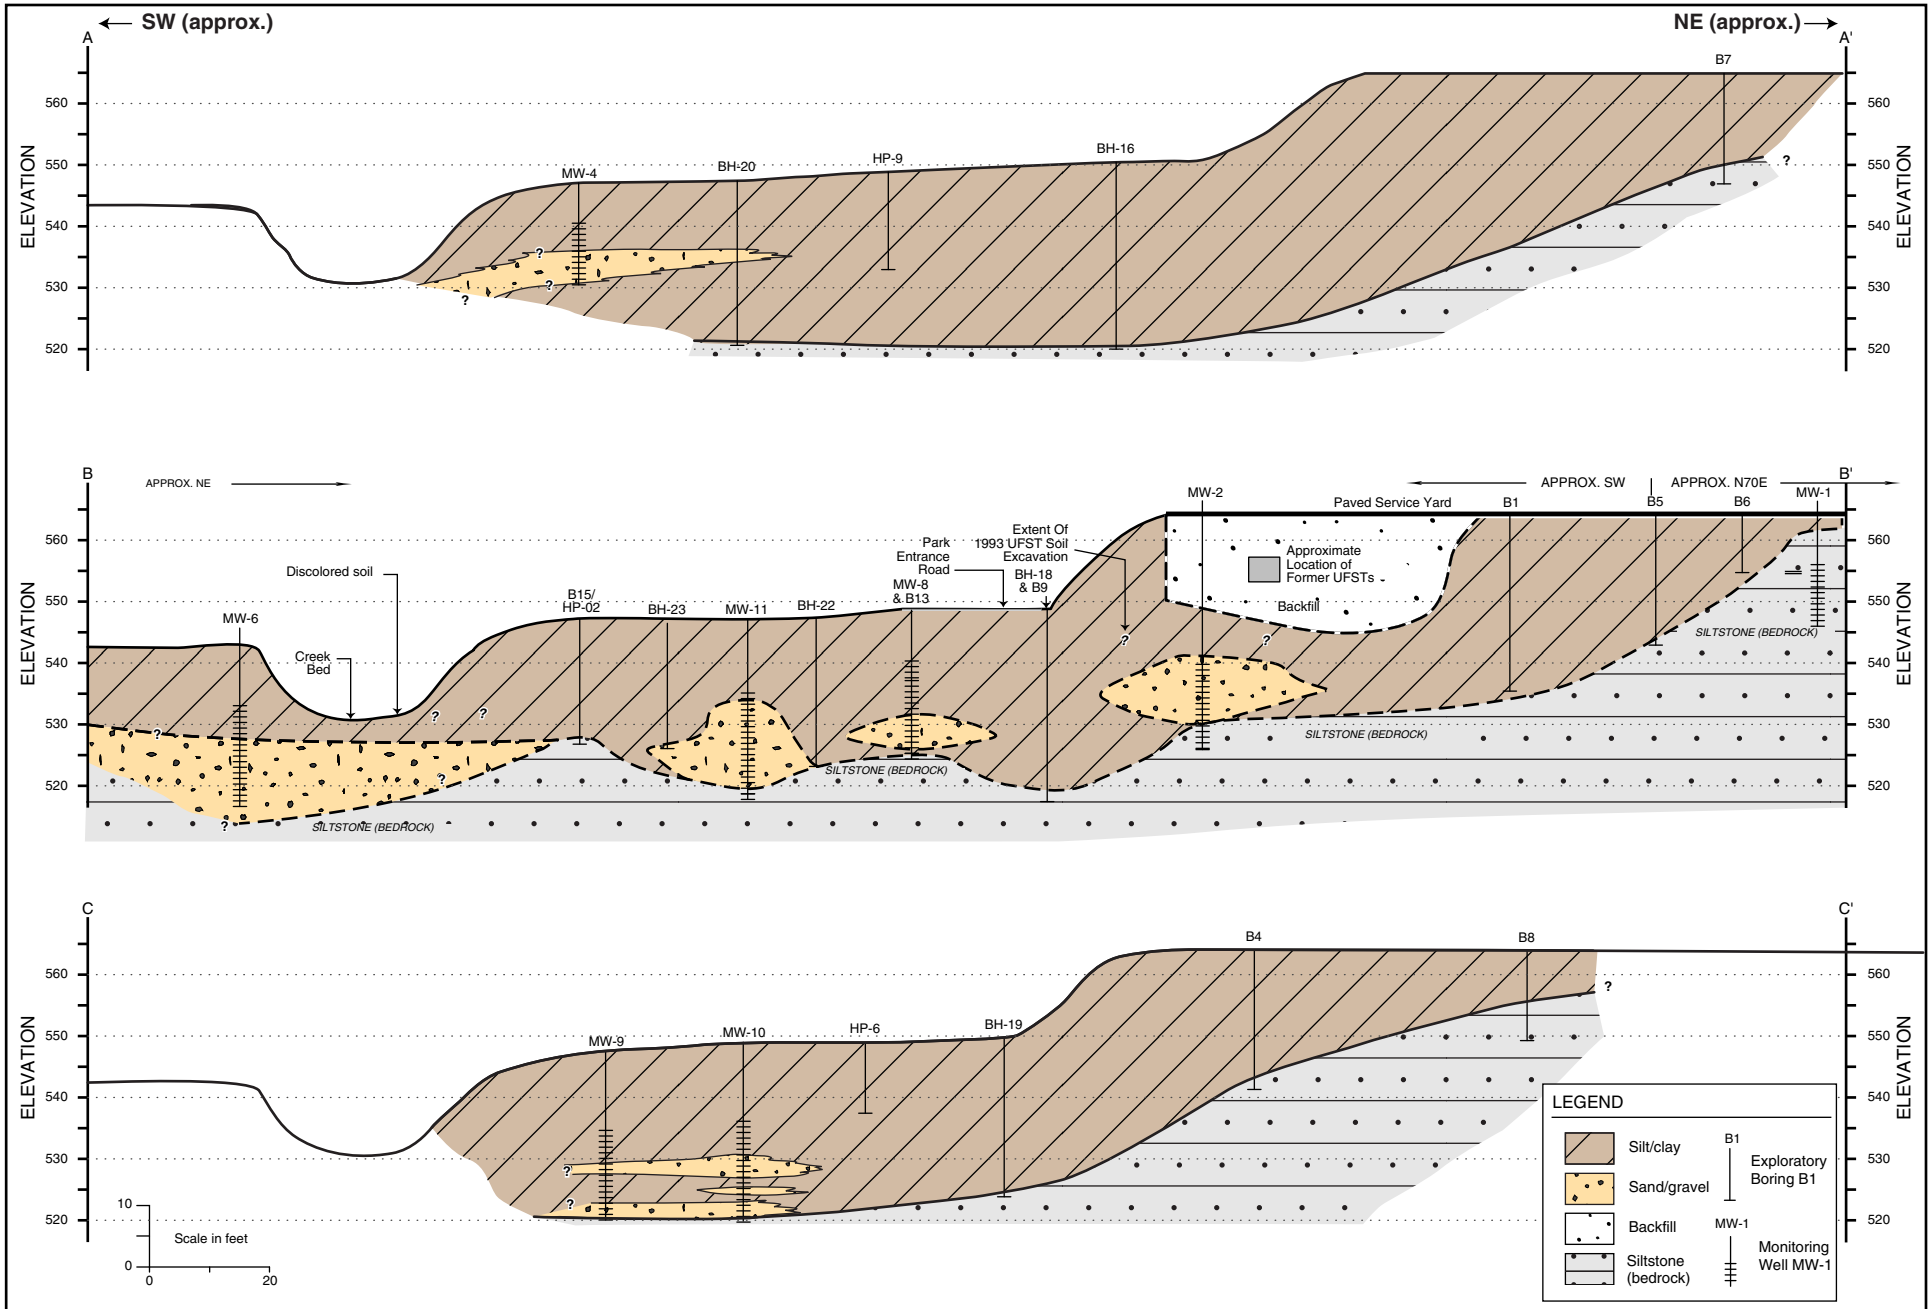
Figure 3 shows the location of geologic cross-sections. Figure 4 shows three sub-parallel geologic cross-sections (A-A' through C-C') along the long axis of the groundwater contaminant plume (i.e., along local groundwater flow direction). Figure 5 shows three sub-parallel geologic cross-sections (D-D' through F-F') roughly perpendicular to groundwater direction. In each figure, the three sub-parallel sections are presented together for ease of comparison. Due to the small scale, these sections show only lithologic conditions (i.e., soil type and bedrock depth). Additional information on water level depths, historical range of water levels, and inferred thickness of soil contamination) were presented in a previous report (SES, 2004c) for cross-section B-B'.

Shallow soil stratigraphy consists of a surficial 3- to 10-foot-thick clayey silt unit underlain by a 5- to 15-foot-thick silty clay unit. In the majority of boreholes, a 5- to 10-foot-thick clayey coarse-grained sand and clayey gravel unit that laterally grades to a clay or silty clay was encountered. This unit overlies a weathered siltstone at the base of the observed soil profile. Soils in the vicinity of MW-1 are inferred to be landslide debris.

GEOLOGIC CROSS SECTIONS — A-A' through C-C'

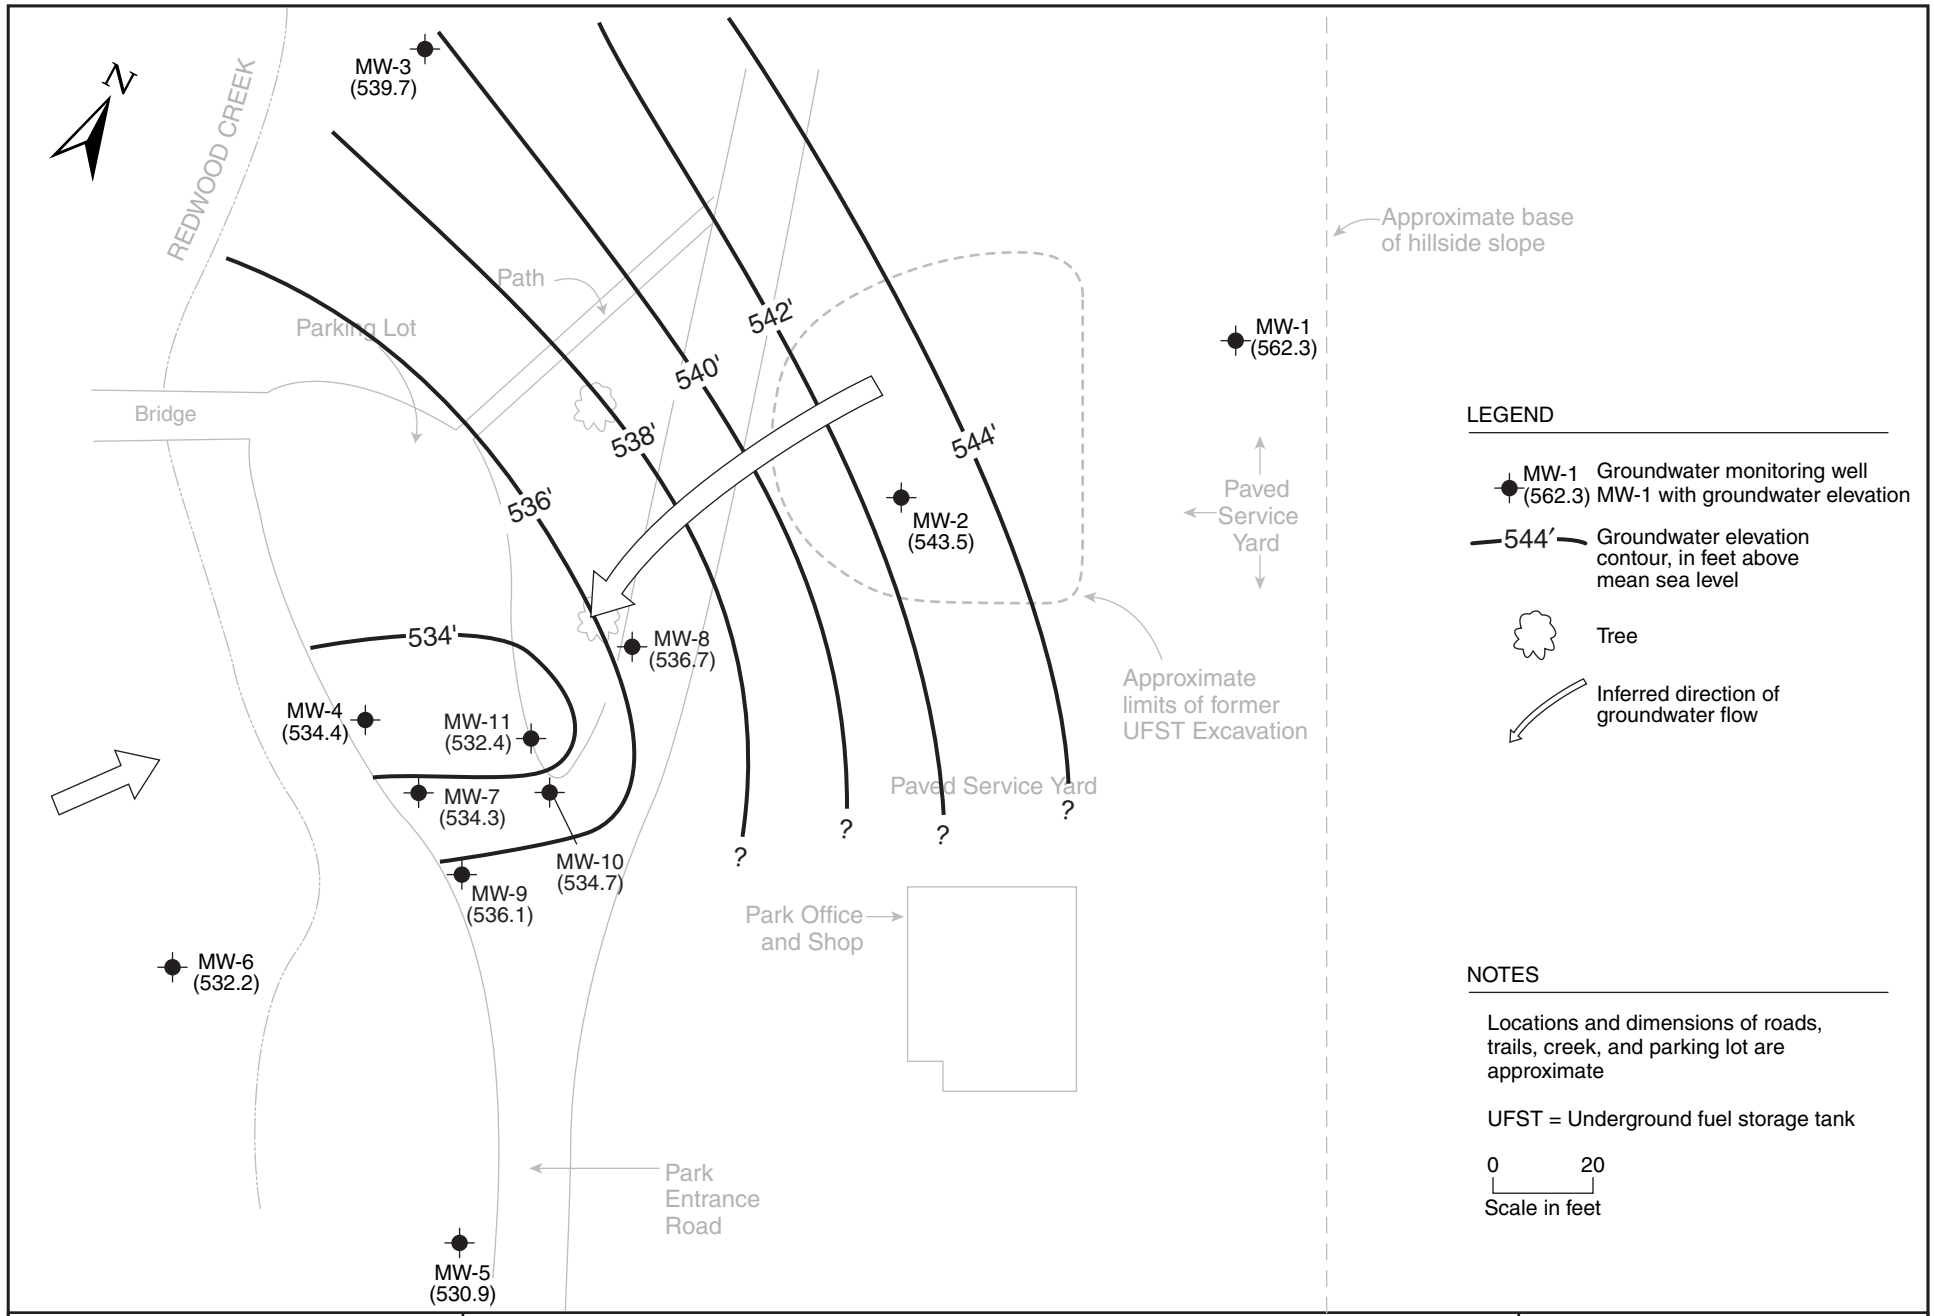
Figure 6 is a groundwater elevation map constructed from the current event monitoring well static water levels. Table 1 (in Section 3.0) summarizes current event groundwater elevation data. Appendix A contains historical groundwater elevation data. Consistent with the bedrock isopleth map showing an elevation depression in the vicinity of MW-11, historical groundwater elevations in MW-11 are generally lower than in the surrounding area. As discussed in the previous sub-section, local groundwater flow direction is likely more variable than expressed by groundwater monitoring well data, due to localized bedrock surface topography.

In the upgradient portion of the site (between well MW-1 and the former UFST source area, in landslide debris), the groundwater gradient is approximately 0.2 feet per foot. Downgradient from (west of) the UFST source area (between MW-2 and Redwood Creek), the groundwater gradient is

GROUNDWATER ELEVATION MAP–September 13, 2005
Redwood Regional Park Service Yard, Oakland, CA

approximately 0.1 feet per foot. The direction of shallow groundwater flow during the current event was to the west-southwest (toward Redwood Creek), which is consistent with historical site groundwater flow direction.

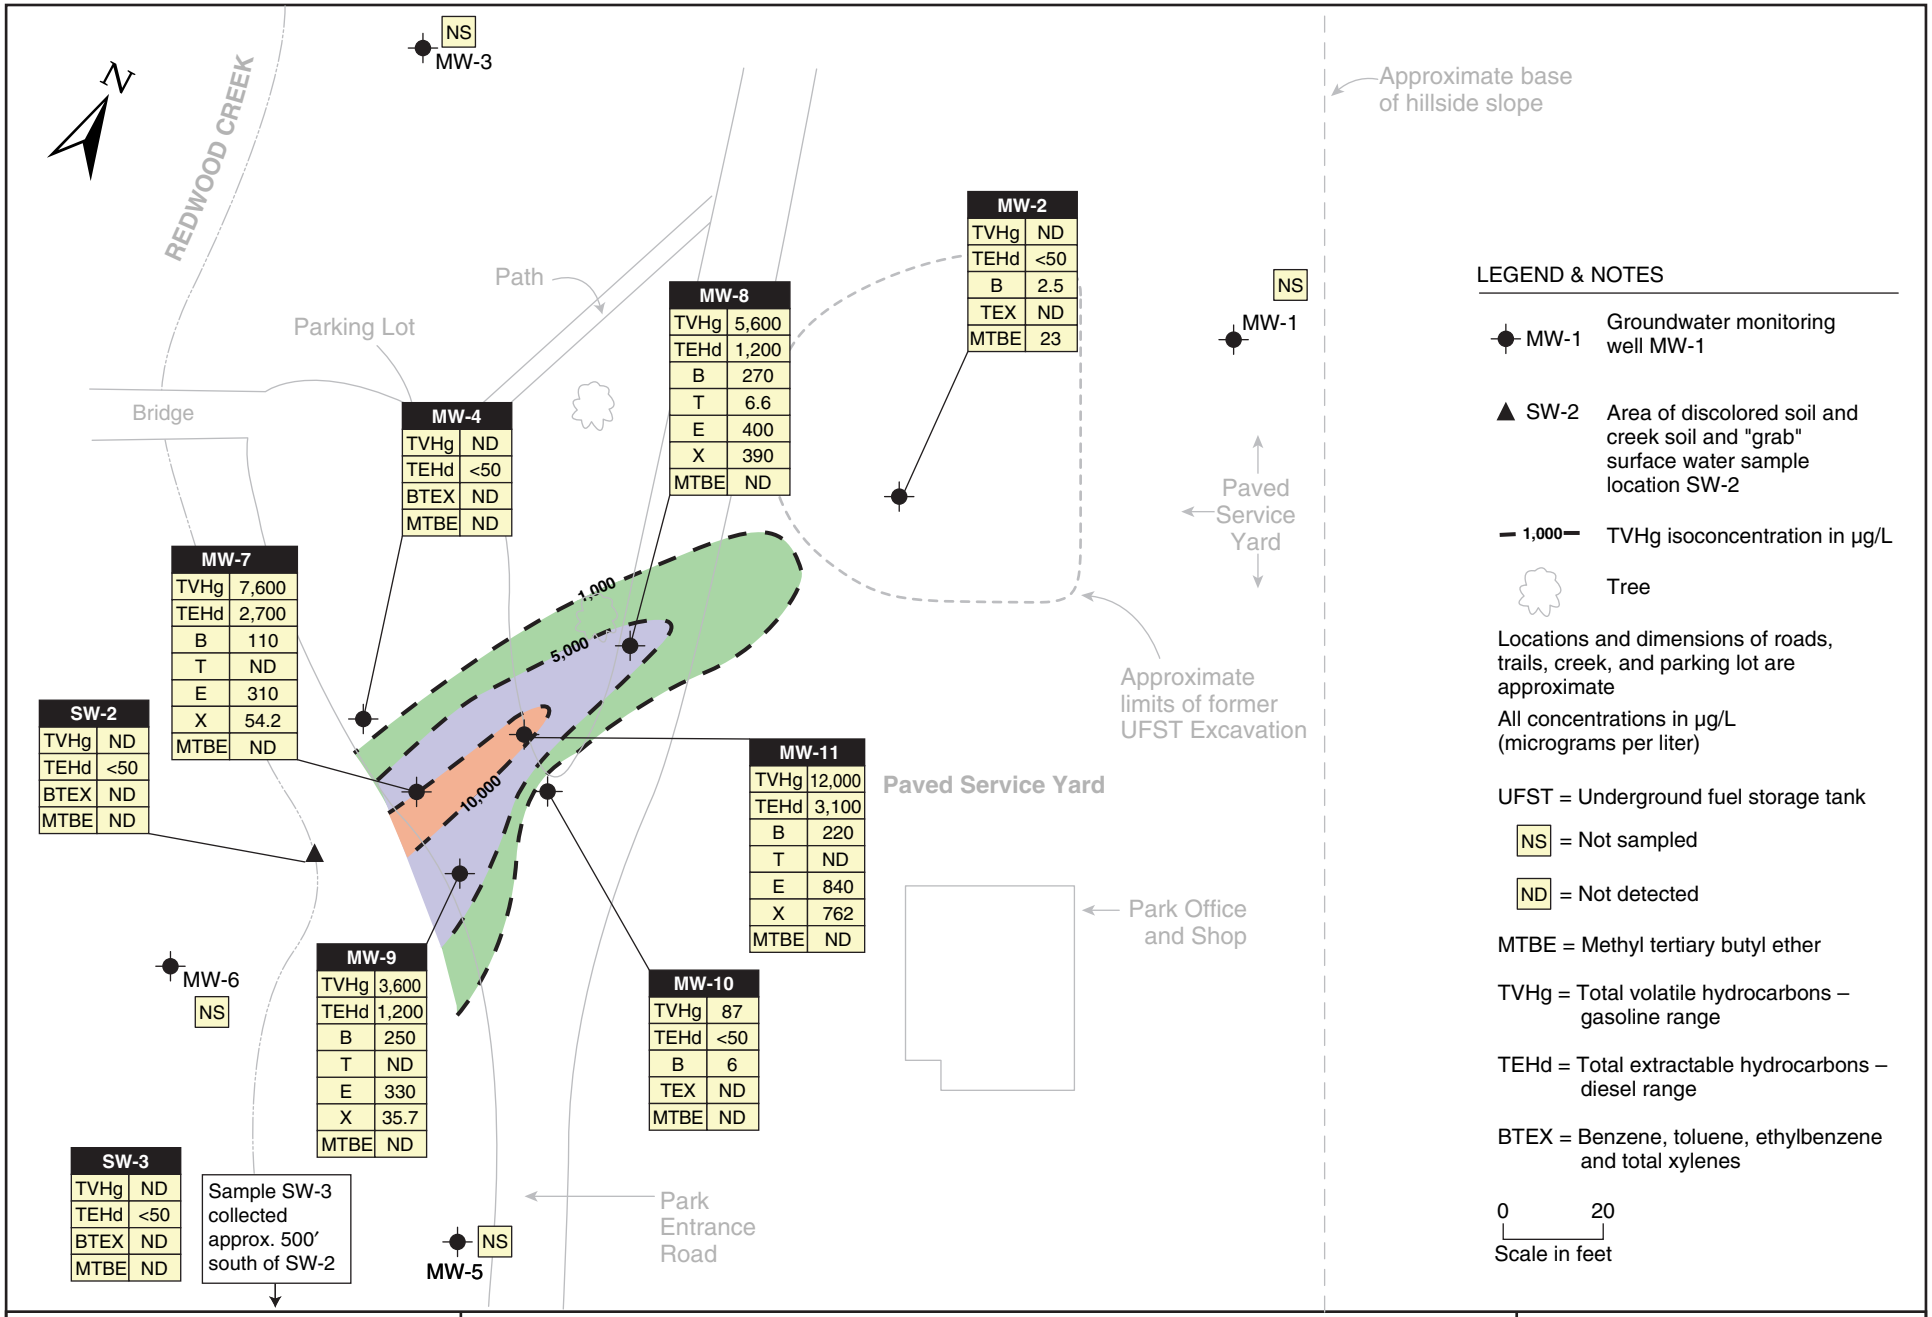
Figure 7

Current quarter site groundwater maximum concentrations exceed their respective groundwater ESLs for all analytes except toluene (under the *drinking water resource is threatened* criterion) and for all contaminants except toluene and MTBE (under the *drinking water resource is not threatened* criterion). Maximum site groundwater contaminant concentrations also exceed all surface water screening levels, with the exception of toluene and MTBE.

Except for benzene and MTBE, maximum groundwater contaminant concentrations were all detected in well MW-11 (located approximately three-quarters of the distance between the former source area and the creek). Maximum benzene concentrations were detected in upgradient well MW-8, while maximum MTBE concentrations were detected in upgradient well MW-2. Elevated contaminant concentrations were also detected in downgradient wells MW-7 and MW-9. The northern and southern edges of the plume in the downgradient area of the plume appear to be well defined by wells MW-4 and MW-10. The current event contaminant plume geometry is consistent with recent historical contaminant distribution, showing the center of contaminant mass in groundwater located downgradient of the former source area.

ANALYTICAL RESULTS AND GASOLINE PLUME—SEPTEMBER 2005
Redwood Regional Park Service Yard, Oakland, CA
