Third Quarter 2008 Groundwater Monitoring Event

Former Fiesta Beverages Facility
966 89th Avenue
Oakland, California 94621
ACHCSA Fuel Leak Site # RO0000314

September 18, 2008
BEI Job No. 203004

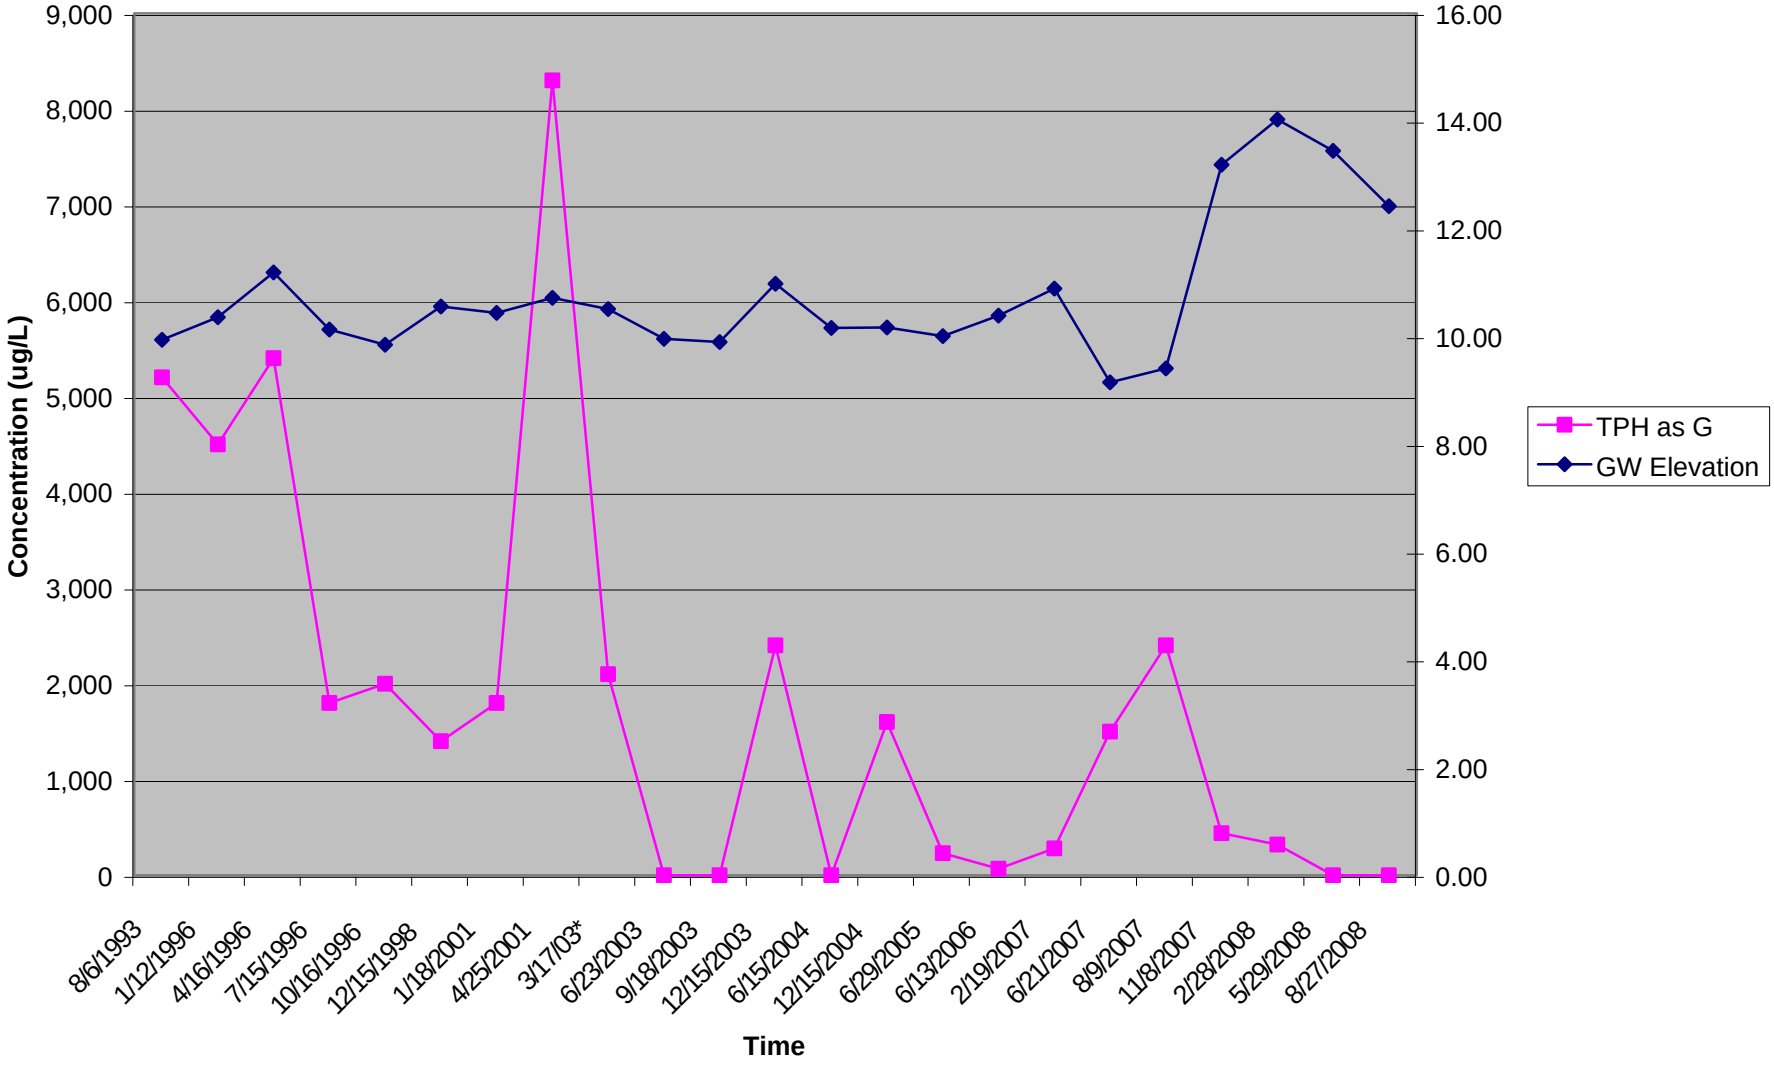
Figure 3: Concentration of TPHG vs. Time in Well MW-3

Data gathered prior to remedial injections have provided evidence at the site for recontamination of groundwater upon rise up into contaminated soil (MW-3; Figures 3 and 4) as well as probable drainage from soil to groundwater as groundwater drops in elevation at the site (MW-1 / MW-1R; Figures 5 and 6). Data from well MW-3 for the current quarter is generally consistent with the historical trend (this quarter, decreasing groundwater and decreasing concentrations) at the well; however, data from well MW-1 / MW-1R is not consistent with historical trends (this quarter, decreasing concentrations with decreasing groundwater levels). This might represent a change, a decrease in availability in the residual soil contamination presumed to be the source of groundwater impacts in well MW-1R. Data from the recent quarters has been somewhat atypical, and has been assumed to be related to the injection of RegenOx fluids. This has generally been presumed to indicate progress in remedial treatments. Specifically, data from MW-1R over the past two quarters tended to suggest that granular backfill and the soil immediately adjacent to and beneath the 6-inch-diameter gas main located approximately 5 feet to the north of well MW-1R and former MW-1 might be providing a reservoir for hydrocarbons not easily and effectively reached. This appears to have ceased during this quarter. (For consistency all groundwater elevations in Figures 3 to 6 utilized the GeoTracker wellhead survey elevations to determine the groundwater elevation.)

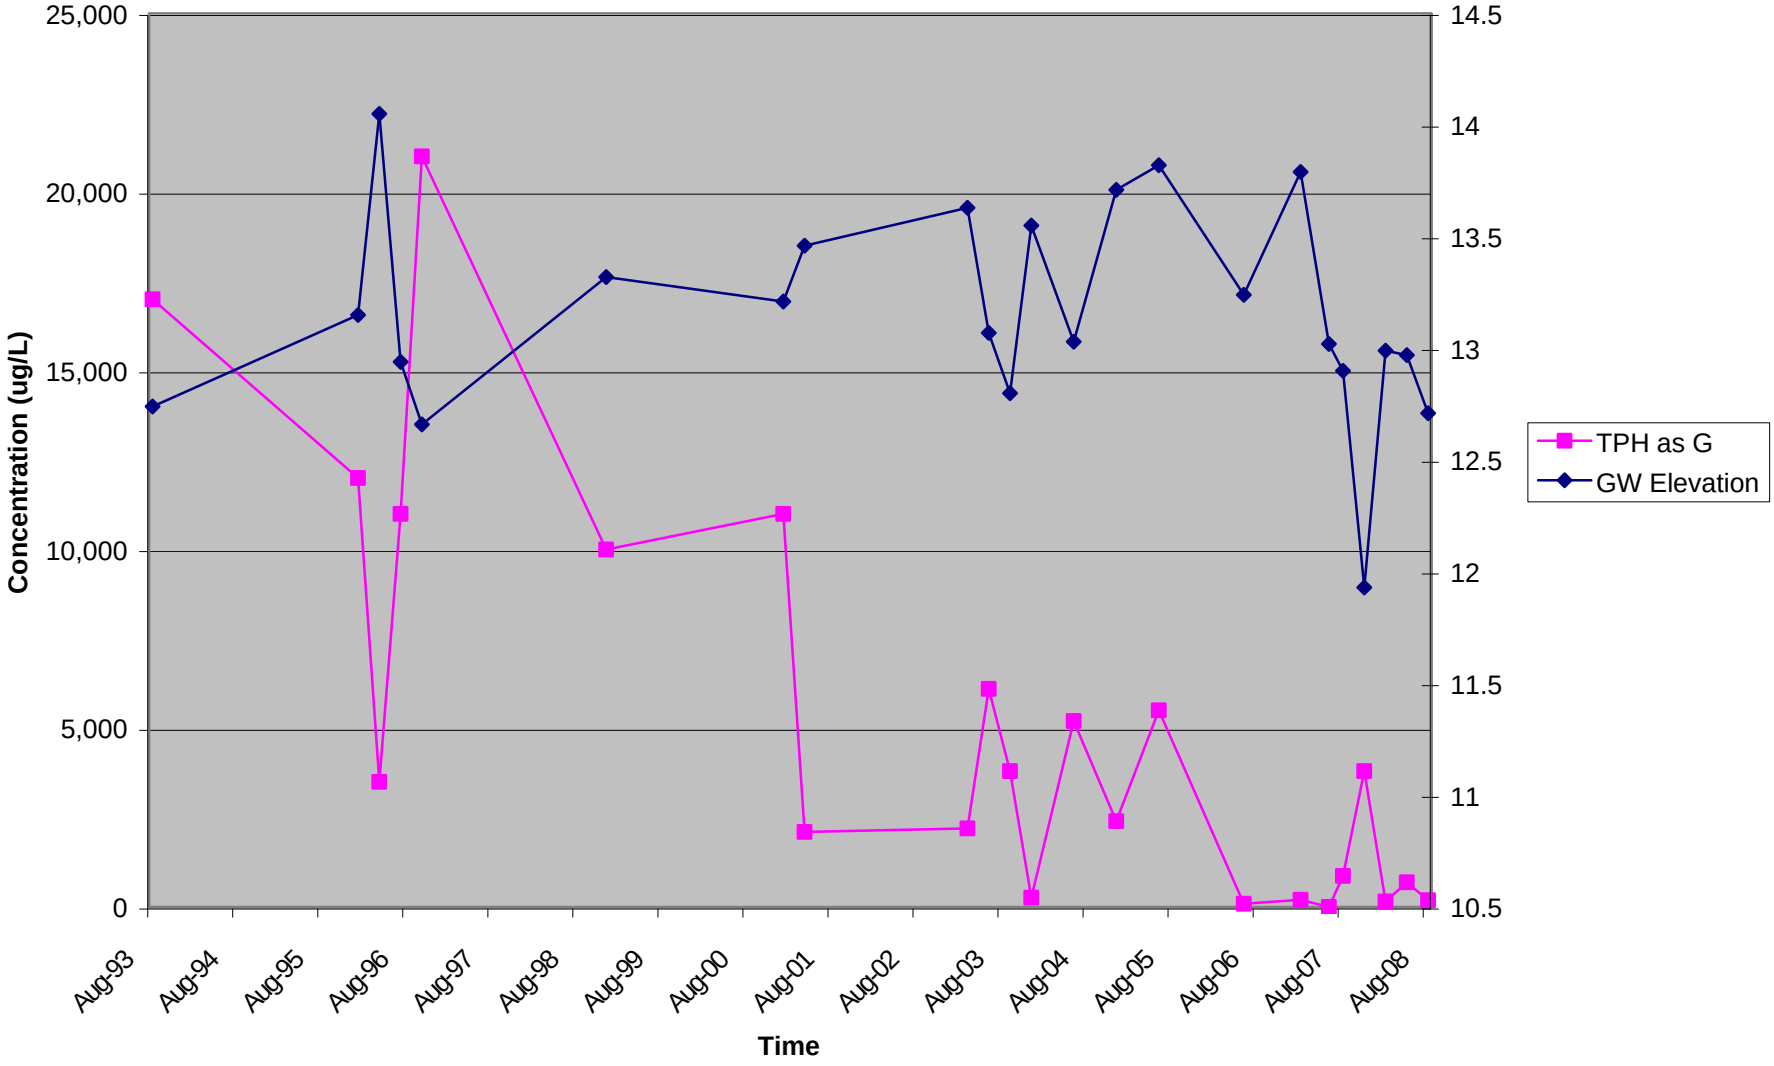
Figure 5: Concentration of TPHG vs. TIme in Well MW-1 & MW-1R

Between the May and August quarterly sampling events all concentrations of TPH as gasoline and BTEX decreased markedly in well MW-1R. The concentrations of TPH as gasoline and benzene in well MW-1R (190 and 14 ug/L, respectively) were below the generic non-drinking water ESLs but over generic drinking water ESLs. All other concentrations in well MW-1R were below all ESL values. In wells MW-2 and MW-3, except for benzene, which increased very slightly, all hydrocarbon concentrations remained nondetectable. The concentration of benzene in wells MW-2 and MW-3 (1.1 and 1.3 ug/L, respectively) are significantly below the generic non-drinking water ESL of 46 ug/L, and slightly above the drinking water ESL of 1.0 ug/L. All other wells (upgradient, downgradient, and lateral) were non-detectable for TPH as gasoline and BTEX.

- Between the May and August quarterly sampling events, all concentrations of TPH as gasoline and BTEX decreased markedly in well MW-1R. The concentrations of TPH as gasoline and benzene in well MW-1R were below the generic non-drinking water ESLs. All other concentrations in well MW-1R were below all ESL values.
