GROUNDWATER MONITORING REPORT
Sampling Round Seven

PACO PUMPS, INC.
9201 San Leandro Street
Oakland, California

January 15, 1995

Jonas and Associates Inc. Job No. PCO-220

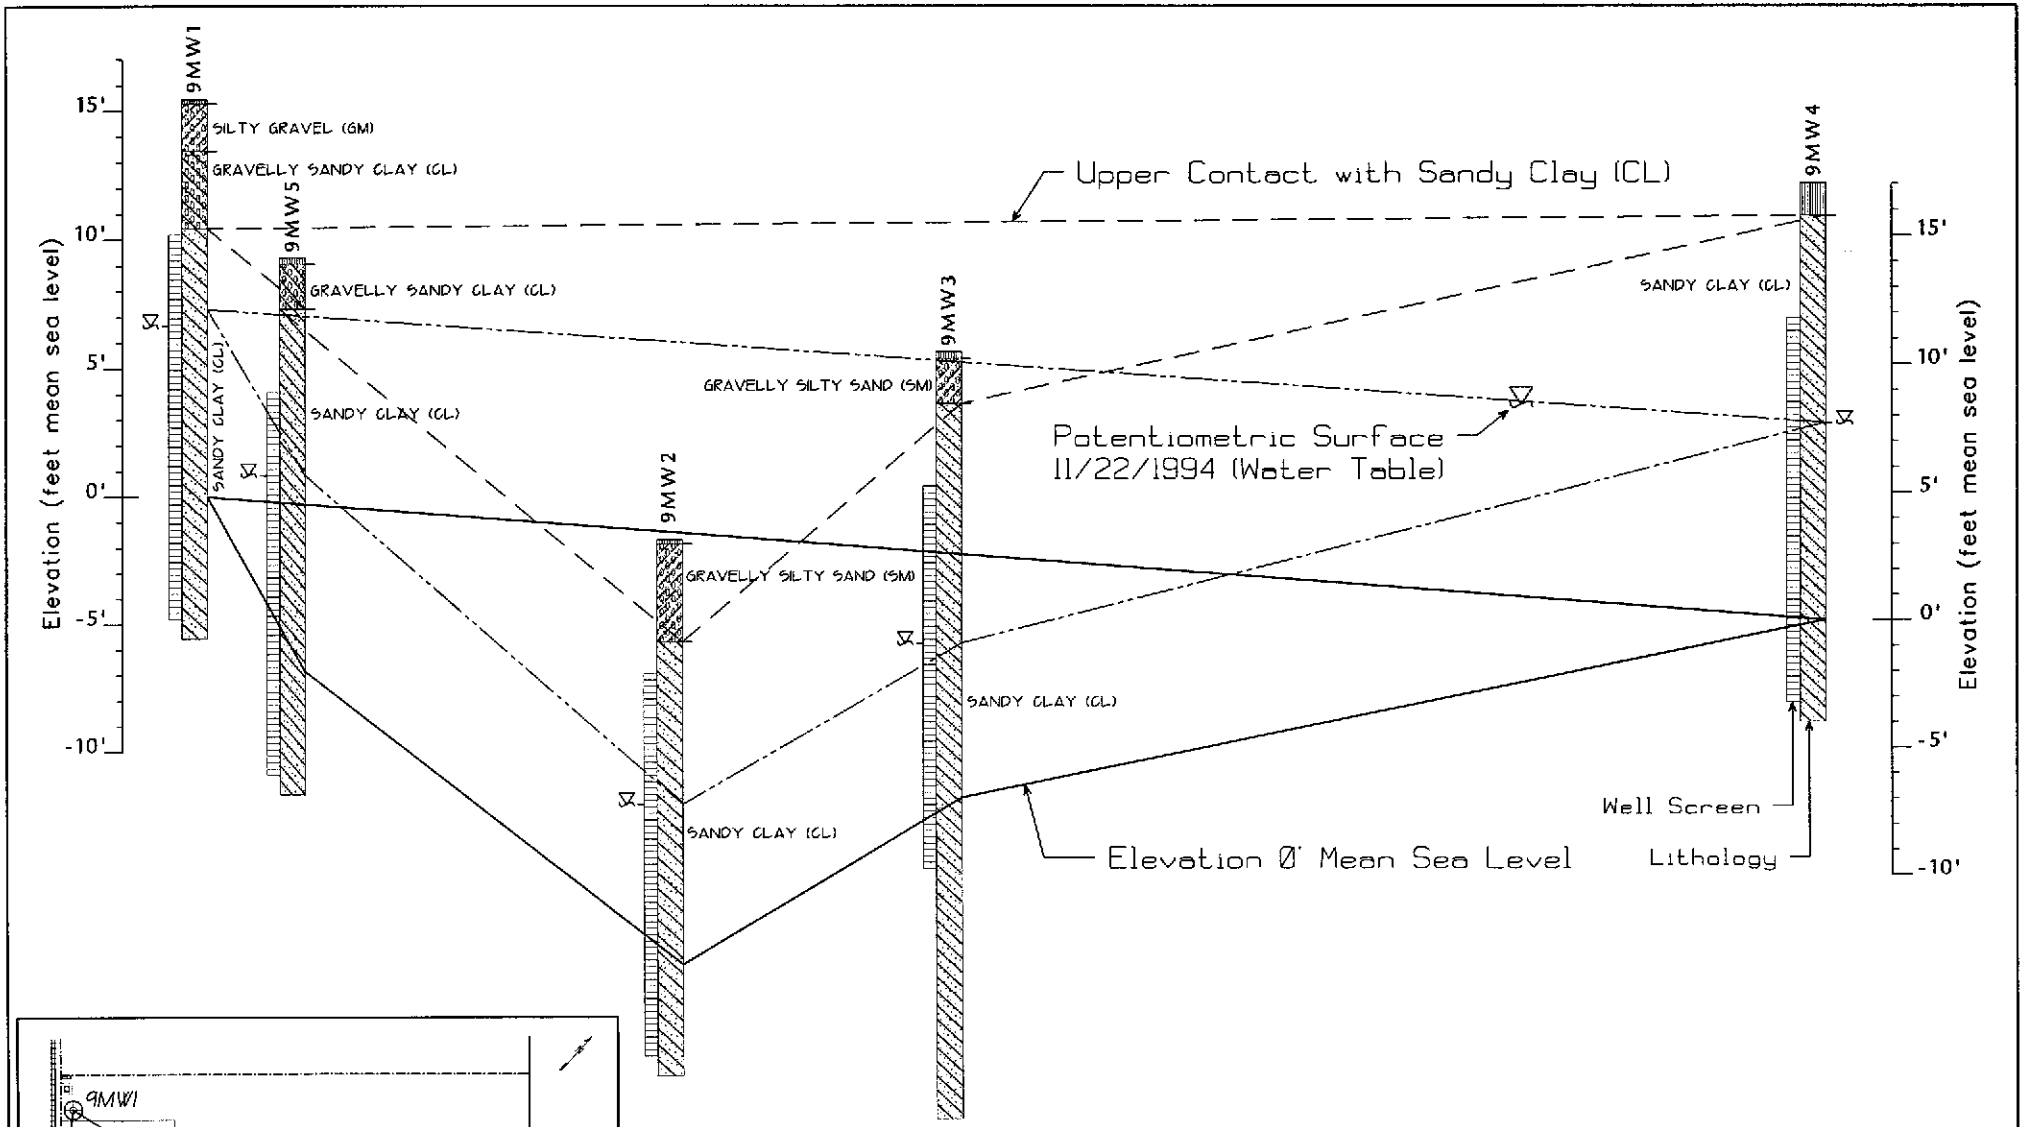
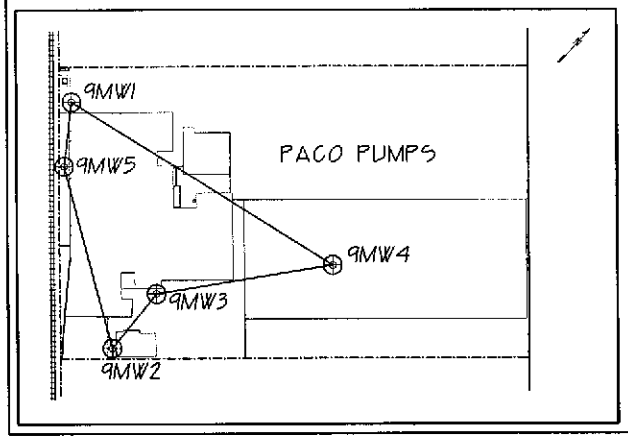
Date: 12-5-1994 Locations Approx.	Figure 2-2	Drawing Number PCO220-12/94:G7F2-2

Figure 2-2 presents a hydrogeologic cross section using potentiometric and lithologic data associated with the monitoring wells.

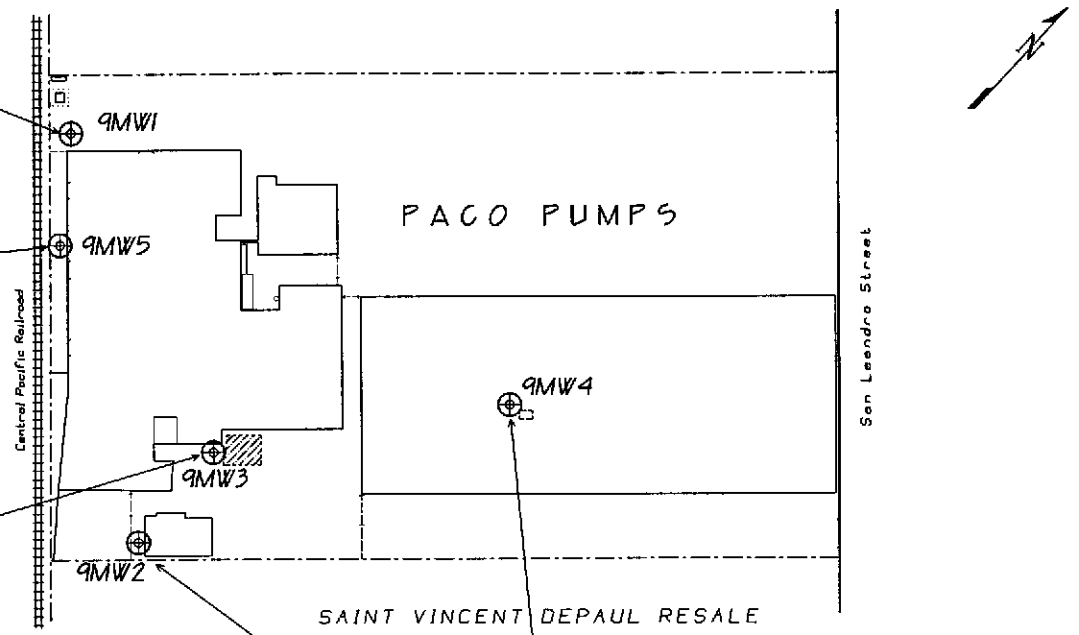
Figure 3-1

9MW3 (Water Elev.:+8.21')

(mg/L)		(mg/L)
TPH-Gasoline	2.2	TEPH-Diesel*	ND(0.05)
Benzene	0.670	TEPH-Kerosene	ND(0.05)
Toluene	0.130	TEPH-Motor Oil	ND(0.5)
Ethyl Benzene	0.031	Detected Method 8010 Volatile Organics:	
Total Xylenes	0.028	1,2-DCA	0.160

9MW2 (Water Elev.:+8.13')

(mg/L)		(mg/L)
TPH-Gasoline	ND(0.05)	TEPH-Diesel	ND(0.05)
Benzene	0.0034	TEPH-Kerosene	ND(0.05)
Toluene	0.0018	TEPH-Motor Oil	1.0
Ethyl Benzene	ND(0.0005)	Detected Method 8010 Volatile Organics:	
Total Xylenes	0.0005	1,1-DCA	0.0005

Oily Sheen

9MW4 (Water Elev.:+9.67')

(mg/L)		(mg/L)
TPH-Gasoline	0.09	Method 8010 Volatile Organics: none detected	
Benzene	0.016		
Toluene	0.0017		
Ethyl Benzene	0.0056		
Total Xylenes	0.0034

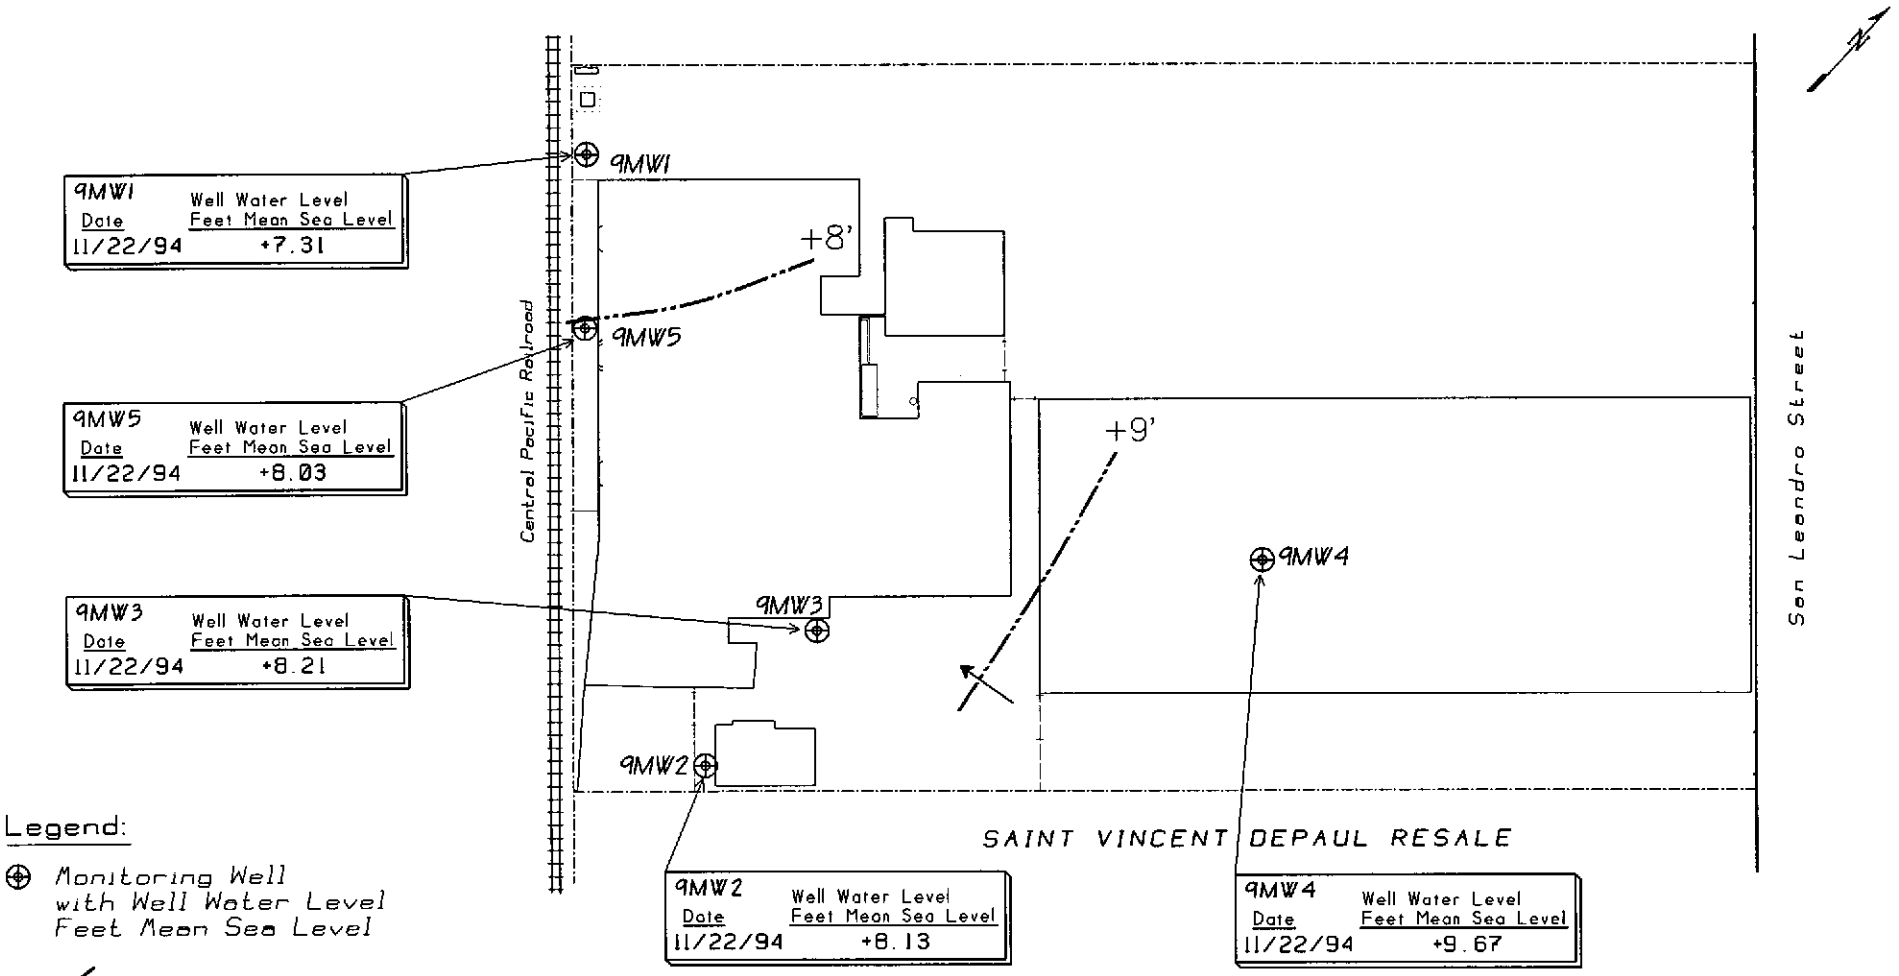
Figure 3-2

Figures 3-2, graphically presents the results of the well water levels collected during the Round Seven sampling event. As identified in Figure 3-2, based upon groundwater elevation data from monitoring wells 9MW1, 9MW2, 9MW3, 9MW4, and 9MW5, the apparent direction of groundwater flow during November 1994 is in a westerly direction from the Saint Vincent DePaul facility to PACO Pumps' property.
