SUBJECT: FORMER BEACON STATION NO. 574, 22315 REDWOOD ROAD, CASTRO VALLEY, CALIFORNIA

ENVIRONMENTAL PROJECT QUARTERLY STATUS REPORT

Subject: **Fourth Quarter 1995 Ground Water Monitoring Report**
Former Beacon Station #574
22315 Redwood Road, Castro Valley, California

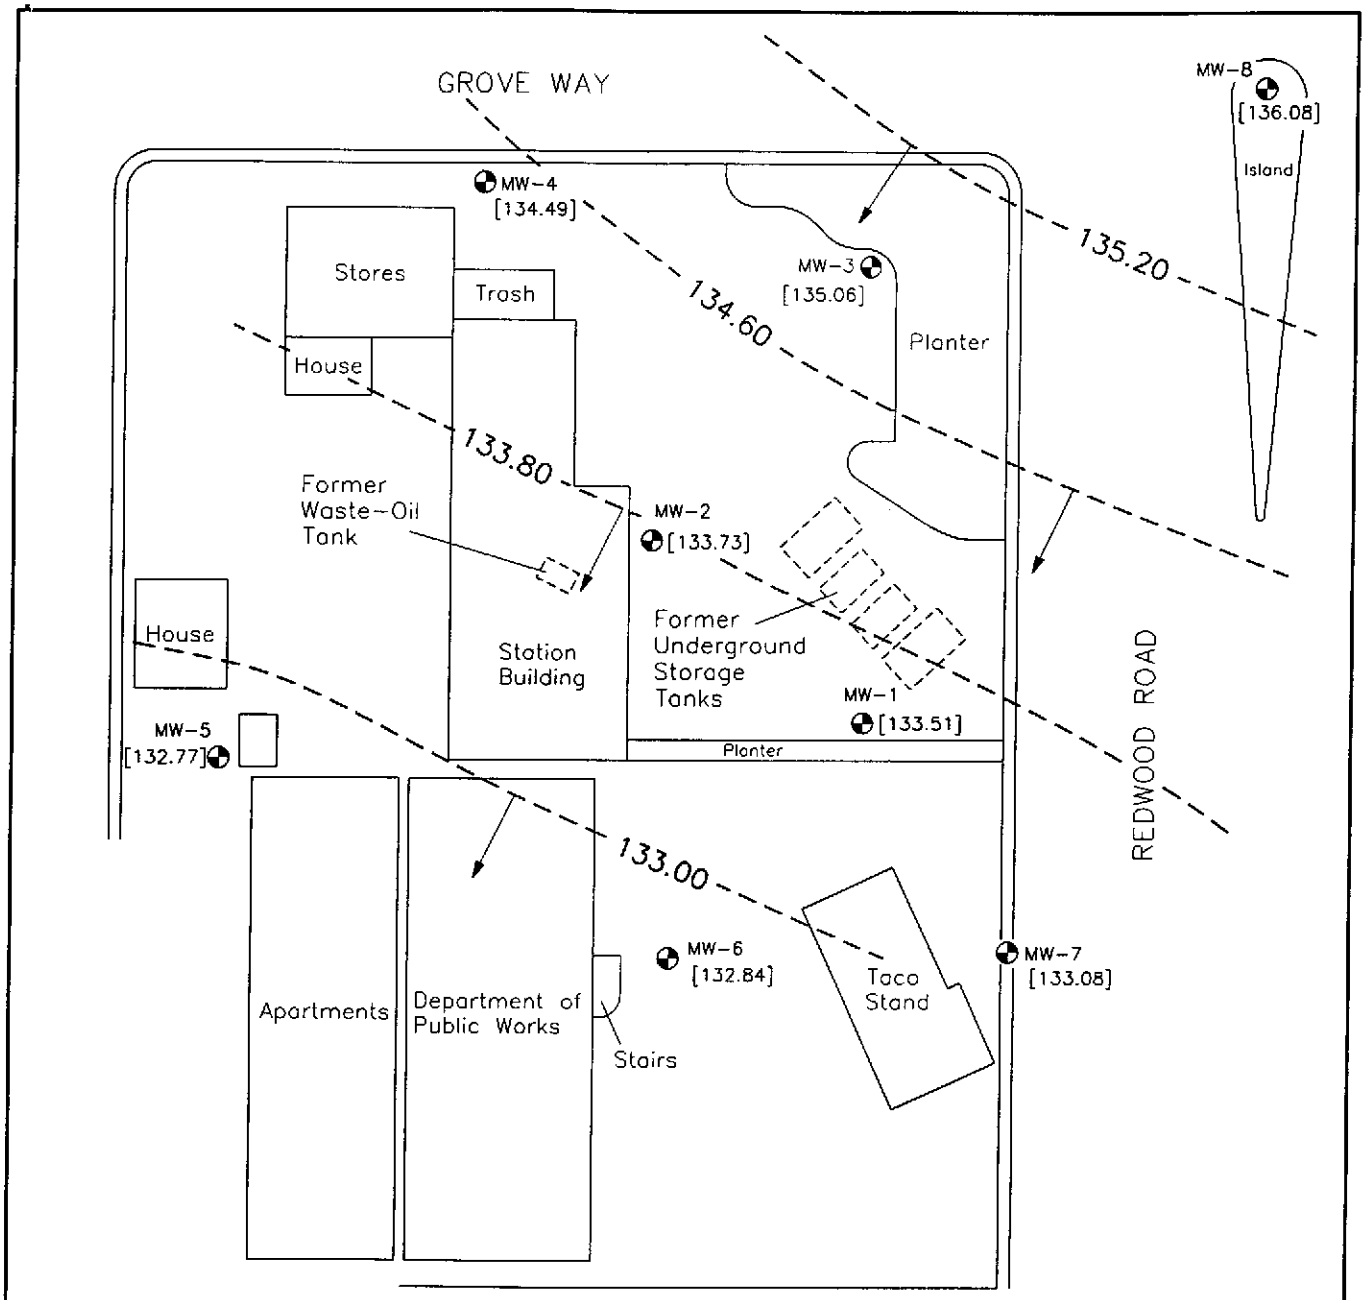
GROUND WATER CONTOUR MAP, DECEMBER 27, 1995	FIGURE 2
BEACON STATION #574 22315 REDWOOD ROAD CASTRO VALLEY, CALIFORNIA	PROJECT NUMBER: U065.01 DRAWN BY: D.A.
EL DORADO ENVIRONMENTAL, INC.	CHECKED BY: DM

Prior to purging, Doulos collected depth to ground water measurements. Copies of Doulos' field data sheets are contained in Attachment B. Ground water elevation data collected since March 1992 are summarized in Table 1. Historical ground water elevation data are contained in Attachment C. On the basis of the current measurements, ground water flows toward the southwest (Figure 2) at a gradient of 0.01 foot per foot. Ground water levels have increased an average of 0.40 feet compared to the last monitoring event.

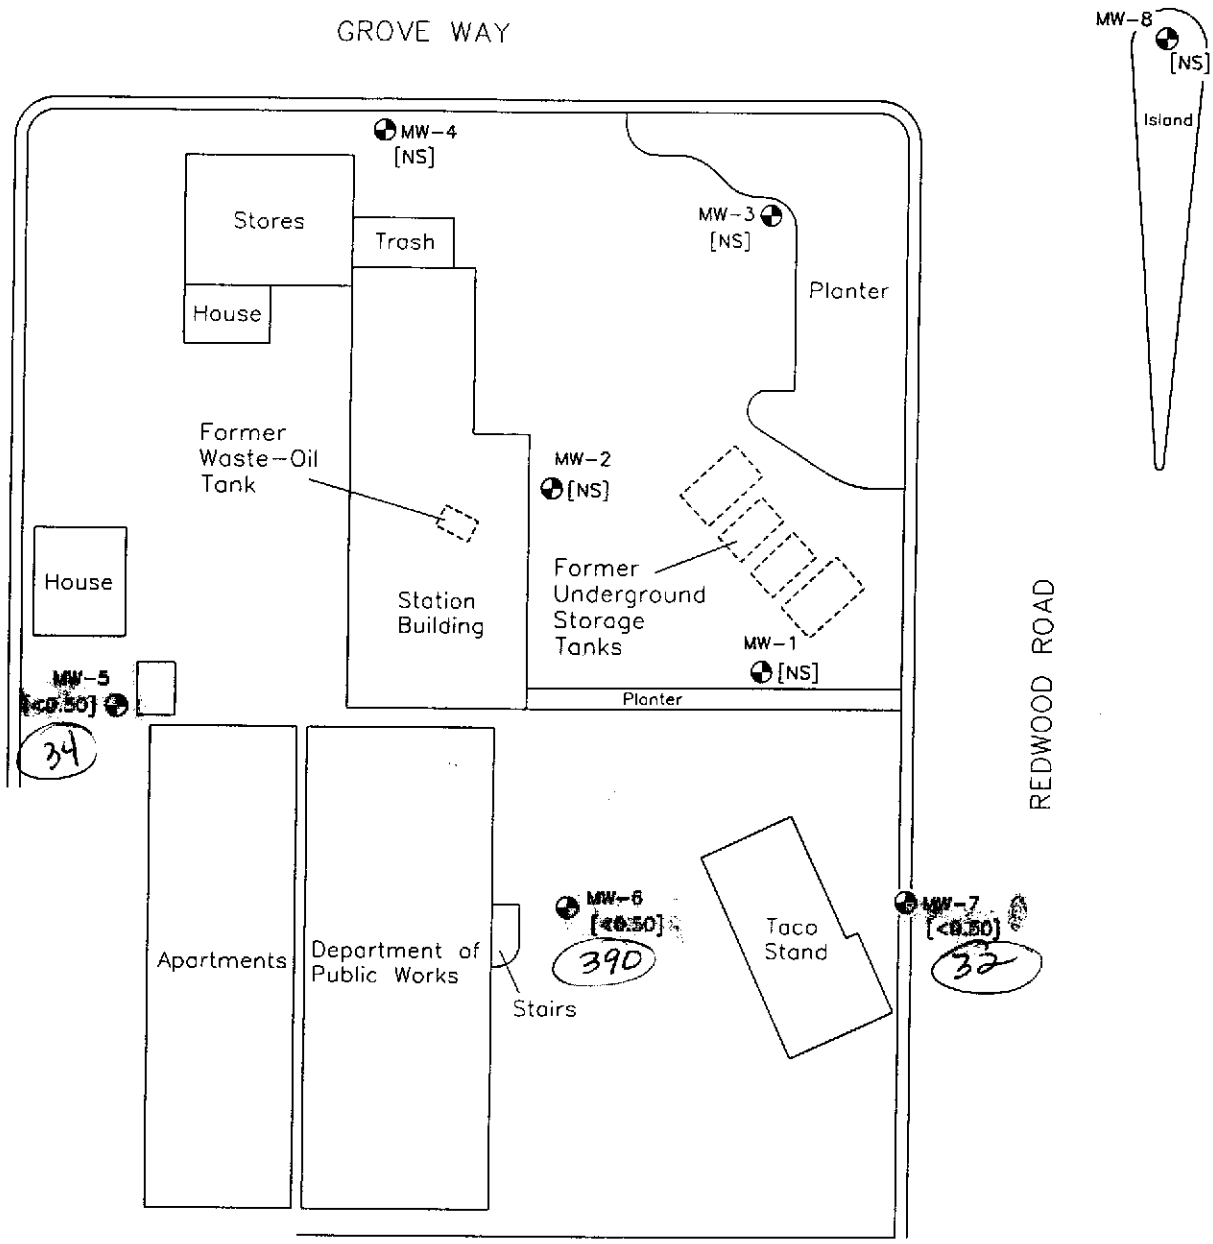
DISSOLVED BENZENE DISTRIBUTION MAP, DECEMBER 27, 1995	FIGURE 3
BEACON STATION #574 22315 REDWOOD ROAD CASTRO VALLEY, CALIFORNIA	PROJECT NUMBER: U065.01 DRAWN BY: D.A.
EL DORADO ENVIRONMENTAL, INC.	CHECKED BY: DwD

Analytical results collected since March 1992 are summarized in Table 2. Historical analytical data are contained in Attachment D. Figure 3 illustrates the inferred distribution of dissolved benzene in ground water based on the current data. The laboratory report and chain-of-custody form for the current sampling event are included in Attachment E. Benzene was not present at detectable concentrations in ground water samples collected from monitoring wells MW-5, MW-6, and MW-7.
