SUBJECT: FORMER BEACON STATION NO. 574, 22315 REDWOOD ROAD, CASTRO VALLEY, CALIFORNIA

ENVIRONMENTAL PROJECT QUARTERLY STATUS REPORT

Subject: **First Quarter 1997 Ground Water Monitoring Report**
Former Beacon Station #574
22315 Redwood Road, Castro Valley, California

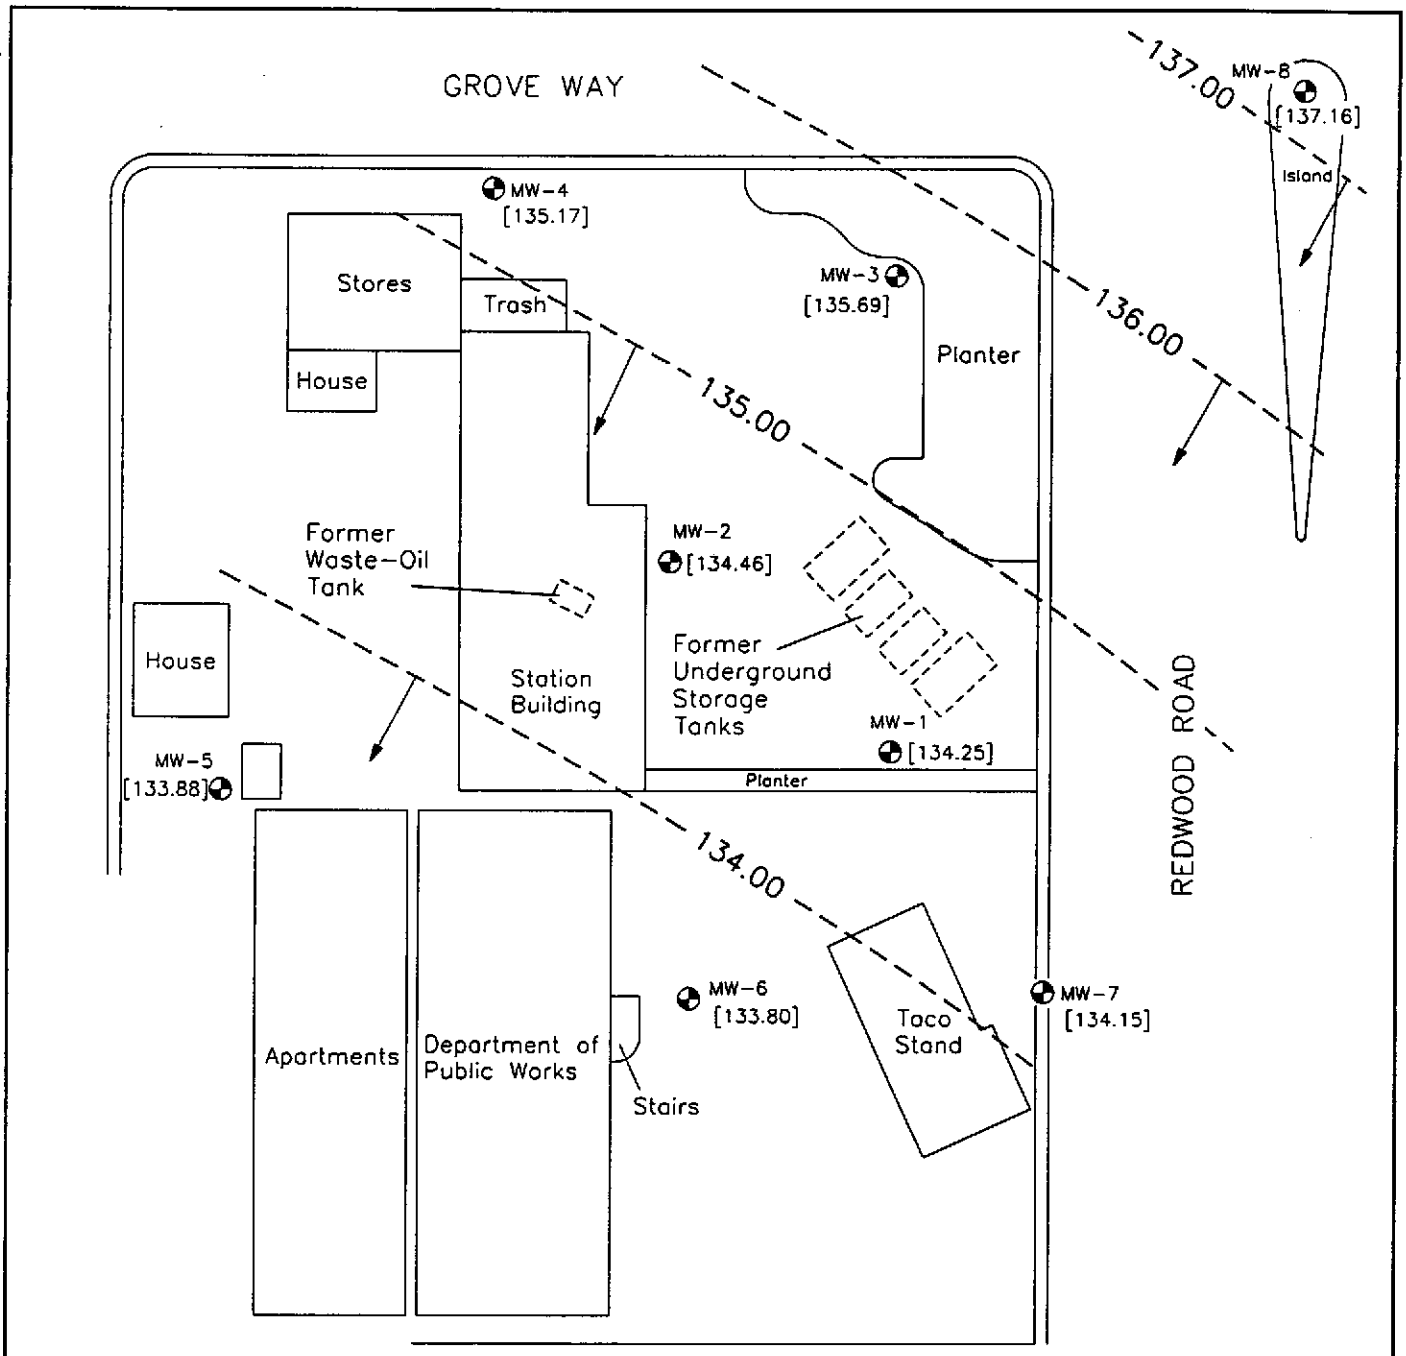
GROUND WATER CONTOUR MAP, MARCH 10, 1997	FIGURE 2
BEACON STATION #574 22315 REDWOOD ROAD CASTRO VALLEY, CALIFORNIA	PROJECT NUMBER: U065.01 DRAWN BY: D.A.
EL DORADO ENVIRONMENTAL, INC.	CHECKED BY: DvD

Prior to purging, Doulos collected depth to ground water measurements. Copies of Doulos' field data sheets are contained in Attachment B. Ground water elevation data collected since March 1992 are summarized in Table 1. Historical ground water elevation data are contained in Attachment C. On the basis of the current measurements, ground water flows toward the southwest (Figure 2) at a gradient of 0.01 foot per foot. Ground water elevations increased an average of 1.05 feet compared to the last monitoring event.

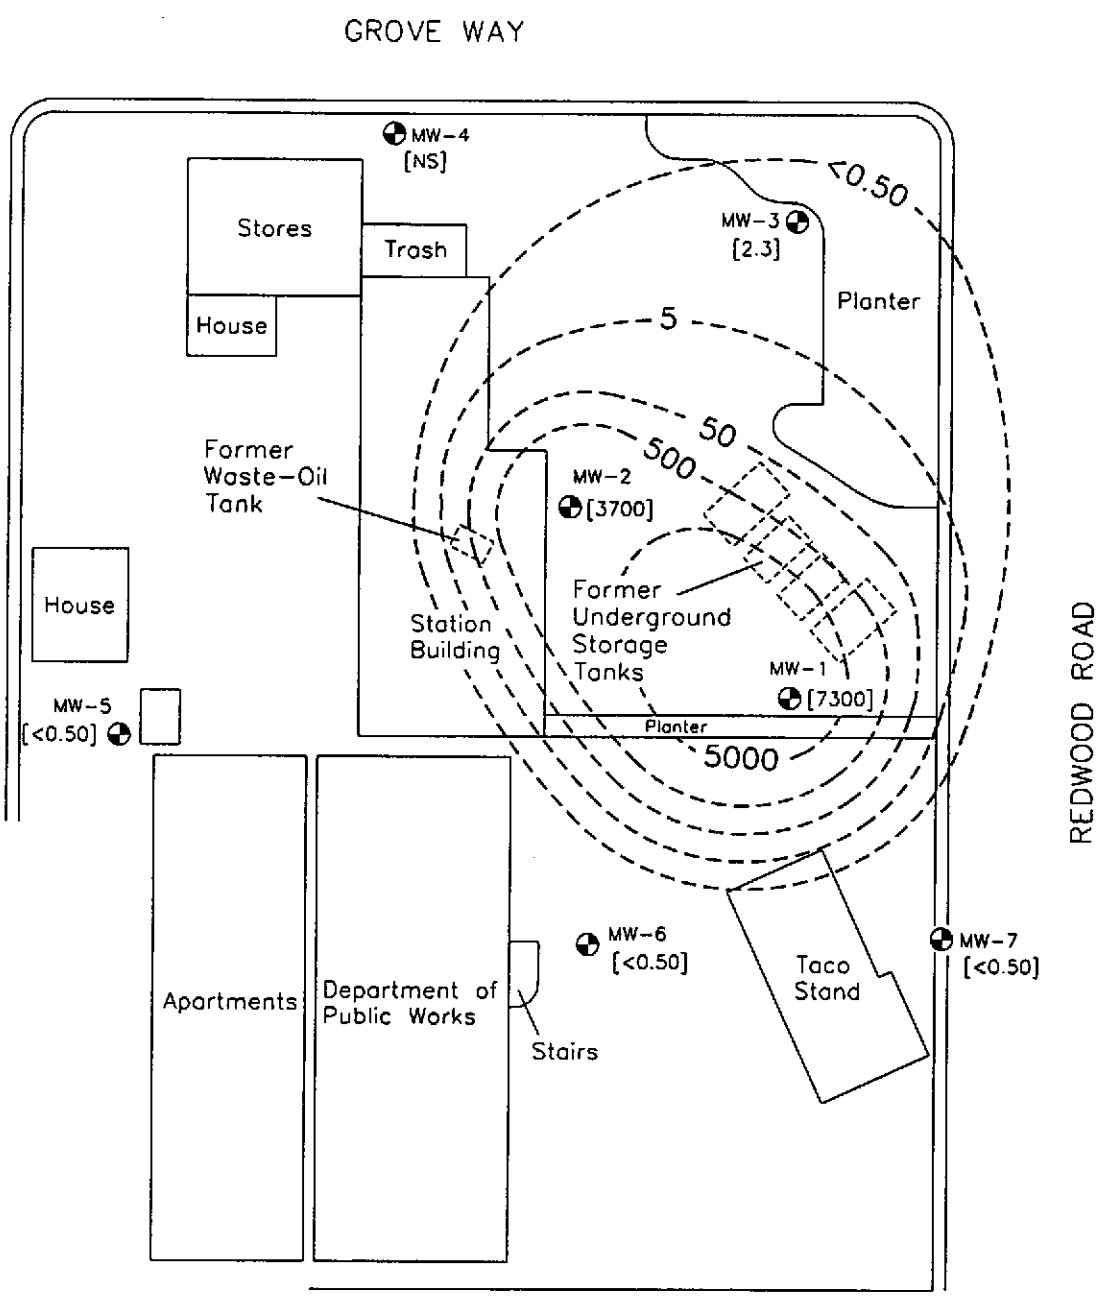
DISSOLVED BENZENE DISTRIBUTION MAP, MARCH 10, 1997	FIGURE 3
BEACON STATION #574 22315 REDWOOD ROAD CASTRO VALLEY, CALIFORNIA	PROJECT NUMBER: U065.01 DRAWN BY: D.A.
EL DORADO ENVIRONMENTAL, INC.	CHECKED BY: DVL

Analytical results collected since March 1992 are summarized in Table 2. Historical analytical data are contained in Attachment D. Figure 3 illustrates the inferred distribution of dissolved benzene in ground water based on the current data. The laboratory report and chain-of-custody form for the current sampling event are included in Attachment E. Benzene was not present at detectable concentrations in ground water samples collected from monitoring wells MW-5, MW-6, and MW-7. Benzene concentrations increased in samples collected from monitoring wells MW-1 and MW-2 and decreased in the sample collected from monitoring well MW-3.
