SUBJECT: BEACON STATION NO. 604, 1619 FIRST STREET, LIVERMORE, CALIFORNIA

ENVIRONMENTAL PROJECT QUARTERLY STATUS REPORT

Subject: Ground Water Monitoring Report, First Quarter 1994
Beacon Station #604--1619 West First Street, Livermore, California

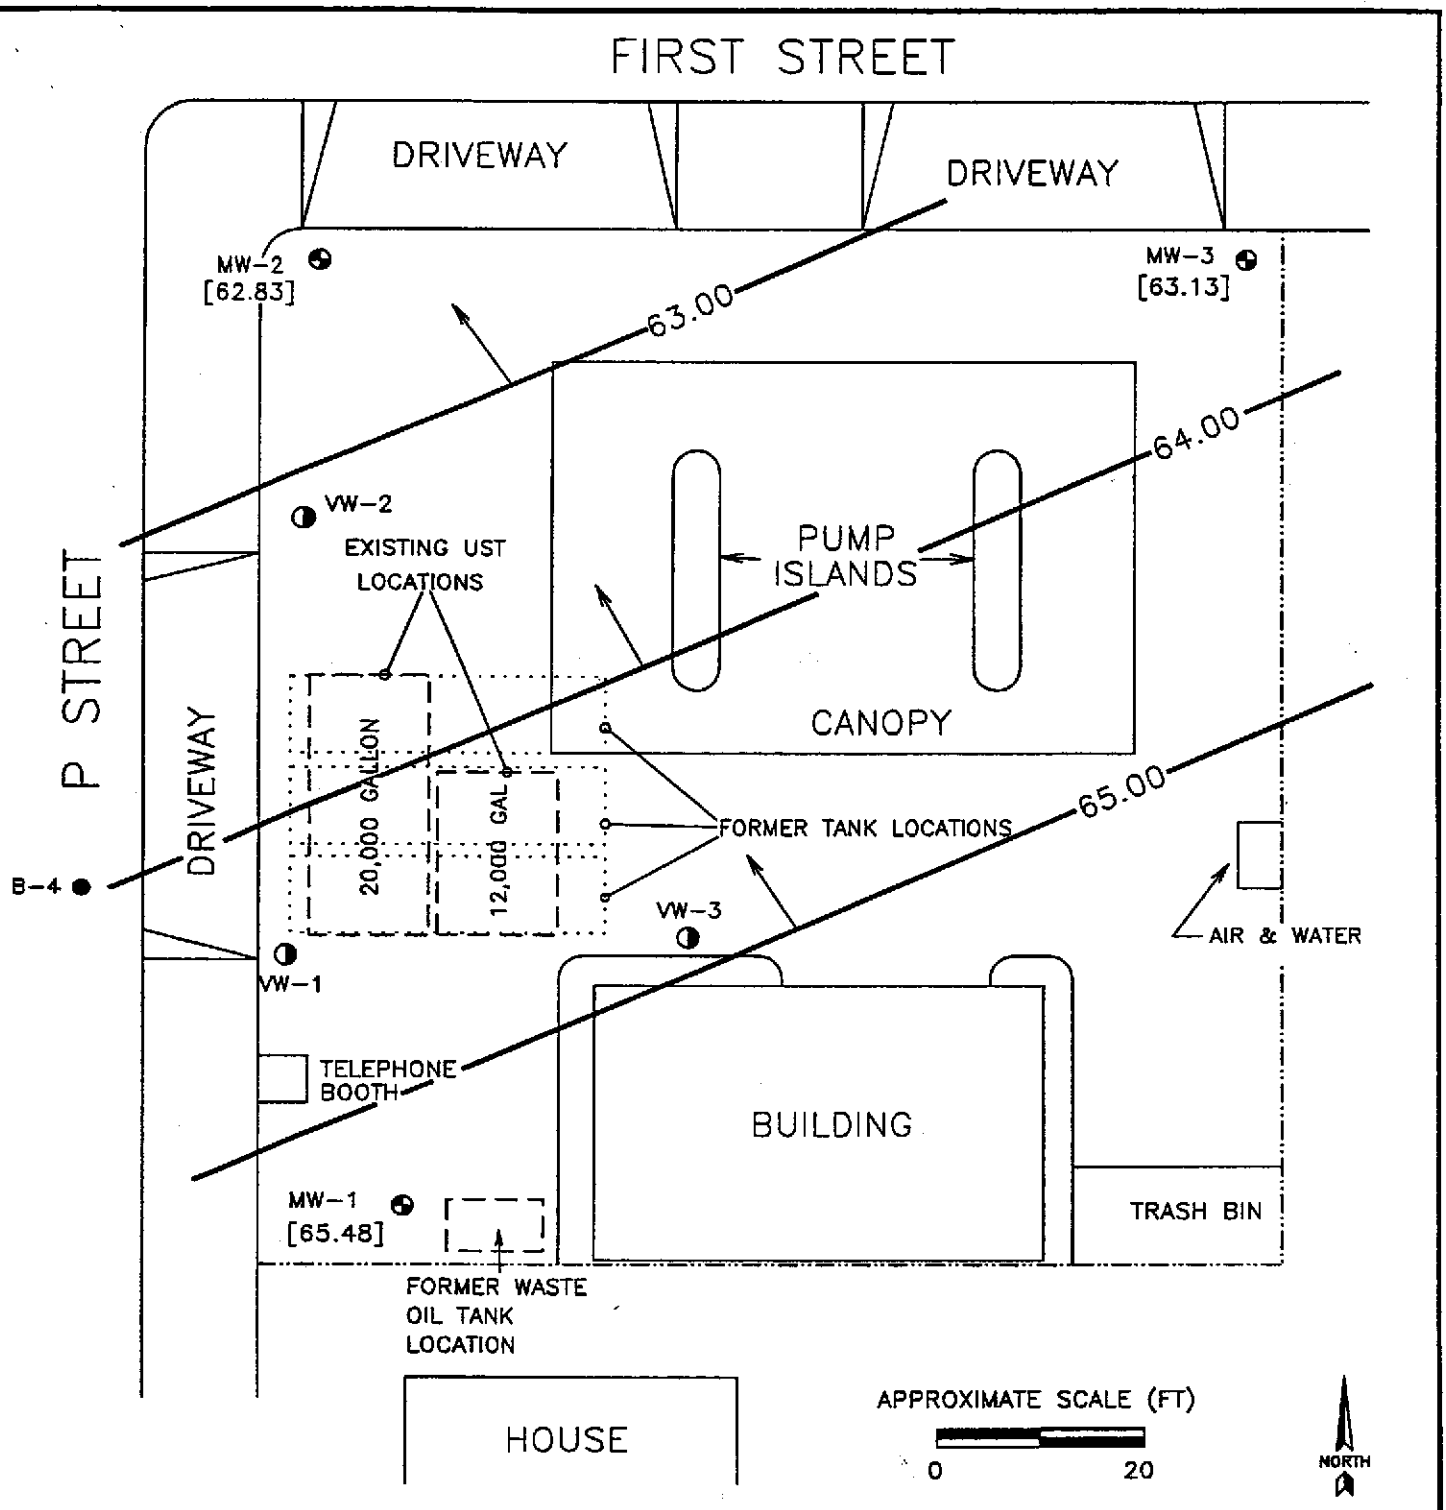
FIGURE 3
WATER TABLE CONTOUR MAP 01/13/94
BEACON STATION #604
1619 WEST FIRST STREET
LIVERMORE, CA

Depth to ground water was measured in monitoring wells MW-1 through MW-3. Depth to ground water ranged from 33.95 to 35.85 feet below top of casing. Ground water level measurements from this sampling event, as well as previous ground water depth measurements, are presented in Table 1. Ground water levels increased an average of approximately 7.6 feet between October 1993 and January 1994. The inferred direction of ground water flow was toward the northwest (Figure 3) which is consistent with previous monitoring events. Gradient was calculated to be approximately 0.03 foot per foot.

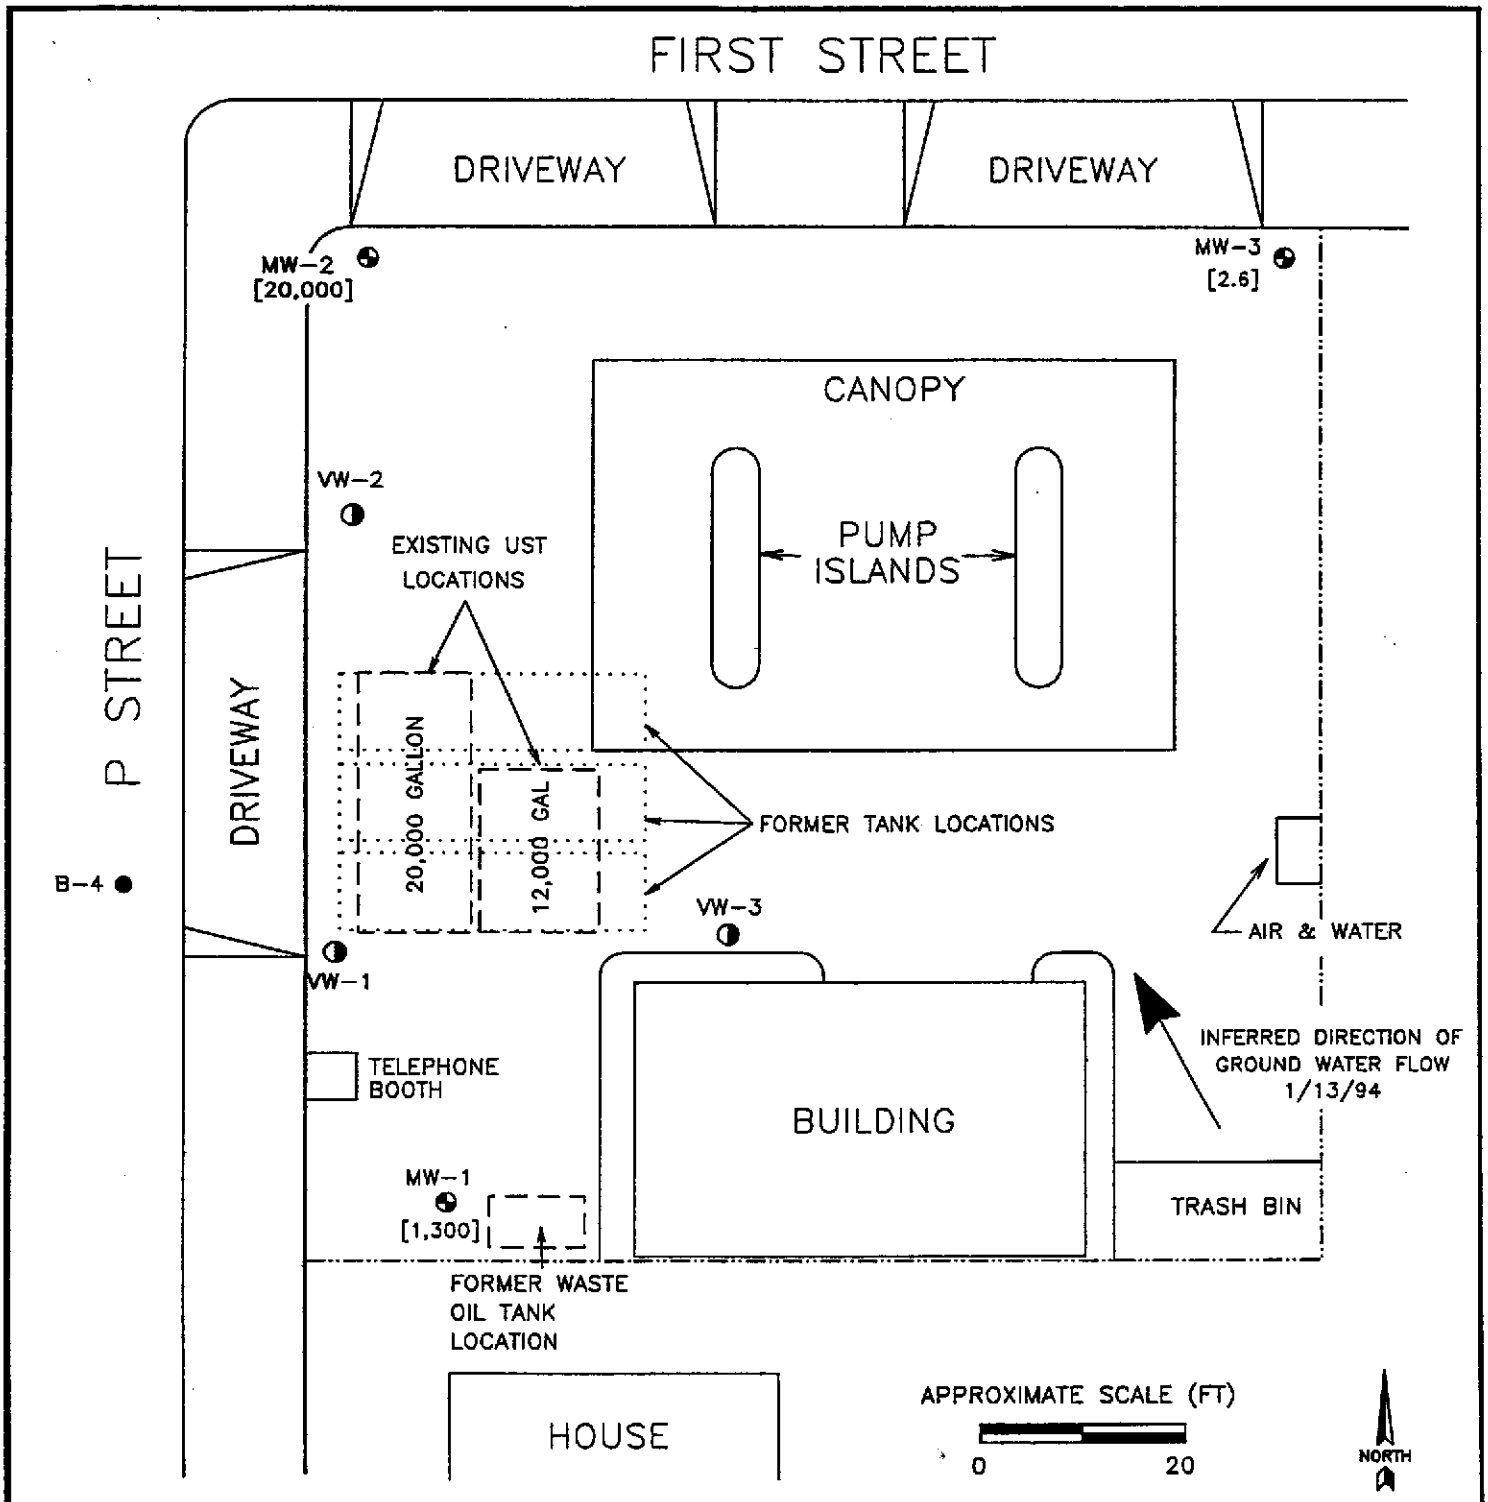
FIGURE 4
BENZENE CONCENTRATION MAP 01/13/94
BEACON STATION #604
1619 WEST FIRST STREET
LIVERMORE, CA

Benzene concentrations in ground water ranged from 20,000 µg/l in the sample collected from monitoring well MW-2 to 2.6 µg/l in a sample collected from monitoring well MW-3. Compared to previous monitoring events, benzene concentrations in water samples collected on January 13, 1994, decreased in monitoring wells MW-1 and MW-3 and increased slightly in MW-2. Benzene concentrations reported from the January 13, 1994, ground water sample analytical results are presented on Figure 4.
