QUARTERLY GROUNDWATER MONITORING REPORT

Third Quarter (July - September) 1995

1055 Eastshore Highway

ALLWEST PROJECT 94117.28

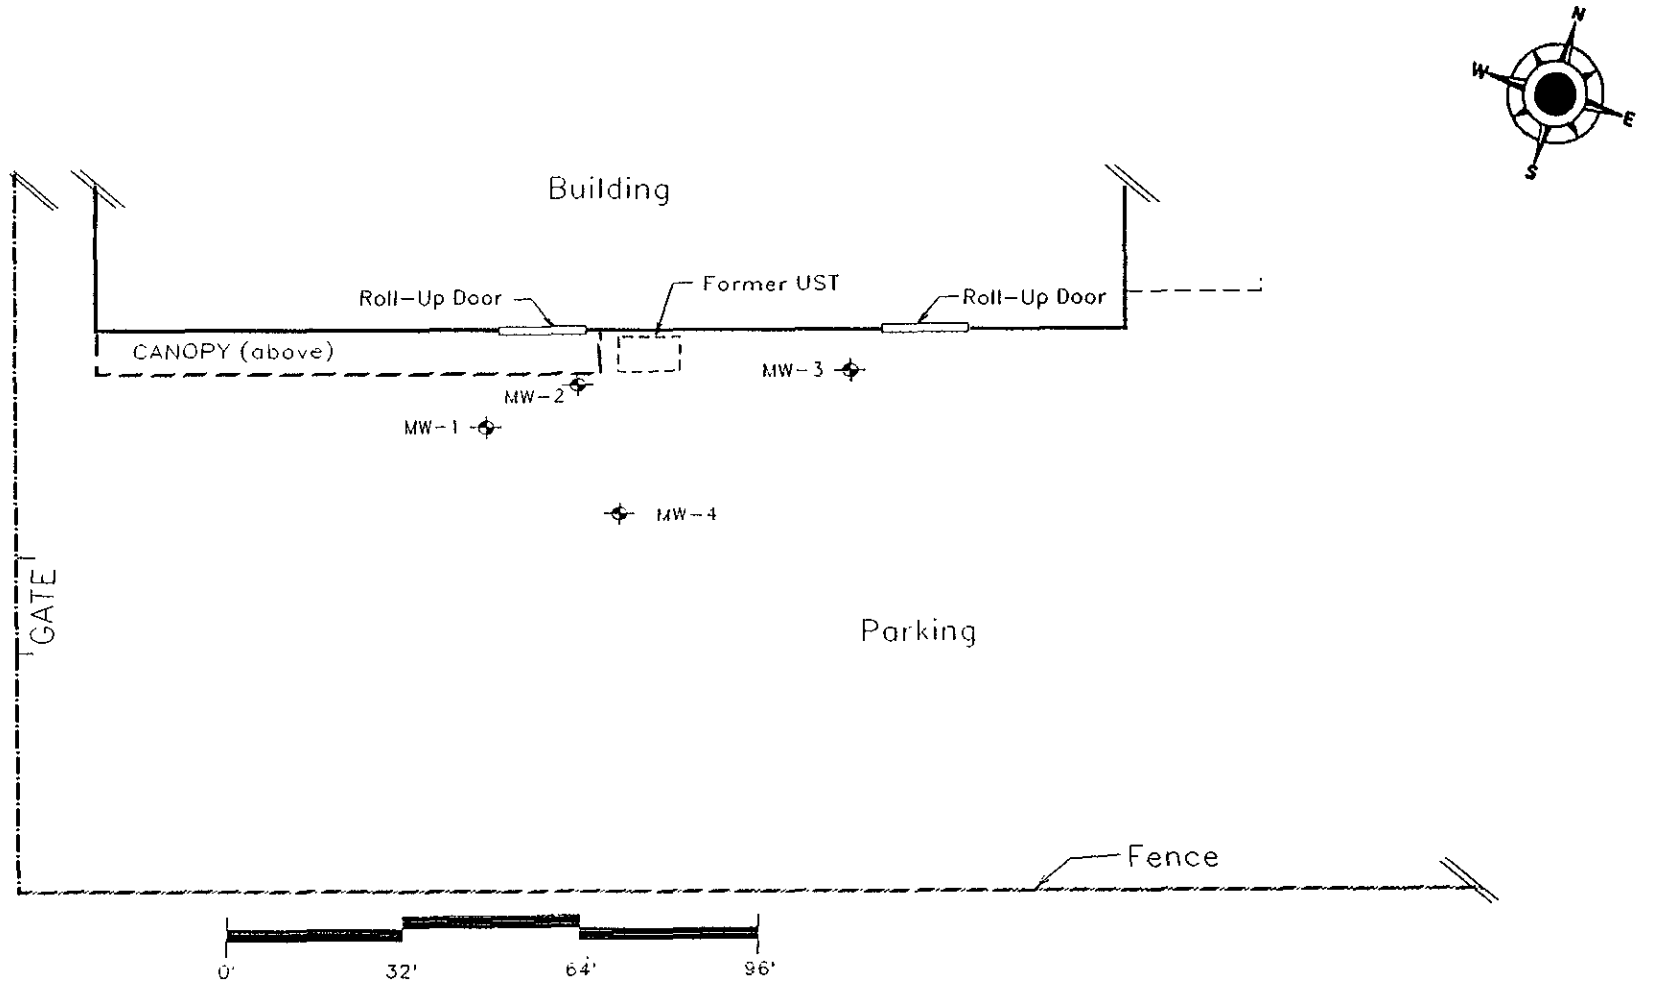
September 1995	**Generalized Site Plan**	Project No. 95117.28	Figure 3
1055 East Shore Highway, Albany, California			Source *AllWest*

A former underground storage tank (UST) containing gasoline was removed by *Resna Industries* on September 2, 1992. The former UST was located south of the building in the bus parking area (See figure 3).

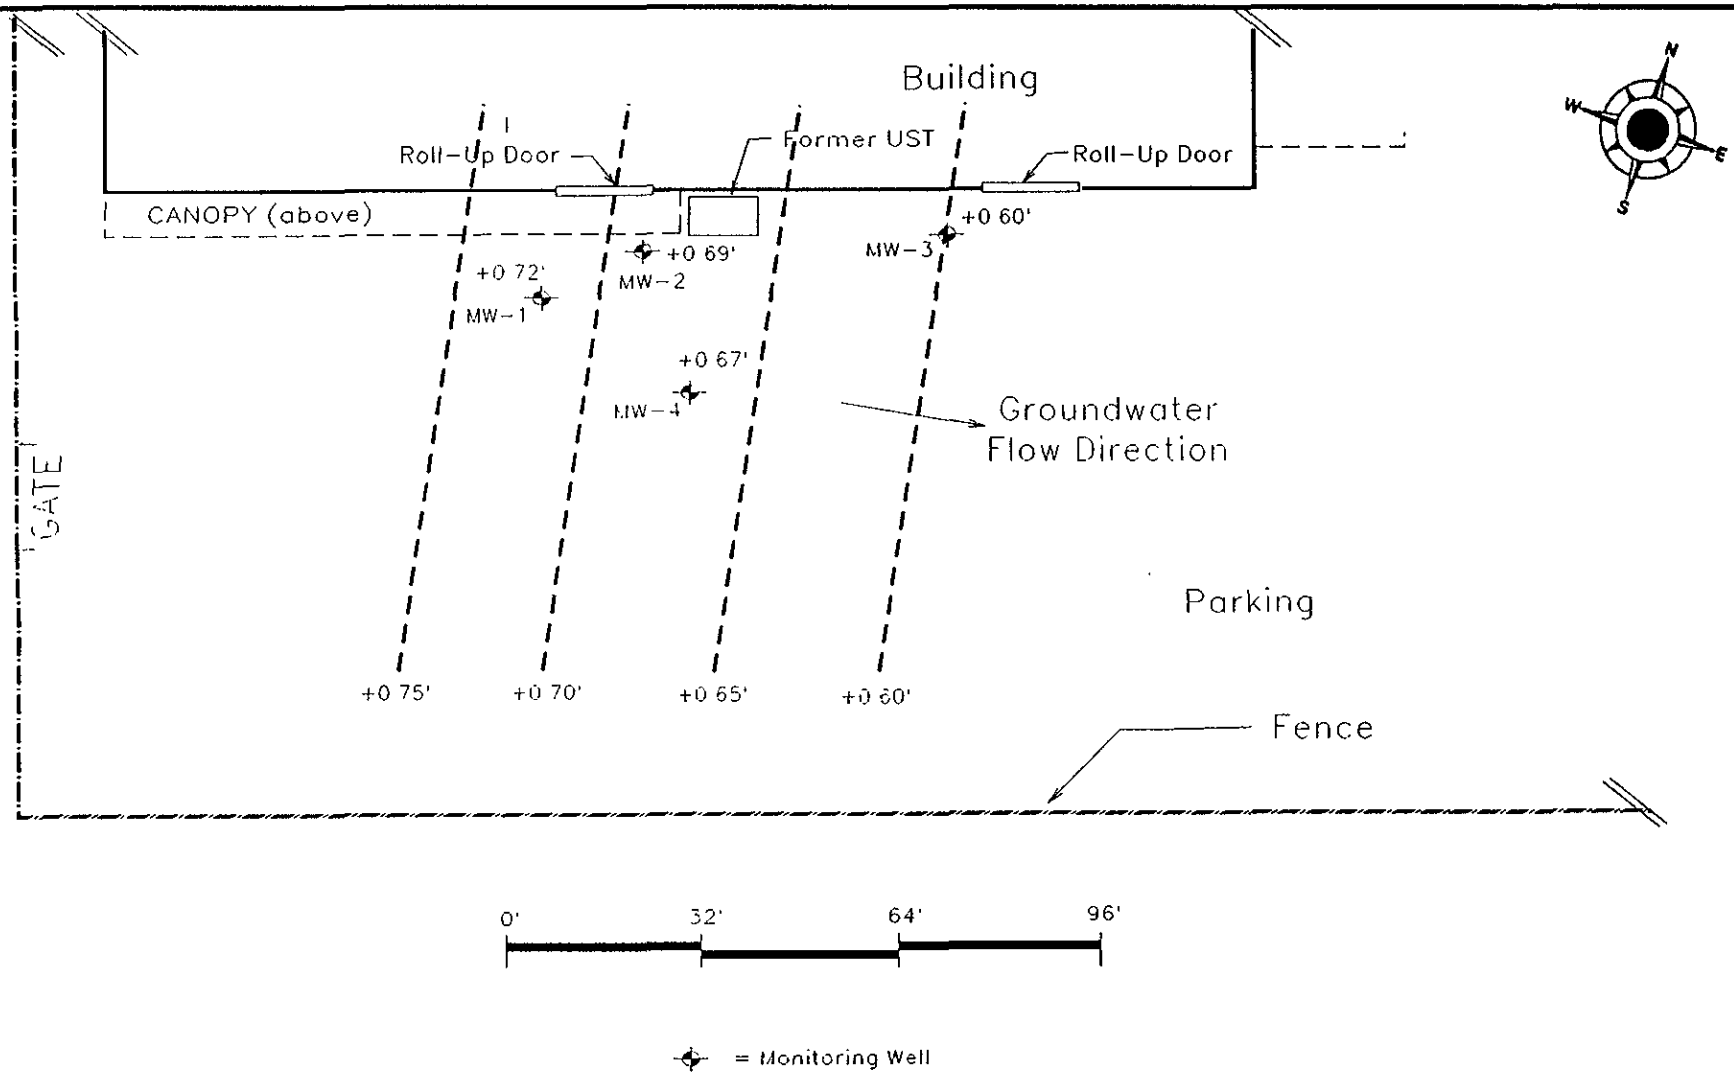
AllWest Environmental, Inc.	September 1995	**Groundwater Surface Contour Map**	**Project No. 95117.28**	**Figure 4**
	1055 East Shore Highway, Albany, California			**Source** *AllWest*

The groundwater levels in wells MW-1 through MW-4 measured during this and previous monitoring events are presented in Table 1, Accumulative Groundwater Level Measurements, in the TABLES section of this report. Groundwater flow direction during this monitoring event was calculated to be towards the east with an average gradient of 0.002 ft/ft.
