REPORT
QUARTERLY GROUNDWATER SAMPLING
SAMPLING PERIOD NO. 3
FIRE STATION NO. 1
7494 DONOHUE DRIVE
DUBLIN, CALIFORNIA

MAR 1991

March 29, 1991 OUR JOB P90103

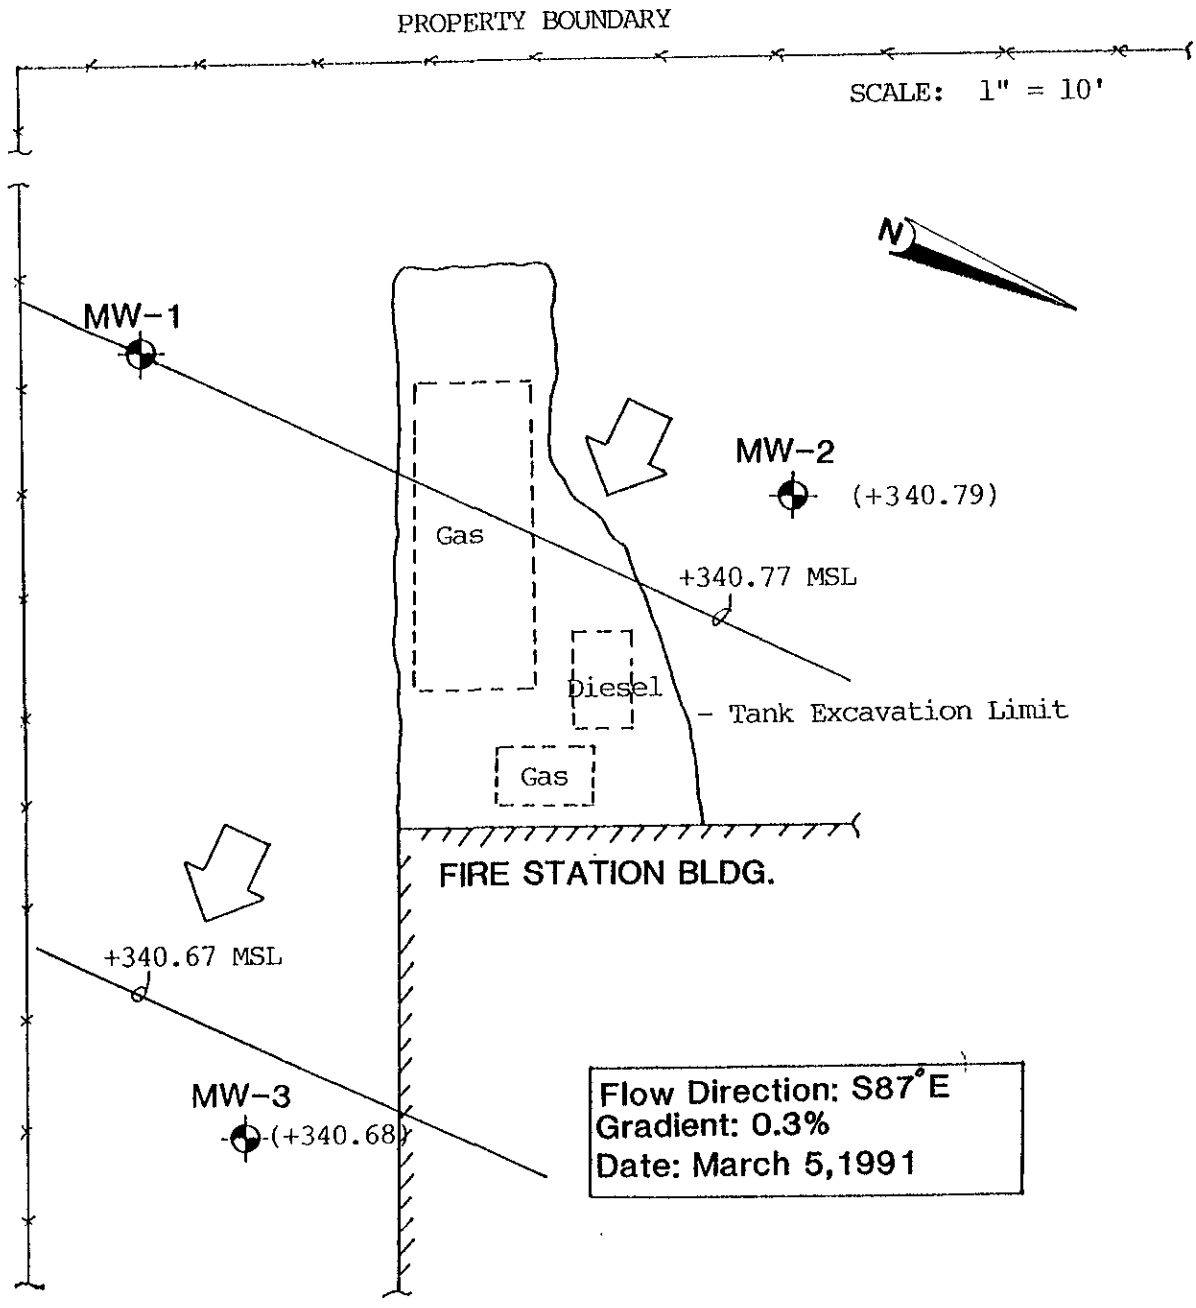
Job No. P90103
March 1991
FIGURE: 5

As stated previously, groundwater levels were measured prior to sampling on March 5, 1991. Groundwater was found to be at a depth of approximately 10 to 11 feet below grade. Precise groundwater measurements with respect to individual well-head elevations enabled a derivation of shallow groundwater flow direction and gradient. As shown on Figure 5, Groundwater Flow Direction And Gradient, flow direction was measured to be S87°E with a gradient of 0.3 percent. In comparison to the direction and gradient measured in November of 1990, flow has rotated to the south by approximately 18 degrees. Gradient has lessened one-tenth of a percent. Depth to groundwater from the tops of the well casings has decreased 1.56 to 1.62 feet. The precise reason for flow direction change is unknown, but may be attibuted to seasonal fluctuations in groundwater level and flow direction, or in response to a man-made alteration of the flow regime.
