PIERS
Environmental Services, Inc.

October 3, 2003

RE: **Report of Additional Phase II Investigation**
2942 San Pablo Avenue
Oakland, CA

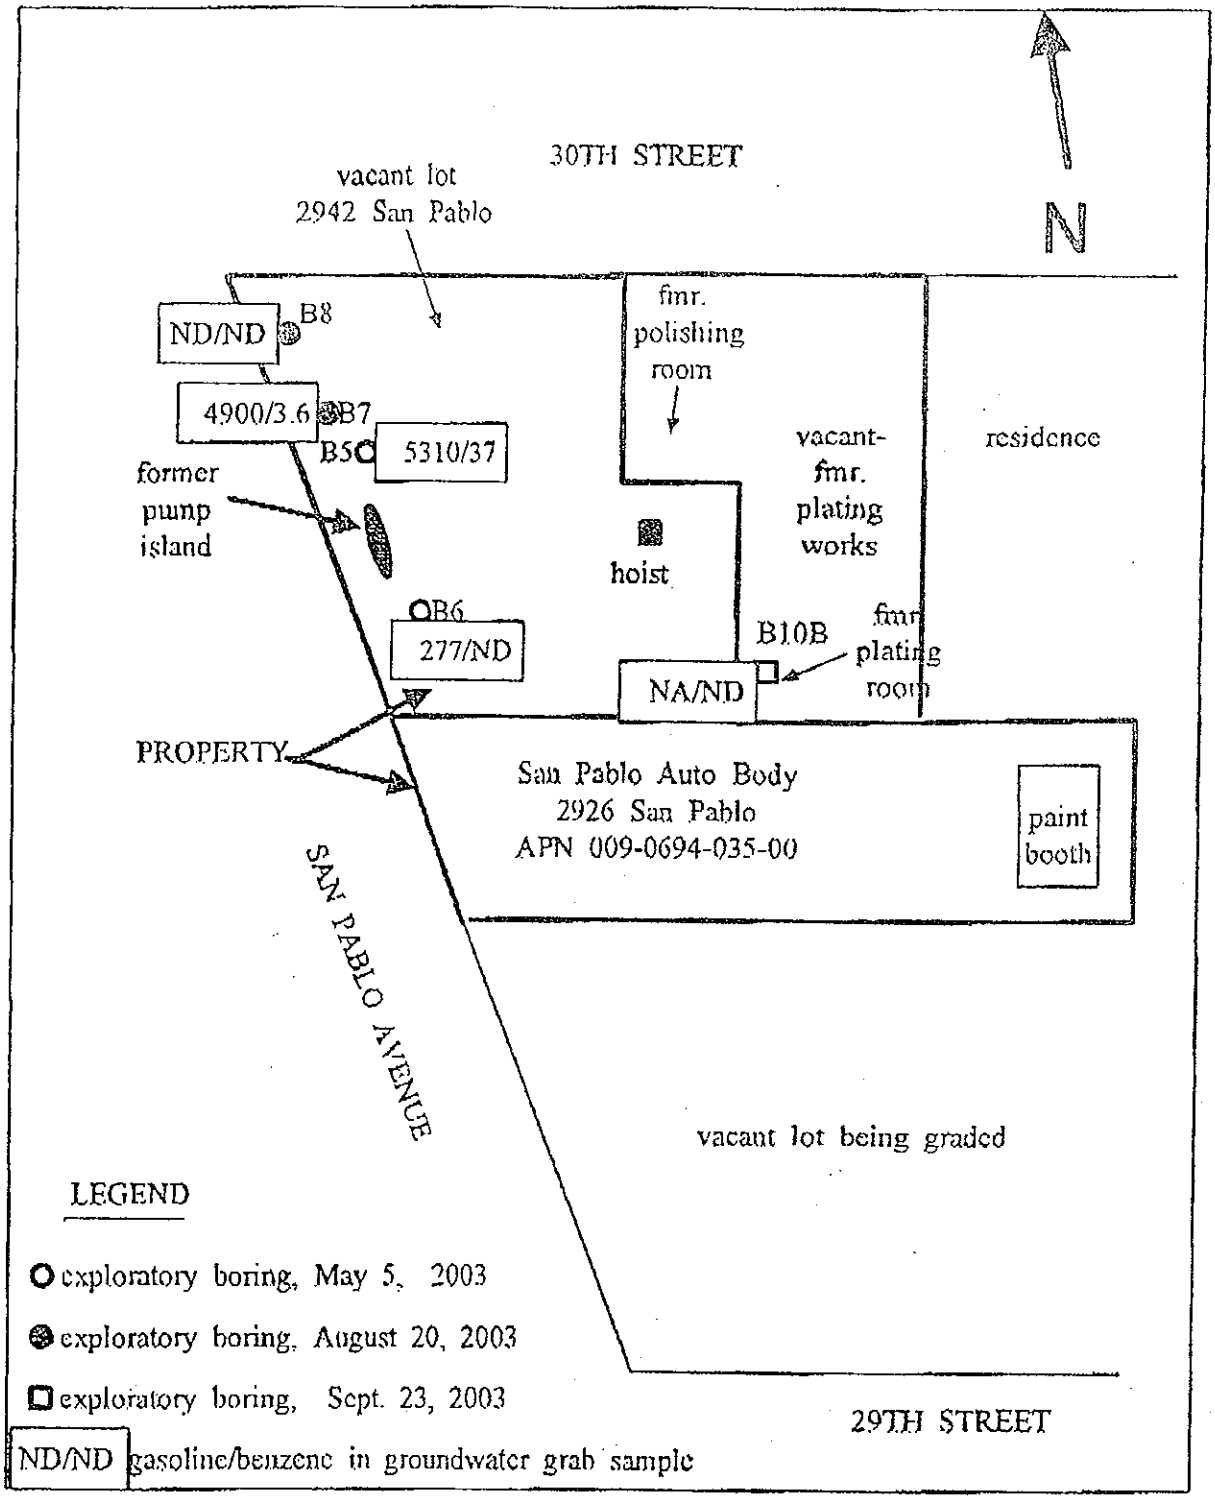
FIGURE 3

The analytical results of the grab groundwater samples collected during this and the previous investigations are summarized on Tables 2A and 2B, and on Figures 3 and 4. The concentrations of hydrocarbons in groundwater now appear to be largely defined to the north and south, and undefined in the presumed downgradient direction. Samples from monitoring wells more representative of groundwater flow conditions would be expected to be an order of magnitude less than those encountered in the grab groundwater sampling. Further delineation downgradient would require drilling within San Pablo Avenue.

DISSOLVED HYDROCARBONS IN GROUNDWATER

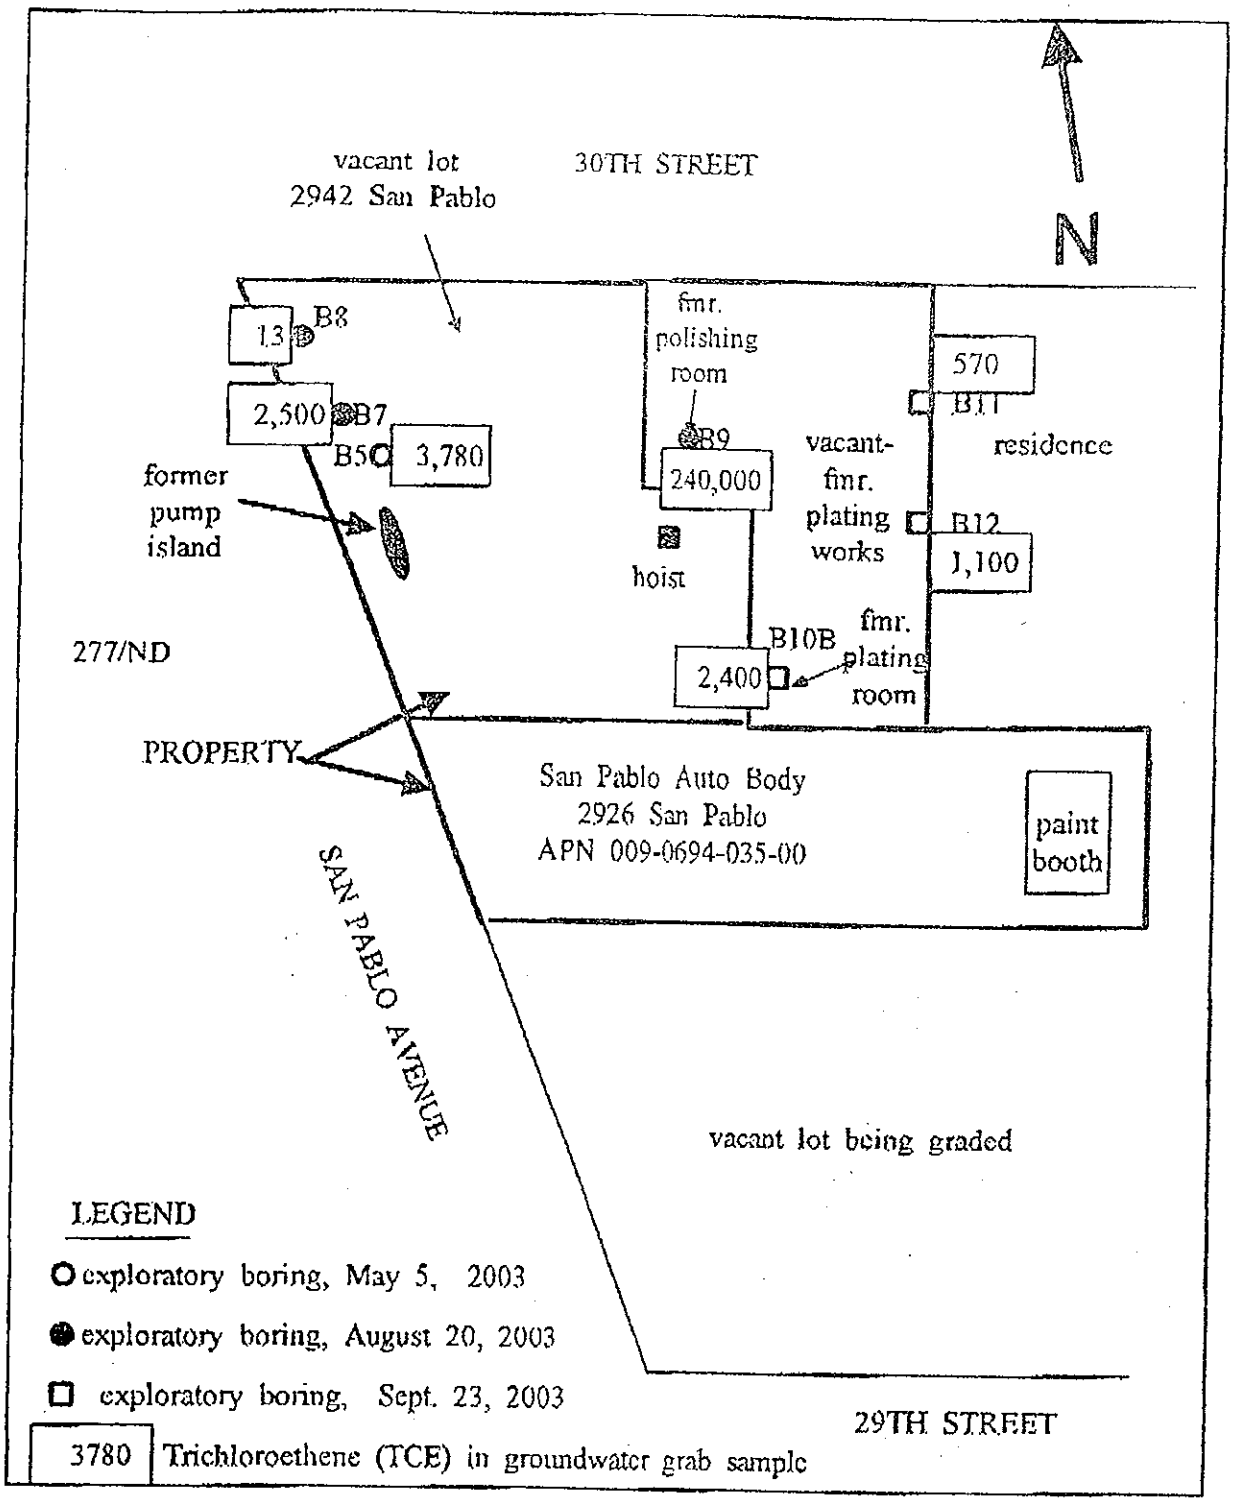
FIGURE 4
TCE IN GROUNDWATER

TCE was detected in groundwater in all grab groundwater samples collected to date where it was analyzed, at elevated concentrations above the PRGs. The compounds 1,2-dichloroethane and cis-1,2-dichloroethene were also detected above the PRGs in B5, and presumably would have been detected above the PRGs in other samples, where they were non-detectable due to dilution factors. During this investigation, cis-1,2-dichloroethene was detected in Boring B10B at a concentration of 1,000 ppb. The analytical results collected to date indicate a source of TCE near B9. The vertical extent of TCE in groundwater, and the extent in soil, is undefined.
