Subject: **Submittal Acknowledgement Statement**
Interim Vapor Intrusion Mitigation Plan Implementation, Revision 1
10700 MacArthur Blvd., Oakland, California
AEI Project # 365948
Toxics Case No. RO0002580

Re: Interim Vapor Intrusion Mitigation Plan Implementation, Revision 1
Former Young's Cleaners
10700 MacArthur Boulevard, Oakland, California
AEI Project No. 261829
Toxics Case No RO0002580

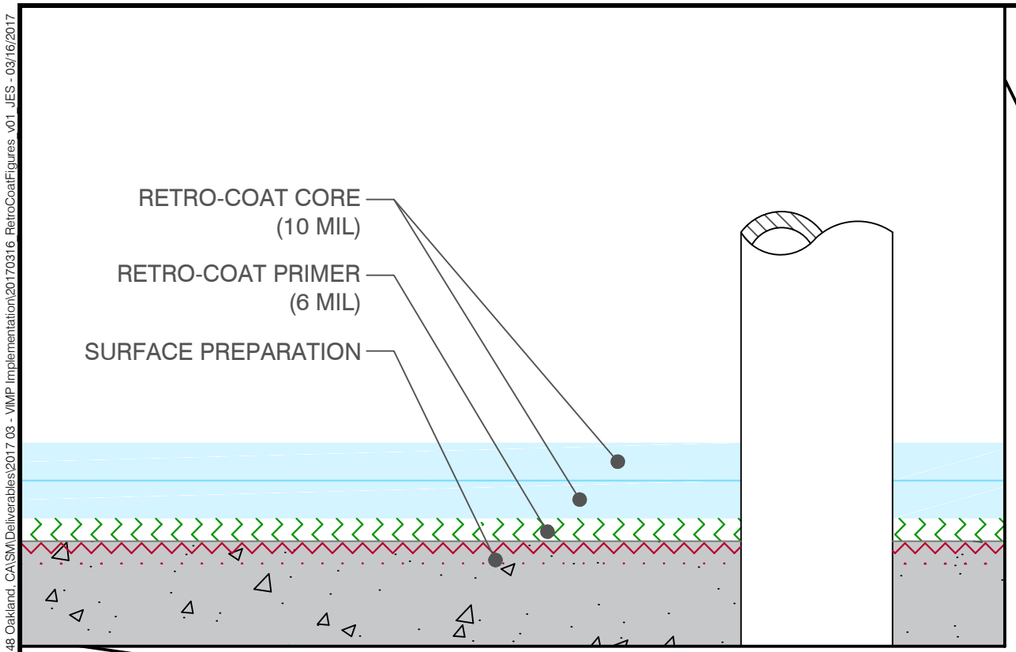
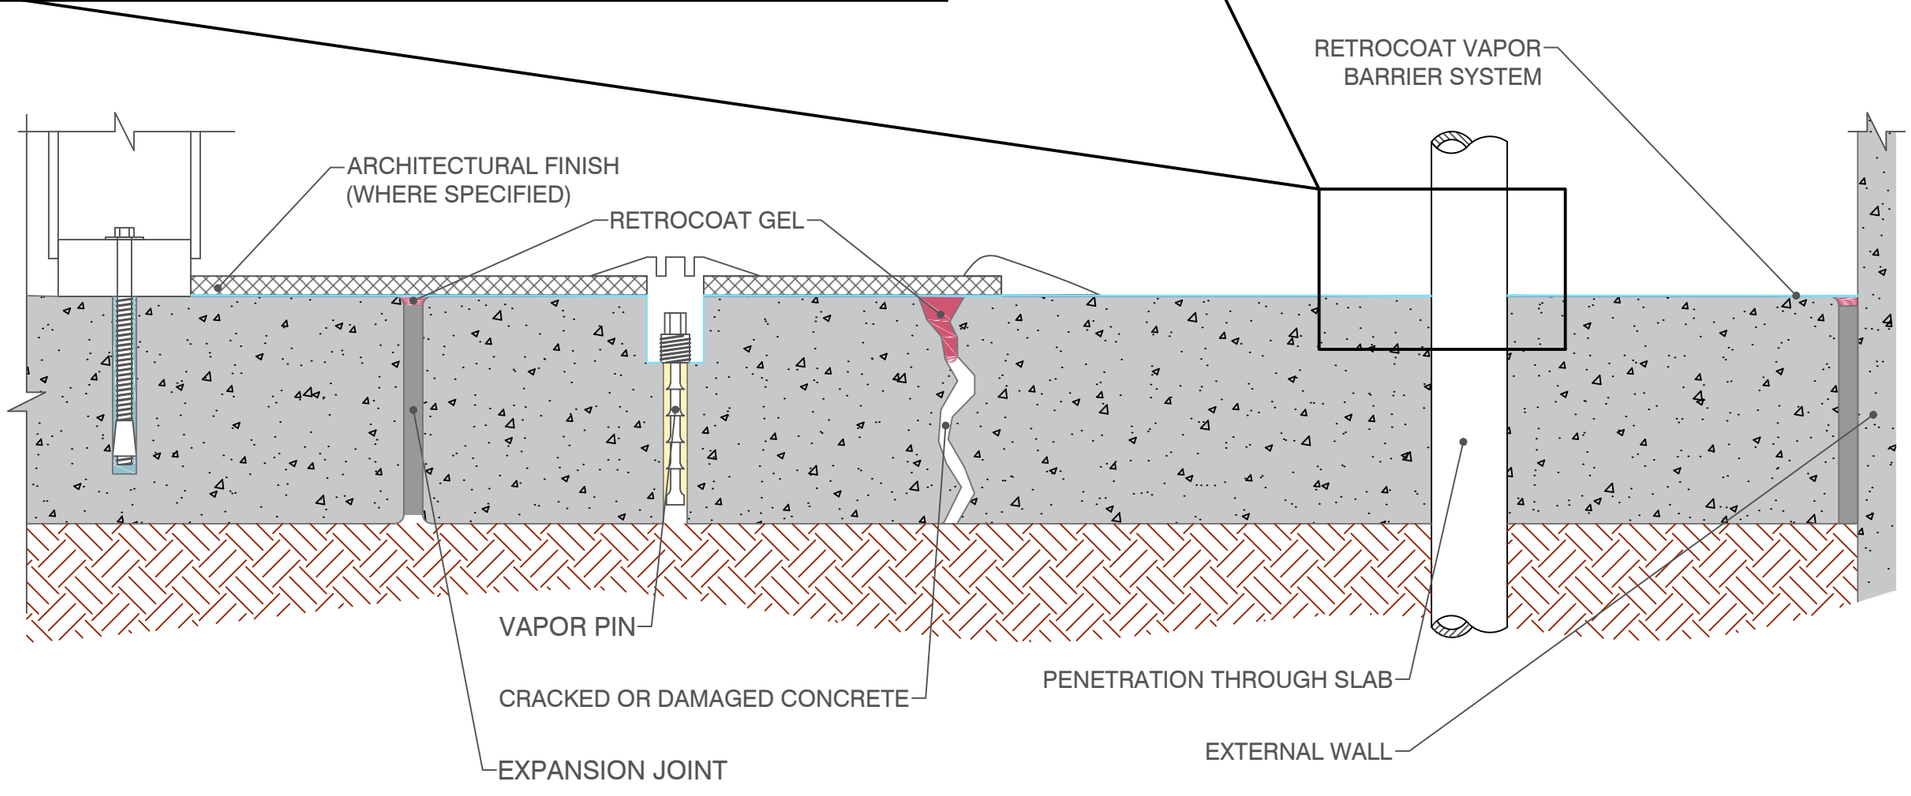
FIGURE 3
Project No. 261829

was contracted by MacArthur Boulevard and Associates to install the vapor barrier system as described in the VIMP. The extents of the installed vapor intrusion mitigation barrier are depicted in Figure 3. Installation details are depicted in Figure 4. Photo documentation of the installation procedures are included as Appendix A.

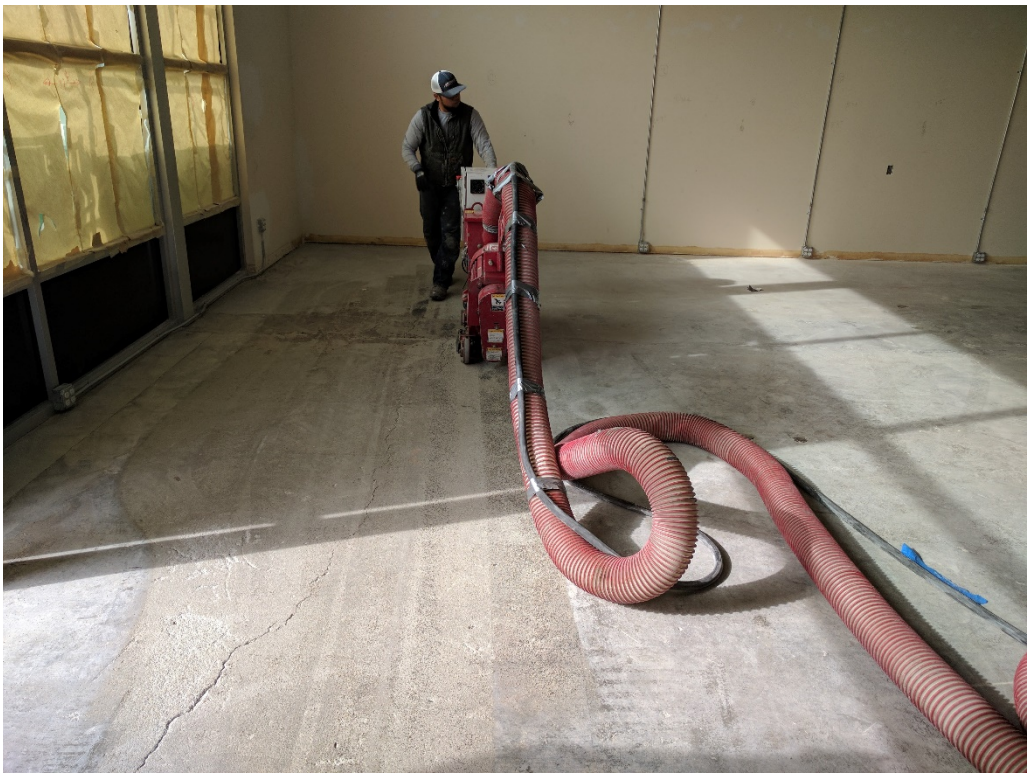
7. Surface preparations of Shoe Palace tenant space sales floor using shot blaster (03/10/2017)

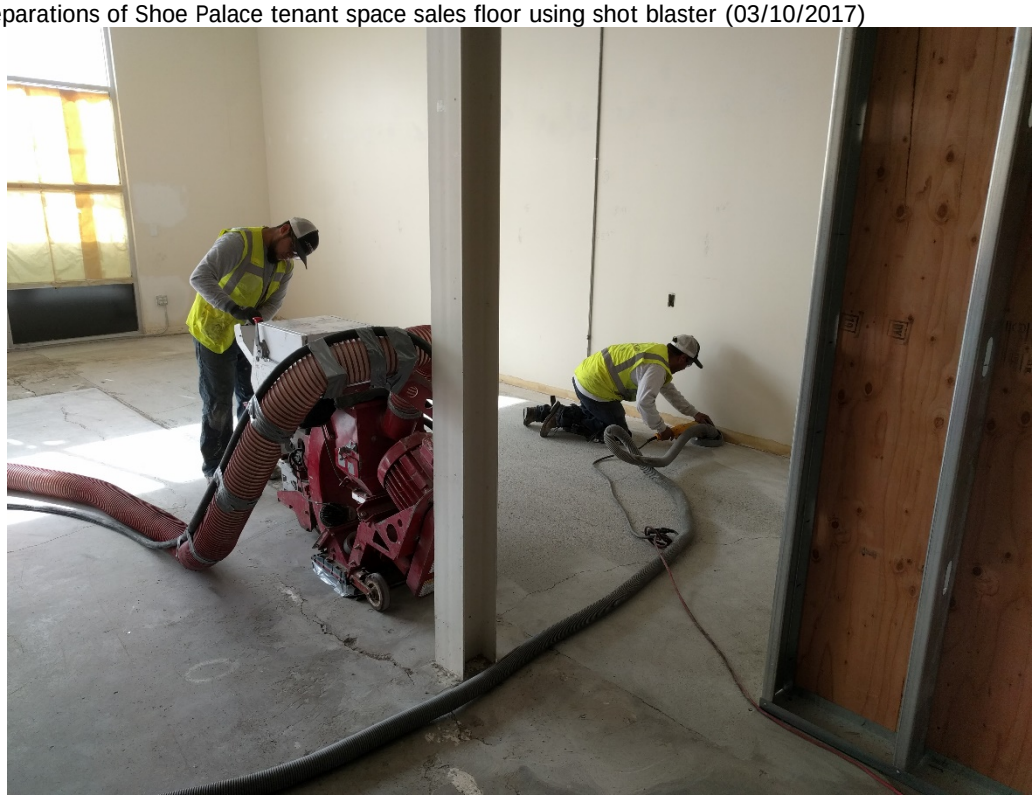
8. Surface preparations of Shoe Palace tenant space sales floor using shot blaster and grinder (03/10/2017)

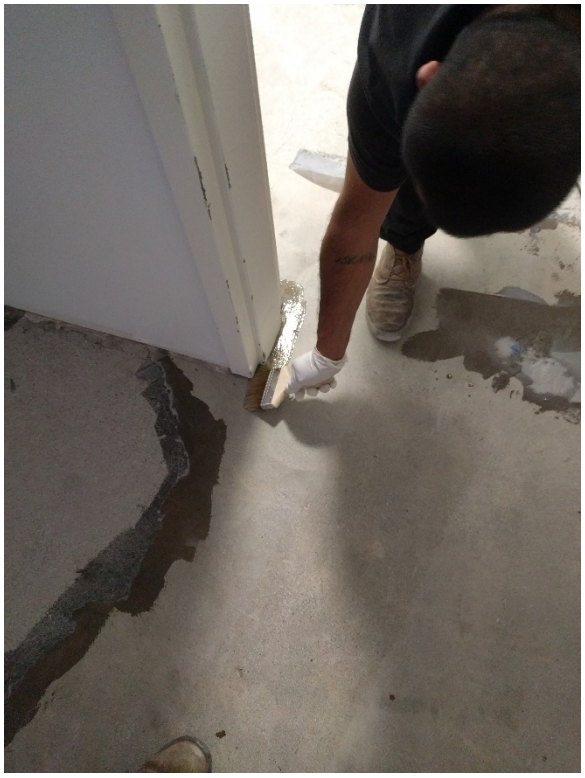
40. Representative application of Retro-coat Primer around vertical terminations using brush (03/11/2017)

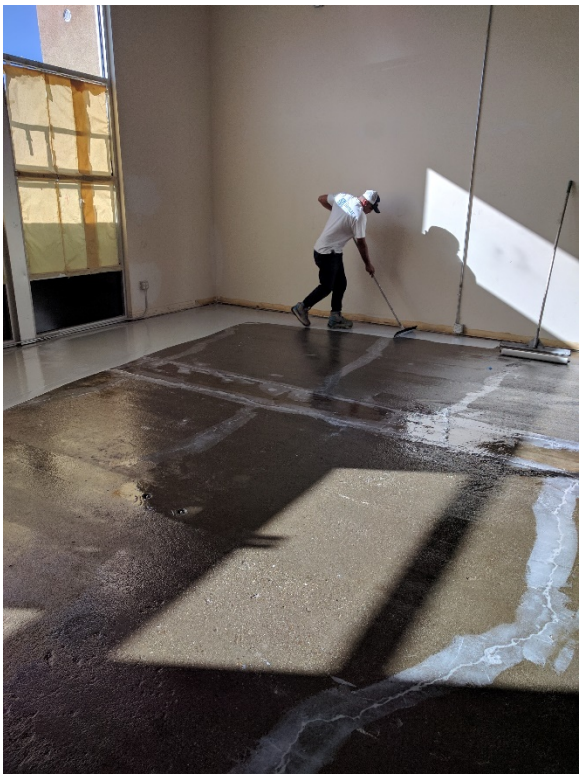
59. Representative squeegee application of Retro-coat Core layer 1 (03/12/2017)

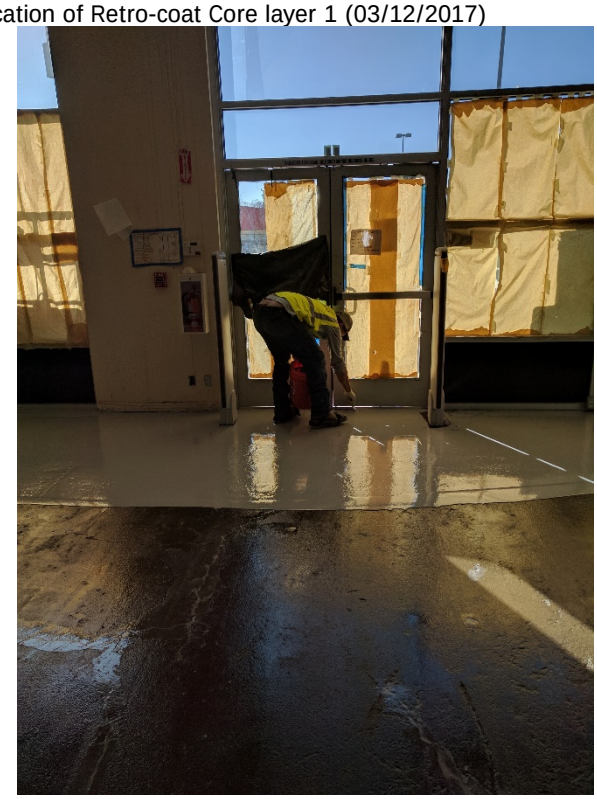
60. Representative detailing of Retro-coat Core layer 1 using a brush (03/12/2017)

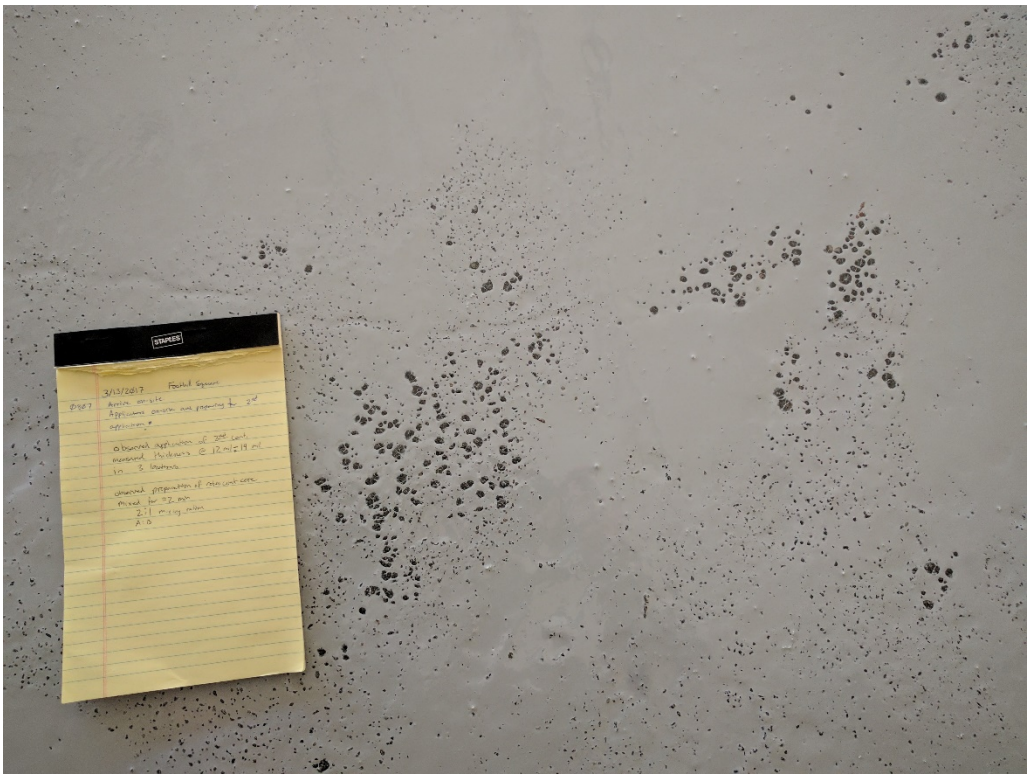
- In areas that were previously identified as having significant primer adsorption, the Retro-Coat™ Core percolated through the concrete resulting in areas of

exposed aggregates as depicted in photographs 78 and 79. AEI noted these deficiencies and requested that the second layer of Retro-Coat™ Core be applied to a thickness of 15-mil in these areas.

79. Representative exposed concrete aggregate in cured Retro-coat Core layer 1 (03/13/2017)

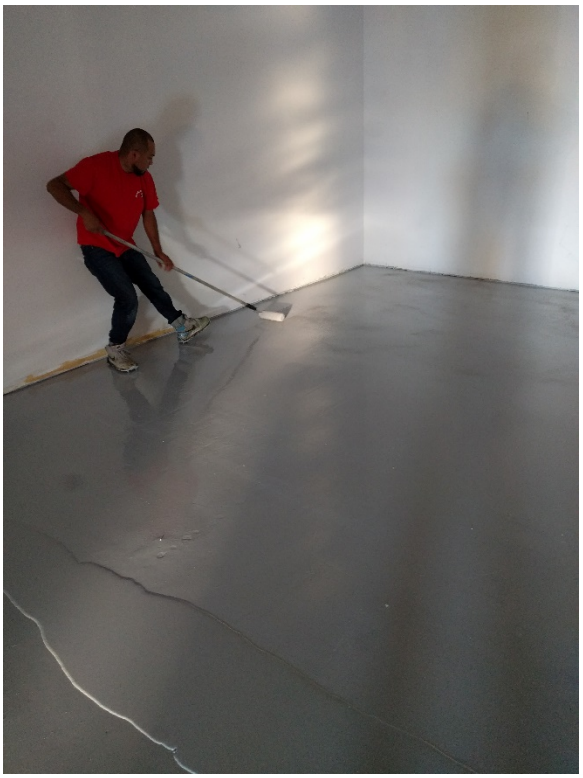
87. Backrolling post addition of sand aggregate to Retro-coat Core layer 2 (03/13/2017)

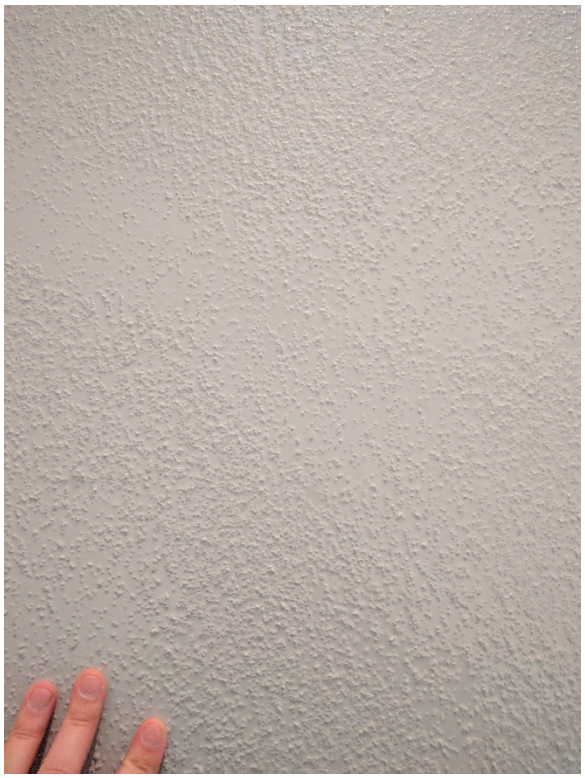
98. Representative aggregate suspended in cured and finished Retro-coat Core layer 2 (03/14/2017)
