SOIL GAS SURVEY

751 - 785 SEVENTH STREET
Oakland, California

USEPA Brownfield Assessment Grant
2B-00T18101-0
Alameda County Case No. RO0002586

BASELINE Environmental Consulting
5900 Hollis Street, Suite D • Emeryville • California 94608
(510) 420-8686

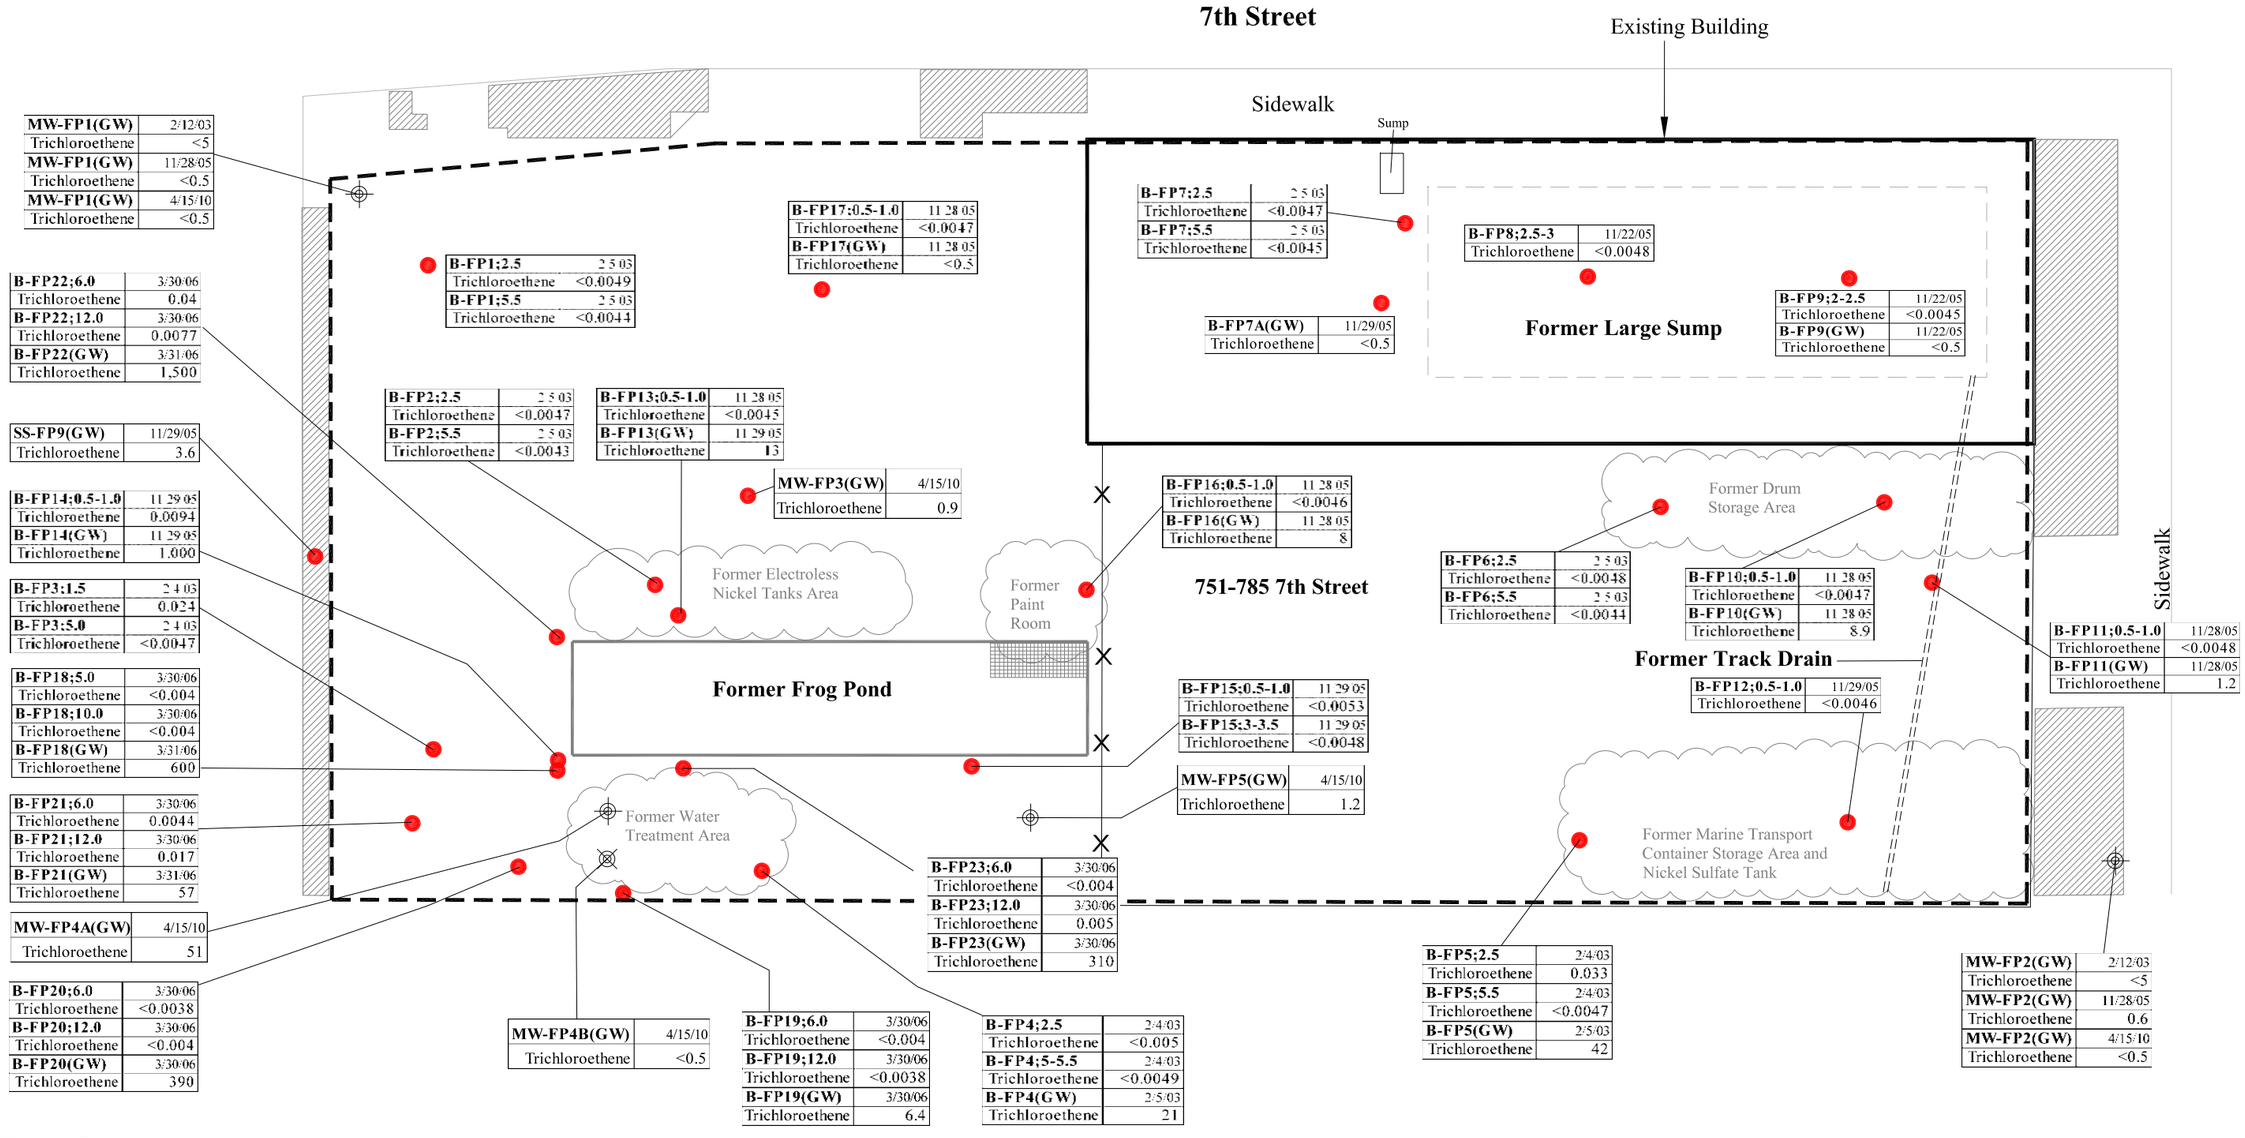
Figure 4

TRICHLOROETHENE CONCENTRATIONS IN SOIL AND GROUNDWATER SAMPLES

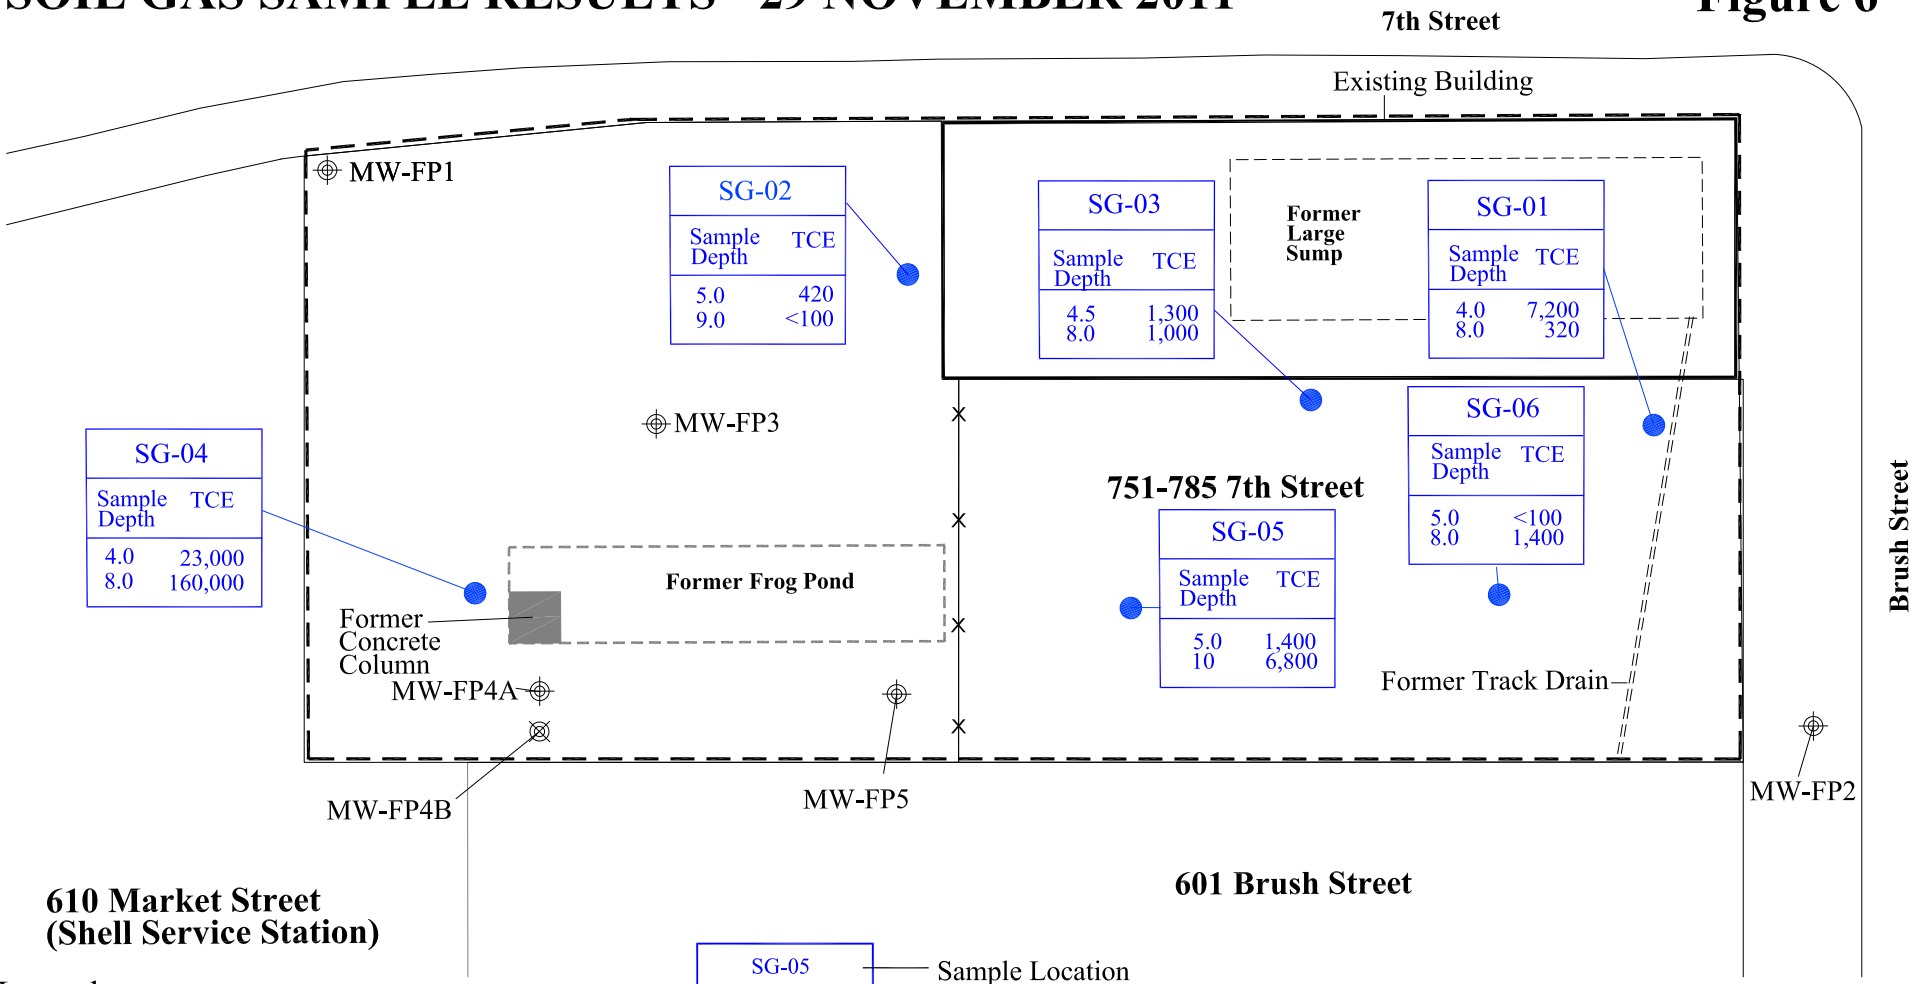
Figure 6

SOIL GAS SAMPLE RESULTS - 29 NOVEMBER 2011

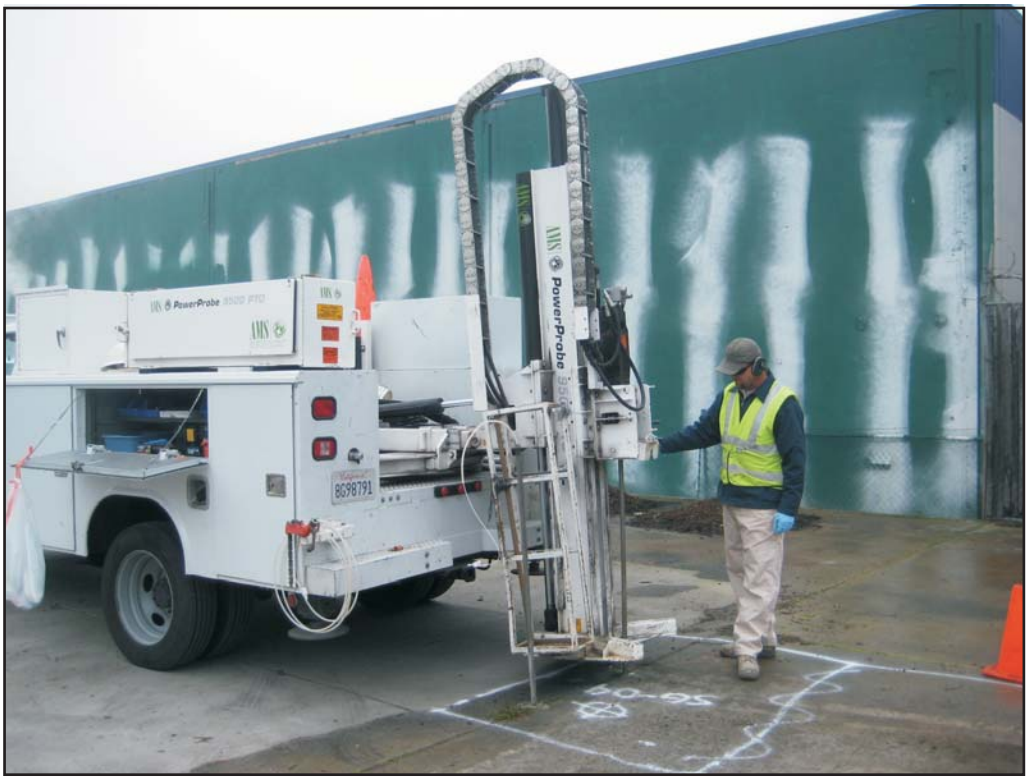
Photograph 3: TEG inserting tubing into vapor probe advanced at SG-04 to 5 feet bgs.

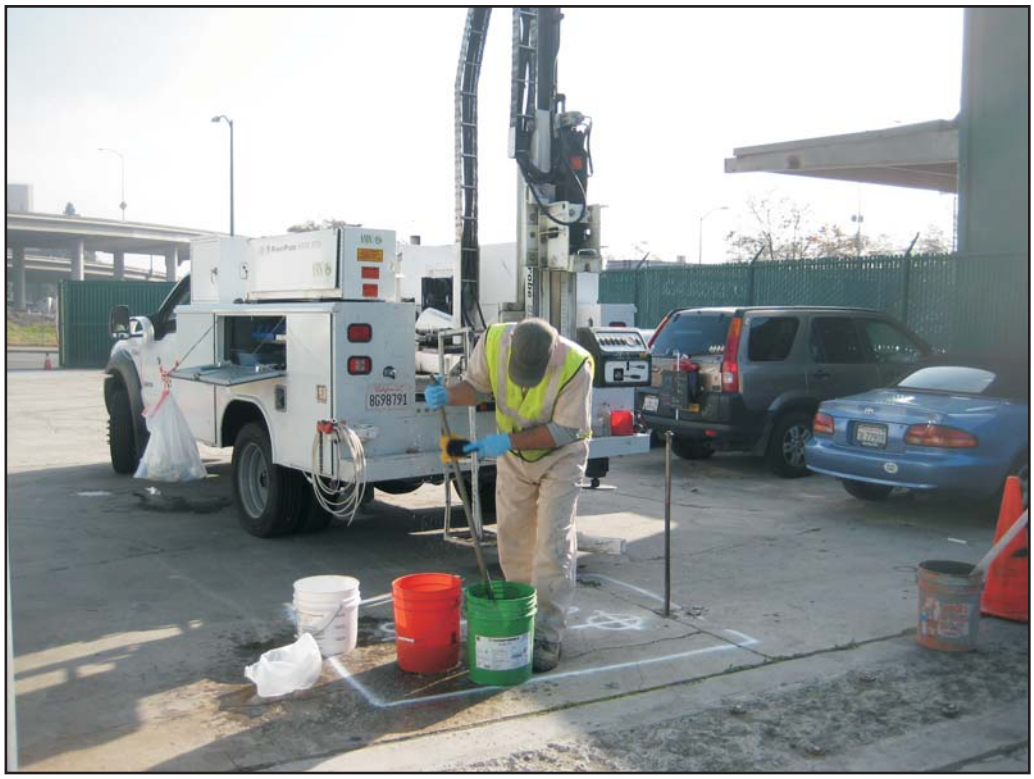
Photograph 14: Leak test at deep probe at SG-05.

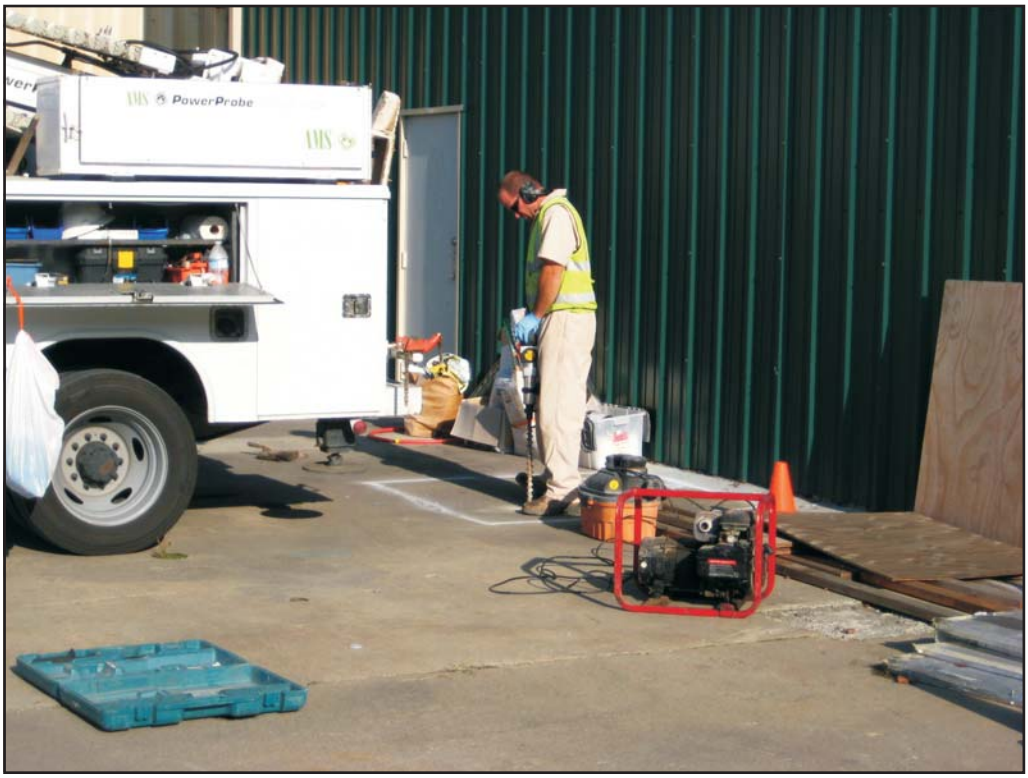
Photograph 25: TEG abandoning of boreholes at SG-01.

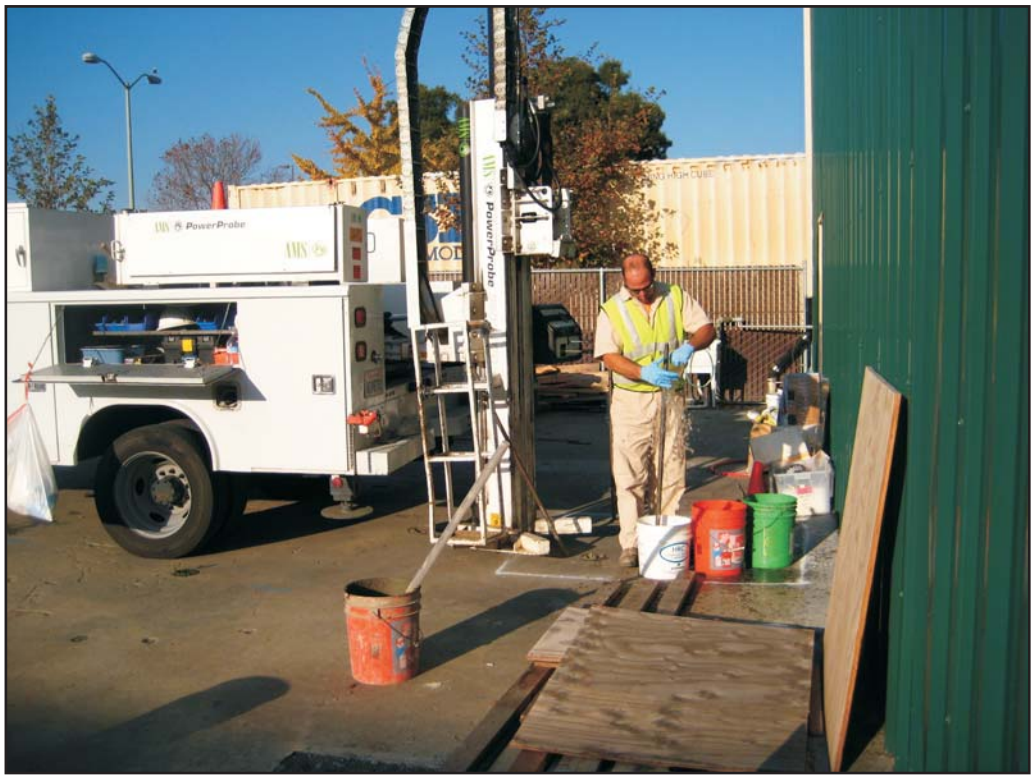
Photograph 31: TEG performing removal and decontamination of probes at SG-02.

Photograph 32: TEG performing abandonment of boreholes at SG-02.

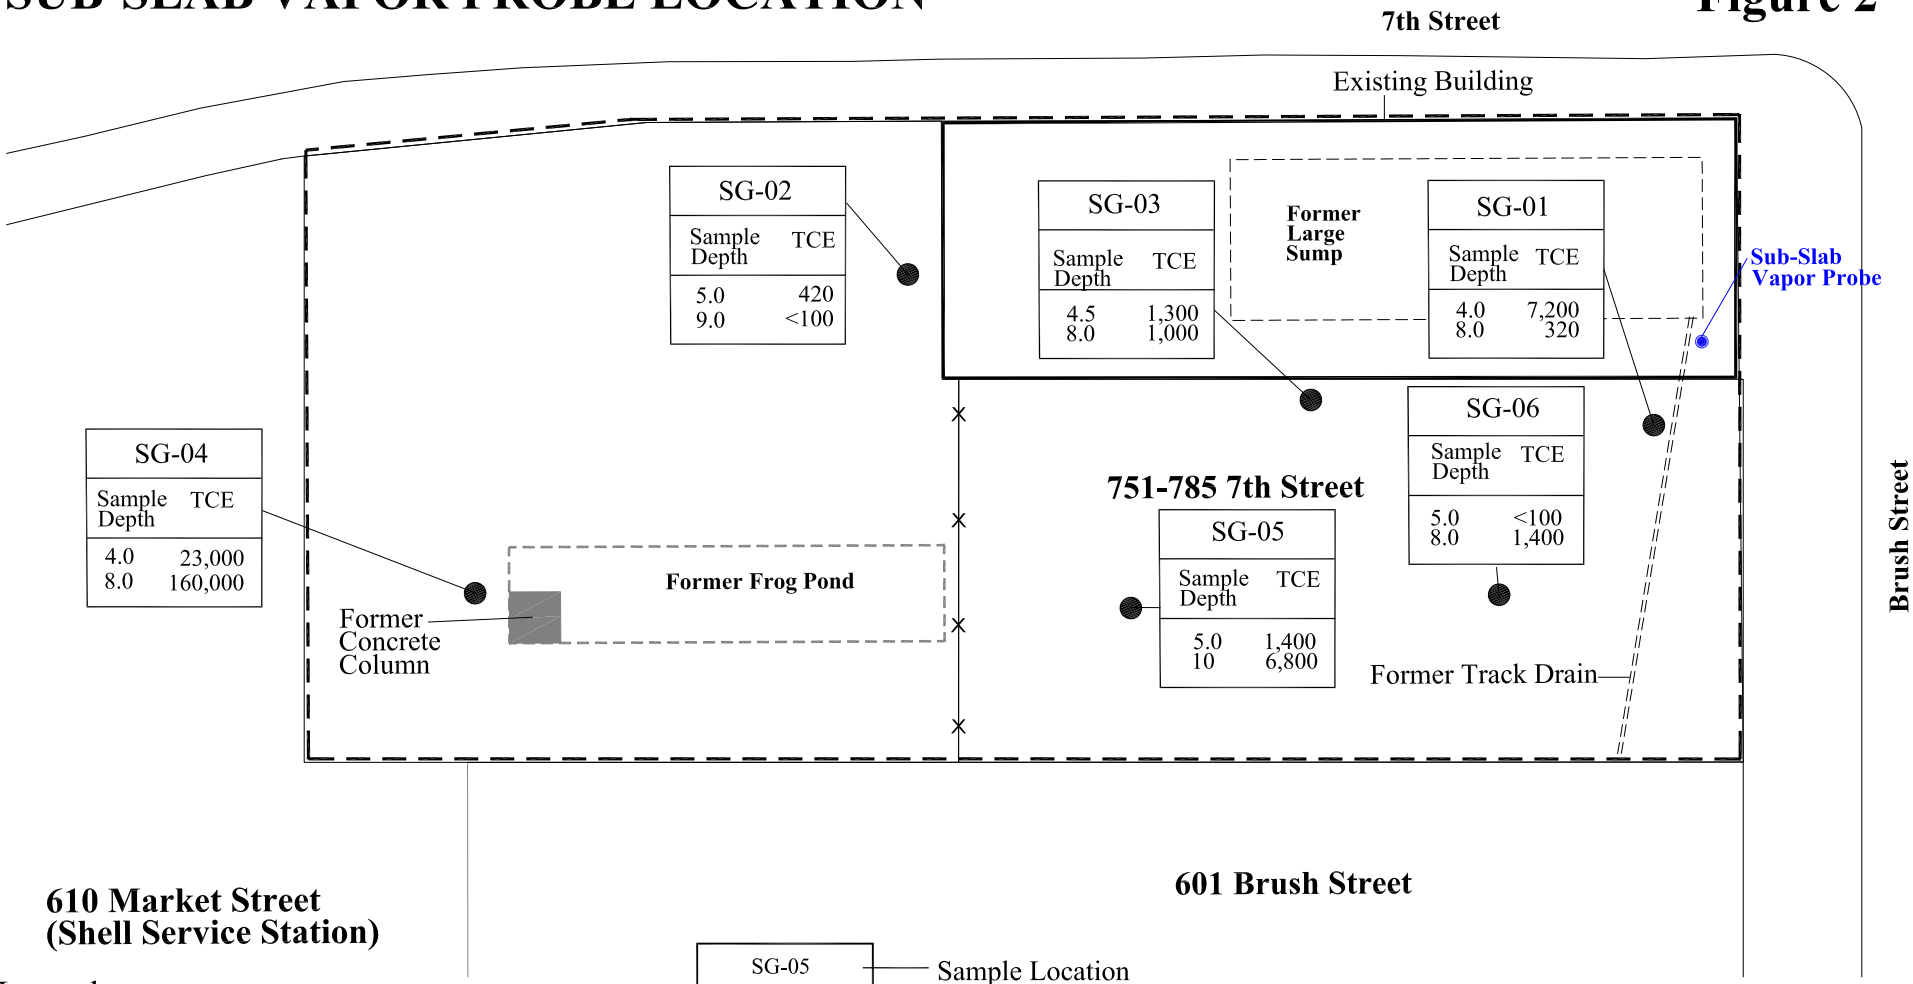
Figure 2

On 31 January 2012, BASELINE installed a stainless-steel sub-slab vapor probe in the southeastern corner of the building (Figure 2). Figure 3 presents a construction diagram of the vapor probe. Using a rotary hammer, BASELINE drilled a 1-inch hole through the slab. The slab was approximately 6 inches thick at the sample location. The vapor probe was placed in the hole with the top of the probe slightly below grade and the annular space was filled with quick-drying cement. A stainless steel cap was screwed into the top of the probe until flush with the floor surface.

Because leak detection agent 1,1-difluoroethane was detected in both samples collected at the site, the reported concentrations may be biased low and corrective action, such as providing additional surface sealant, is recommended prior to collecting additional samples. Additional sampling following re-sealing of the top of the vapor sample probe would provide more conclusive data regarding the potential indoor air concentrations at the site.

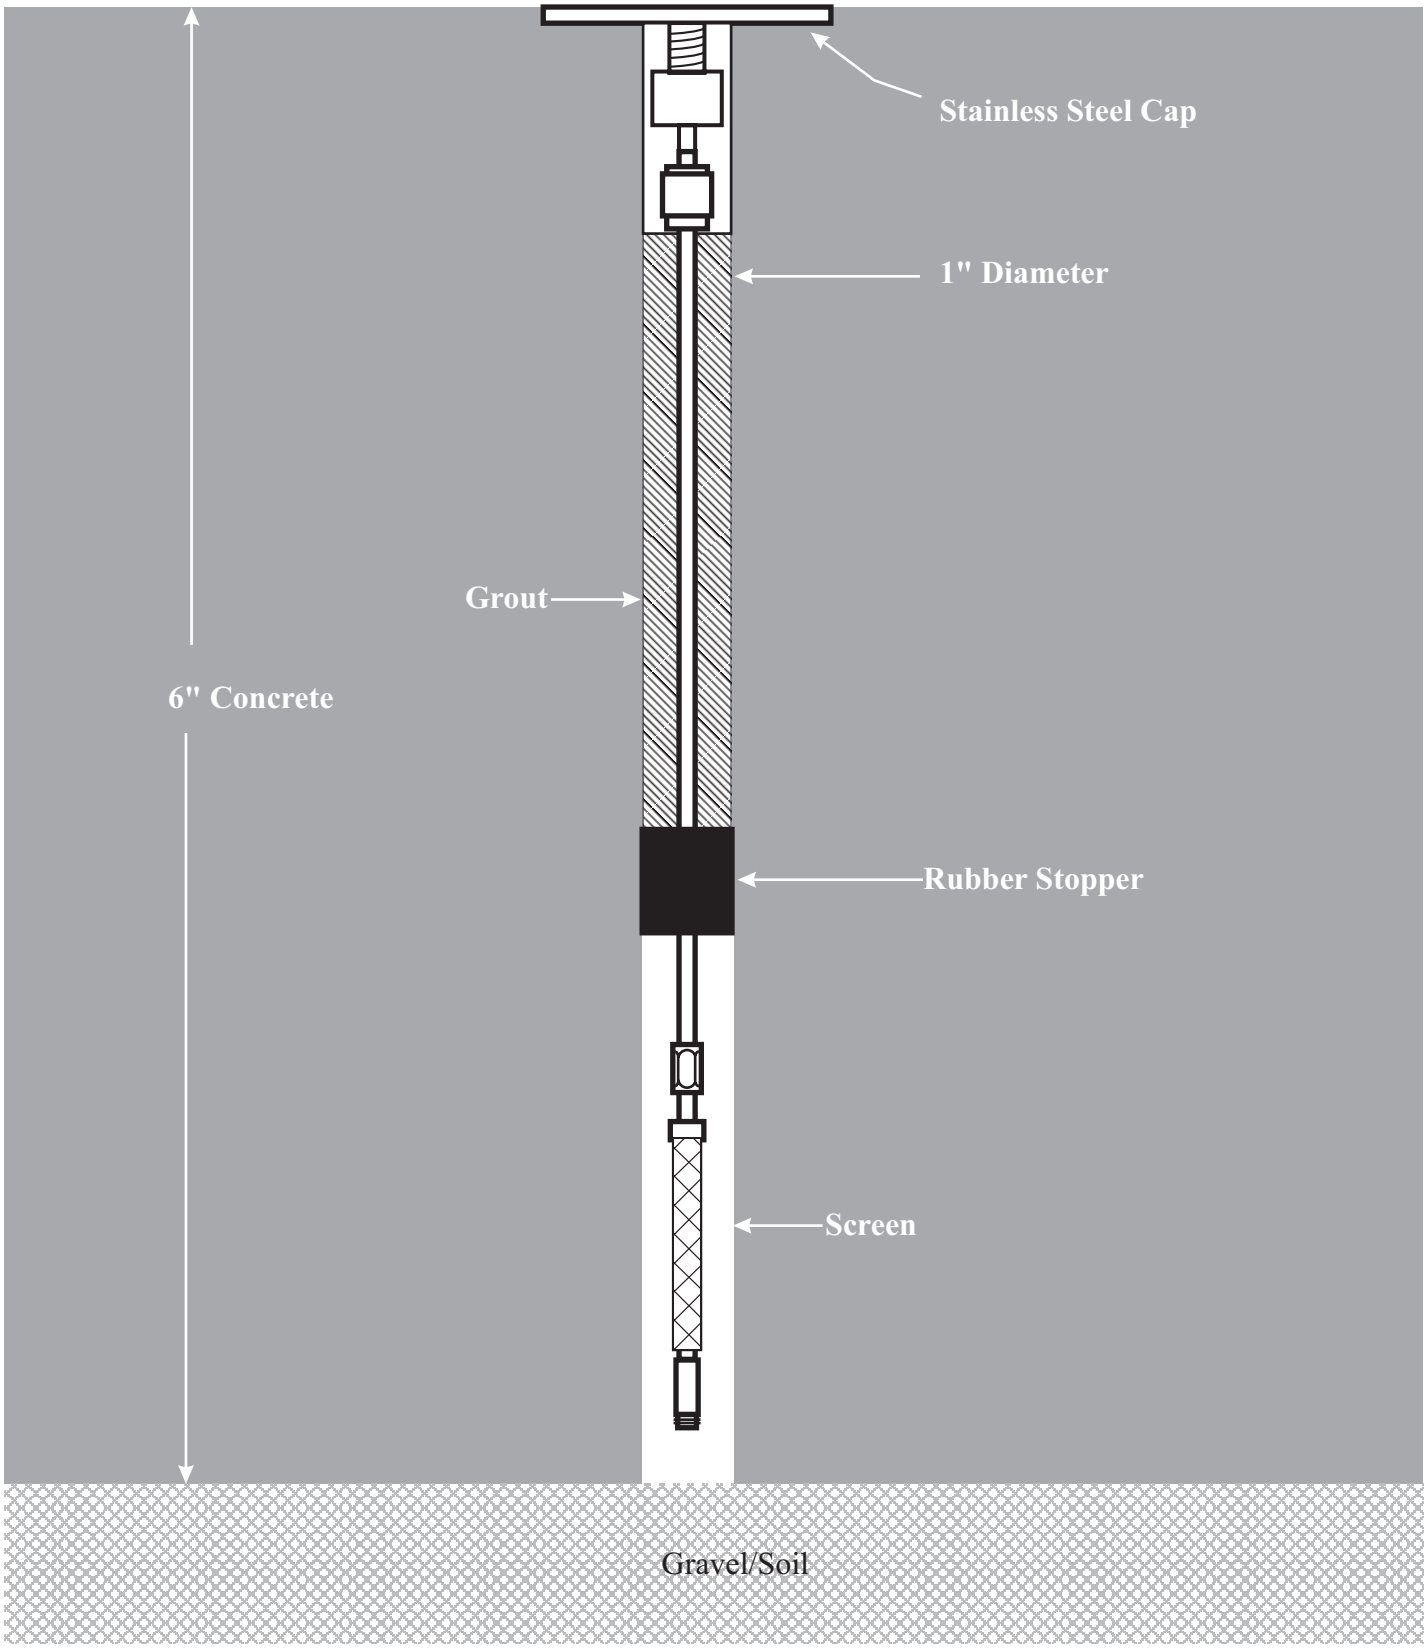
VAPOR PROBE CONSTRUCTION DIAMGRAM Figure 3

Leak detection agent 1,1-difluorethane was reported in both samples indicating the results are biased low. Because the two samples contain similar amounts of 1,1-dichloroethane, the leak was likely around the annular space or fittings of the vapor probe rather than around the fitting on either of the individual Summa canisters.
