Re: Soil sampling and analysis, building 42, Emeryville facility

SOIL CHARACTERIZATION
Building 42
Westinghouse Emeryville Facility

Project 0F88-001.15

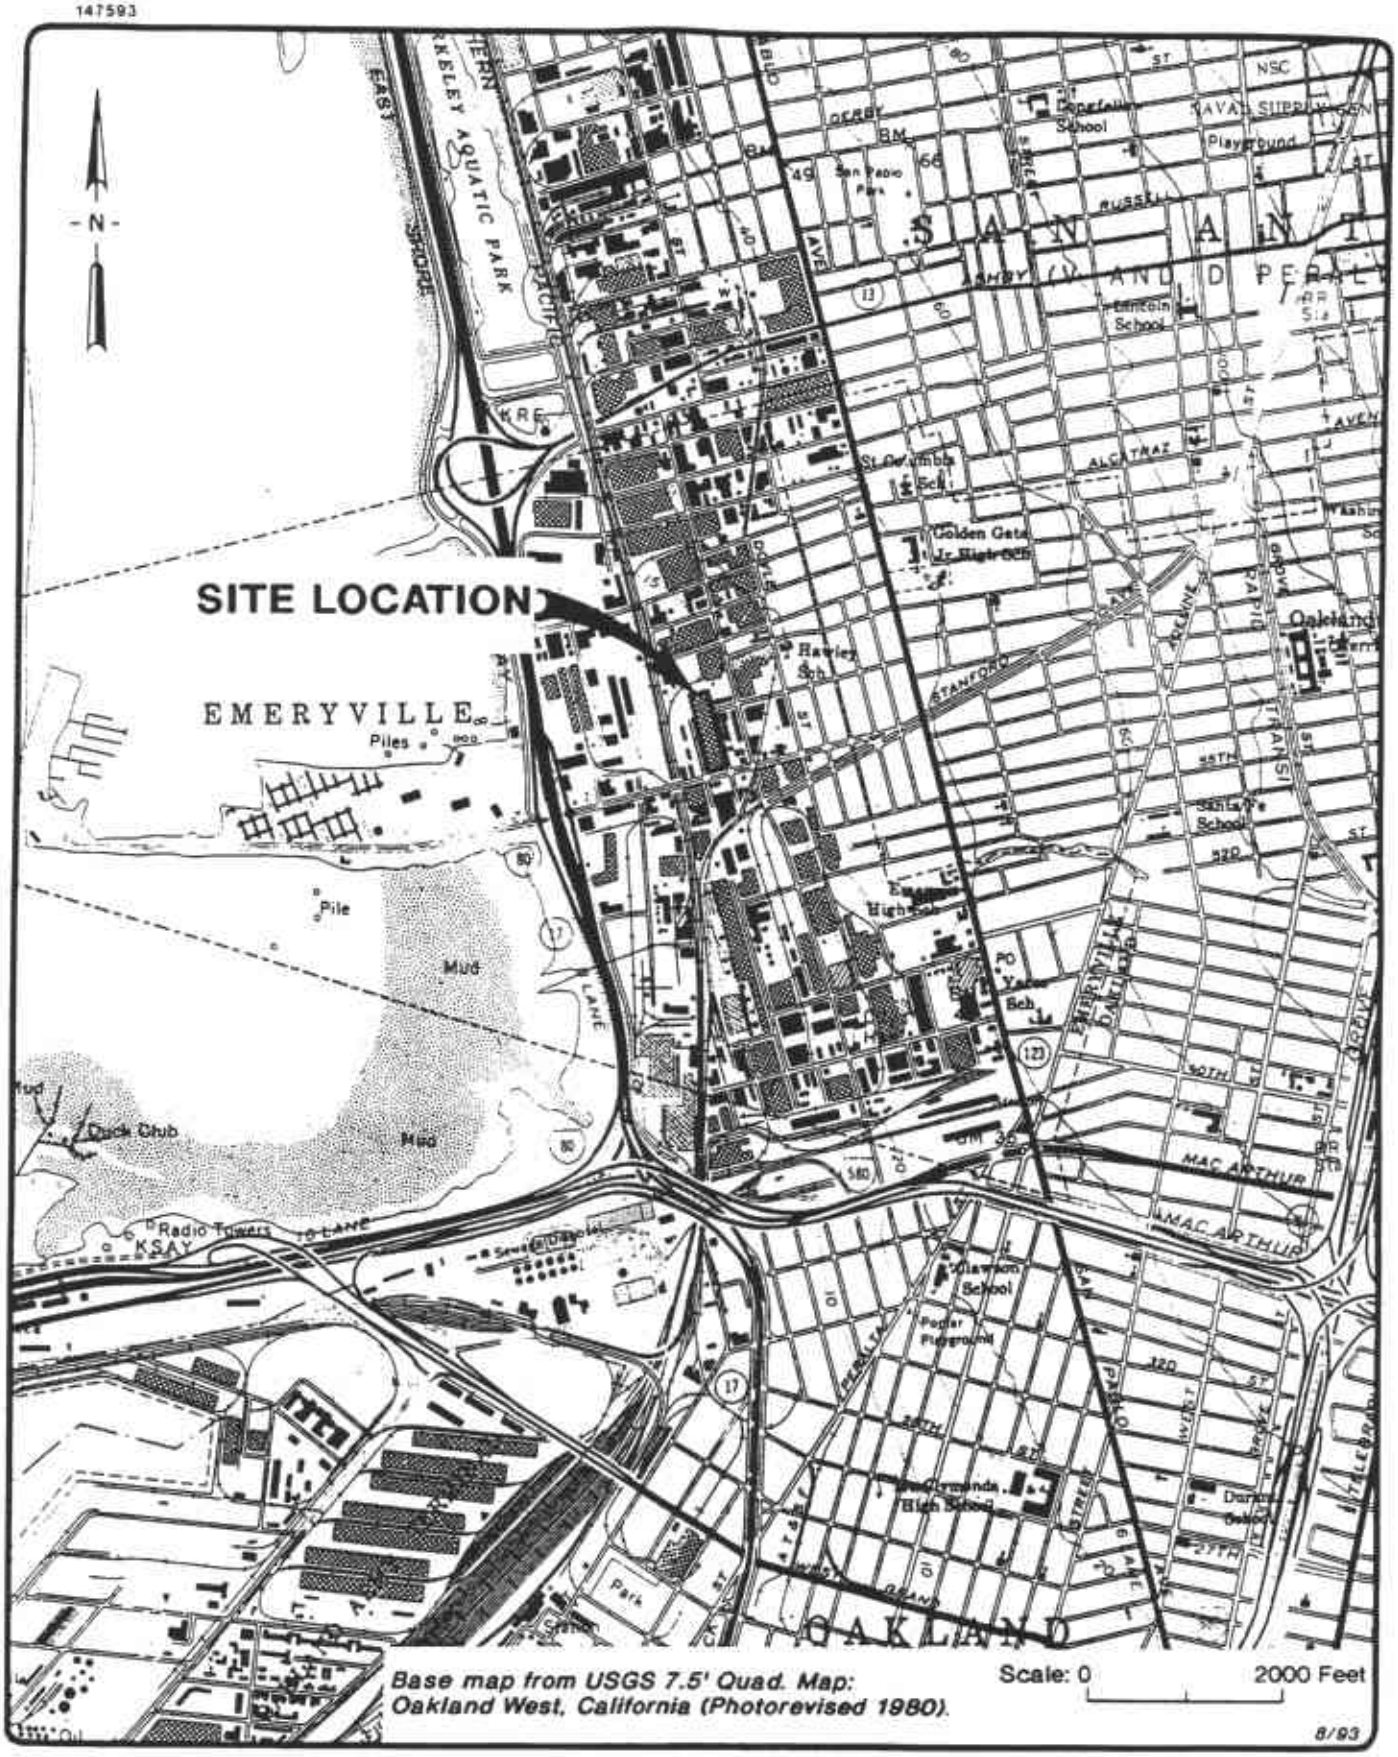
WESTINGHOUSE ELECTRIC CORPORATION
SOIL SAMPLING
EMERYVILLE, CALIFORNIA

VOCs (chlorobenzene or dichlorobenzenes) were detected in three of the samples, and TPH as gasoline was detected in one sample. No TPH as gasoline, or BTEX were detected in any of the remaining 15 soil samples.

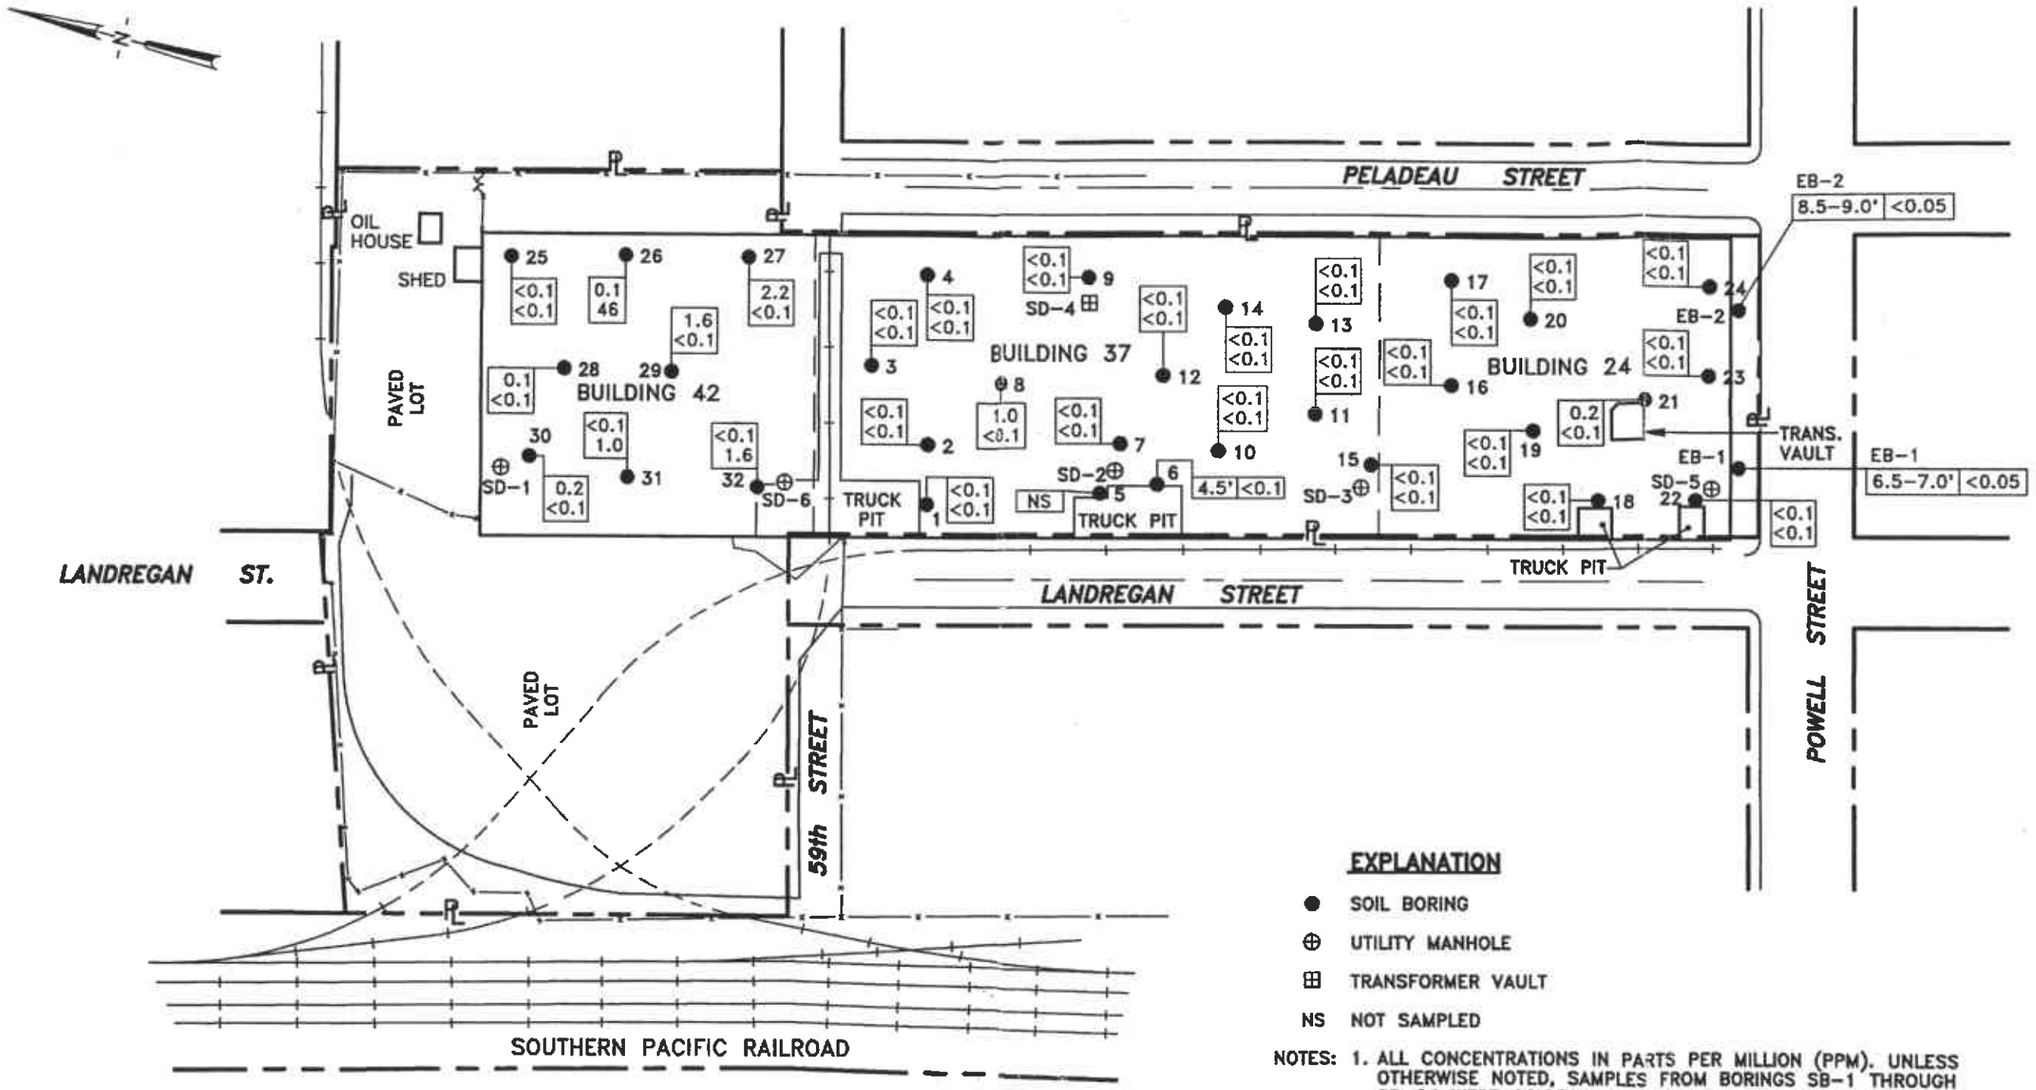
FIGURE NO. 2

Beneath the building 42 slab, eight samples had detectable concentrations of PCBs. Seven soil samples contained PCBs between 0.1 and 2.2 parts per million (ppm). Sample SB-26 at 3.5 feet contained 46 ppm PCBs. All other samples (8 total) did not contain PCBs above the analytical method reporting limit of 0.1 ppm.

PCBs were detected in 8 of the 16 soil samples collected under building 42, with the highest concentration being 46 ppm. The other samples that contained PCBs were all less than 3 ppm.

POLYCHLORINATED BIPHENYLS (PCBs) CONCENTRATIONS

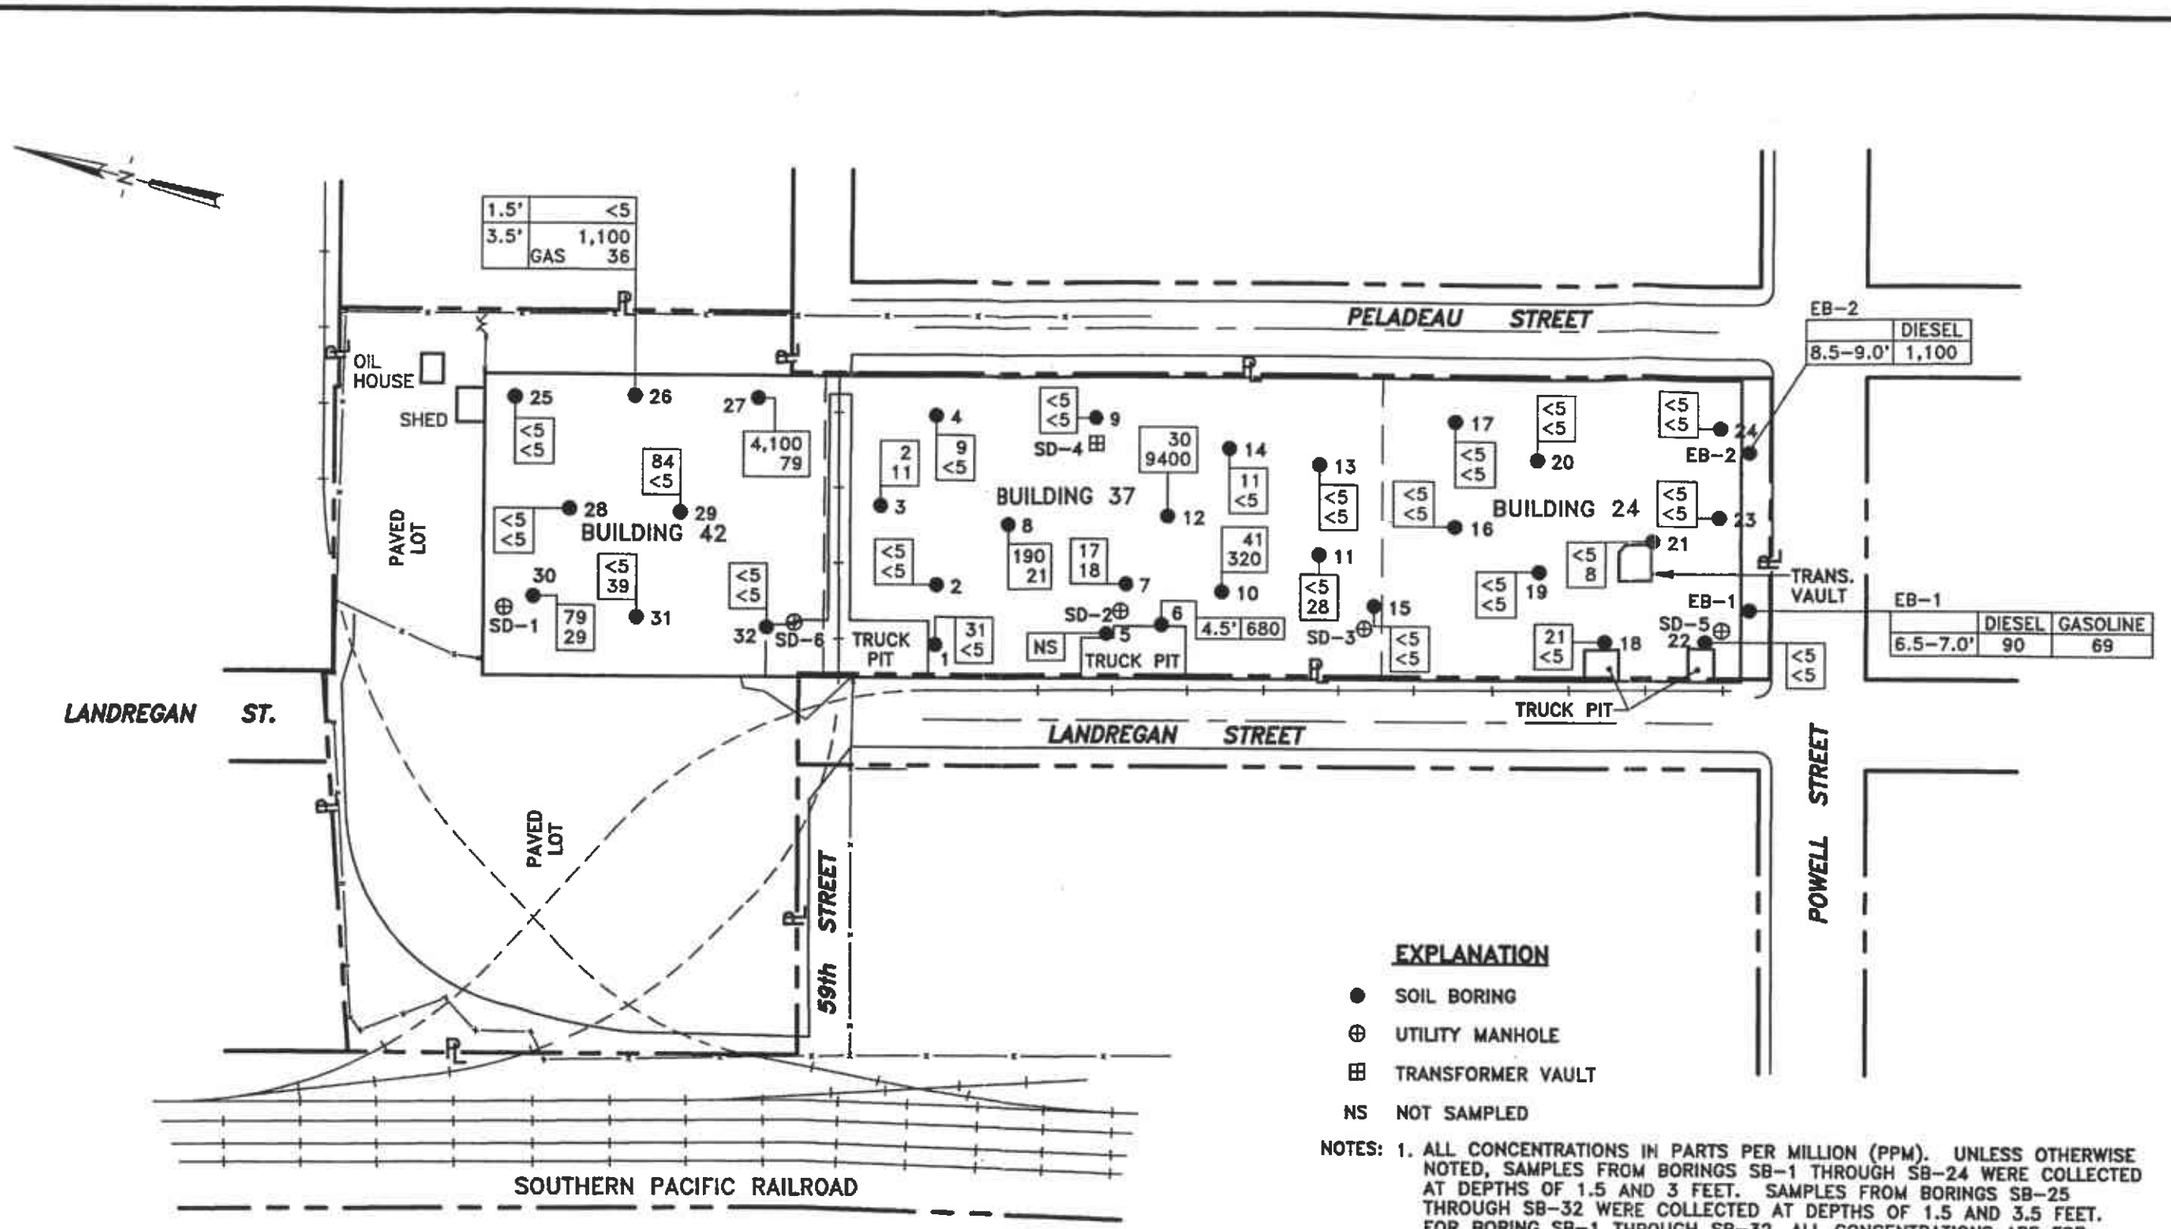
FIGURE NO. 3

Although TPH as hydraulic oil or diesel were detected in 7 of the 16 soil samples, concentrations in only 2 samples exceeded 100 ppm. Sample SB-26 at 3.5 feet contained 1,100 ppm TPH as hydraulic oil and sample SB-27 at 1.5 feet contained 4,100 ppm TPH as hydraulic oil. The remaining 5 samples that contained TPH as hydraulic oil had concentrations between 29 and 84 ppm.

The highest TPH concentration (as hydraulic oil) was 4,100 ppm in SB-27 at 1.5 feet. One other sample contained TPH (as hydraulic oil) above 100 ppm. Five soil samples contained TPH between 29 and 84 ppm.

TOTAL PETROLEUM HYDROCARBON CONCENTRATIONS

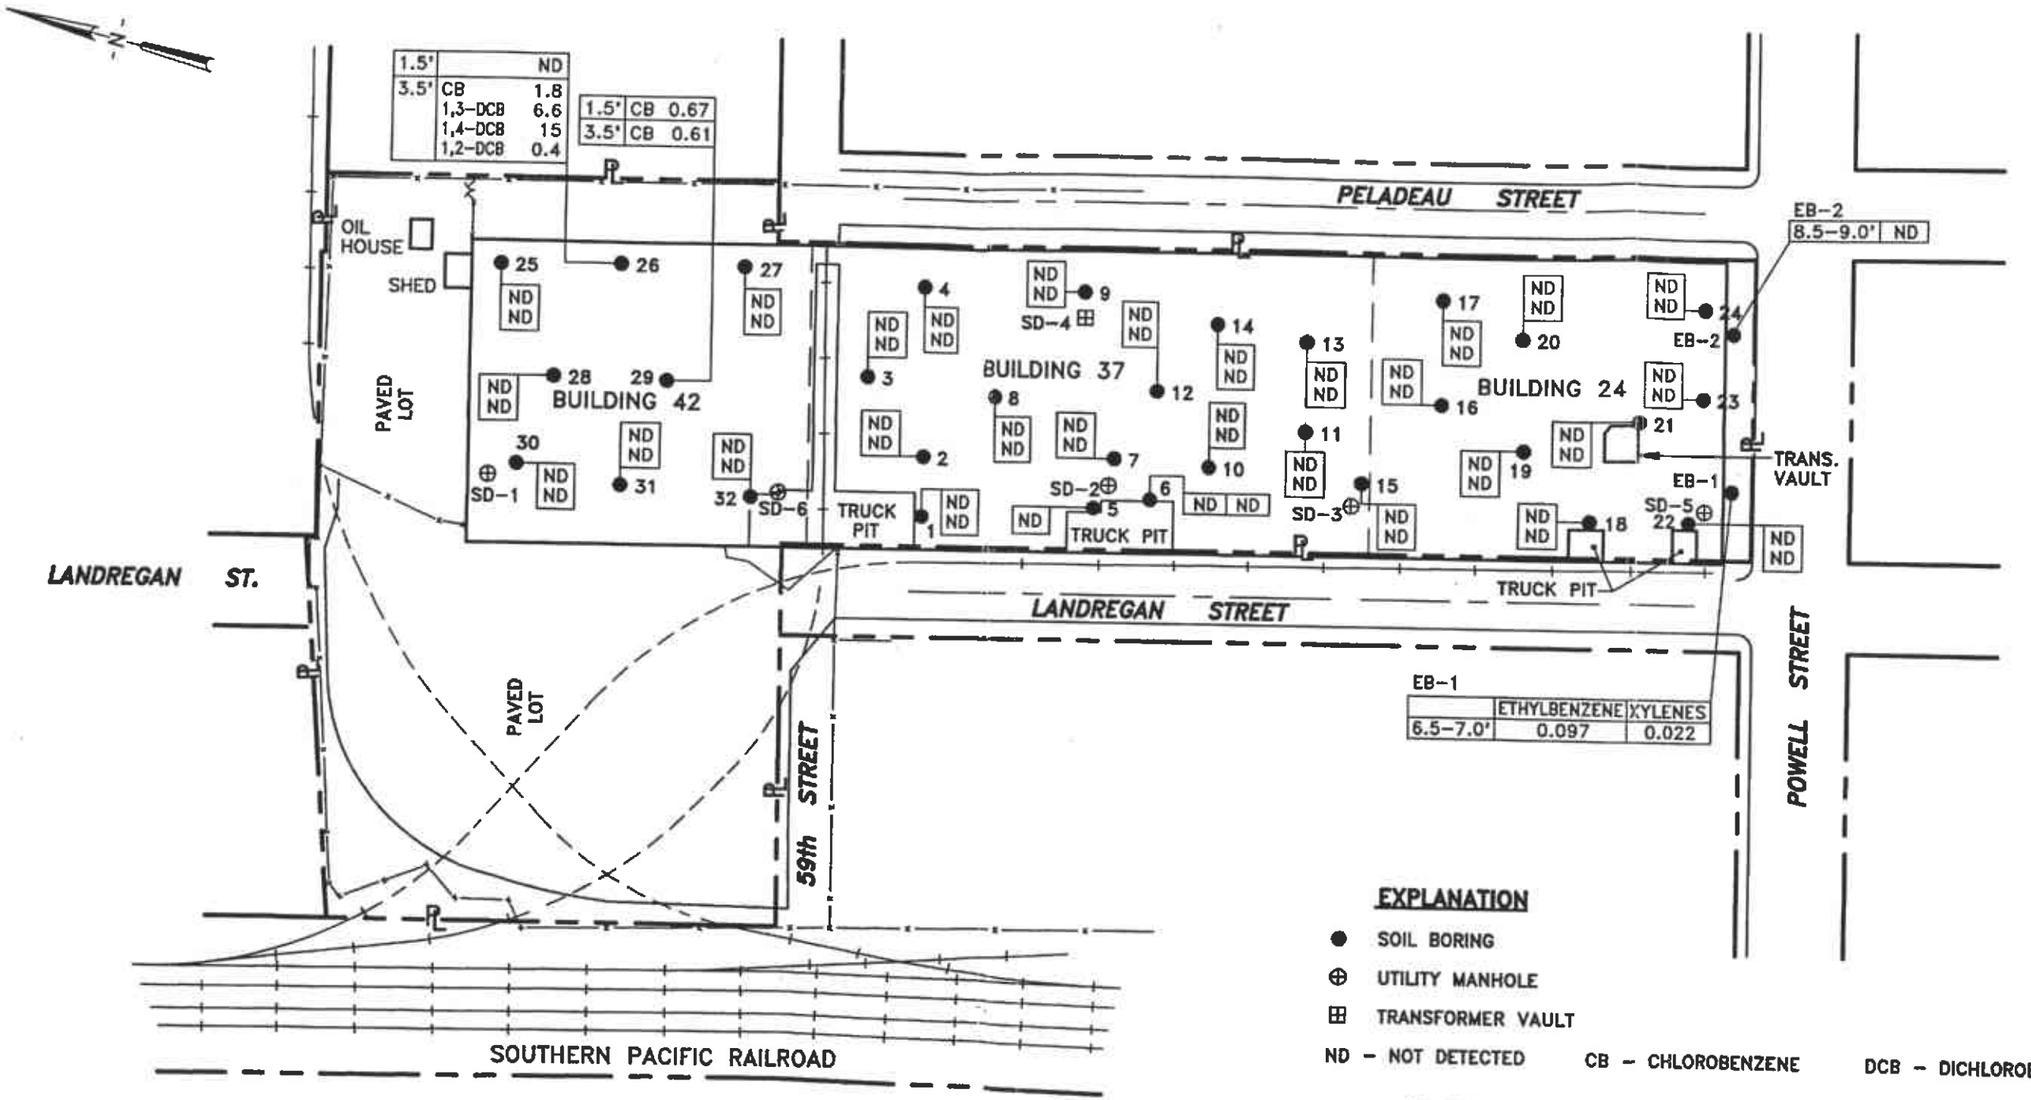
FIGURE NO. 4

VOCs were detected in 3 of the 16 samples. Samples SB-26 at 3.5 feet, and SB-29 at 1.5 and at 3.5 feet contained chlorobenzene at concentrations between 0.61 and 1.8 ppm. Sample SB-26 at 3.5 feet also contained dichlorobenzenes (DCB) (1,2-DCB, 1,3-DCB, and 1,4-DCB) at concentrations between 0.4 and 15 ppm.

VOLATILE ORGANIC COMPOUNDS CONCENTRATIONS
