Transmittal
Groundwater Monitoring Report, Second Semi-Annual 2013 Event
Sparkle Cleaners
Eastmont Town Center
7000 Bancroft Avenue
Oakland, California
SLIC Case RO0002942

GROUNDWATER MONITORING REPORT
SECOND SEMI-ANNUAL 2013 EVENT
SPARKLE CLEANERS
EASTMONT TOWN CENTER
7000 BANCROFT AVENUE
OAKLAND, CALIFORNIA

JANUARY 6, 2014

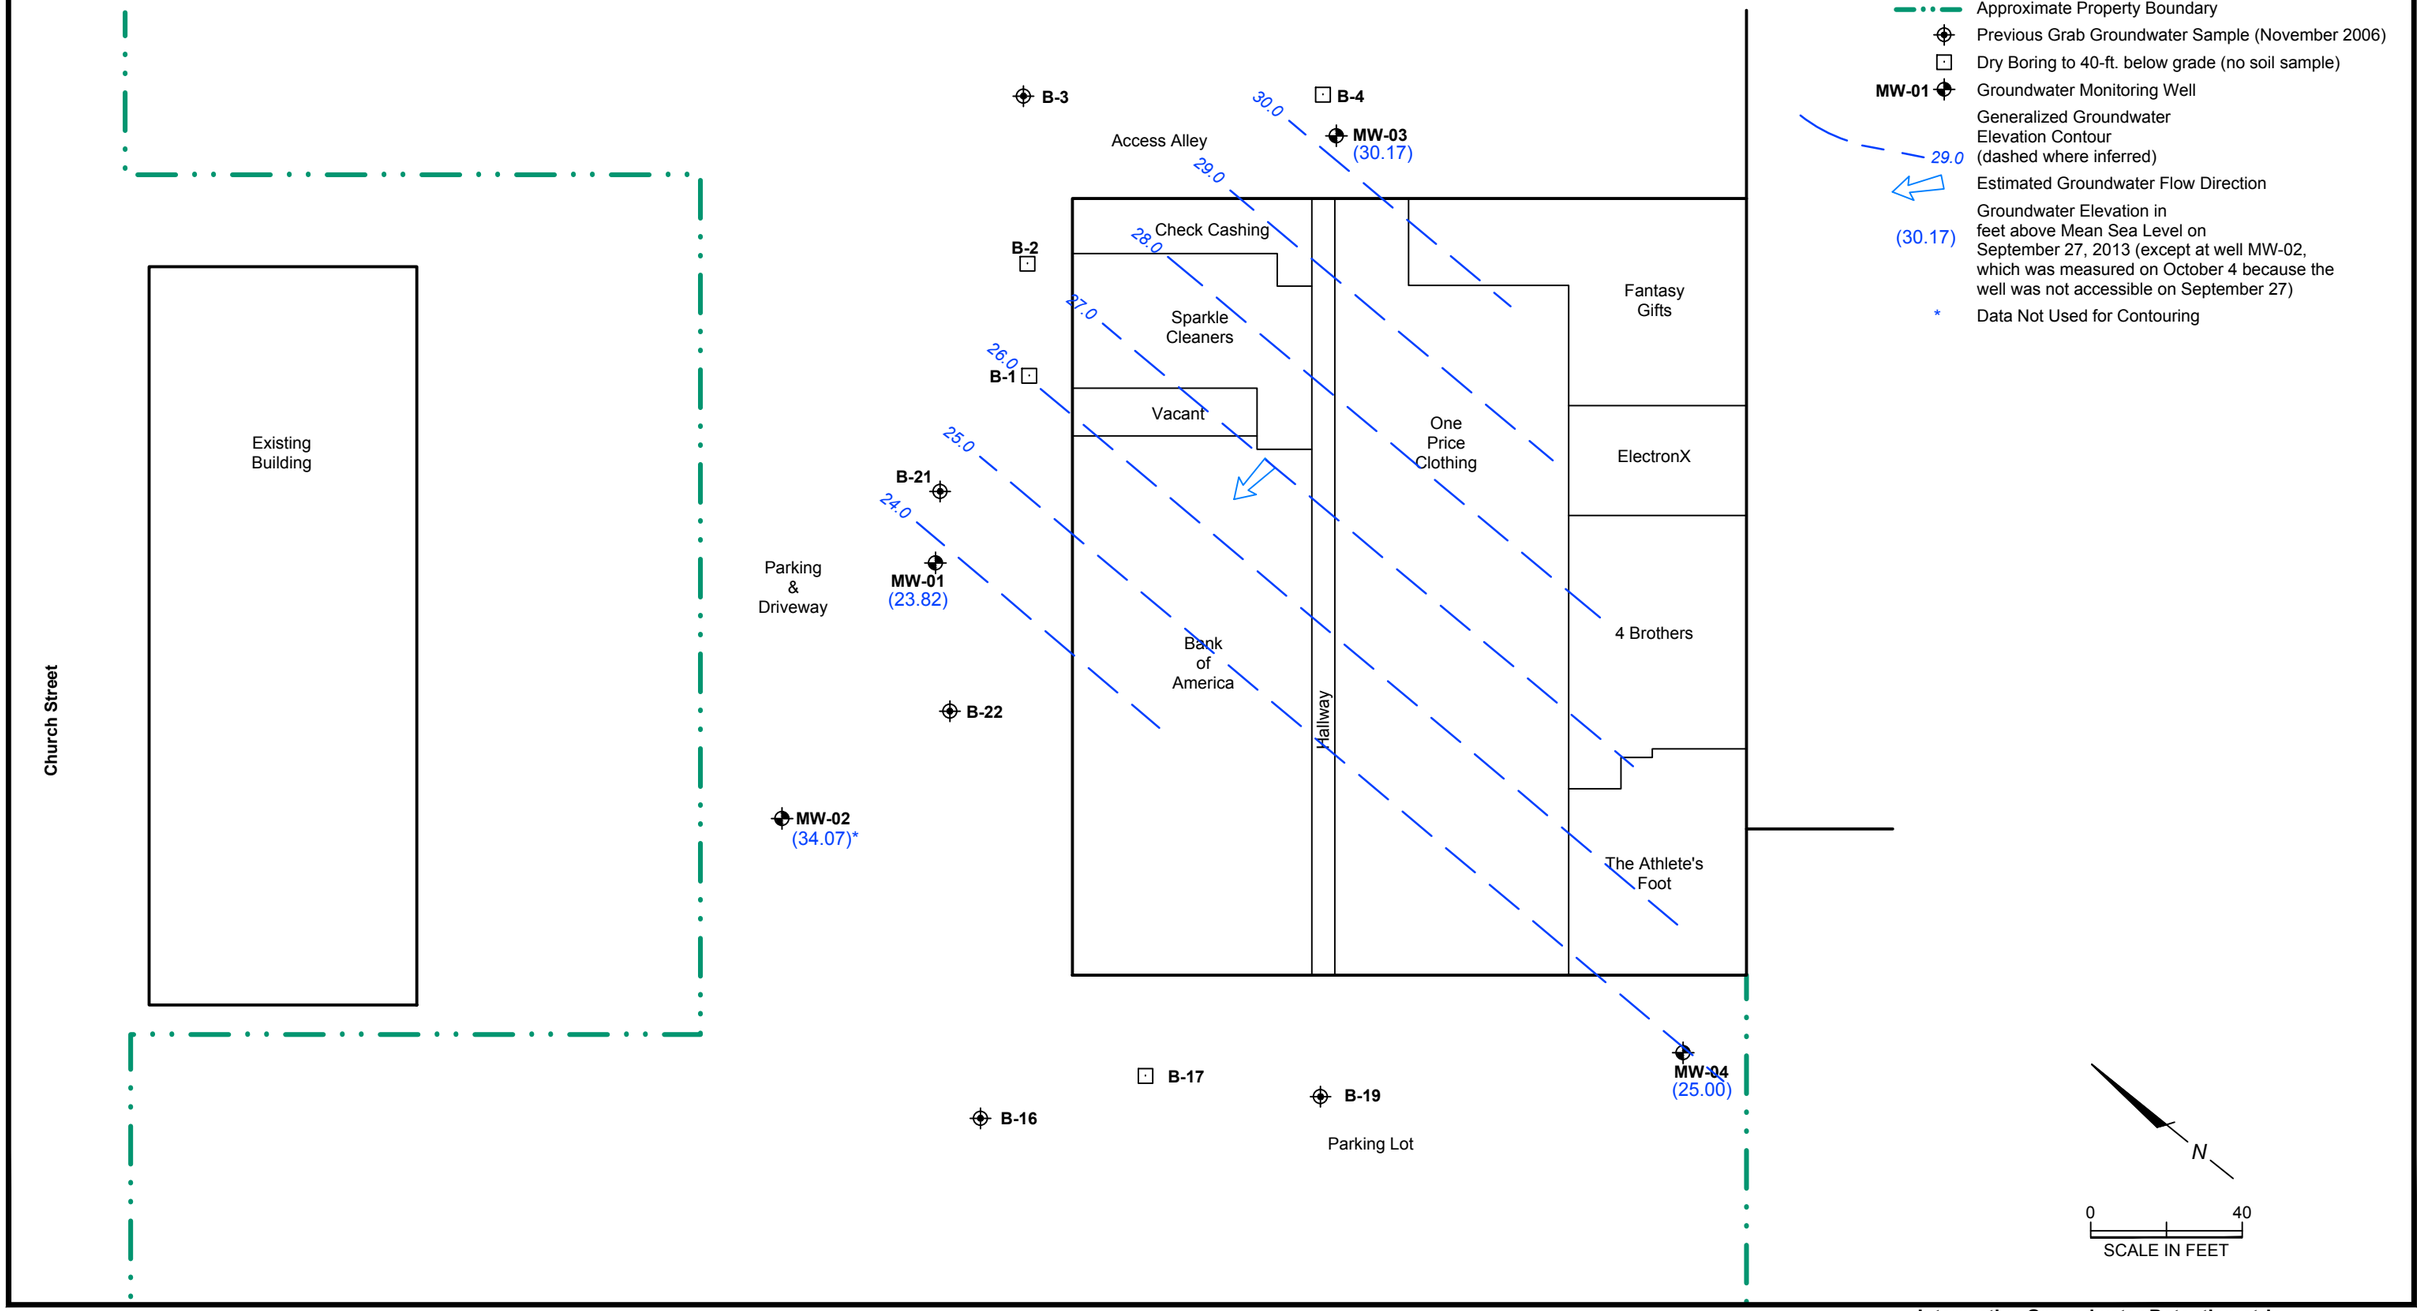
PLATE
2

Groundwater elevations measured during the current monitoring event ranged from 23.82 feet MSL in well MW-01 to 34.07 feet MSL in well MW-02 (see Table 2 and Plate 2). As indicated on Plate 2, the elevation data from well MW-02 is not used for contouring because the groundwater elevation in this well is significantly higher than the elevations in the other wells. As described in the previous monitoring reports, the cause of the higher water-level elevation at well MW-02 appears to be from a screen interval that is at least 9 feet shallower (i.e., relative to the ground surface) than the other three wells. Well MW-2 was constructed in this manner because groundwater was observed at a shallower depth while drilling the borehole for this well.

Based on the groundwater elevation data from wells MW-01, MW-03, and MW-04, the hydraulic gradient during the current monitoring event was approximately 0.041 foot per foot to the west (see Plate 2). In addition, the analytical results discussed below suggest a westerly to northwesterly direction for groundwater flow.

Based on the groundwater elevation data from wells MW-01, MW-03, and MW-04, groundwater flow at the Site during this sampling event continues to be westerly (see Plate 2). The only VOC constituents detected above laboratory reporting limits in groundwater during this monitoring event were PCE, TCE, and cis-1,2-DCE. The maximum concentrations of PCE and TCE were detected in well MW-01 at 120 μg/L and 3.1 μg/L, respectively. PCE and TCE were also detected at 120 μg/L and 3.0 μg/L, respectively, in the duplicate sample from well MW-01. These concentrations are generally similar to those observed during previous monitoring events. Groundwater monitoring data collected since removal of the vadose zone source area in 2007 indicate that VOC concentrations are fairly stable in downgradient monitoring wells MW-01 and MW-02.
