FOURTH QUARTER 2010 GROUNDWATER MONITORING REPORT

R & H AUTO REPAIR
5315 SAN PABLO AVENUE
OAKLAND, CALIFORNIA

December 3, 2010

Project No. 2010-06

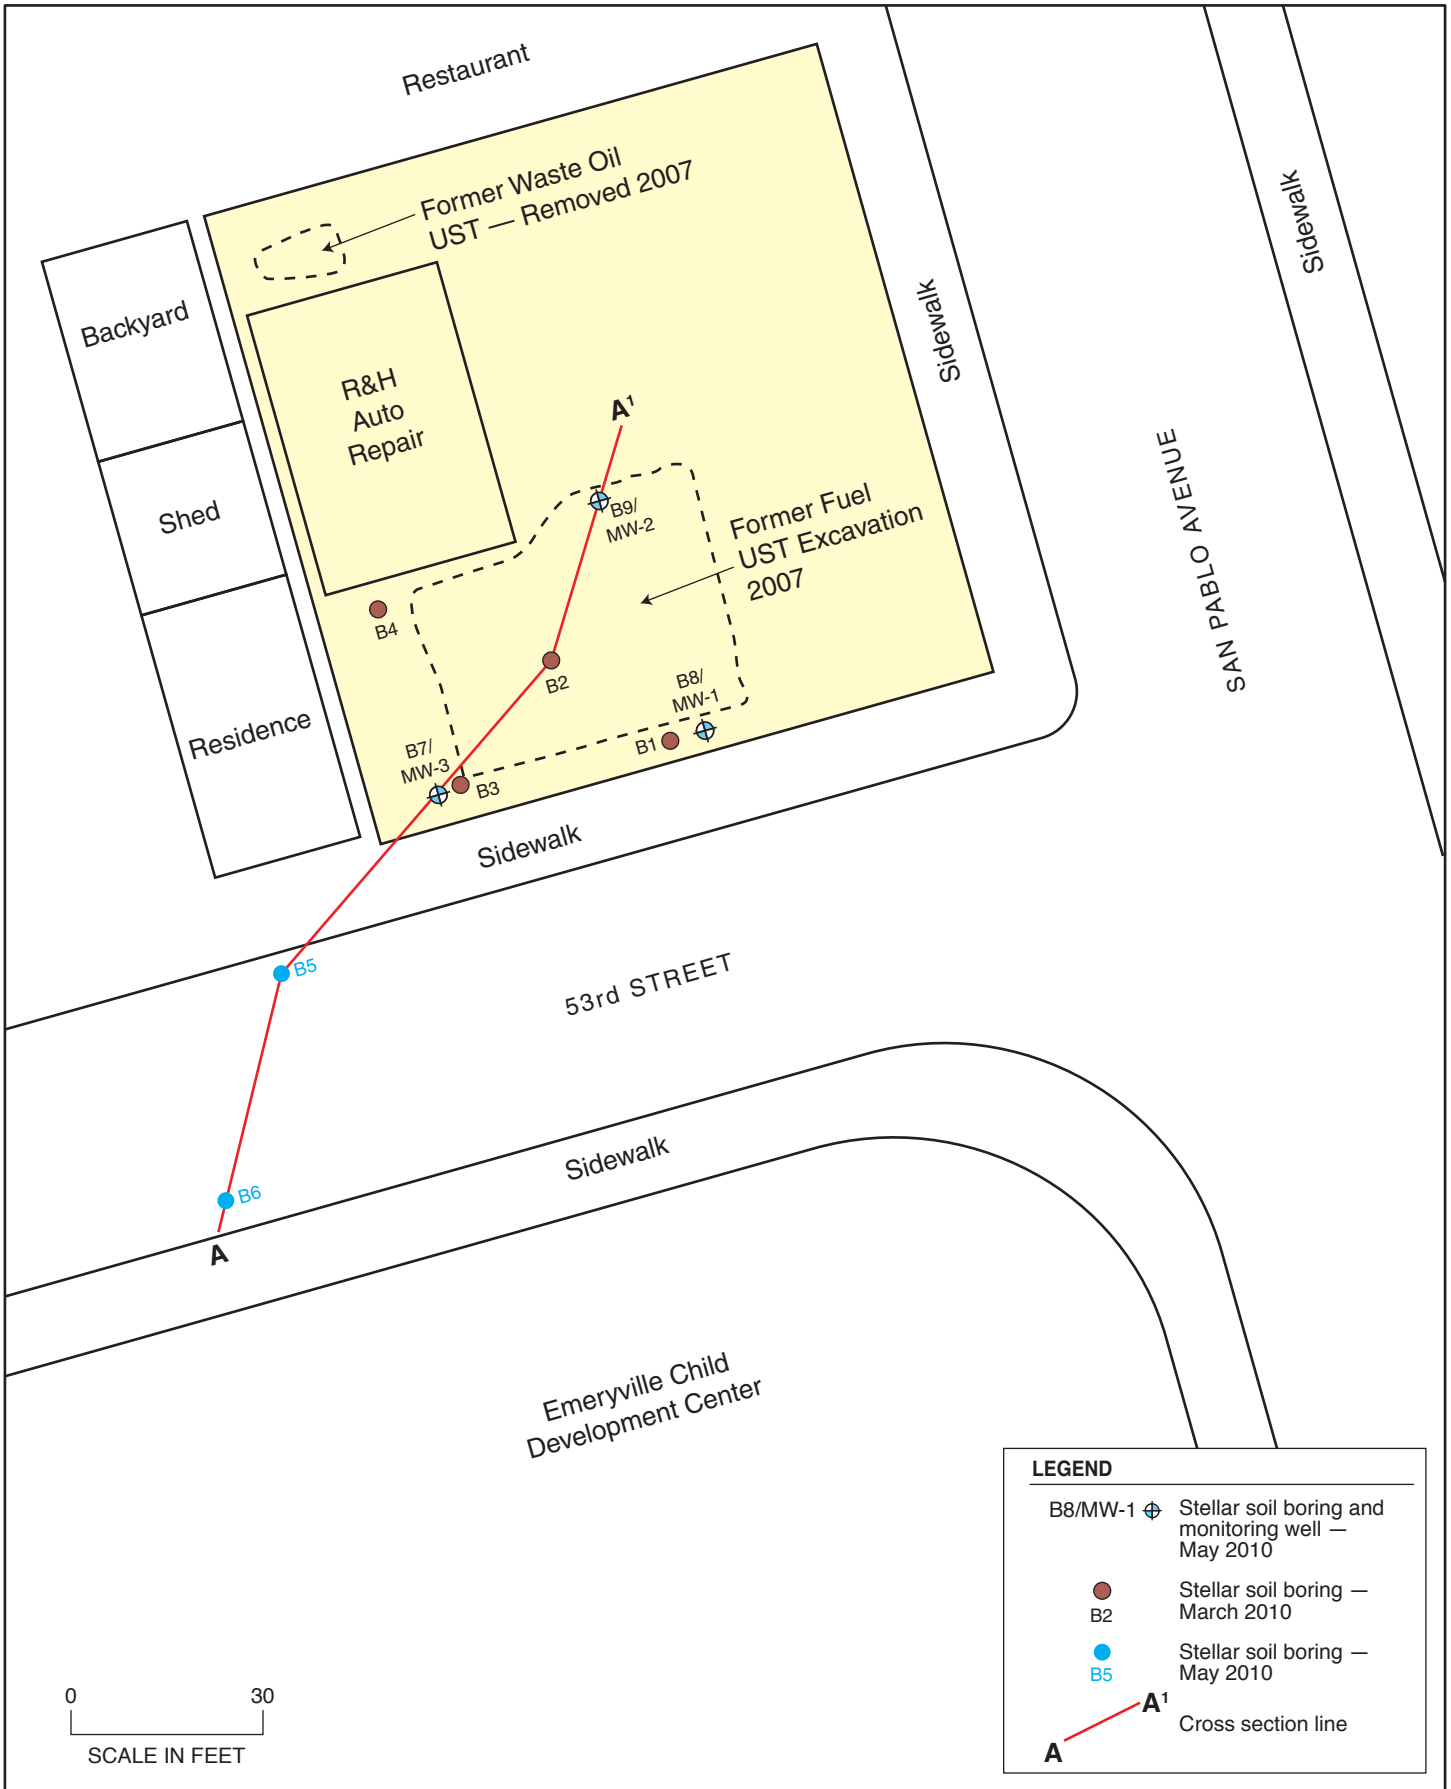
5315 San Pablo Avenue Oakland, CA	By: MJC	DECEMBER 2010
	Figure 2

Figure 1 shows the site location. Figure 2 shows the site plan and locations of current groundwater monitoring wells, previous investigative borings and former underground fuel storage tanks (UFSTs).

SITE PLAN AND BORING/MONITORING WELL LOCATIONS

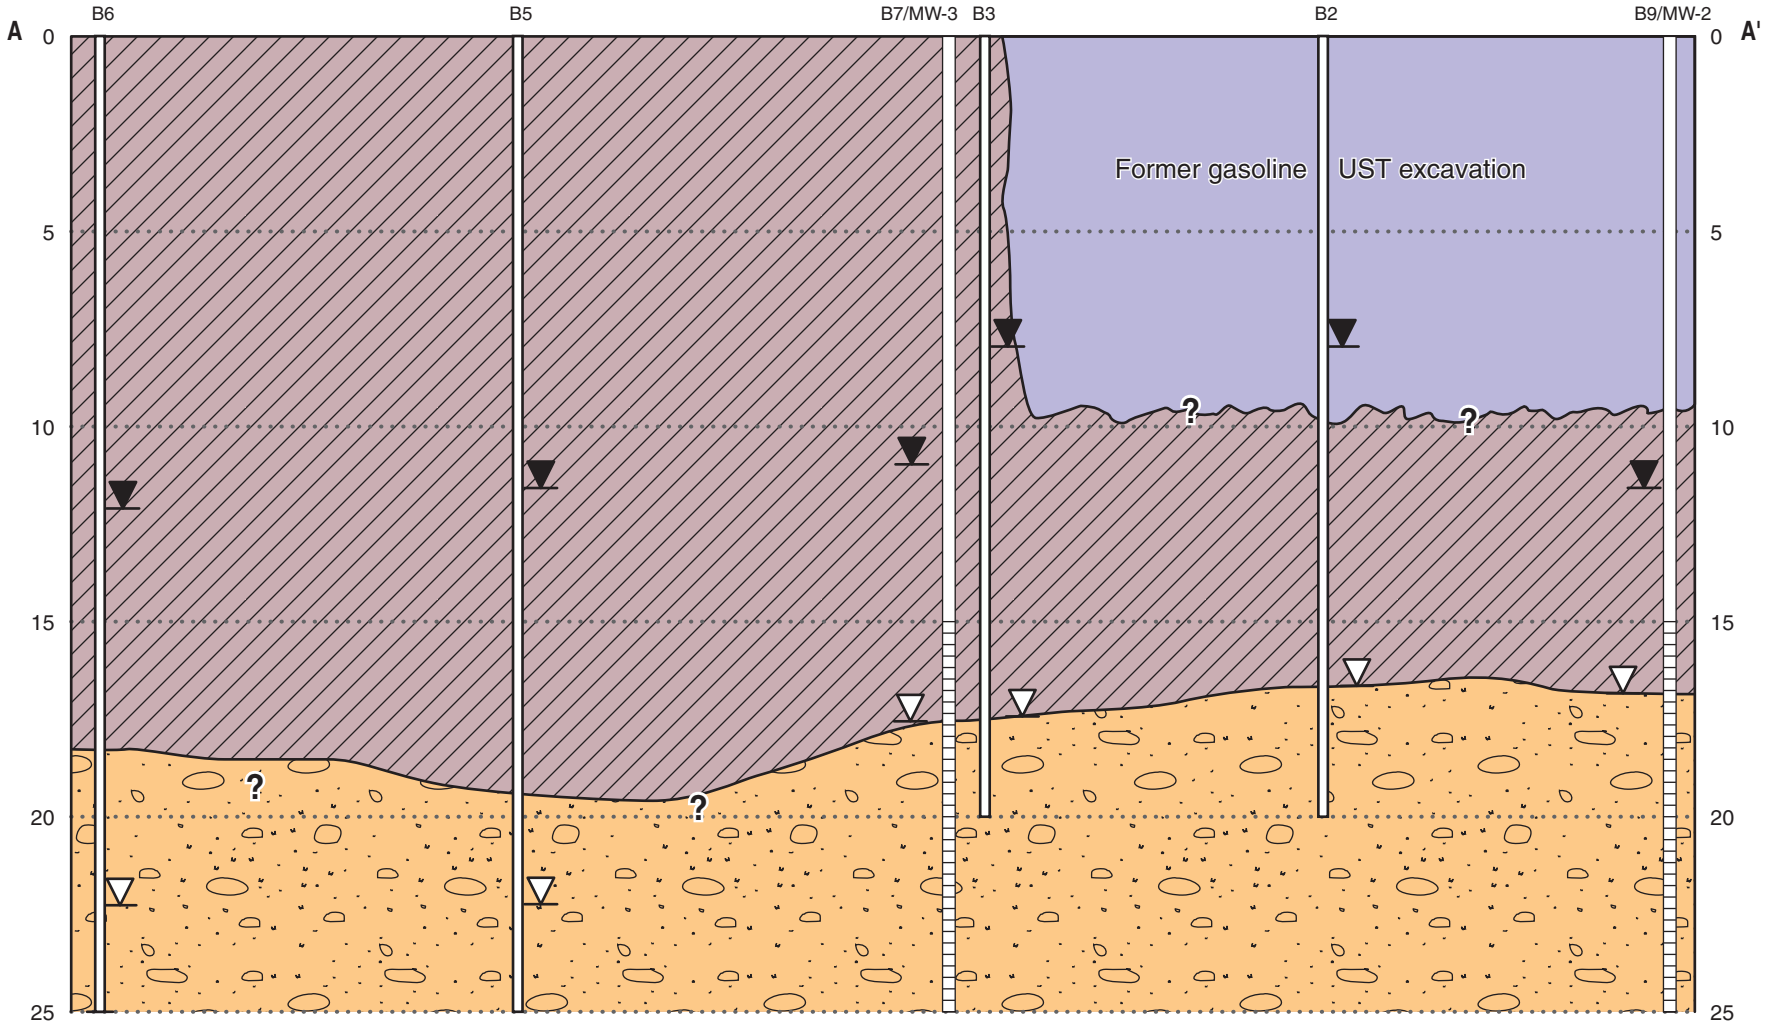
Figure 3

Site-specific lithology has been characterized to a depth of 20 feet bgs in onsite borings B1, B2, and B3; to a depth of 22 feet bgs in boring B4; and to 25 feet bgs in onsite and offsite borings B5 through B9. Subsurface lithology can be described as silty clay to gravelly clay fill with fragments of brick to approximately 2.5 feet bgs. The upper fill is underlain by native, low permeability, stiff, expansive, silty clay to about 17 feet bgs. Between 17 feet and 25 feet bgs, interbedded layers of moist to saturated sandy silt, silty sand, and clayey gravel are present. Geologic cross-section A-A' depicting the shallow site lithology is shown on Figure 3.

GEOLOGIC CROSS SECTION AREA A-A'

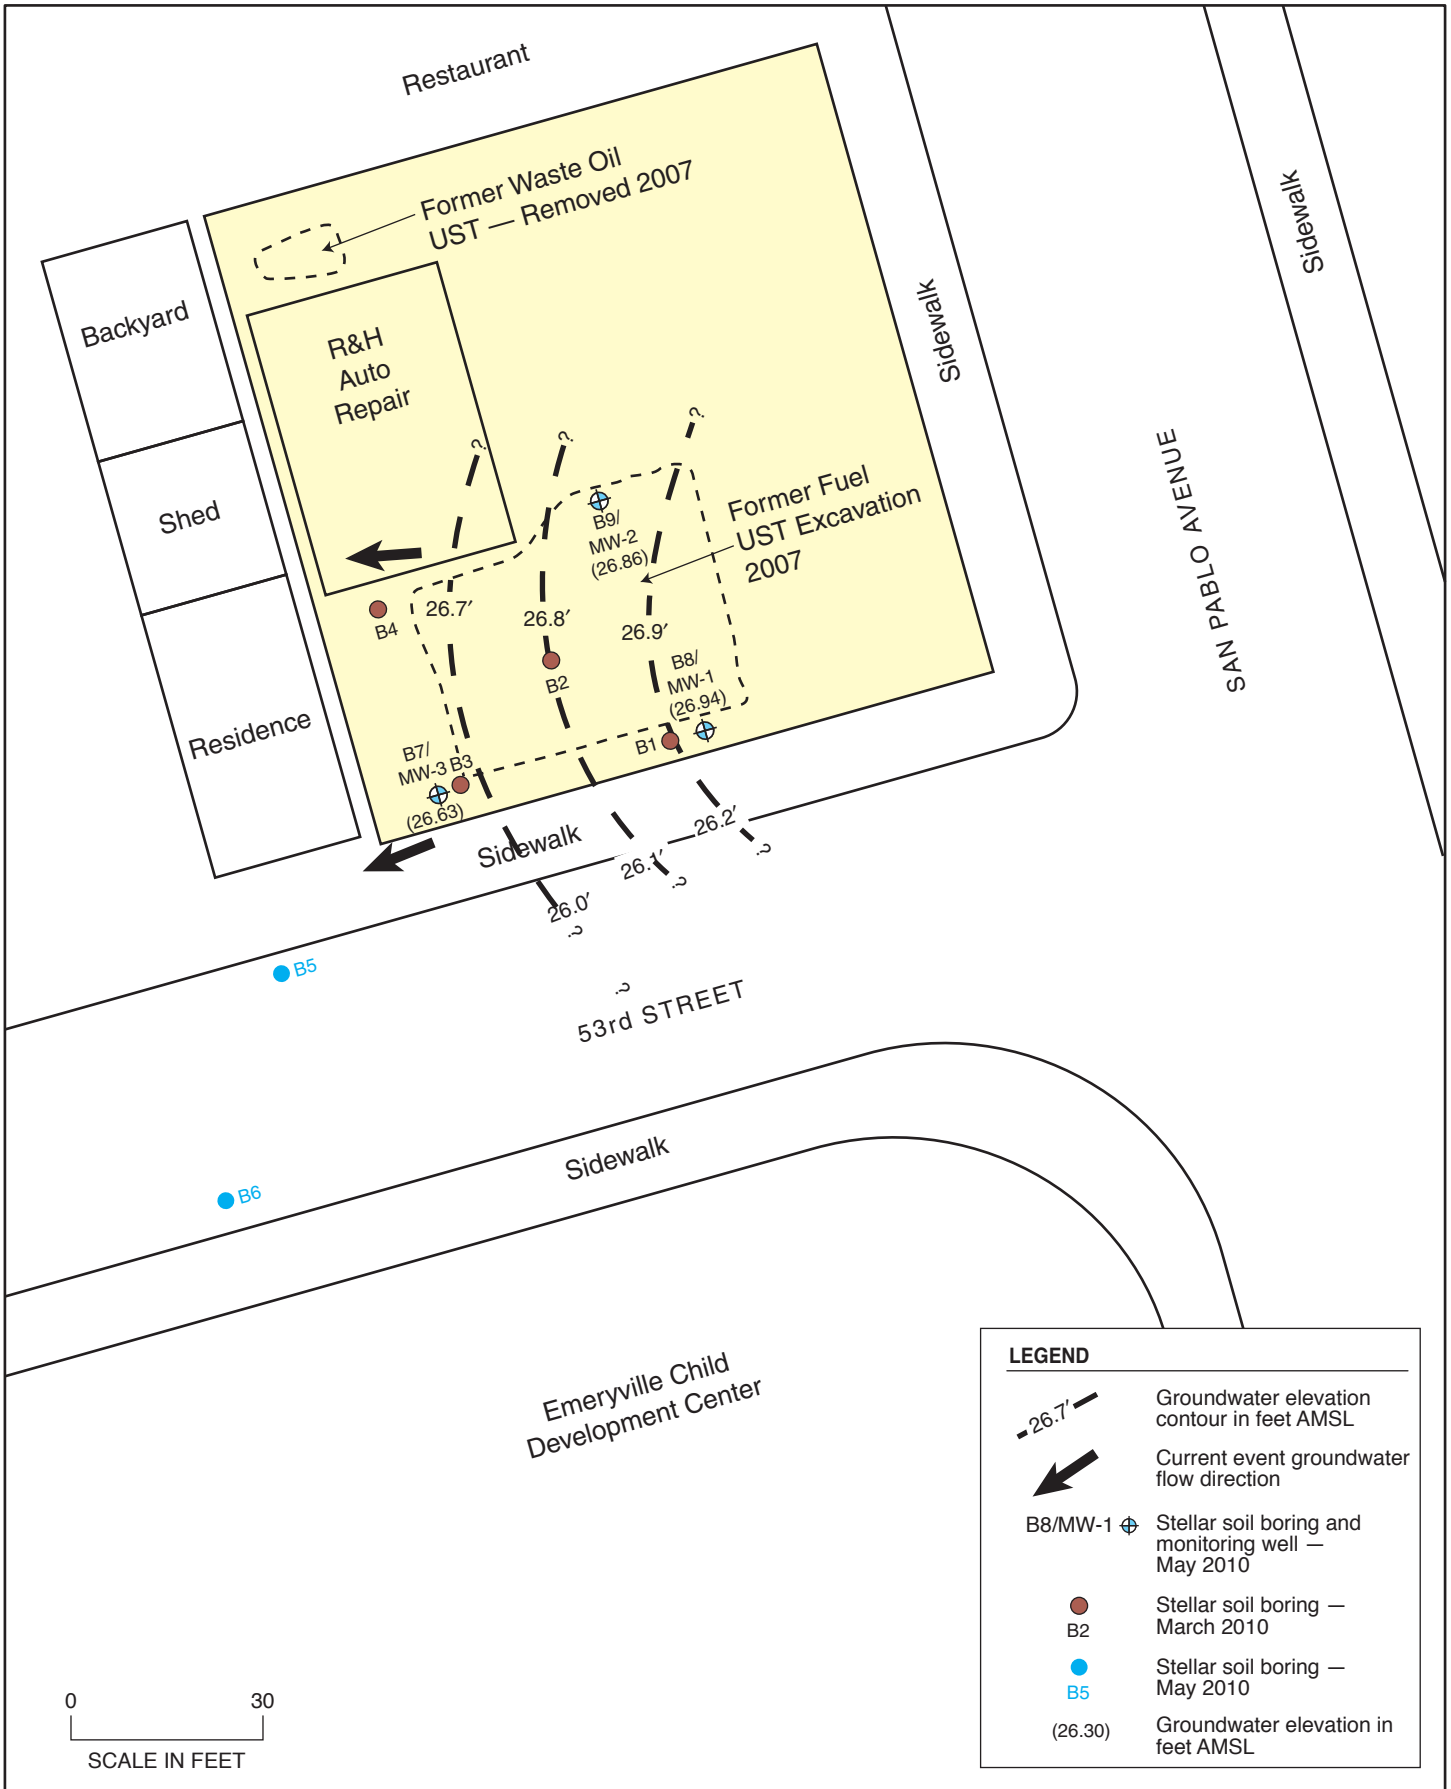
5315 San Pablo Avenue Oakland, CA	By: MJC	DECEMBER 2010
	Figure 4

Figure 4 is a groundwater potentiometric surface map for the current groundwater monitoring event that occurred on November 17, 2010 (activities discussed in Section 3.0).

GROUNDWATER ELEVATION MAP, NOVEMBER 17, 2010

measurement. The groundwater elevations and flow direction are generally consistent with previous measurements. Figure 4 shows the groundwater elevation map with the direction of flow indicated.

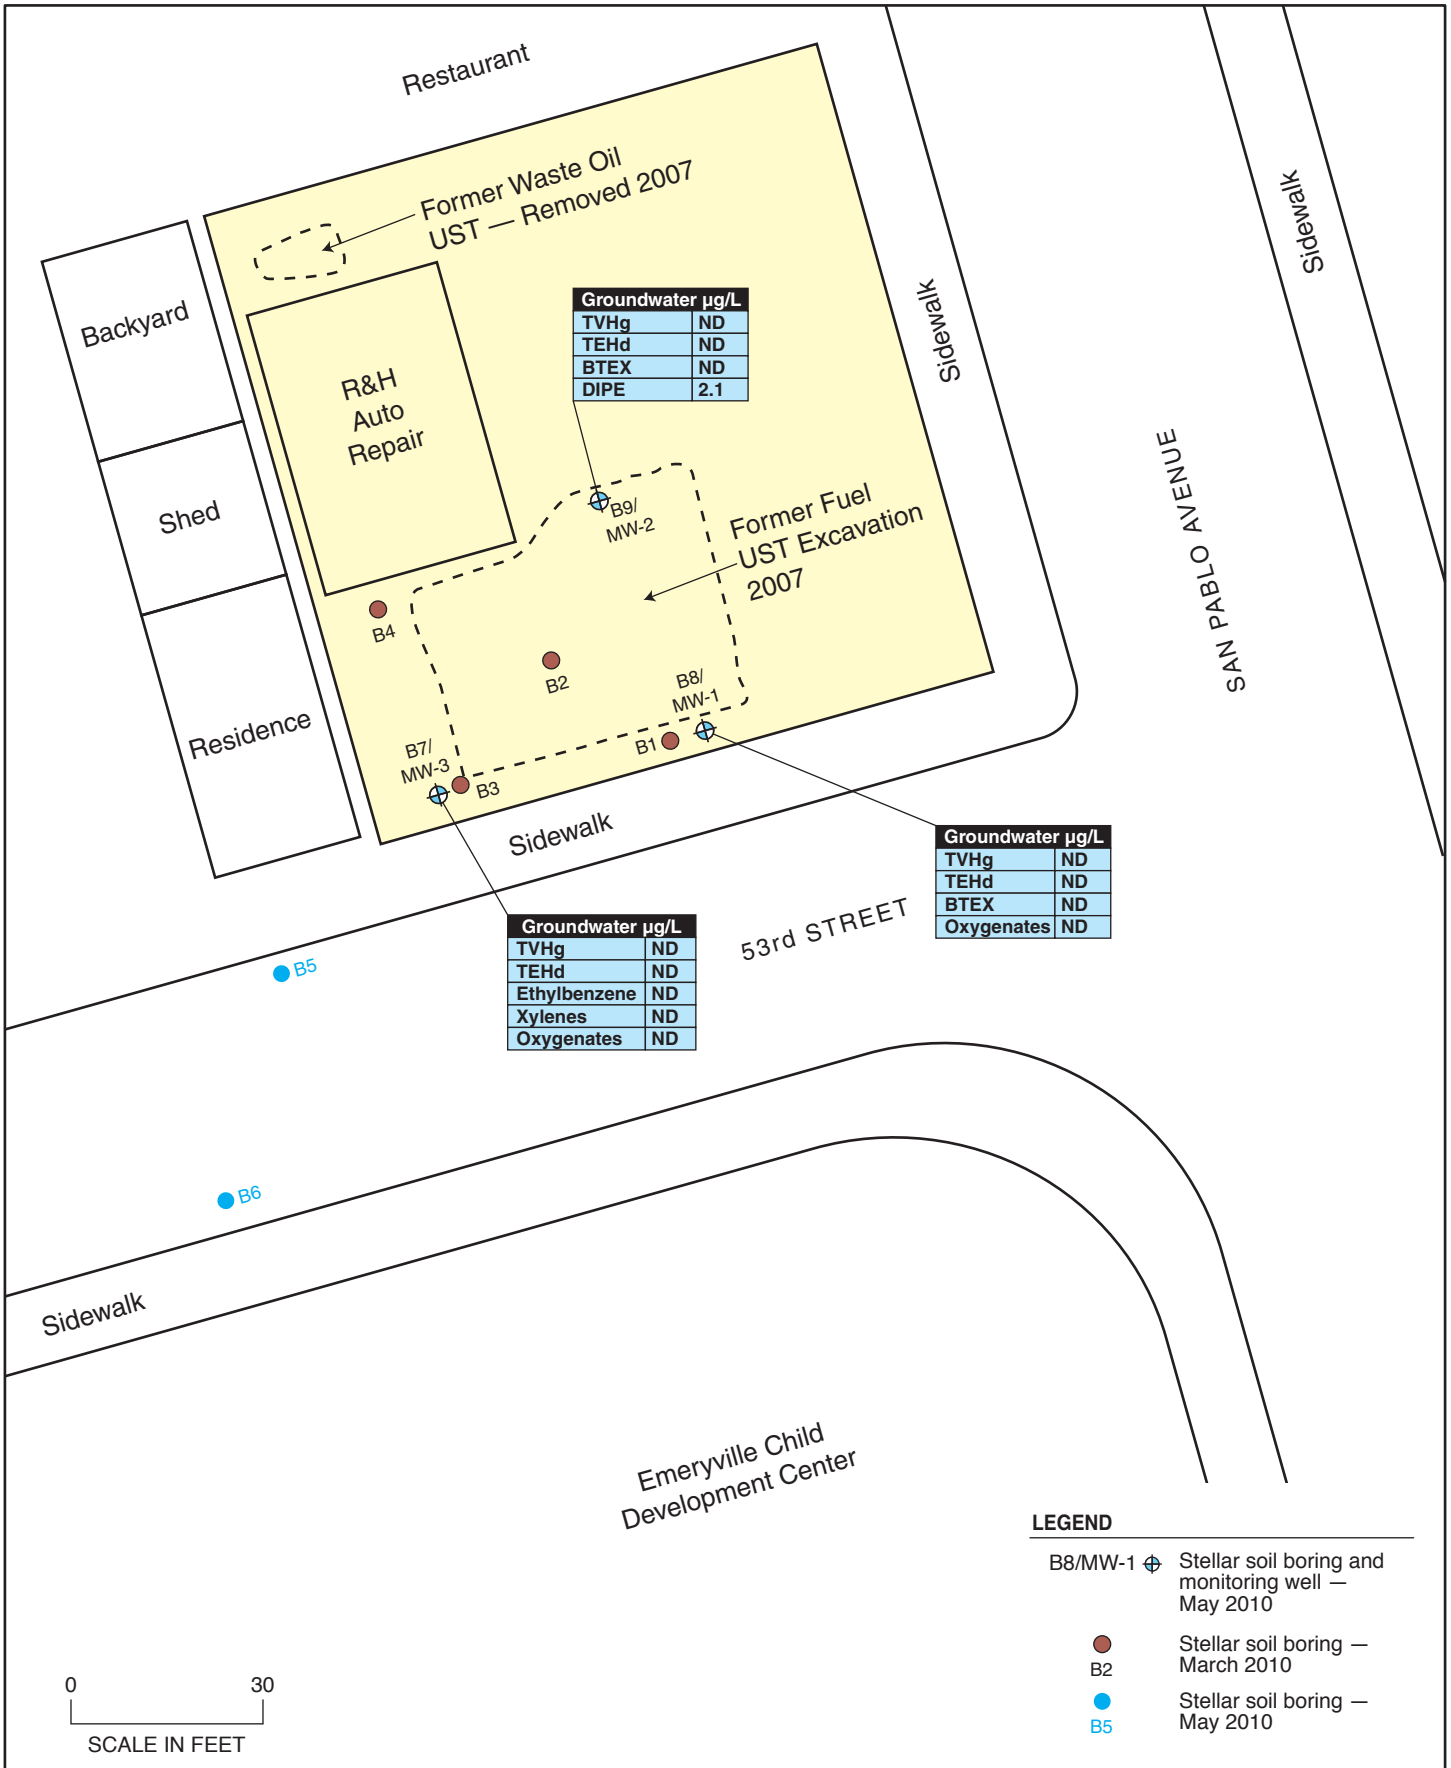
5315 San Pablo Avenue Oakland, CA	By: MJC	DECEMBER 2010
	Figure 5

Tables 2 and 3 summarize the analytical results of the current monitoring event. Appendix B contains the certified analytical laboratory report and chain-of-custody record. Figure 5 depicts contaminant concentration in groundwater.

Groundwater samples collected from wells MW-1, MW-2, and MW-3 did not contain detectable concentrations of TVHg or TEHd. Wells MW-1 and MW-3 did not contain detectable concentrations of BTEX or fuel oxygenates. The groundwater sample from MW-2 contained 2.1 µg/L of DIPE, but did not contain detectable concentrations of BTEX.

CONTAMINANTS OF CONCERN IN MONITORING WELLS, NOVEMBER 17, 2010
