**PRELIMINARY
ENVIRONMENTAL SITE ASSESSMENT**

**LATHROP PROPERTY
EMERYVILLE, CALIFORNIA**

June 1989

Woodward-Clyde Consultants

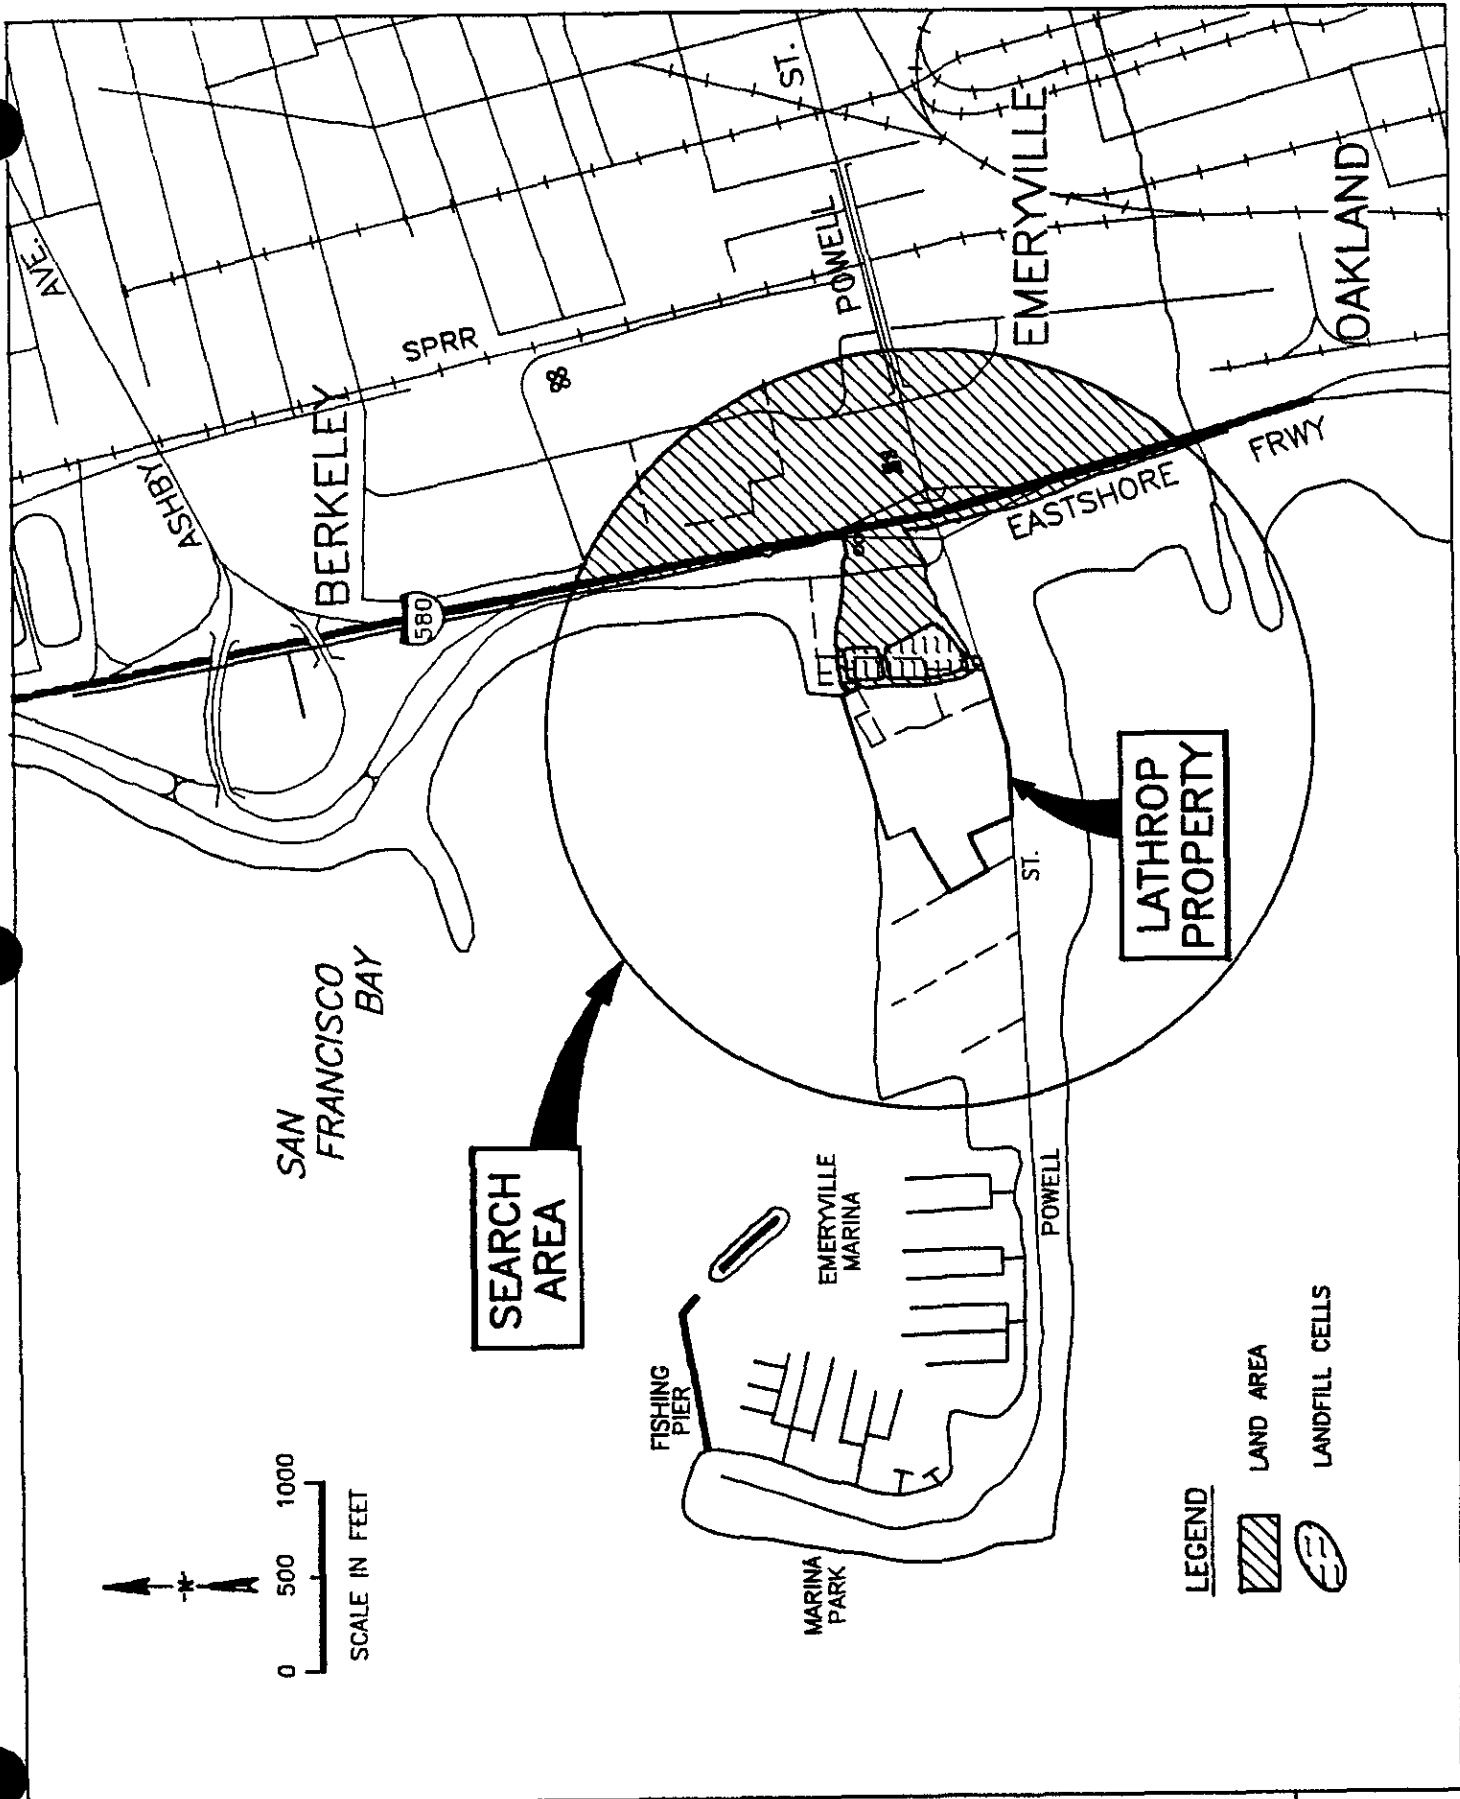
Project No. 8810235A	LATHROP PROPERTY ENVIRONMENTAL ASSESSMENT	1947 AERIAL PHOTO INTERPRETATION	Figure 2
Woodward-Clyde Consultants

pairs of aerial photographs were obtained for the years 1947, 1949, 1953, 1959, 1969, and 1971. The results of this study are presented in Figures 2 through 7. These results will be used to plan drilling locations for soil and water sampling during a future Phase II subsurface investigation. A brief discussion of each photo follows.

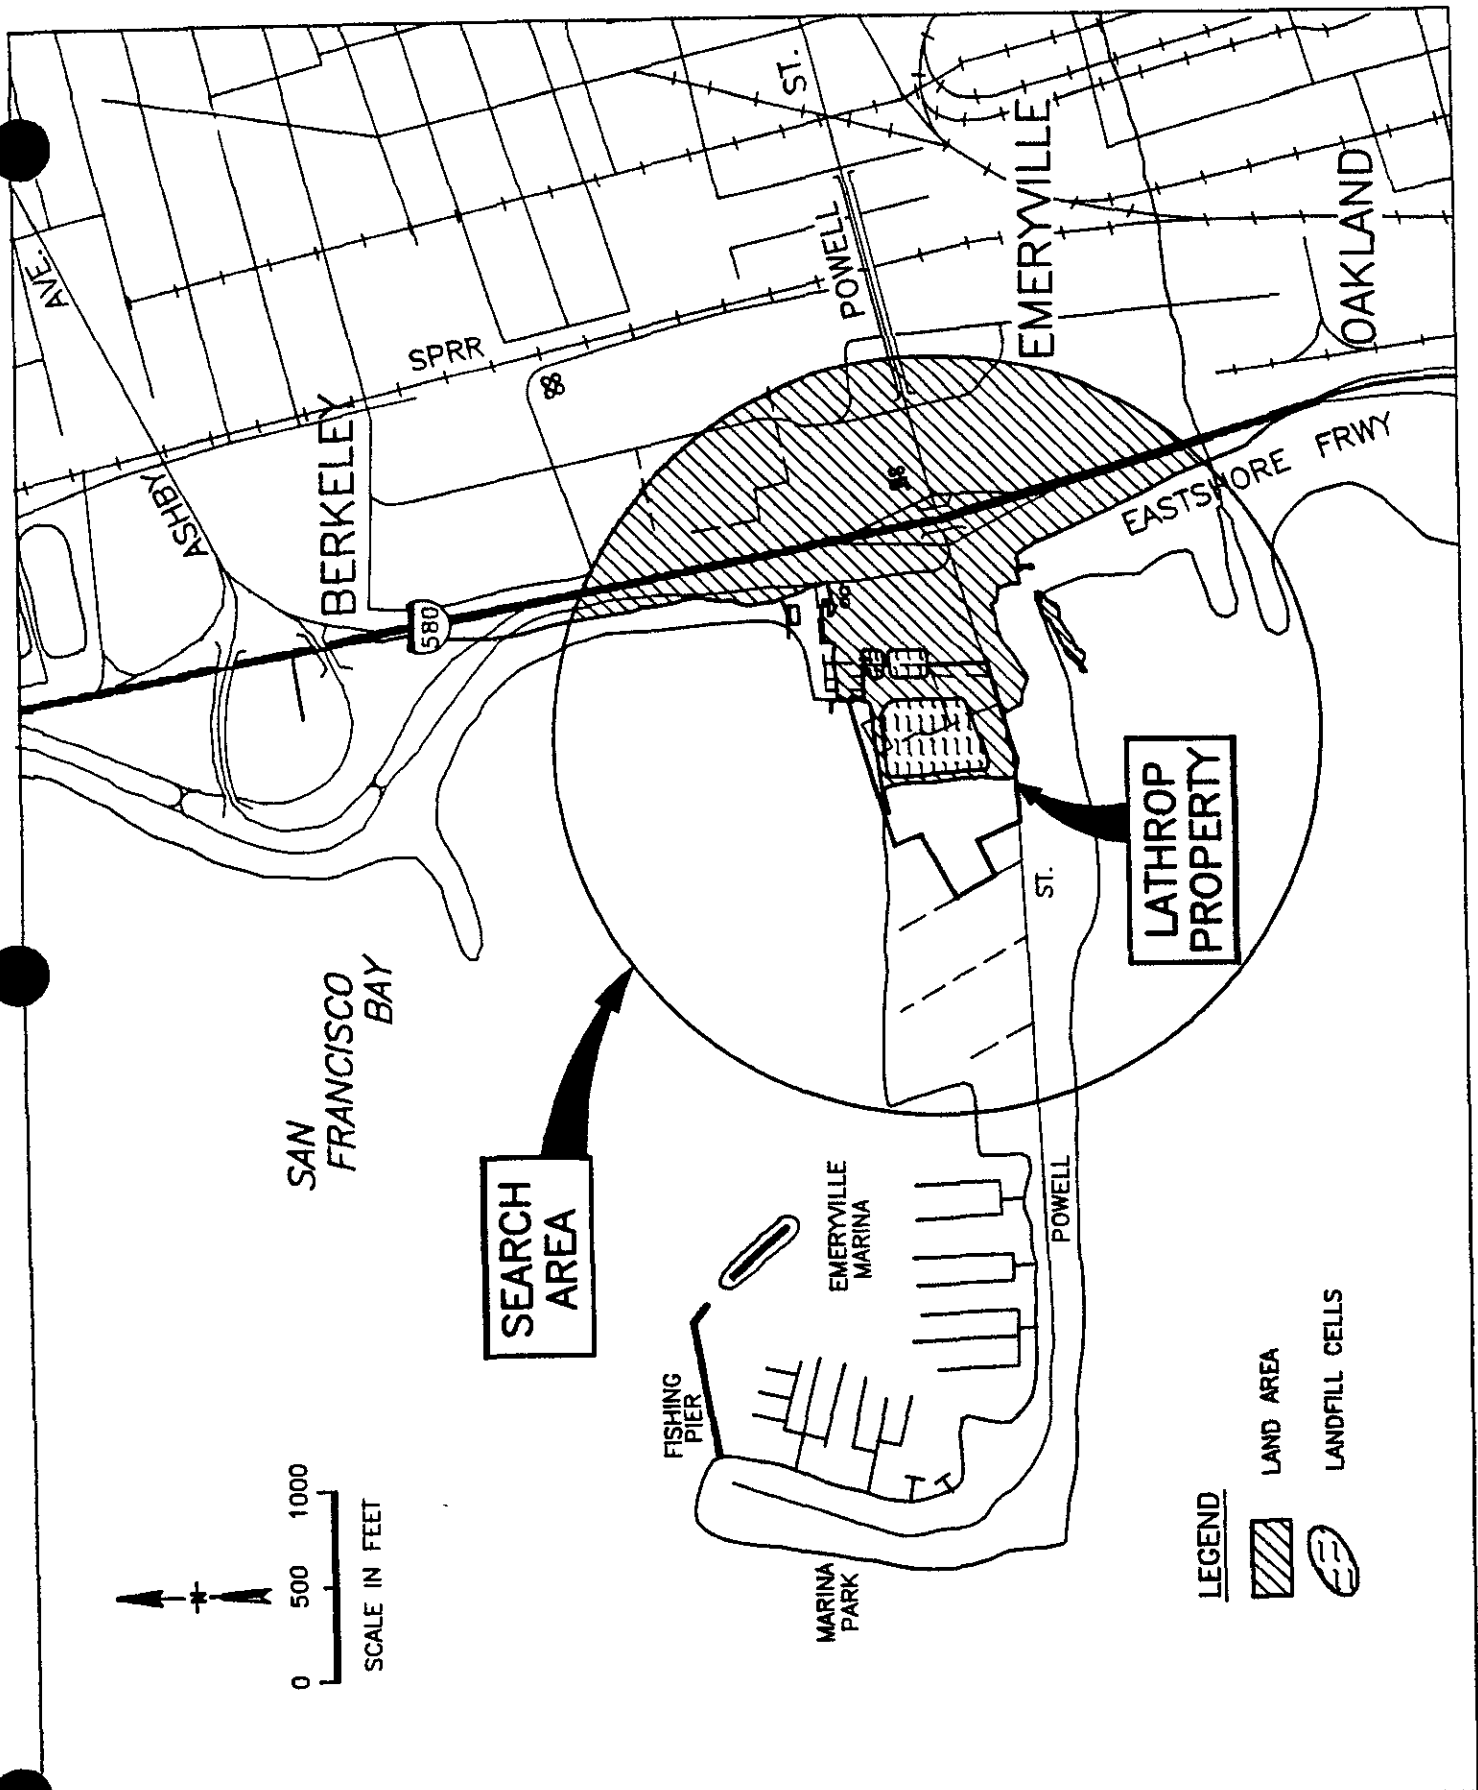
**Figure
4**

**1953 AERIAL PHOTO
INTERPRETATION**
