Subject: Corrective Action Implementation Work Plan
Pacific Gas and Electric Company, Oakland General Construction Yard
4930 Coliseum Way, Oakland, California

Corrective Action Implementation Workplan

Oakland General Construction Yard
4930 Coliseum Way
Oakland, California

January 2016

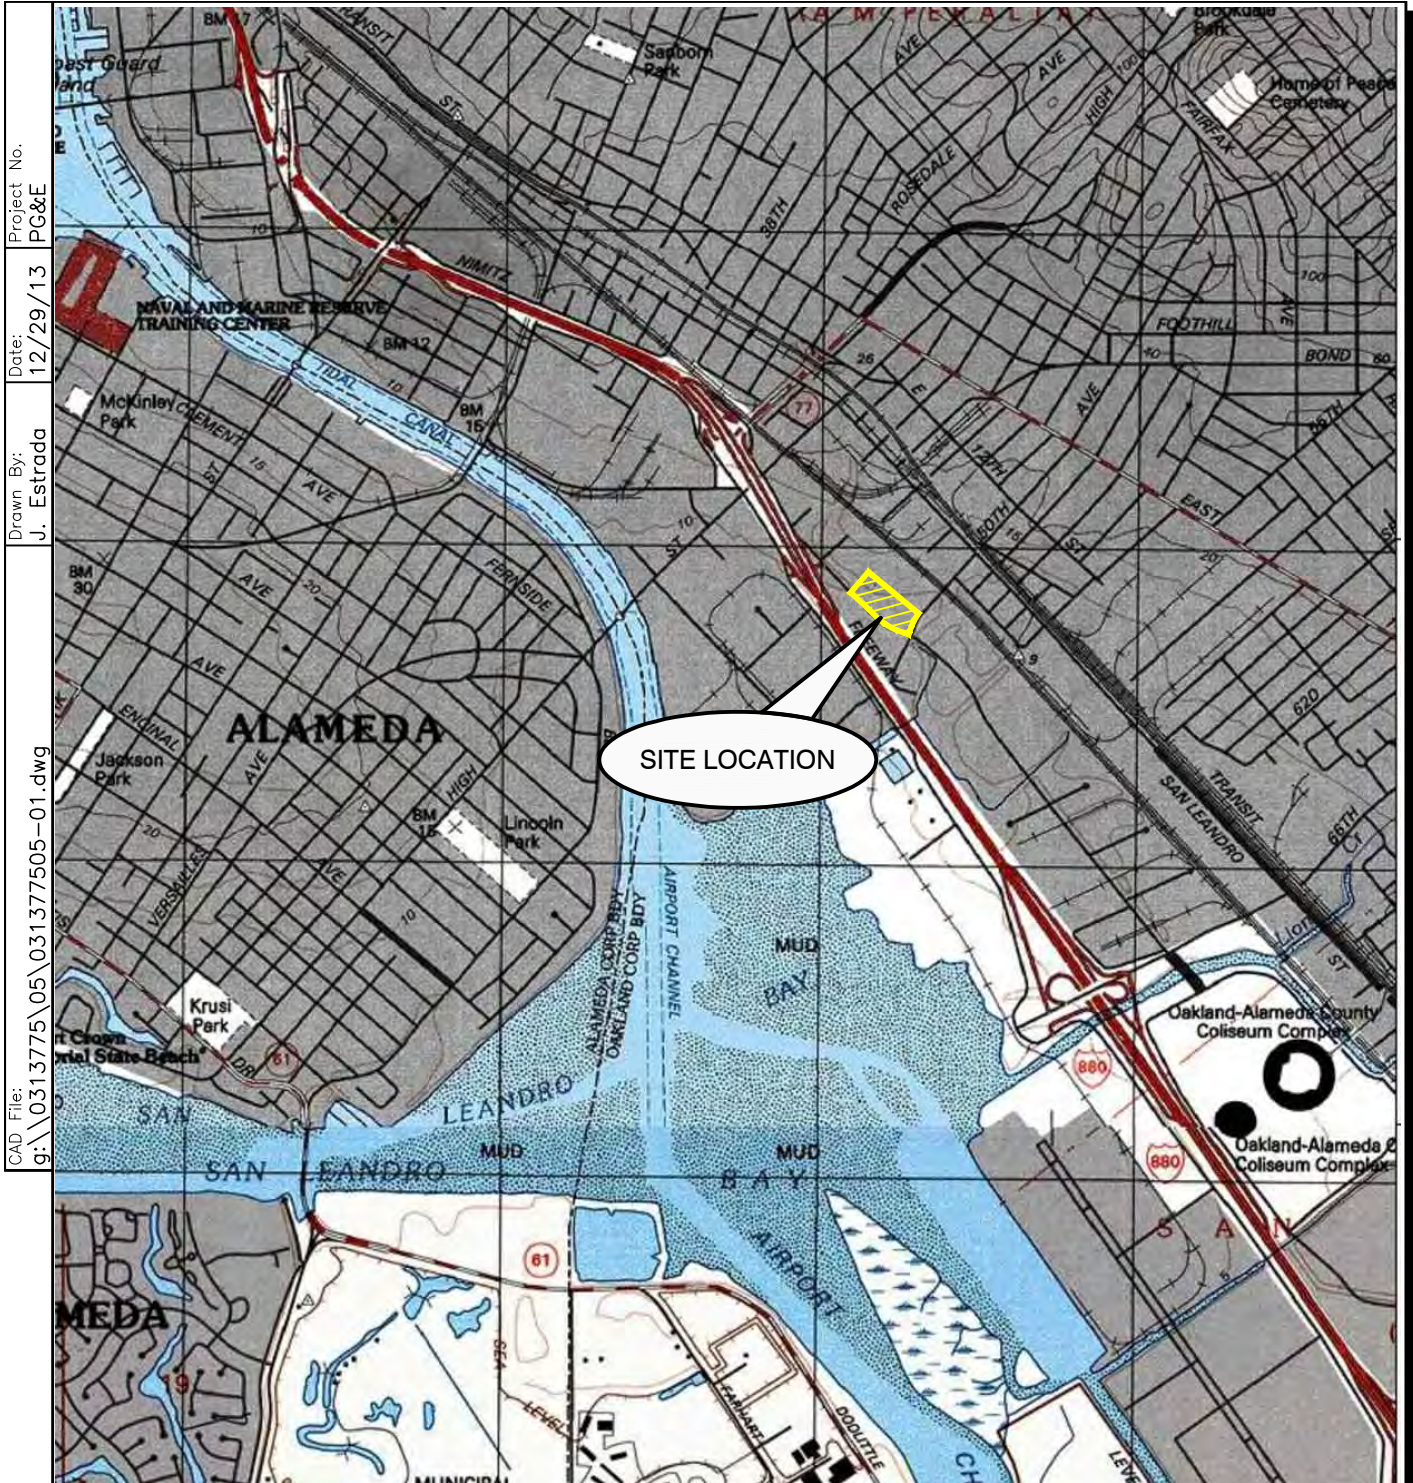
Figure 2
 Proposed Cap Repair Areas
 Pacific Gas and Electric Company
 Oakland General Construction Yard
 4930 Coliseum Way
 Oakland, California
 ERM 1/16

Primary requirements for cap integrity include no significant cracking, deterioration, standing water, or vegetation growth on any of the concrete surfaces. ETIC Engineering, Inc. (ETIC) conducted the annual inspection of the asphalt concrete cap located at the above-referenced site on 1 December 2015. Visual inspections by ETIC also included a photo documentation. The 2015 Cap Inspection Report is included as Appendix B. As detailed in the report, areas of the Cap that had previously been sealed or replaced were generally in good condition. However, areas within the sealed pavement were observed to have deteriorated and should be repaired as necessary to prevent further deterioration that might expose lead-impacted soil. Vegetation in the cracked asphalt decreased in 2015, but persisted along the perimeter of the Cap.

Recommended maintenance at the Site as shown on Figure 2 includes:

- Areas G and K: Vegetation removal and crack sealing;
- Areas C, E, I: Maintenance, repair, or replacement of approximately of asphalt with alligator cracking.
- Areas D, F, H, J: Asphalt containing cracks should be monitored for spreading, and sealed with asphaltic slurry as needed;
- Areas outside of the cap (areas A and B): Monitor for spreading and seal as needed; and
- Area to the southeast and outside of the Cap: Nine fencepost holes are recommended to be backfilled and sealed, as needed.

The proposed cap repair/replacement will be conducted in a manner consistent with the intent of the selected CAP alternative. The areas of the cap that require repair/replacement have been modified to reflect cap repairs conducted as part of facility operations and the results of the December 2015 cap inspection, as shown of Figure 2. Based on observations made during the 2015 cap inspection, the areas requiring replacement/repair do not consistently coincide with areas identified in the CAP. After assessing the site and consistent with the CAP, some areas outside of the cap will also be repaired and the cap boundary will be extended to include the area as shown on Figure 2. The specific activities to be performed for repair and maintenance are described below.

The areas of removal/replacement and repair are listed below and the approximate areas are shown on Figure 2. The varying thicknesses of asphalt are proposed to accommodate how the area is currently used (i.e., heavy traffic, parking of heavy equipment, etc.):

In areas with vegetated cracks (Area G), the vegetation will be removed to the extent practicable, and the cracks blown clean. The approximate area of the crack filling/sealing inside the cap is estimated to be 200 linear feet (Figure 2). The actual footage will be determined in the field. The cracks will be filled with a hot asphaltic emulsion and/or asphalt caulking troweled to a smooth finish.
