SUBJECT: Corrective Action Plan Development Report, Phase I
Cox Cadillac, 230 Bay Place, Oakland, California

Corrective Action Plan Development Report Phase 1

Cox Cadillac
230 Bay Place, Oakland, CA

April 1, 1996

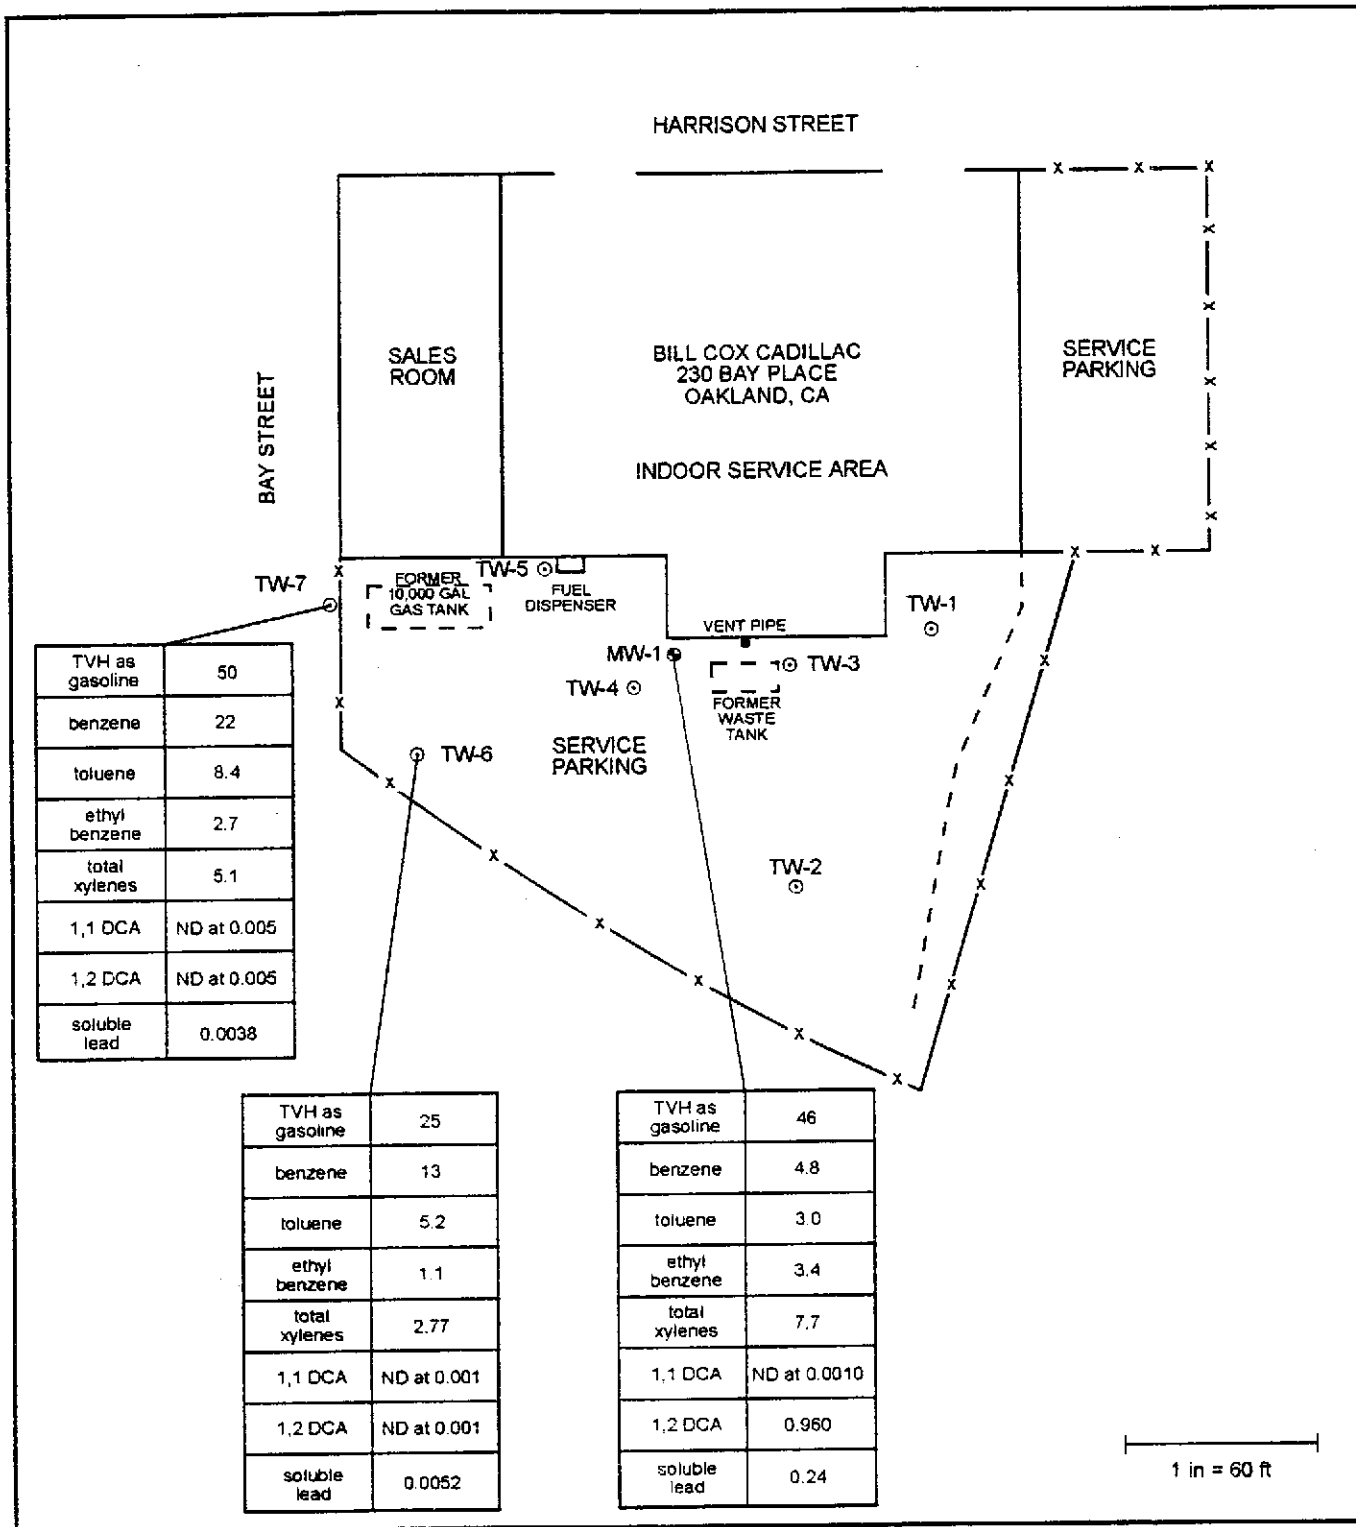
FIGURE 8a: GROUNDWATER ANALYTICAL RESULTS
FEBRUARY 23, 1996

January 1994 after the tank was excavated. The samples were collected in the south and north sidewalls of the tank excavation at depths of 4 and 5 feet, respectively. Samples S-1, S-2, S-3, S-4, and S-5 were collected in June 1994 after additional soils were excavated from the pipe trench. Soils were excavated to depths ranging from 5-8 feet (Figure 7). Soil samples were collected at depths ranging from 3-7 feet (Table 2). The maps of estimated hydrocarbon impacts to groundwater are based on the most recent groundwater sampling and analyses on February 23, 1996 (Table 3 and Figure 8a). Results of the hydropunch sampling are shown on Figure 8b.
