PHOTOS TAKEN BY RON OWCARZ  
AT UGT MODIFICATION AT VICKY  
SHELL, 2120 MONTANA ST. IN OAK.  
ON 7/6, 7/19 + 7/20/93

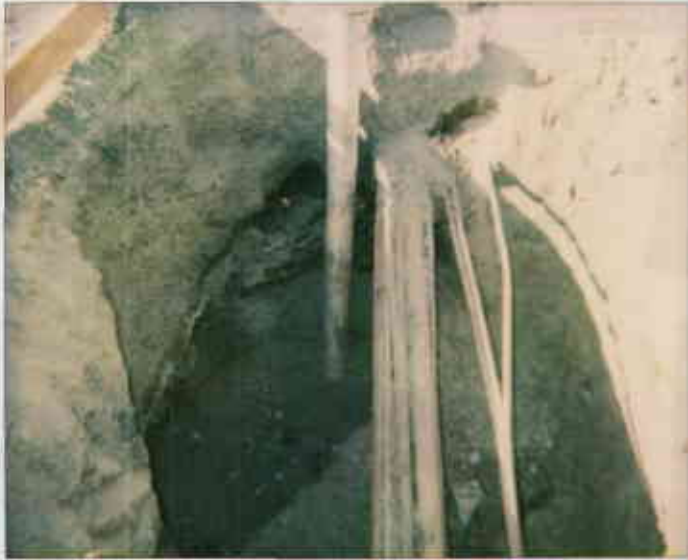
7/20/93-Photo taken by Ron Owcasz at Bansal Shell, 2120 Montana Ave. in Oak. Red caps indicate soil sample locations in side wall of pit overexcavation for UGT pipe med. @
