Re: Site Closure Report
P&D 23rd Avenue Associates
1125 Miller Avenue, Oakland, CA
Clearwater Project No. CB018
ACEH Fuel Case Leak No. RO0000294

SITE CLOSURE REPORT

23rd Avenue Partners
1125 Miller Ave.
Oakland, California

October 3, 2002

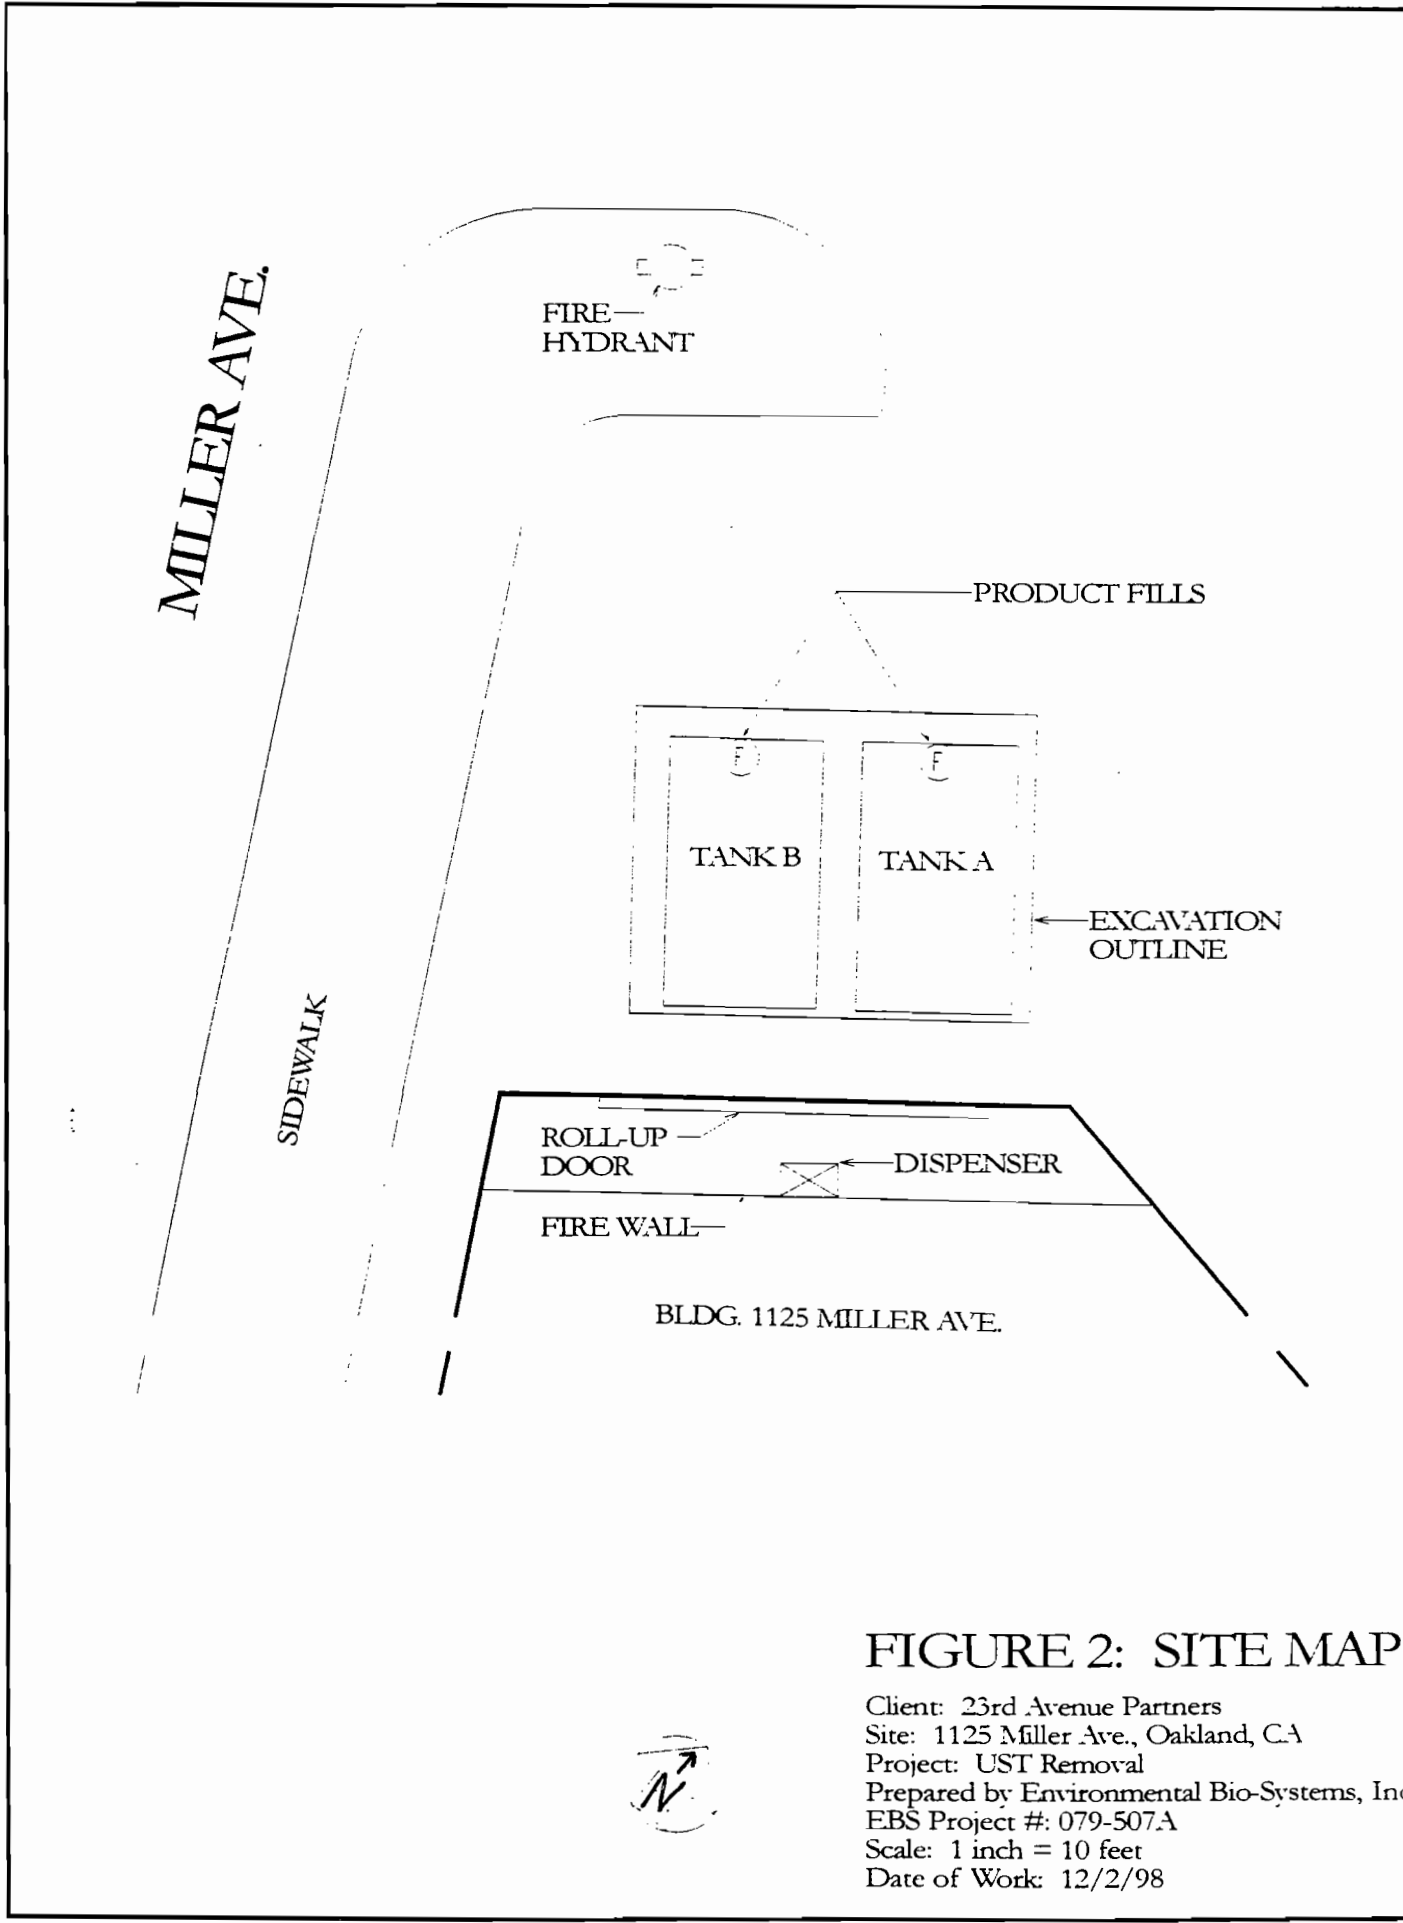
FIGURE 2: SITE MAP

TW3
TPHd=800
B=0.90

TW2
TPHd=660
B=65
T=2.4
X=3.2

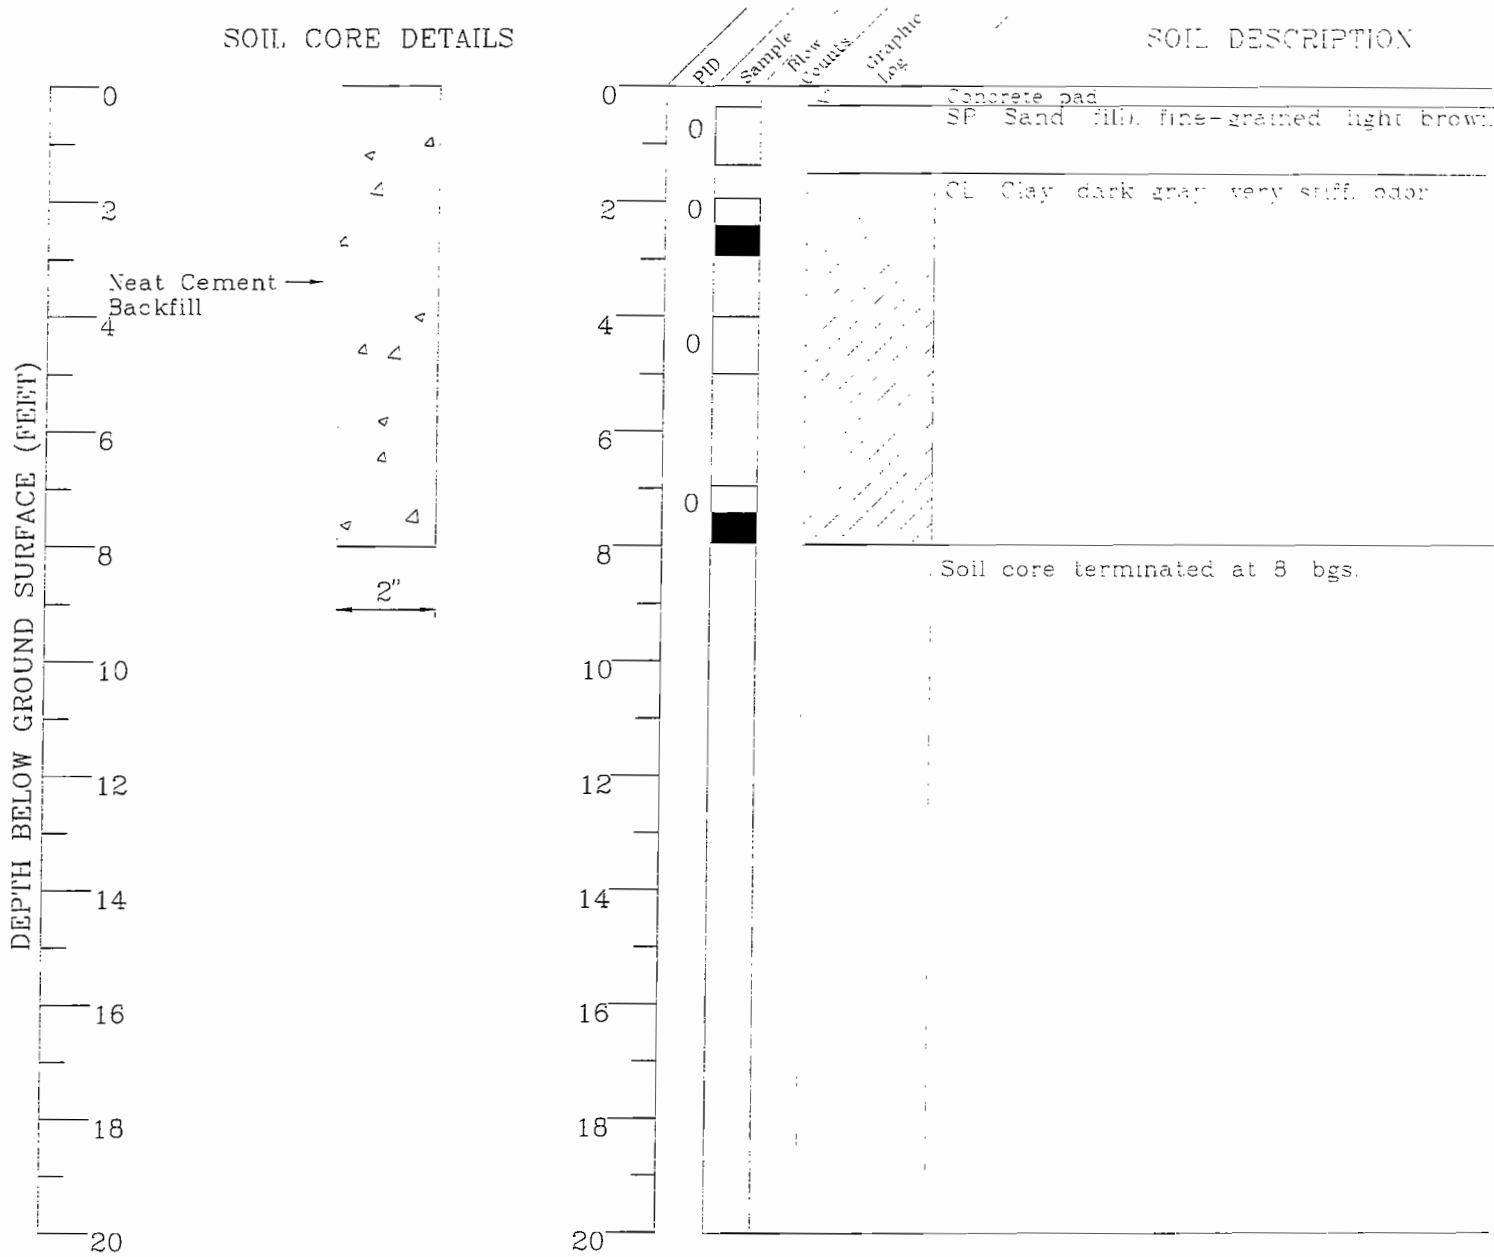
LOG OF SOIL BORING D1

Analytical Results Soil sample TW2-16.5' was found to contain 4,200 mg/kg TPHd and 1.4 mg/kg benzene. Soil sample TW3-17' was found to contain 2,700 mg/kg TPHd. Soil samples D1-3' and D1-8' were found to contain 3,400 and 34 mg/kg TPHd, respectively. Groundwater sample TW2-H₂O was found to contain 660 µg/L TPHd, 65 µg/L benzene, 2.4 µg/L, toluene, and 3.2 µg/L total xylenes. Groundwater sample TW3-H₂O was found to contain 800 µg/L TPHd and 0.9 µg/L benzene. The results were presented in an EBS Subsurface Exploration Report dated December 31, 2001.

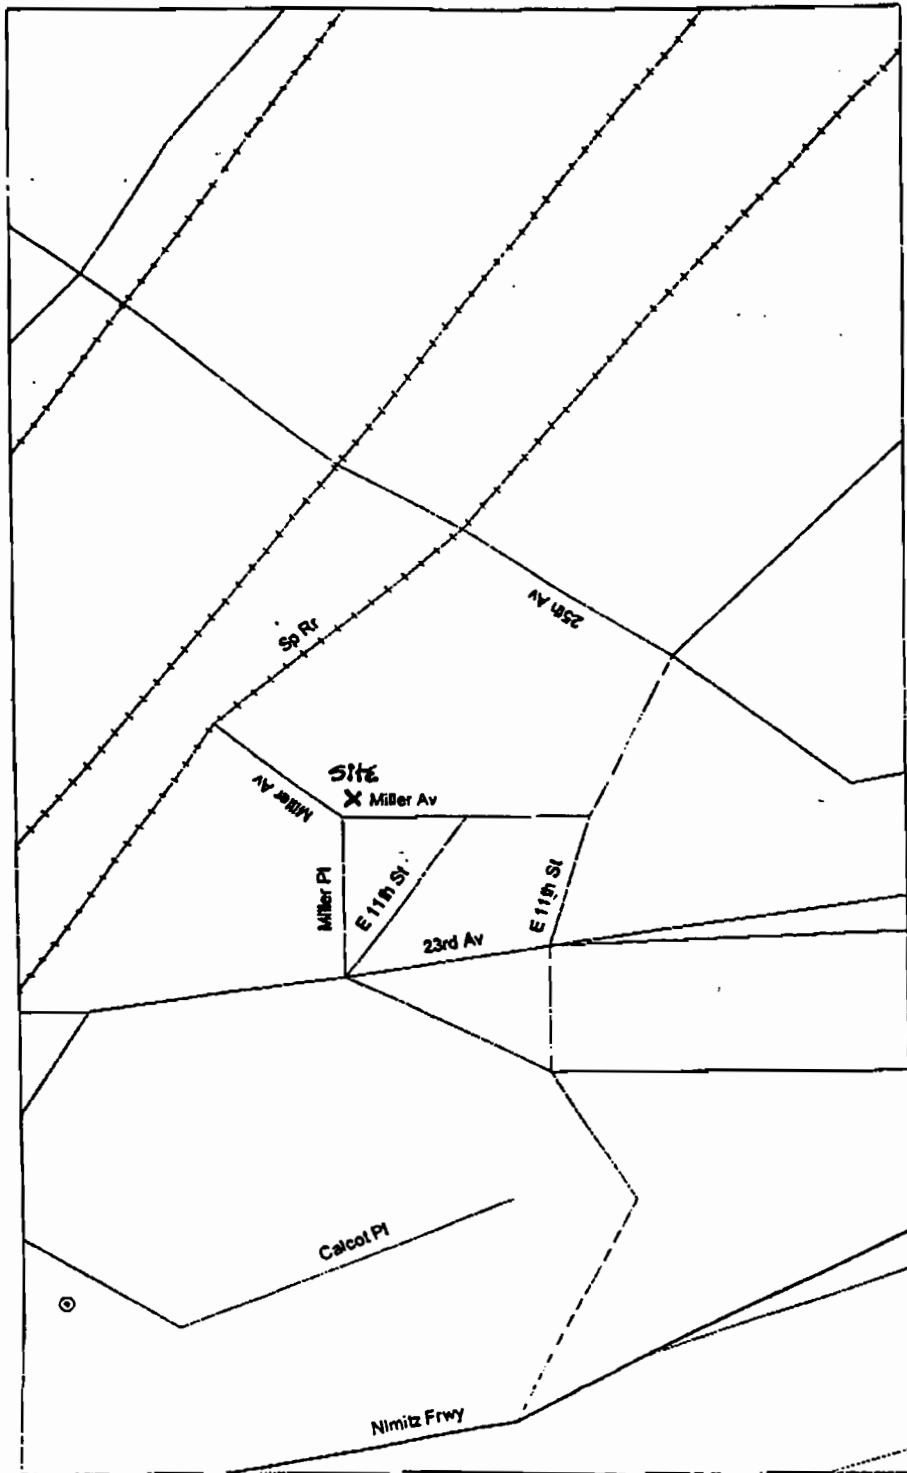
FIGURE 5: WELL SEARCH MAP

EBS contracted with Environmental Data Resources for a database report with reported water wells, and public water supply wells posted on the map. No wells were found on the Federal USGS Well Information Database, the Federal FRDS Public Water Supply System Information Database or the State Database Well Information System within 1,000 feet of the Subject Property.
