Subject: Cap Status Assessment Report
September 2016
64th Street Properties, Emeryville, California
(EKI 990016.08)

**PHOTOGRAPHS TAKEN FOR THE CAP
STATUS ASSESSMENT
(ON 29 AUGUST 2016)**

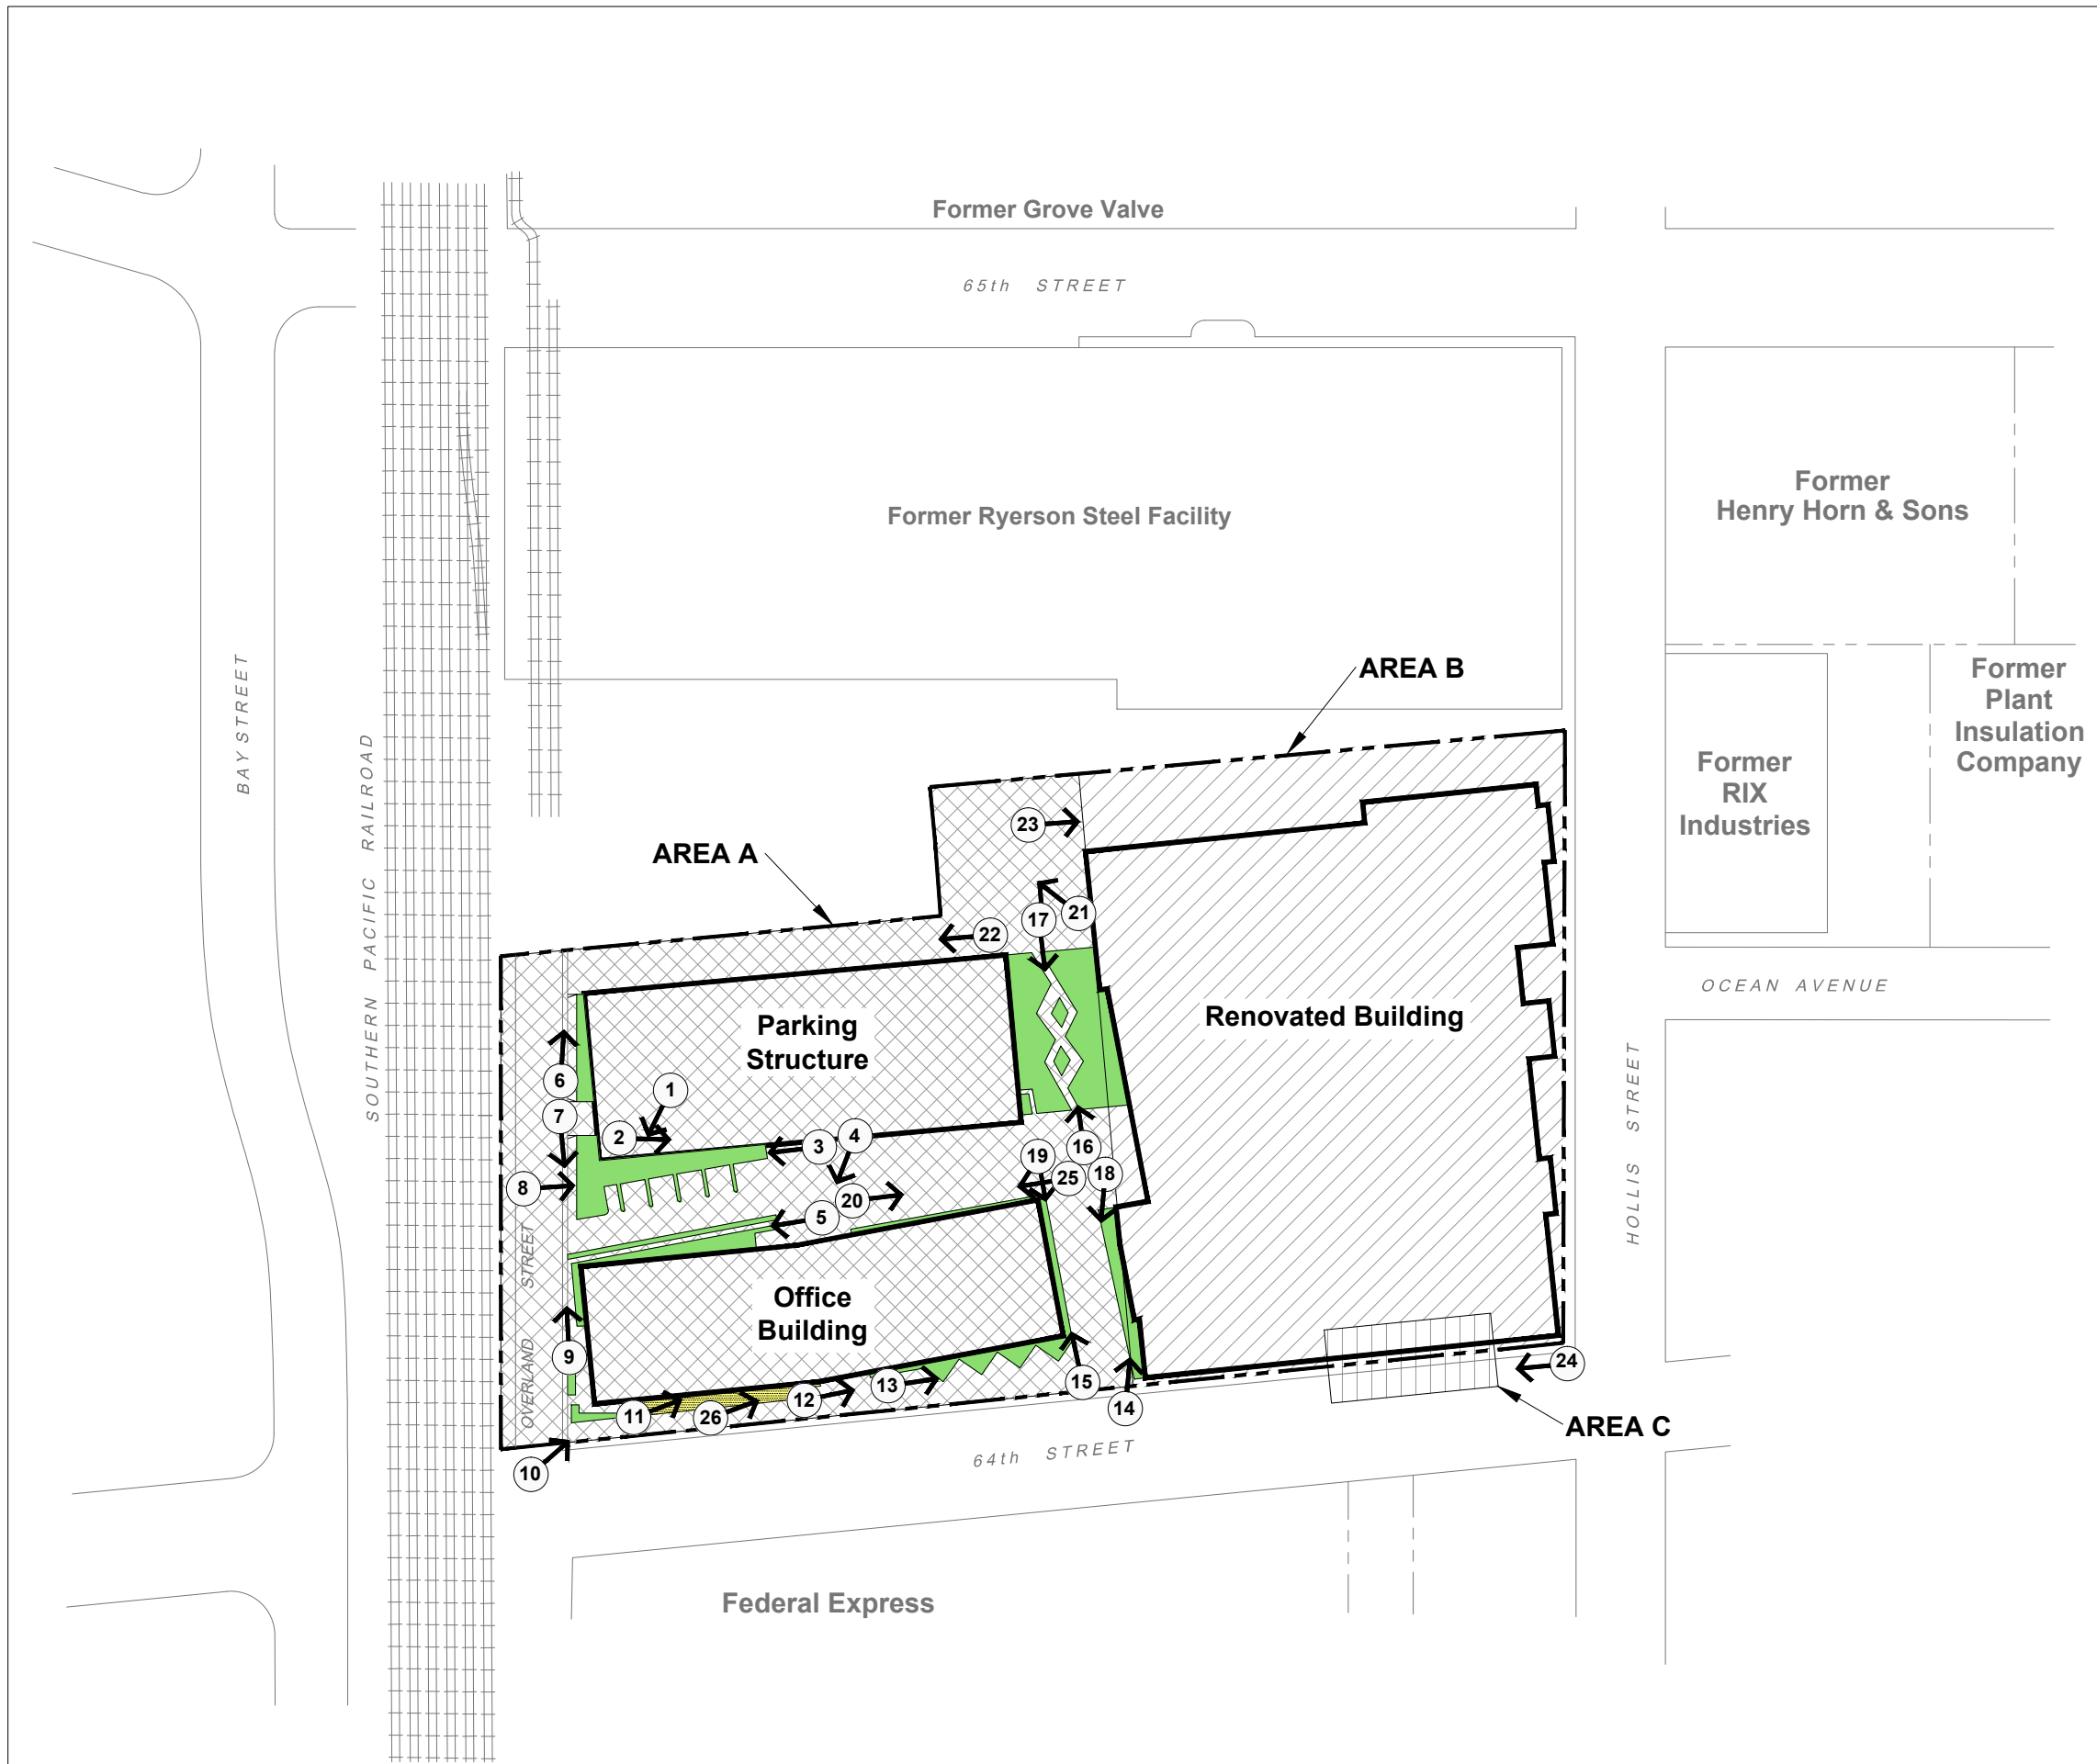
Cap Status Assessment
Photograph Locations

In accordance with the RMP, Areas A and C are required to be covered with buildings, asphalt, concrete, or 3 feet of clean fill in landscaped areas. Areas A and C are shown on the figure included as Attachment B. In accordance with the RMP, EKI observed the Site landscaped and paved areas to assess whether the cover materials are significantly damaged or disturbed. On 29 August 2016, EKI conducted a visual cover system status assessment. The landscaping appeared to be in place as it was two years ago with no visible signs of degradation. The paved areas were also observed to be in good condition, except for some cracks in the sidewalk along the southern edge of Area A (Photo 26, Attachment C). Photographs taken for the cap status assessment are included as Attachment C. Refer to Attachment B to identify photograph locations.
