Challenge Dairy Products

Summary Report:

Soil and Groundwater

Investigation and Remediation

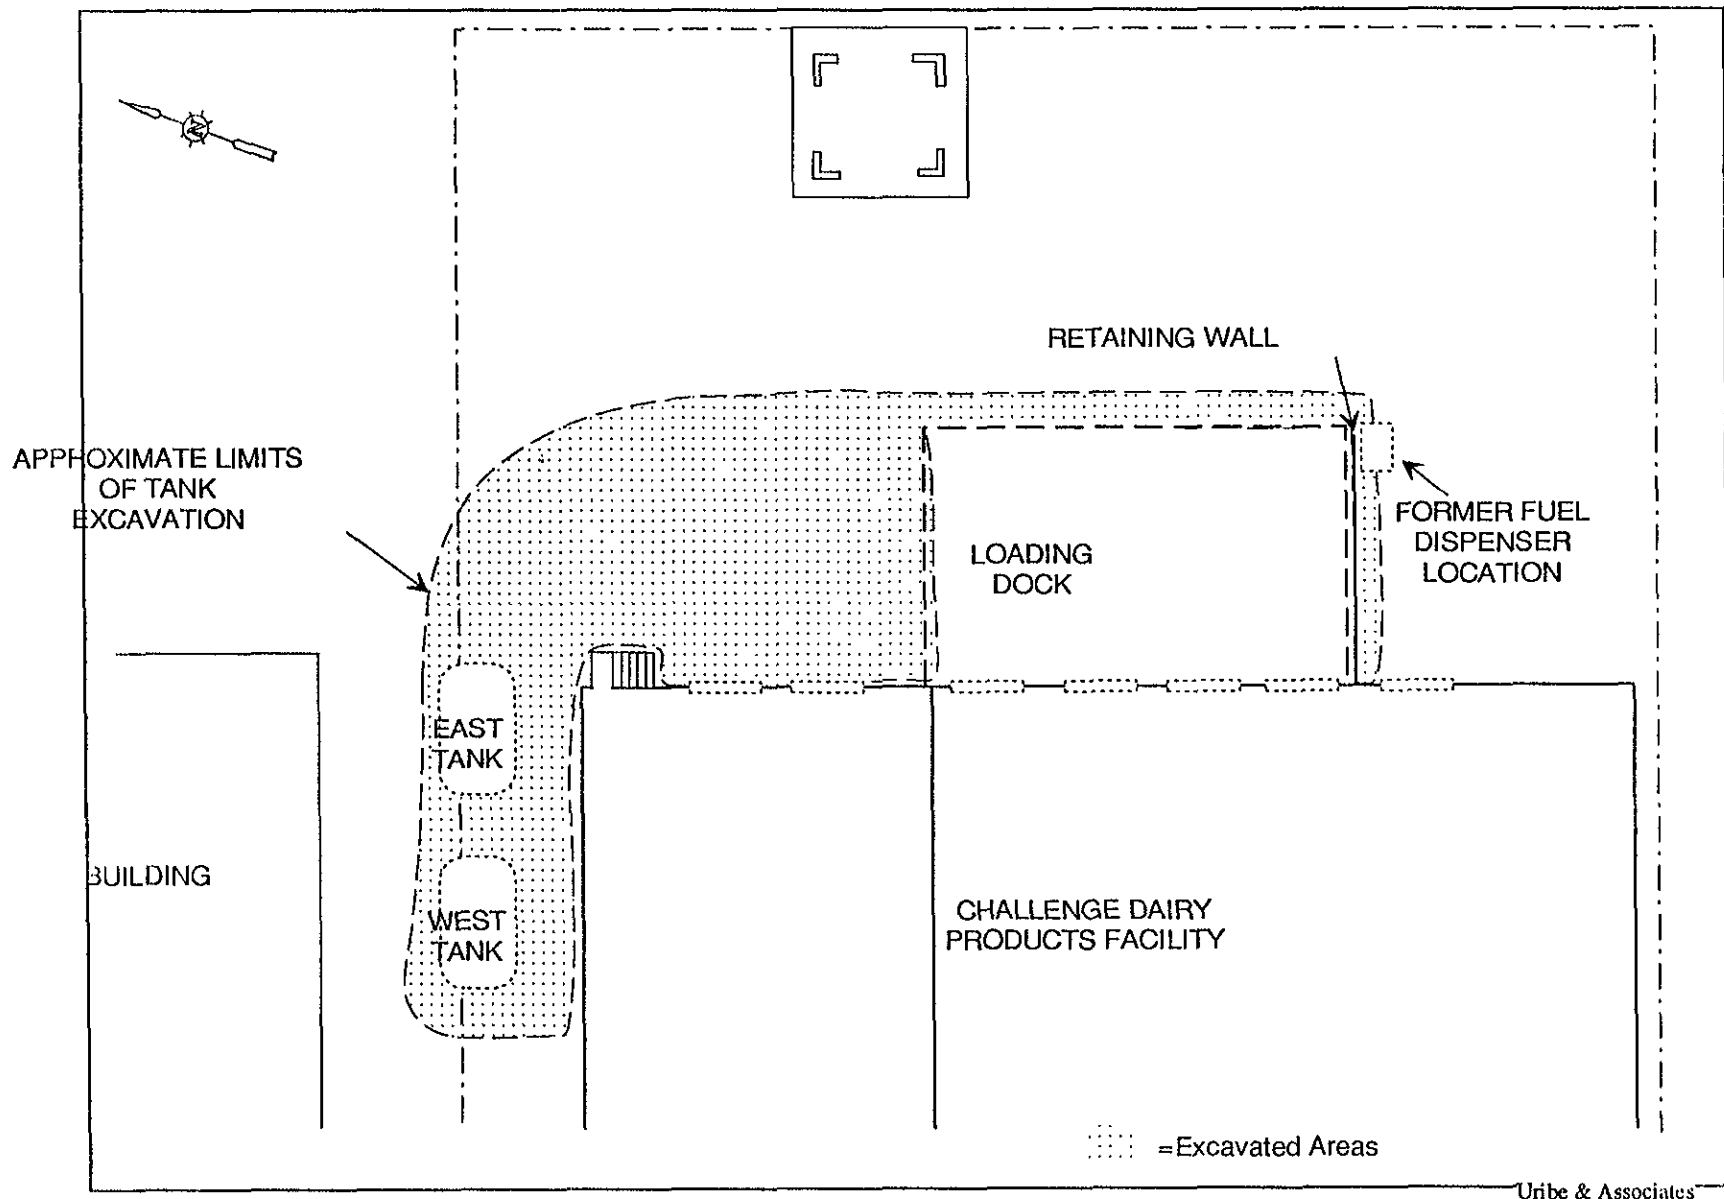
Figure 2-2: Excavated Area - Challenge Dairy Facility

The Catalina Business Park is located in southwest San Leandro approximately 0.8 miles east of the San Francisco Bay. The Challenge Dairy Products Inc. distribution facility consists of one lot (# 87) of the Park. The lot contains one single story building with approximately 26,400 square feet of floor space (163' x 163'). The lot itself is approximately 56,900 square feet, 30,475 square feet of which is used for truck parking and landscaping (see Figure 2-1). The truck parking area is covered in asphalt ranging from 3 to 4 inches in thickness. A six inch thick loading dock pad made of concrete is located on the south-east side of the building. This concrete pad underlaid both loading dock areas before soil excavation operations removed the northern portion (see Figure 2-2).

The two removed underground storage tanks were located end-to-end just north of the building on the center line between lot 87 and 81 (see Figure 2-2).

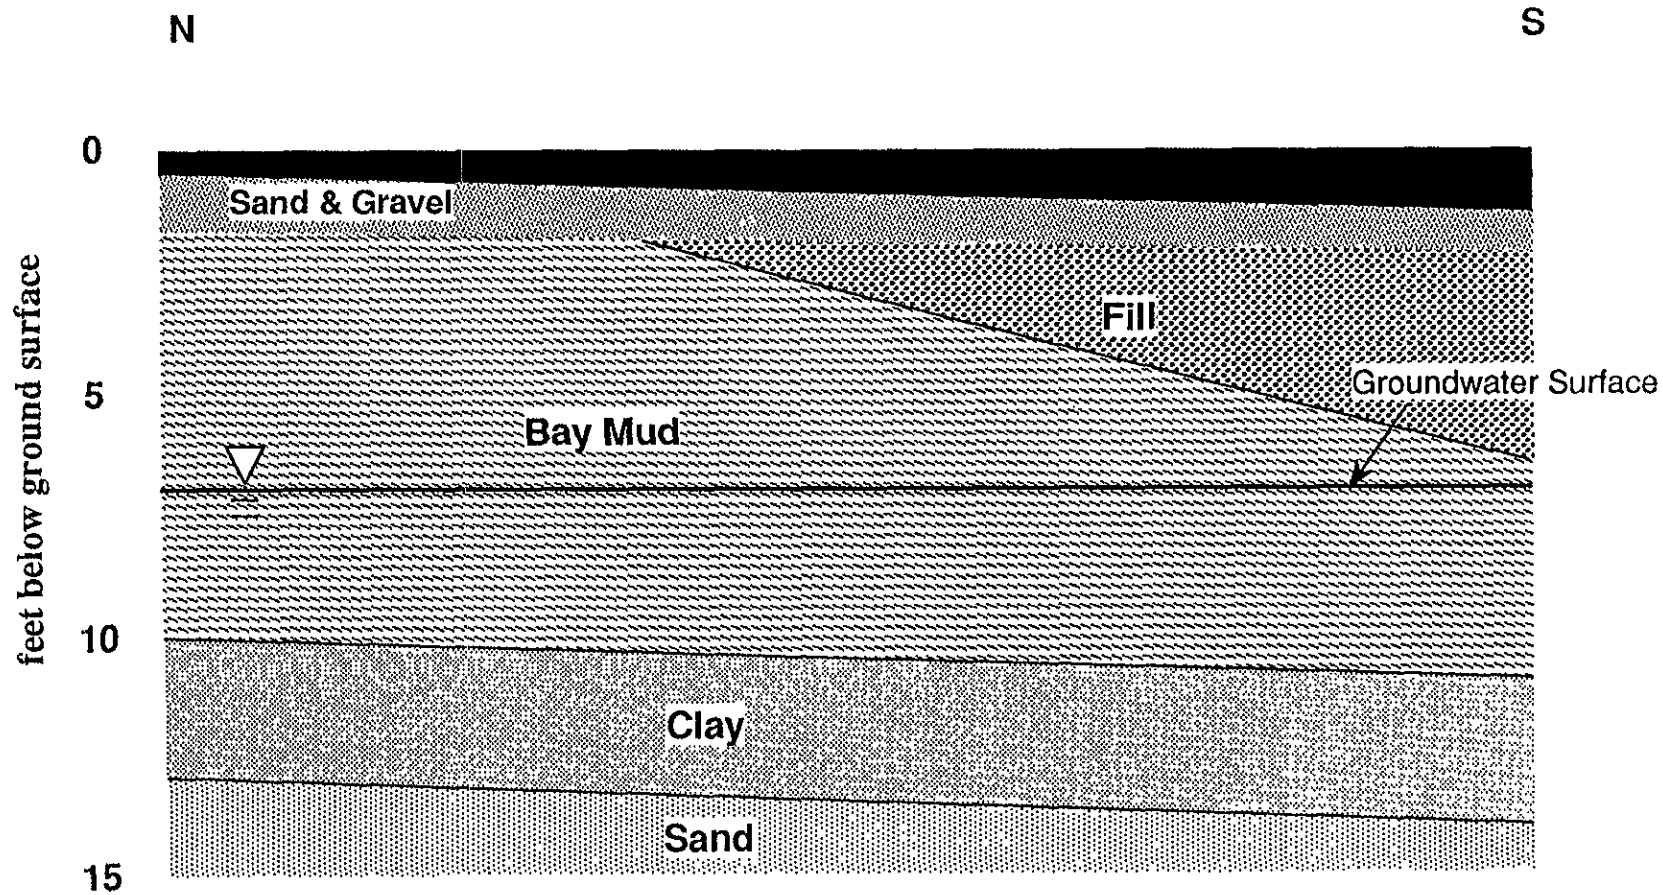
Figure 2-3	Uribe & Associates
GENERALIZED (N-S) CROSS SECTION	CHALLENGE DAIRY PRODUCTS FACILITY UNDERGROUND TANK REMOVAL

The area was historically a tidal marsh or mud-flat combined with intermittent inlet channels. Sand and gravel ranging from 0.5 feet to 1.5 feet in thickness underlies the asphalt. In the southwest areas of the site, a fill consisting of broken asphalt, concrete, black sand and dark reddish brown sand was found ranging from 1.5 feet to 6.5 feet in thickness (Golder, Ref. #3). This fill was apparently deposited in the late 1960s (Minney, Ref. #5). Debris, such as spark plug cables and a fan belt, was found in this fill approximately four to five feet below the ground surface in the area of the excavated loading dock (per conversation with Tom Ditto, 8/14/91). Beneath this fill is a layer of native clays and silts ranging from 3.5 feet to 9 feet in thickness. Approximately 14 feet below ground surface, an olive colored sand begins to appear, characteristic of natural bay channel deposits. Figure 2-3 is a generalized cross section of the upper 15 feet of the subsurface.

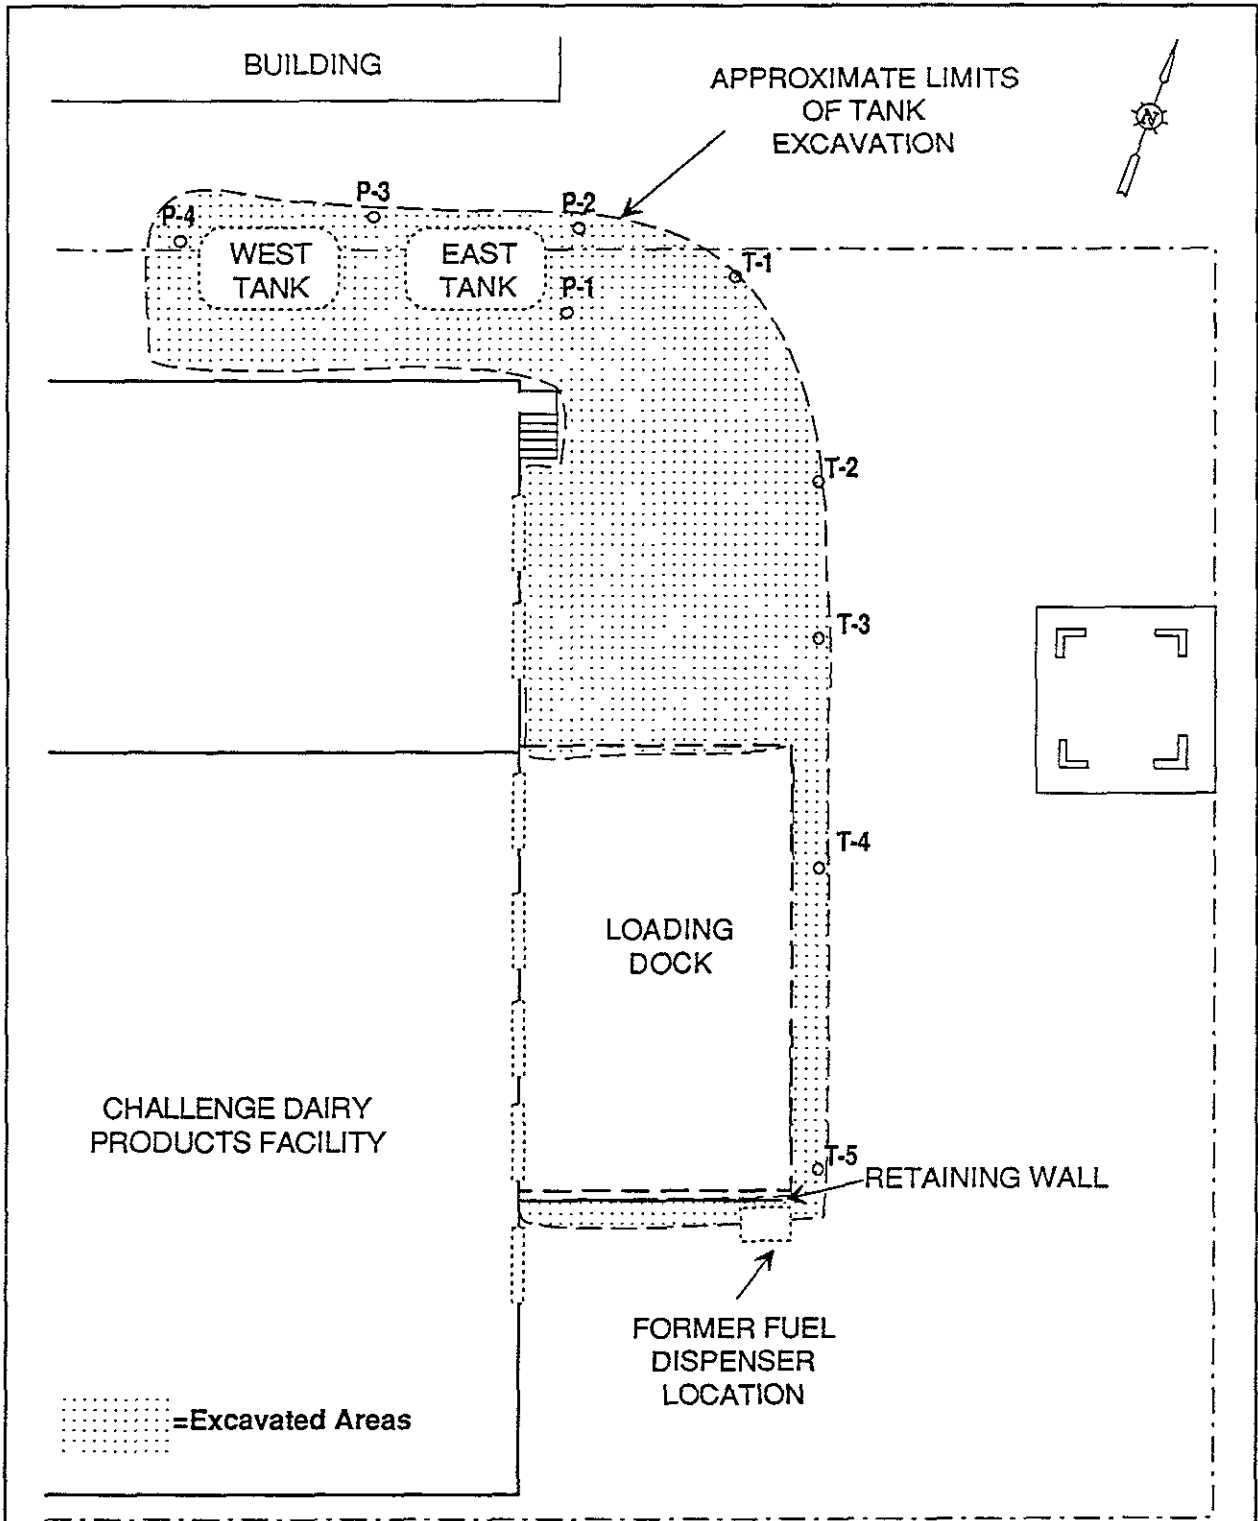
Figure 3-2	Uribe & Associates
SOIL AND GROUNDWATER SAMPLE LOCATIONS FROM GOLDER REF. #2	CHALLENGE DAIRY PRODUCTS FACILITY UNDERGROUND TANK REMOVAL

The soil sampling locations were discussed with the San Leandro Fire Department representative who was on site during the excavation to inspect the excavation activities. A total of nine samples were collected. The sampling locations are given in Figure 3-2.

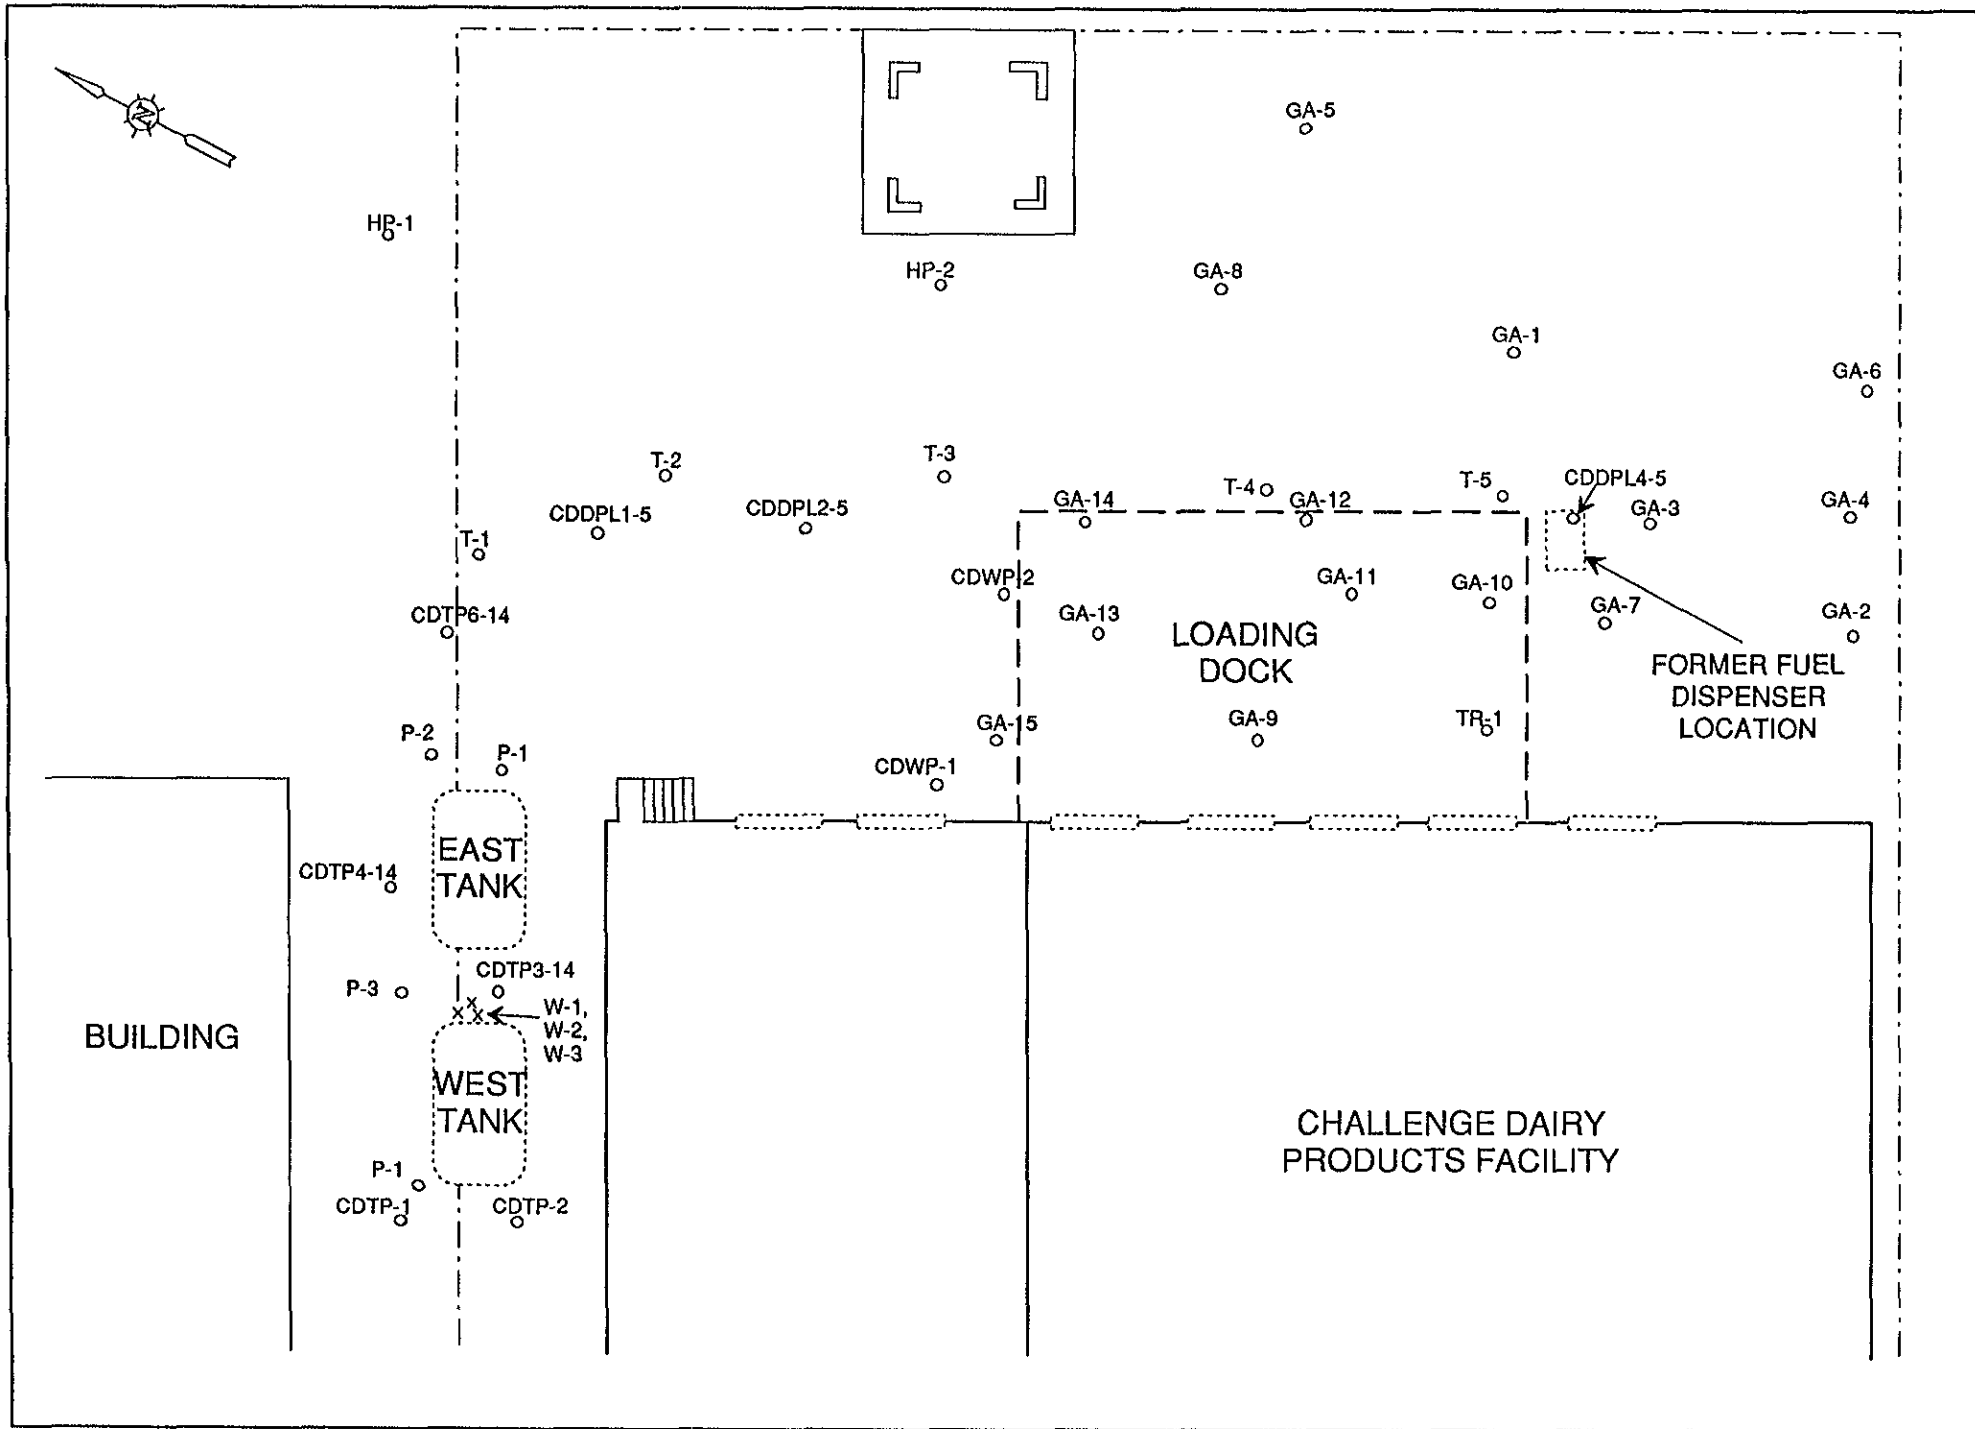
Figure 4-1: Sample Locations at Challenge Dairy Facility

The analysis results for the four phases of the sampling program are presented in this section. The majority of the sample collection and analyses at the site were associated with Phase Two and Phase Three. Figure 4-1 presents all of the sampling locations at the Challenge Dairy Facility.

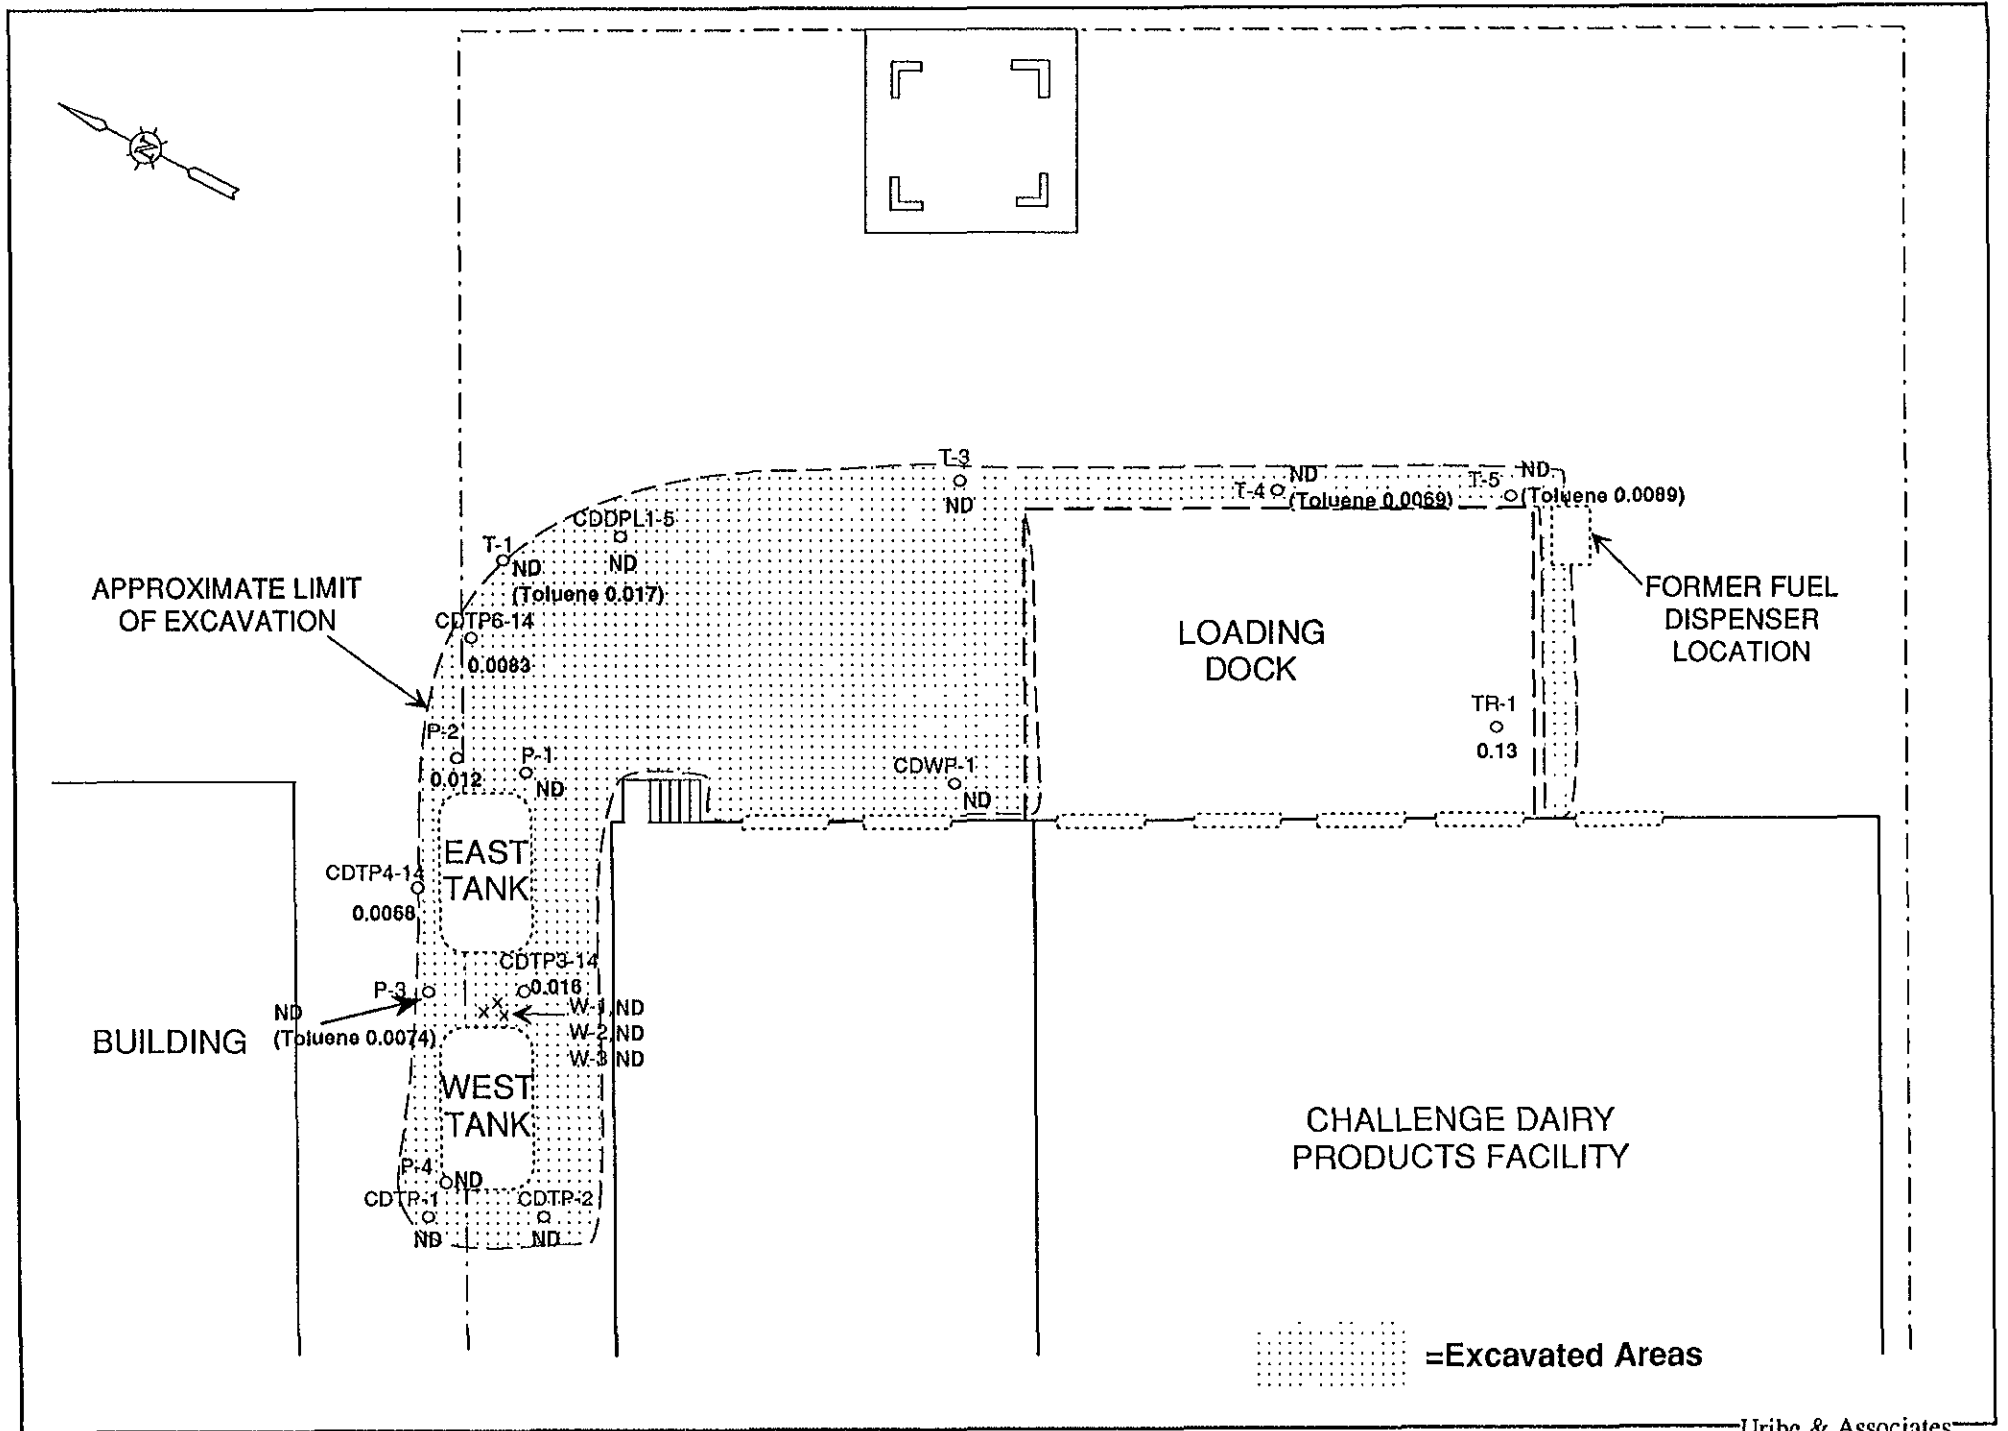
Figure 4.3-B: Benzene Levels (Method 8020) in Excavated Areas (ppm)

Results from EPA Method 8015 can be referred to as TPH as Diesel or TPH as Gasoline, depending on whether the analyses are quantified against diesel or gasoline standards. Detected TPH that are quantified by these standards contain hydrocarbons that are constituents of diesel or gasoline. The results of the EPA Method 8015, TPH as diesel, analyses are summarized in Figure 4.3-A. The results of the EPA Method 8020 analyses for benzene are summarized in Figure 4.3-B.
