ENVIRONMENTAL RISK ASSESSMENT
THE HARBOR TUG AND BARGE COMPANY
GRAND STREET FUEL TERMINAL
ALAMEDA, CALIFORNIA

Versar Job No. 6721.4

June 6, 1990

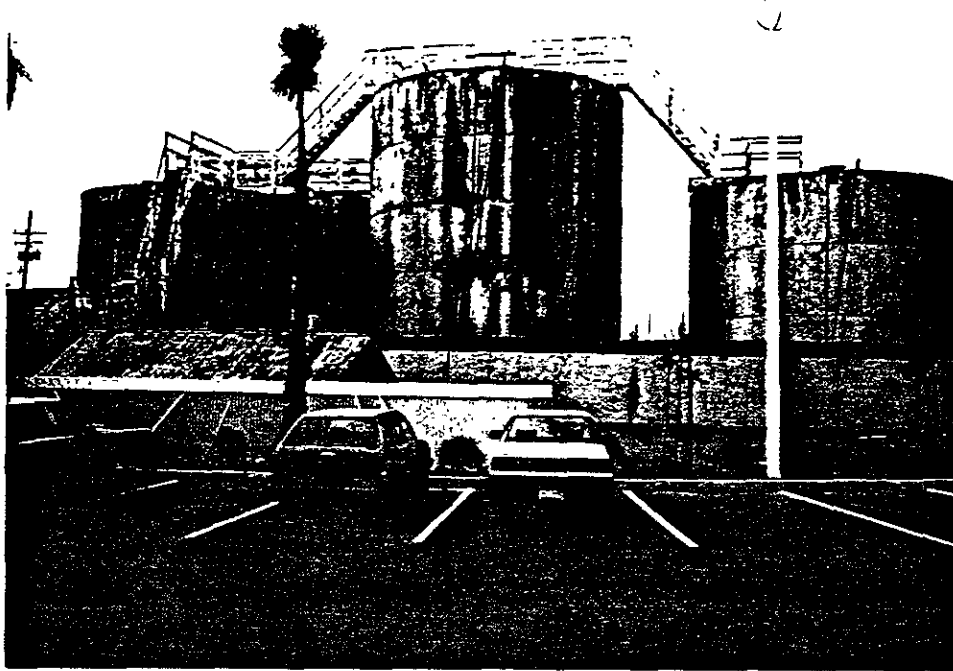
The fuel storage facility consisted of six permanent above-ground storage tanks which were previously used to store diesel fuel (see Photo 1, Appendix A). Two of the permanent tanks are approximately 22 feet in diameter and 25-feet high, three permanent tanks are approximately 10 feet in diameter and 27-feet high, and one permanent tank is approximately 22 feet in diameter and 35-feet high. A seventh tank which is a horizontal, skid-mounted tank was previously used to store lube oil. An additional skid-mounted tank, used to store slop oil and bilge water from vessels, was previously located on site, but was no longer present at the time of the site inspection. The tanks are

Photograph 1. Fuel Storage Facility
