SITE: FORMER MOBIL STATION 04-H6J  
1024 MAIN STREET  
PLEASANTON, CALIFORNIA

RE: REQUEST FOR REIMBURSEMENT OF WELL REPAIR COSTS

**04-H6J - 1024 Main Street, Pleasanton:  
WELL BOX REPAIRS**

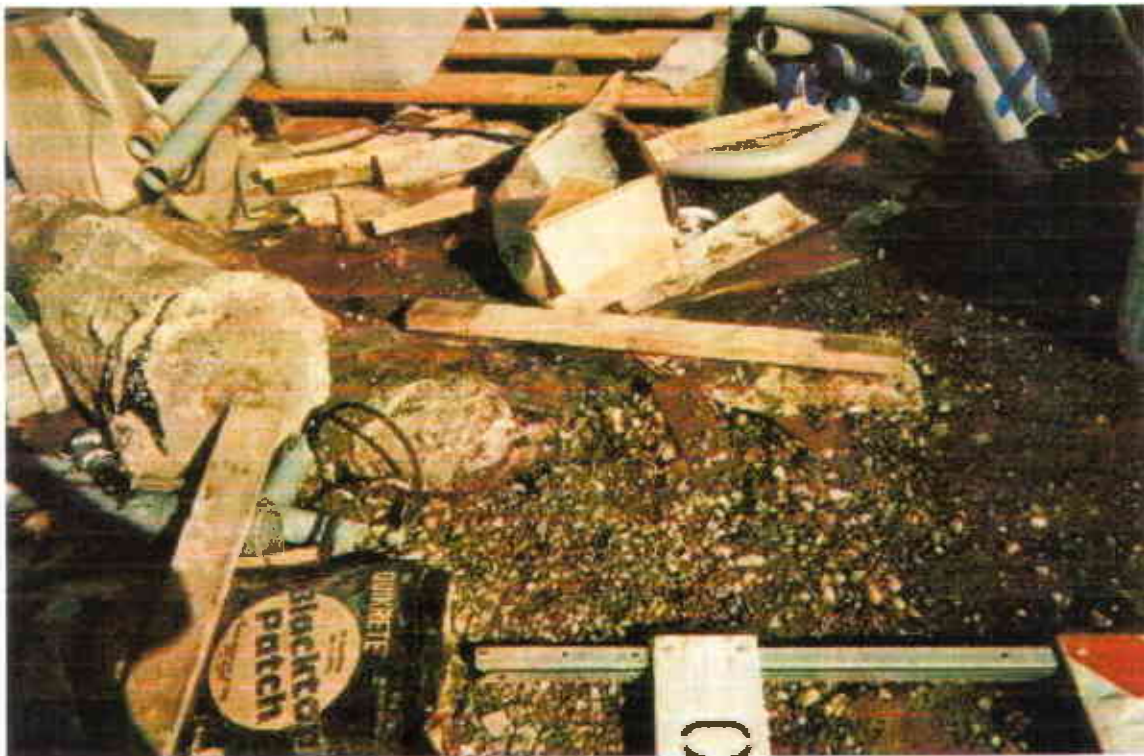
MW-5

- Well MW-5. The well cover bolts are sheared off at the surface. The sheared bolts need to be drilled out and new bolts installed.
- Well MW-3. The well cover and well-box is broken. The well-box must be removed and replaced.
