**Subject: Phase One Tunnel Remediation Investigation and Phase Two Work Plan,
Intake and Discharge Tunnels, Former Seabreeze Yacht Center, Oakland**

Phase One Tunnel Remediation Investigation and Phase Two Work Plan

FORMER SEABREEZE YACHT CENTER
Oakland, California

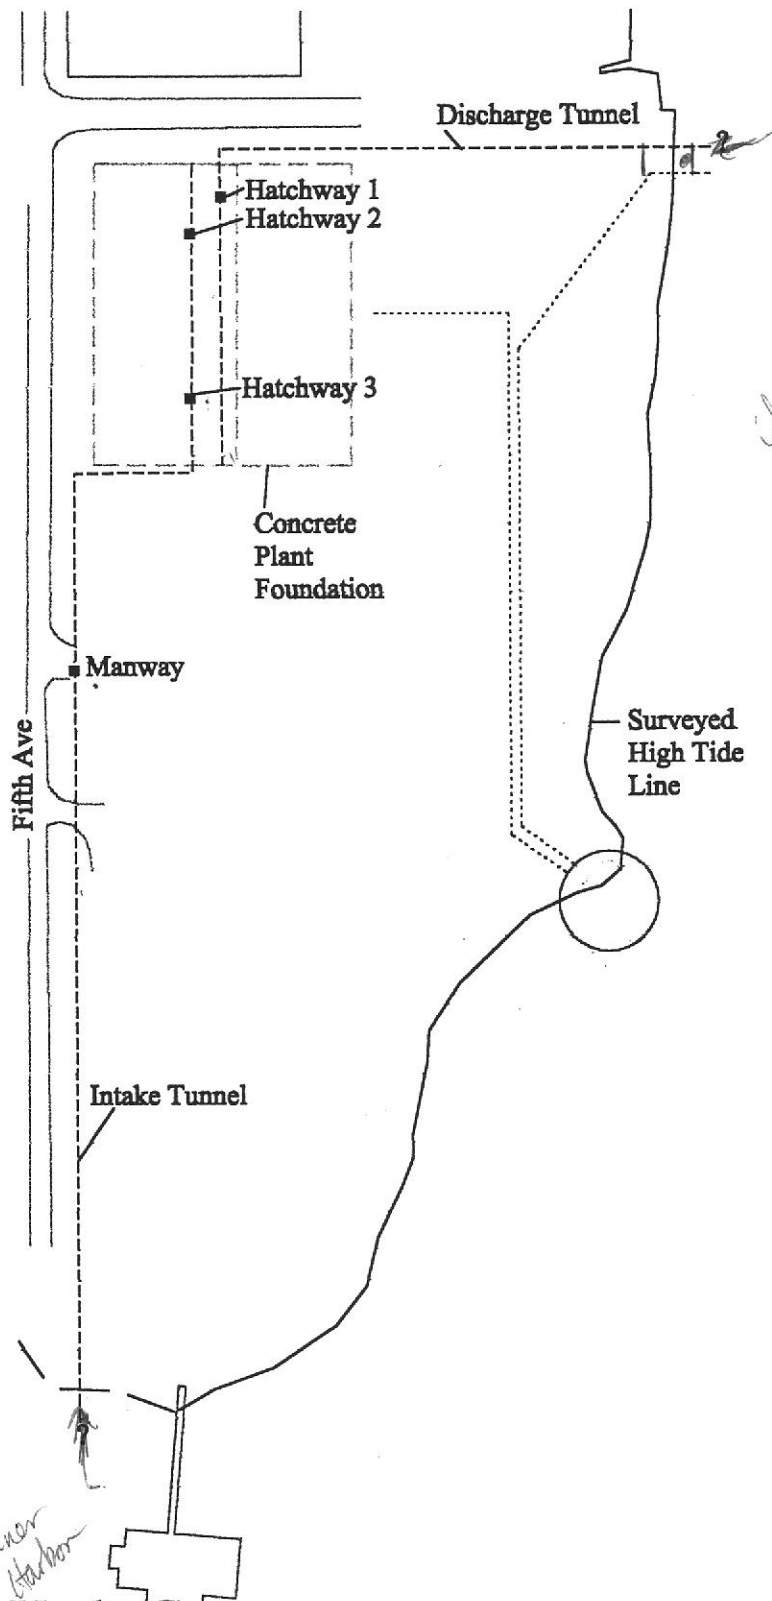
During field activities, three tunnel hatchways and one manway were located and exposed to access the tunnels; Figure 2 shows the hatchways and manway locations. The approximate hatchway and manway locations were identified from past facility drawings of the former power generating plant. Past drawings indicated that Hatchway 1 provided access to the discharge tunnel and Hatchways 2 and 3 and the manway were associated with the intake tunnel. A description of field activities and observations are provided below.

Hatchway 2. Available historic drawings of the former power plant identified the presence of Hatchway 2 within the footprint of the concrete plant foundation (Figure 2). During 1999 field activities, the hatchway surface was exposed at approximately two inches bgs (Figure 4). The hatchway was approximately three feet wide, six feet long, and extended to 12 feet bgs. Gravelly soil, debris (e.g., old ceramic materials possibly associated with former power generating activities), concrete rubble, and broken steel pipelines filled the inside of the hatchway; these materials were removed using a backhoe. During removal, an oily sheen was observed on the soil and debris surfaces.

Hatchway 3. Available historic drawings of the former power plant identified the presence of Hatchway 3 within the footprint of the concrete plant foundation (Figure 2). During field activities, the hatchway surface was exposed at approximately two inches bgs. The hatchway was approximately three feet wide, six feet long, and extended to approximately 13.5 feet bgs. Gravelly
