CORRECTIVE ACTION REPORT

SNK Andante Project

3992 San Pablo Avenue
Emeryville, California

August 2003

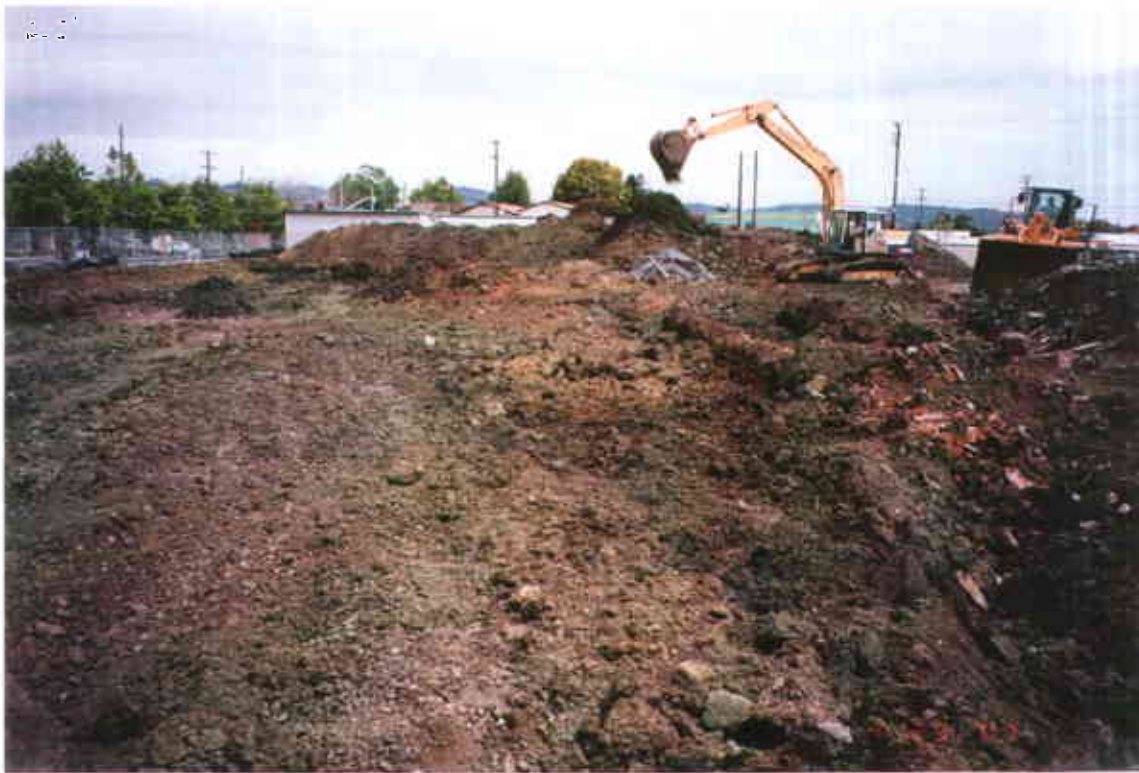
Plate 3: Clearing Clean Surficial Soil from Remediated Area
Note: Clean soil stockpile is seen in background

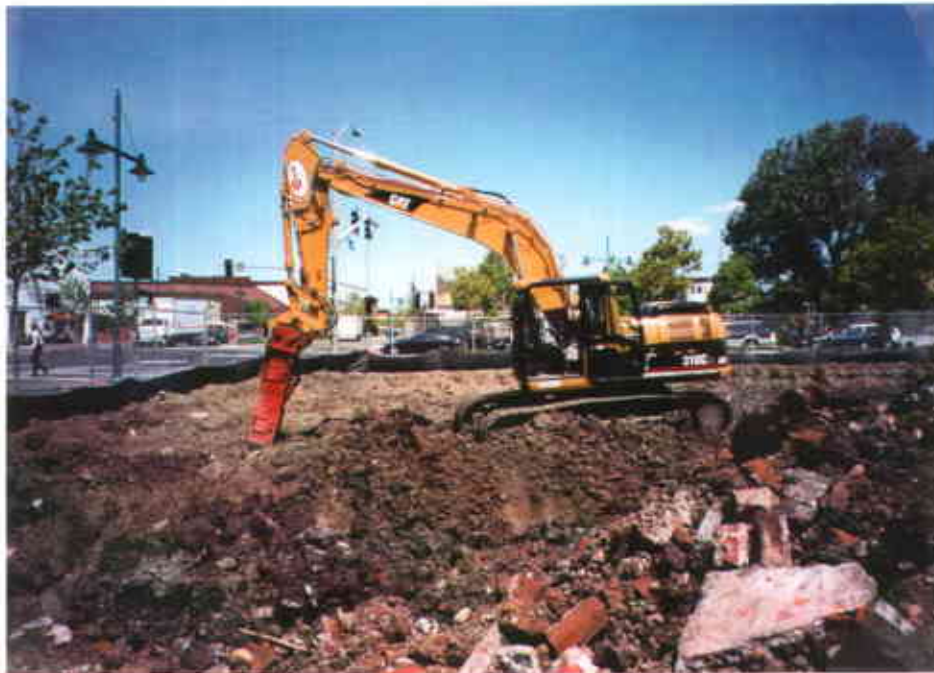
Plate 4: Hydraulic Breaker Demolishing Buried Masonry and Concrete

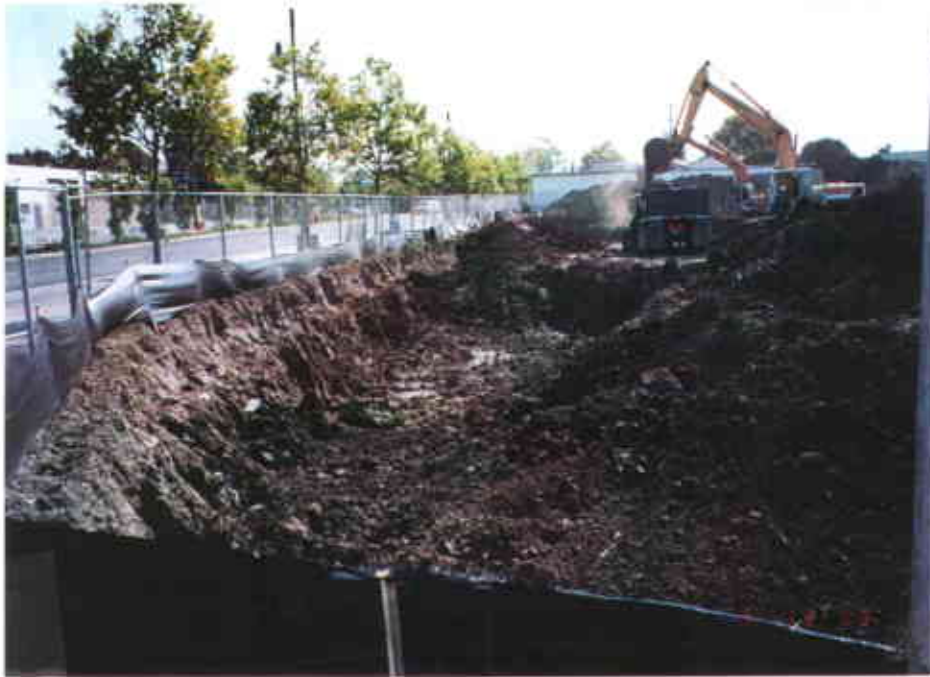
Plate 5: First Stages of Removal of Affected Soil Along 40th Street Frontage

Notes: 1) Excavator is directly loading end-dump truck for off-site transport. 2) Bench in north wall of excavation seen on left is at bottom of initial excavation made to remove clean overburden. 3) Excavation will be deepened during later stages of remediation.

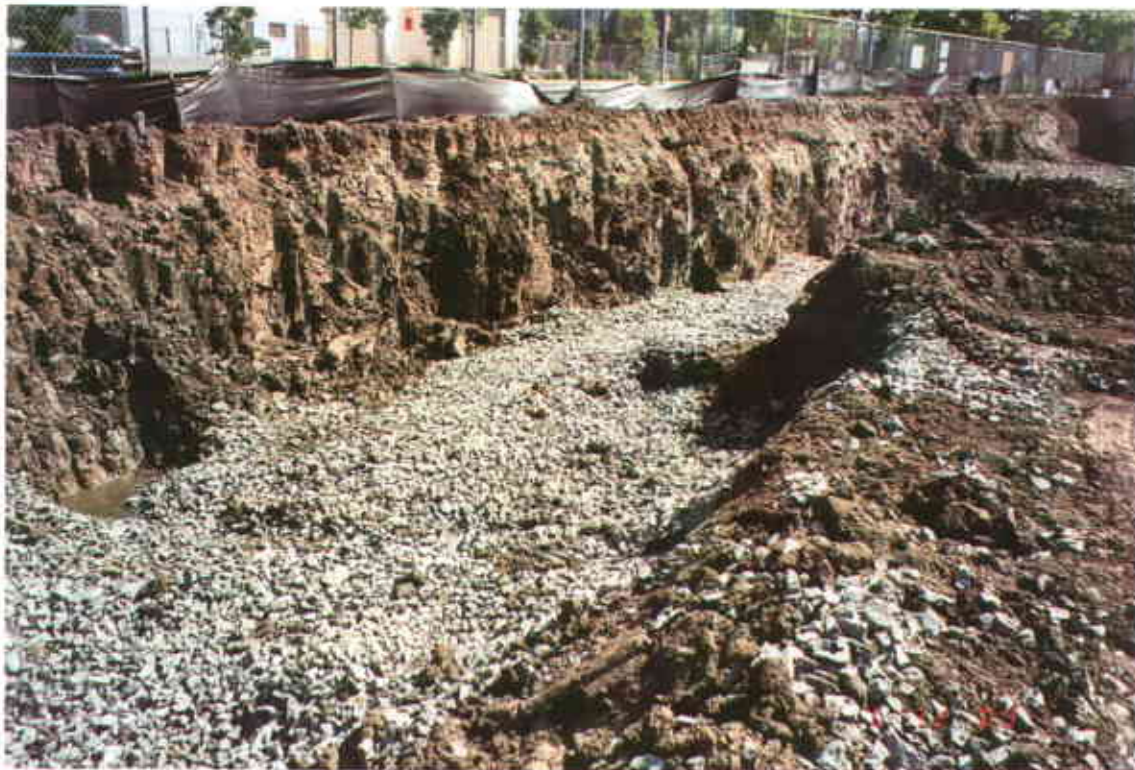
Plate 6: Northern Wall of Remedial Excavation

Note: Portion of remedial excavation below groundwater table is filled with rock backfill

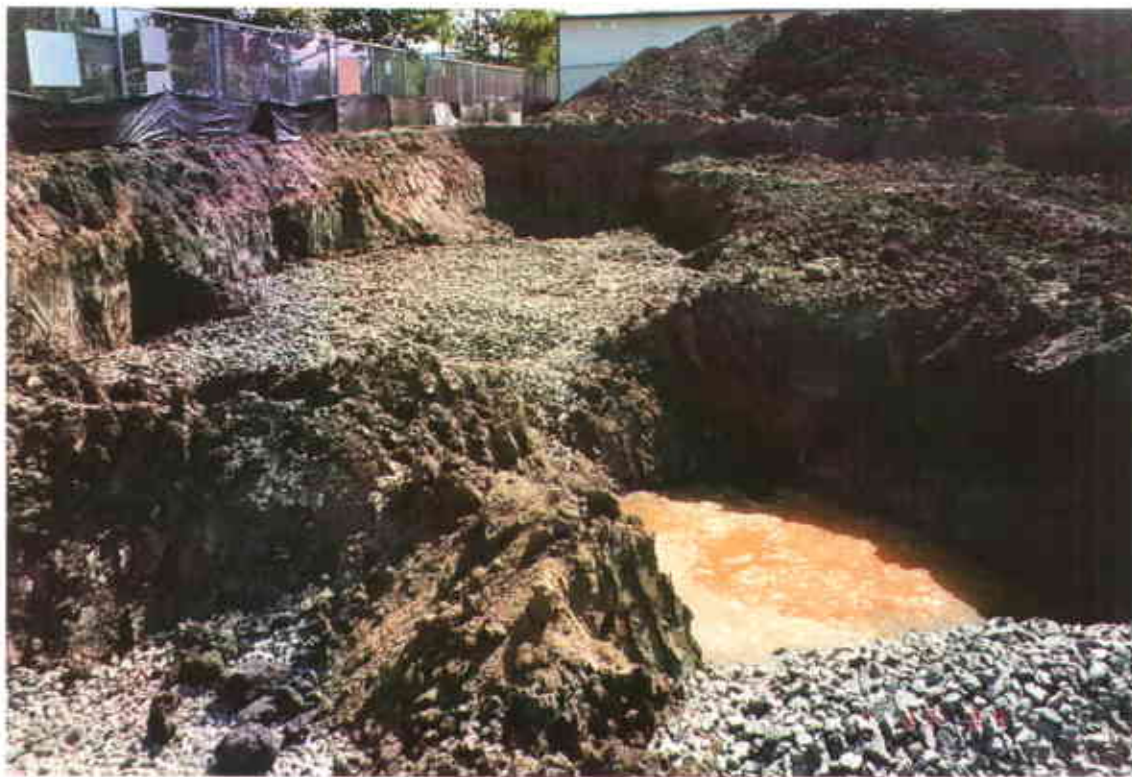
Plate 7 shows a typical open excavation cell at the 3992 San Pablo Avenue site. It extends from an area of merged cells that have already been filled with rock fill.

Plate 7: Typical Excavation Cell

Notes: 1) Rock fill in foreground will be pushed into open cell and compacted by vibration. 2) Merged cells that have been completely backfilled to provide dry standing above water table are seen in mid-field.

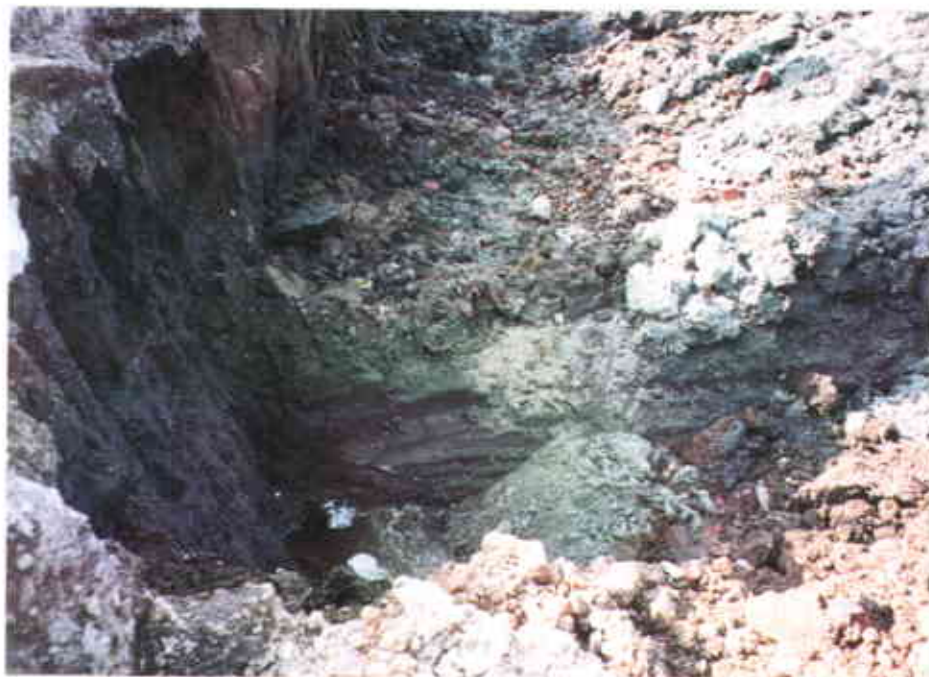
Plate 8: Streambed Deposits Exposed in Western Wall of Remedial Excavation

Note: Streambed deposits are the darker material seen on the left.

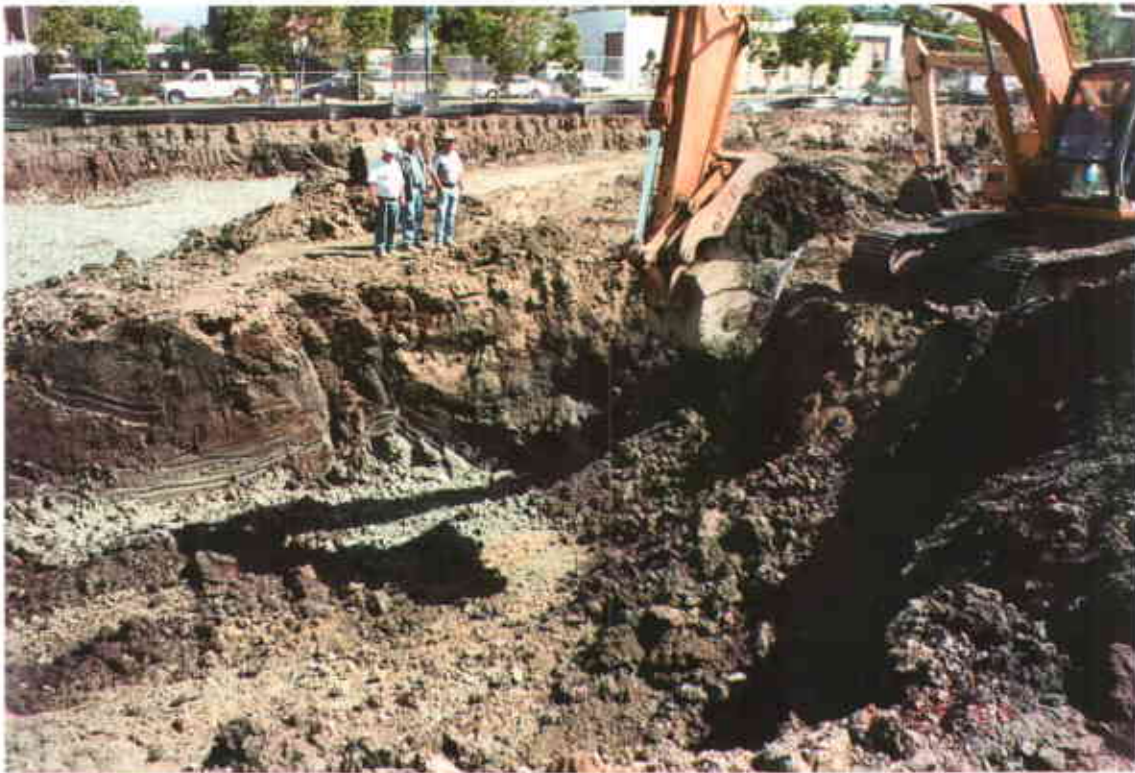
Plate 9: Excavation to Remove Paleo Streambed Deposits

Note: Affected soil in island where personnel are standing was later removed.

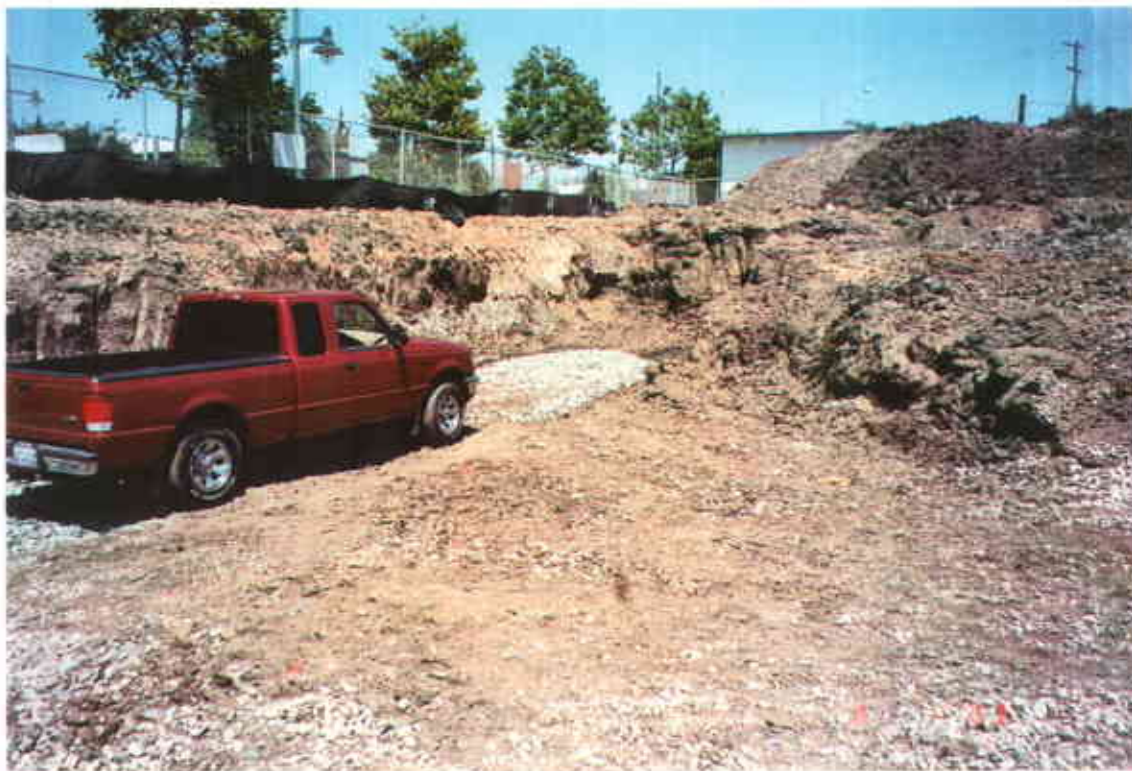
Plate 10: View of Northern End of Paleo Streambed Excavation

Note: Clay plug is beyond rock backfill in front of pickup truck.

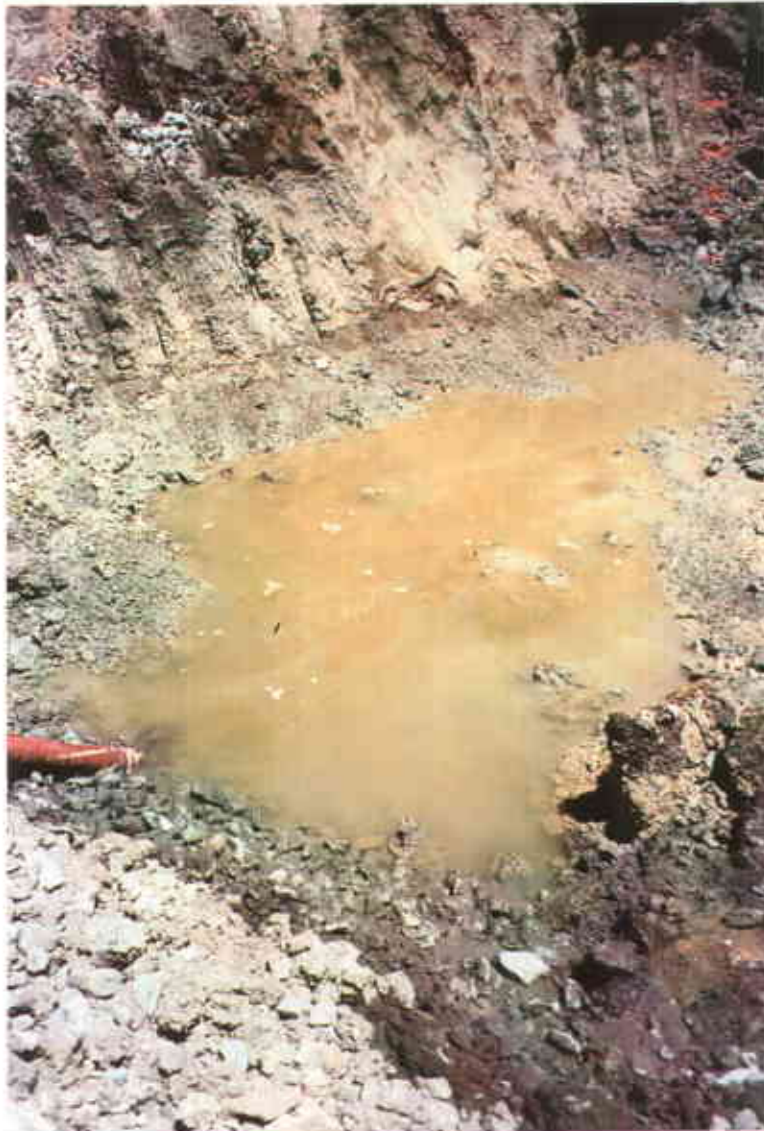
Plate 11: De-watering Paleo Streambed Excavation to Permit Placement of Clay Cap

Notes: 1) Red vacuum truck hose can be seen at left in use as a skimming device. 2) As can be seen from coloration of pit wall, a late stage of de-watering is shown. 3) Affected groundwater pumped into the vacuum truck was transported off-site to a permitted disposal facility.

Because the coarse sand and gravel deposits in the streambed were unusually deep at the point where the stream had crossed onto the site from what is today the 40th Street right-of-way, it was necessary to dewater that area before the clay plug could be placed. This was achieved by suctioning water from a temporary coffer dam constructed from the local clays into a vacuum truck. To ensure that most contaminated water contained in the pit being dewatered was evacuated and to prevent any LNAPL that may have been present in a scum of windblown soil and hydrocarbon sheen that formed on its surface from settling onto the bottom of the dewatered pit, this dewatering was performed by maintaining the vacuum truck suction pipe at all times at, or close to, the surface of the water. This operation is shown in Plate 11. Although this procedure reduces the pumping efficiency of the vacuum truck, it ensures that scum and water affected by high concentrations of fuel hydrocarbons does not settle on the bottom of the dewatered pit.

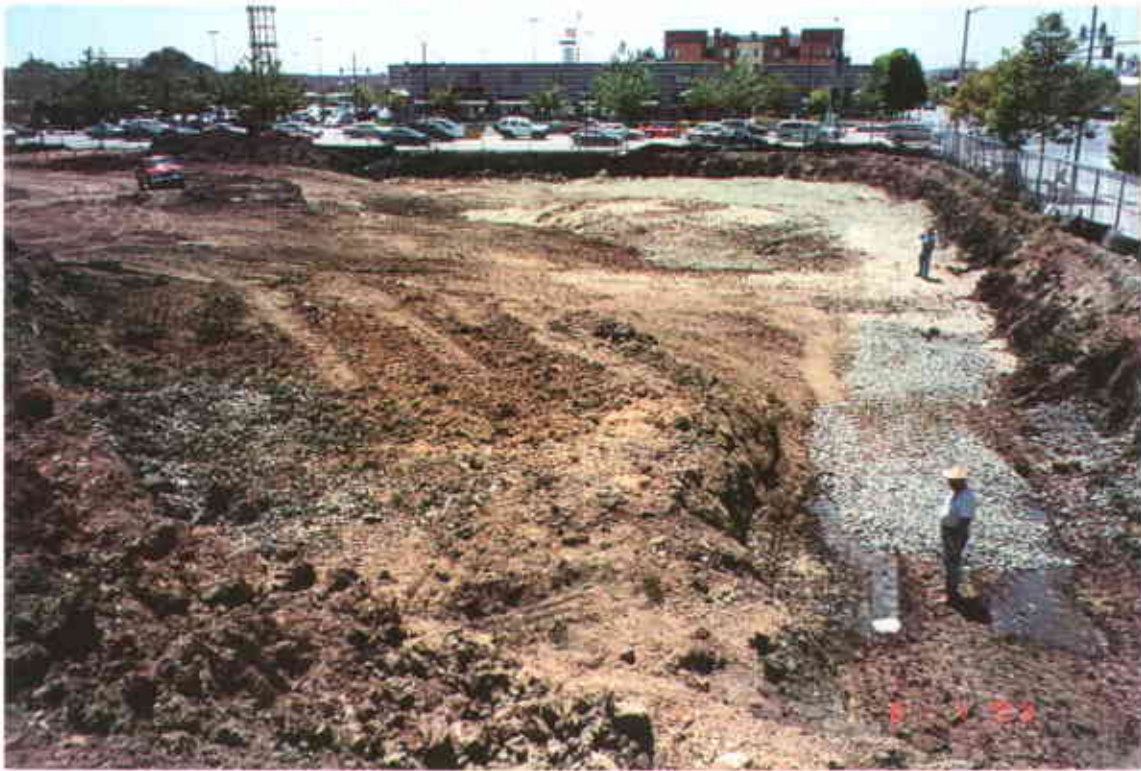
Views of the completed excavation showing portions that were partially backfilled with rock fill because, at the time they were excavated, they were submerged beneath the water table can be seen in Plates 13 and 14.

Plate 13: The Remedial Excavation Viewed from the East
Note: Gravel fill is located in areas where excavation extended below the water table.

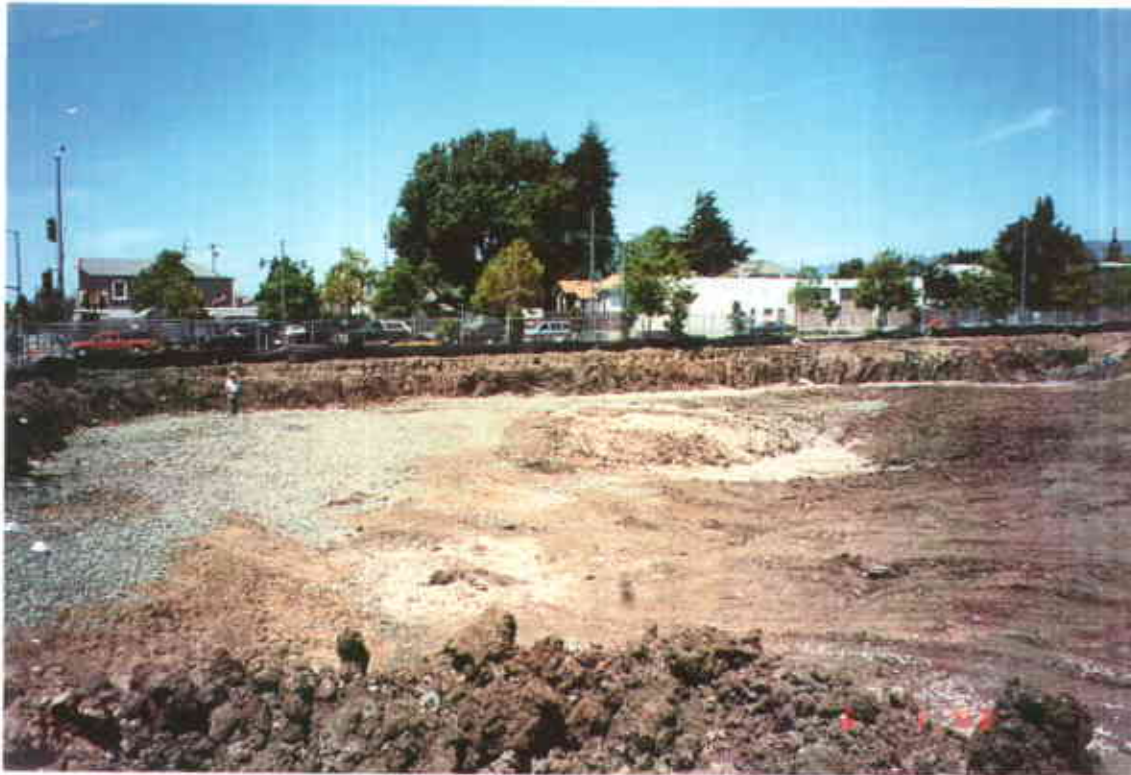
Plate 14: The Remedial Excavation Viewed from the South

Note: Gravel fill is located in areas where excavation extended below the water table.

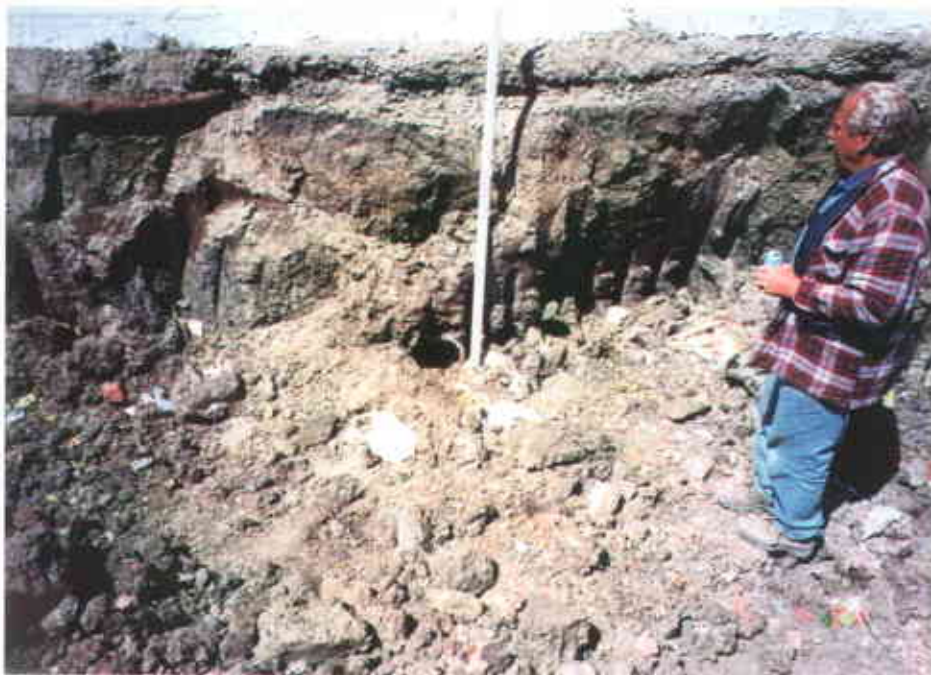
Except for a few electrical conduits found at a shallow depth along the San Pablo Avenue frontage of the site, which were well above the high groundwater level and play no role in contaminant transport, only one utility was found penetrating through the walls of the remedial excavation. This was an 8-in. diameter malleable iron sewer pipe. This pipe appears to have served the warehouse that was formerly located on the property and that is shown on the Sanborn Fire Map from 1951 (see Appendix I-A). The pipe, which crossed the property boundary at a point 95 ft. south of the intersection of San Pablo Avenue and 40th Street, extended, prior to its removal, some 60 ft. in a easterly direction from the back of the sidewalk on San Pablo Avenue. Its appearance as it was exposed in the walls of the remedial excavation is shown in Plate 15.

Plate 15: Sewer Pipe in West Wall of Remedial Excavation

Note: Pipe was later plugged and, after deepening, excavation around pipe was filled with compacted impermeable clay.

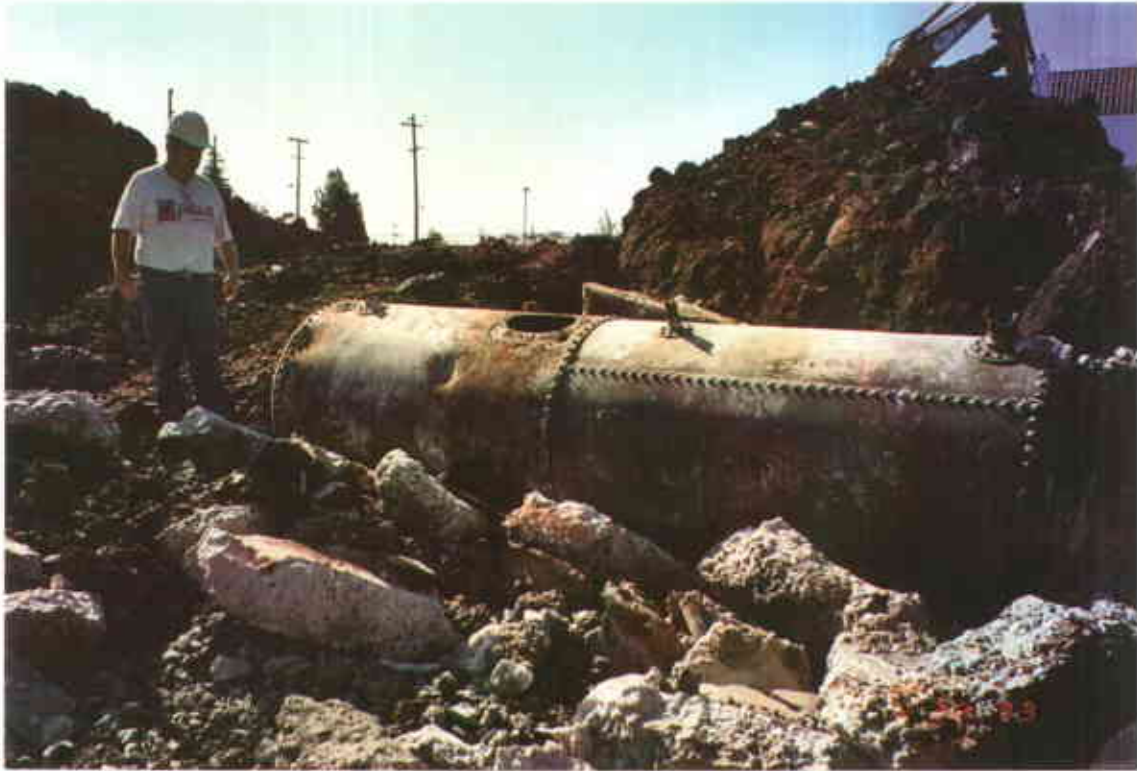
Plate 16: Tank No. 3 Shown After Concrete Casing Was Removed
Note: Obsolescent design of tank and riveted plate construction.

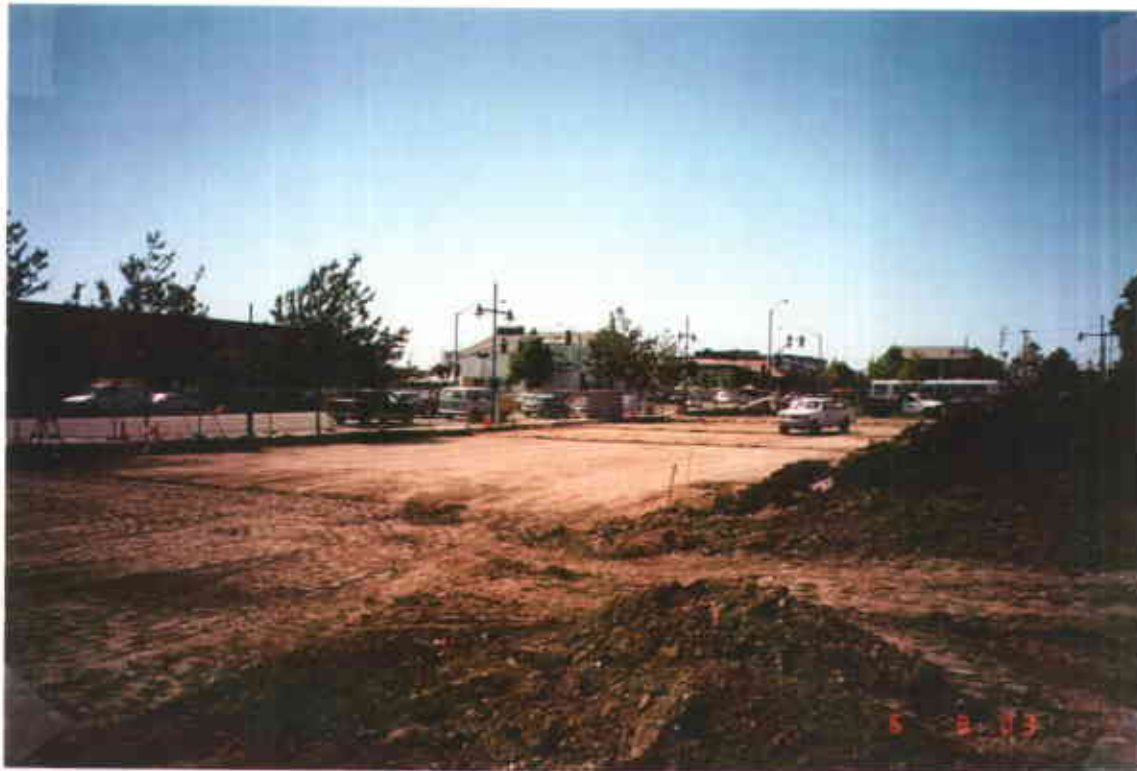
Plate 17: Western Portion of Remediation Backfilled to Grade
Note: Soil for backfilling is seen stockpiled in right of photograph.

Because the off-site disposal of affected soil removed from the northwestern area of the site generated an imbalance in the cut and fill volumes required to comply with the development project's grading plan, shallow clay soil having the same properties as the clean soil that had been stockpiled was used to bring the remediated area up to grade. The excess borrow that was required in the southern portion of the site to provide material for the engineered cap over the remediated area was restored by importation of off-site material having suitable engineering properties. In that way, the low permeability characteristics of the cap were maintained. The completed cap varied in thickness between 7 ft. and 13.5 ft., depending on the local depth of the remedial excavation. Plate 17 shows the compacted backfill in the western portion of the remediated area after it had been brought up to final grade.

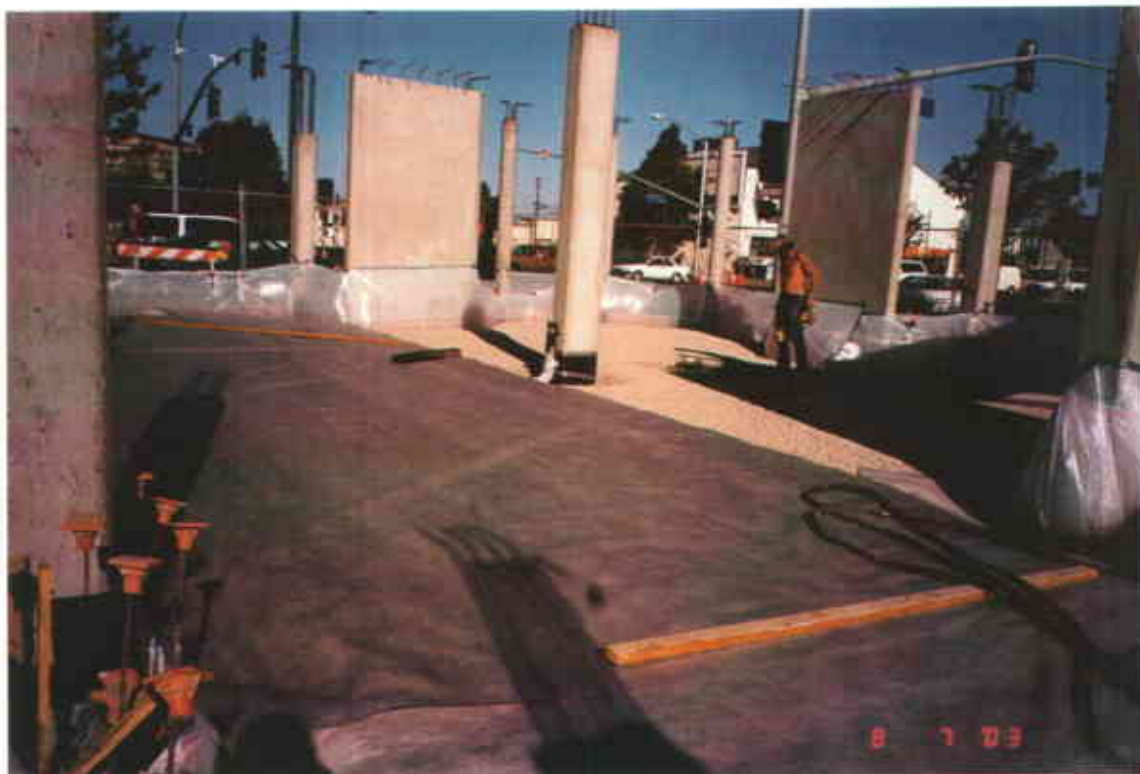
Plate 18: Geotextile Fabric Laid Down to Receive Liquid Boot[®] Membrane

around each utility pipe or other penetration passing through the floor slabs, all of which were installed prior to its application. That application technique ensures that the membrane formed a complete seal against ingress of vapors or gases into the buildings' interior spaces. Plate 18 shows the geotextile fabric which served as a substrate for the membrane. Plate 19 shows the Liquid Boot® being applied prior to the pouring of the concrete floor slab of Building 1. Plate 20 shows a typical membrane seal around a utility duct that passes through the floor slab.

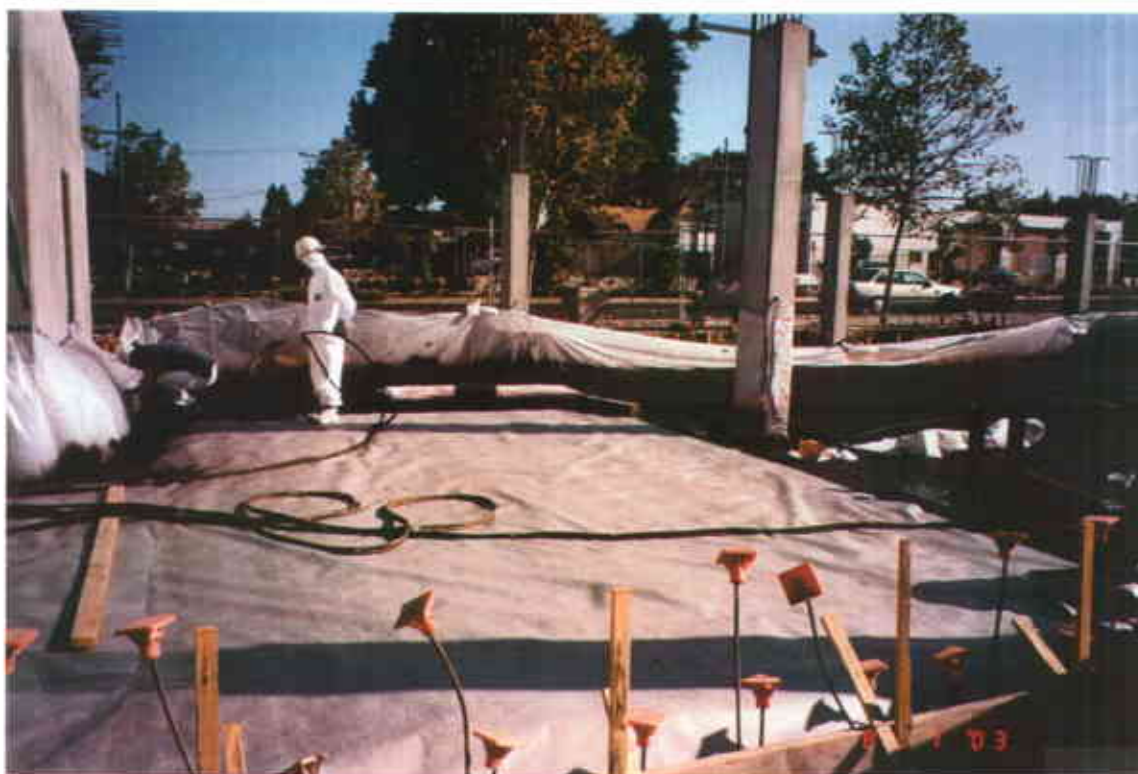
Plate 19: Application of Liquid Boot[®] Membrane

Note: Application of membrane has been completed in bay on the right of the photograph.

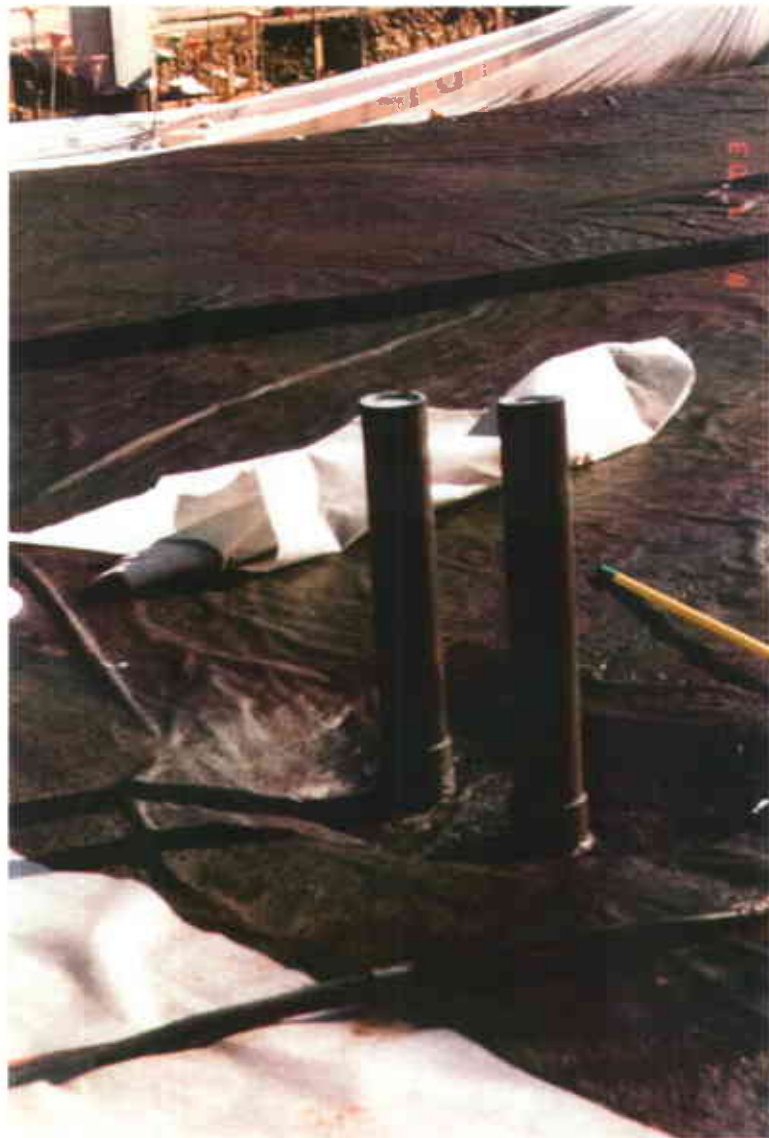
Plate 20: Membrane Seal Around Utility Duct Passing Through Floor Slab of Building 1
