## ENVIRONMENTAL SITE CHARACTERIZATION

Oak Walk Redevelopment Site  
Emeryville, California

April 2005

Project No.: 0004.083

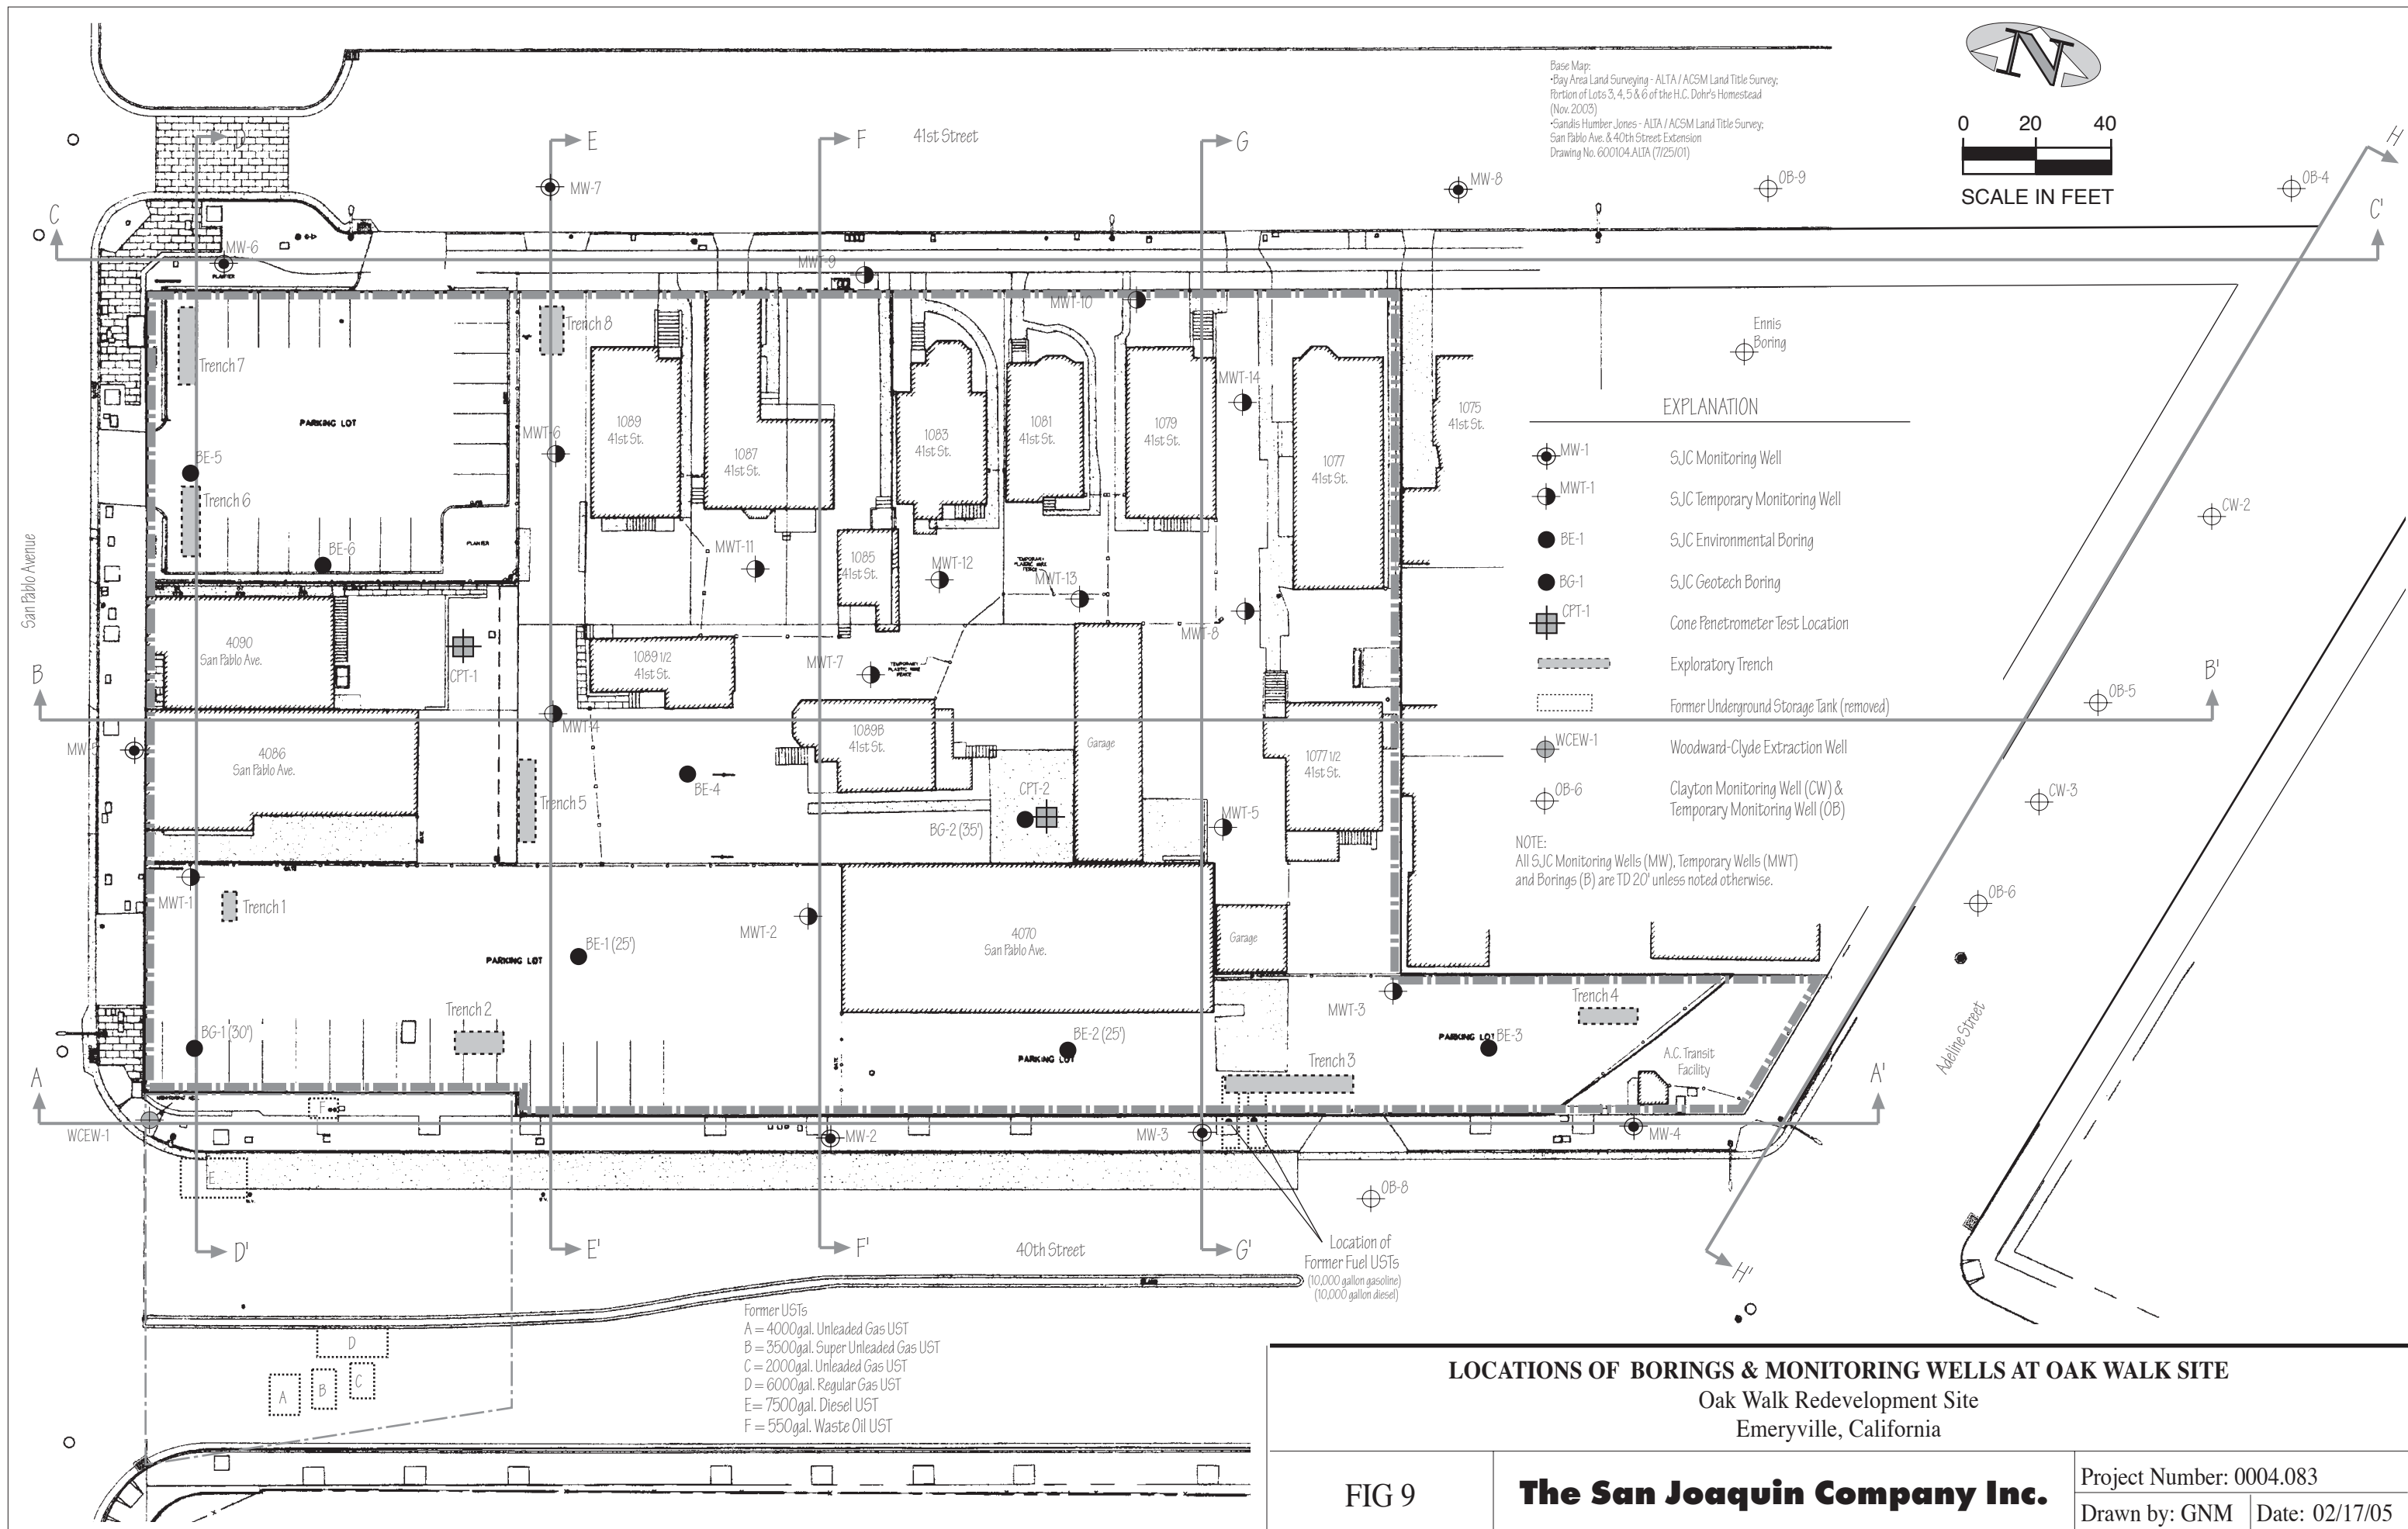
FIG 9

The borings drilled for the environmental and geotechnical investigations were used as common sources of information about the sedimentary geology of the subject site and to provide for the recovery of samples for both environmental engineering and geotechnical engineering purposes. In addition, the geotechnical program included two cone penetrometer tests, conducted at the locations CPT-1 and CPT-2 that are shown on Figure 9.

Information from the logs of the trenches, borings and wells drilled on the site was synthesized to develop hydrostratigraphic sections along the lines A-A', B-B', C-C', D-D', E-E', F-F', G-G' and H-H' that are located as shown on Figure 9. The sections are shown on Figures 10 through 17.

Figure 9 also shows the location of a boring drilled on the Ennis property for its owner that was used to make a visual and olfactory inspection of the environmental condition of the subsurface beneath that site. SJC understands that the boring was not logged and no samples of soil or groundwater recovered from it were analyzed. However, it is reported that soil in the boring reeked of a petroleum solvent.

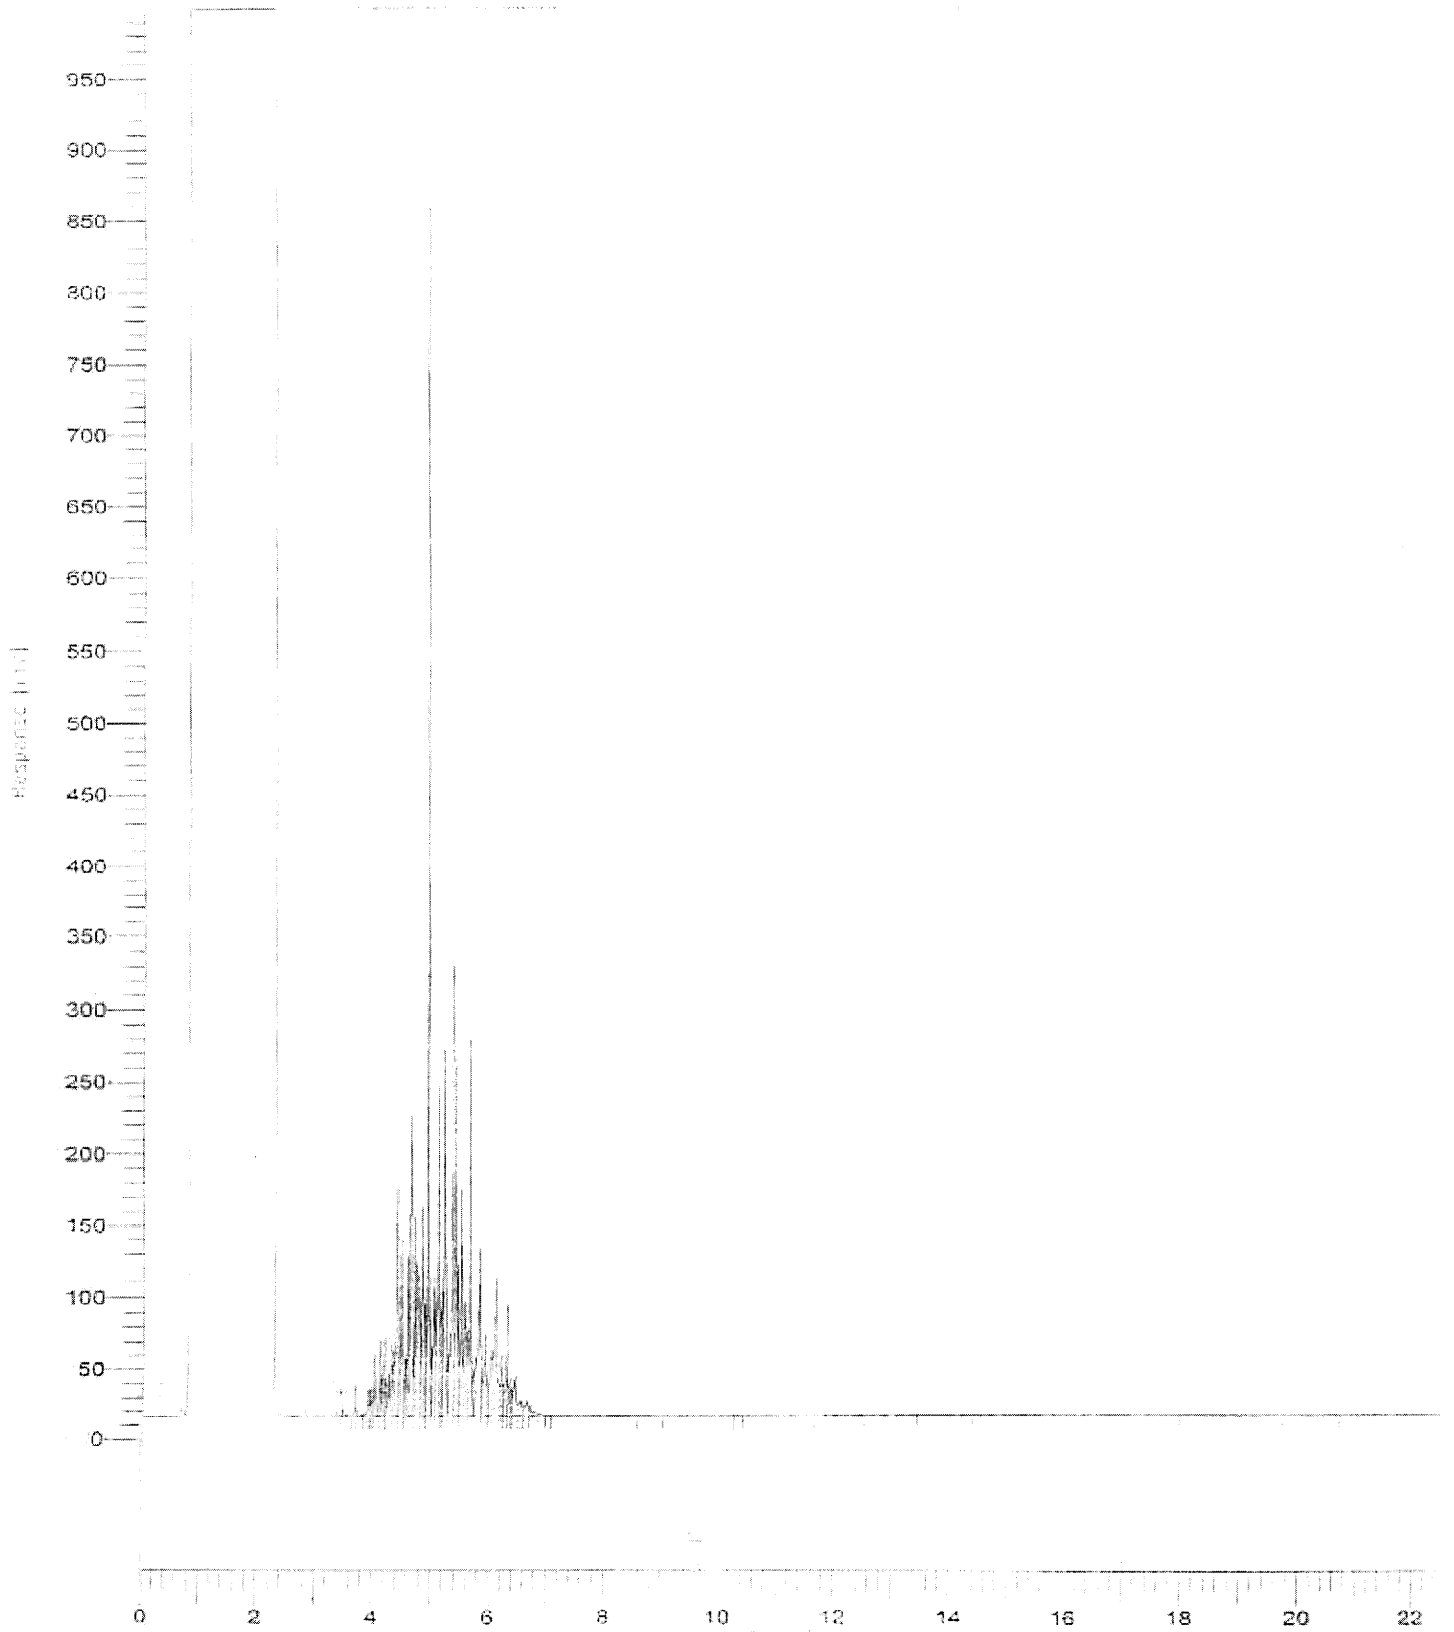
Plate 8: Laboratory Standard Chromatogram for Mineral Spirits

The chromatogram from the analysis of TEPH in sample MWT-6-10.5, when compared to the standard chromatogram for diesel that is presented on Plate 11, shows clearly that a diesel fuel product is not present. Only compounds in the approximate 3.5- to 7.0-minute range are prominent in the chromatogram from the sample, while there are no peaks in the remaining 7.0- to 12.0-minute interval where there are abundant peaks on the standard diesel fuel chromatogram. However, as the laboratory reported, the chromatogram from the analysis of sample MWT-6-10.5 for TEPH is a good match for the standard chromatogram for mineral spirits shown on Plate 8.
