**Subject:** Phase I Environmental Site Assessment Report  
1160-1168 36<sup>th</sup> Street and 3601 & 3623 Adeline Street  
Emeryville, California 94608

Phase I Environmental Site Assessment

**1160-1168 36<sup>th</sup> Street and  
3601 & 3623 Adeline Street  
Emeryville, California**

Clayton Project No. 70-03661.00  
May 28, 2003

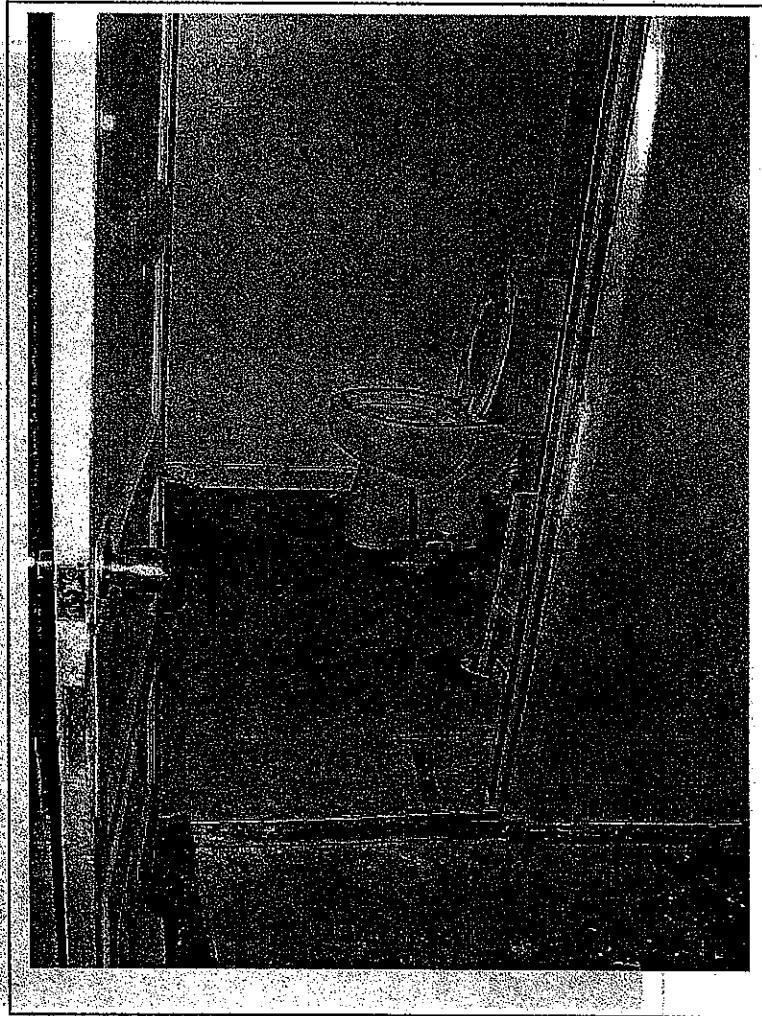
<b>Clayton Project No.</b> 70-03661.00	<b>Description</b>	View of typical restroom with resilient flooring materials	<b>15</b>
	<b>Site Name</b>	1160-1168 36 <sup>th</sup> Avenue, 3601 and 3623 Adeline Street, Emeryville, California	<b>Photo Date</b> April 17, 2003

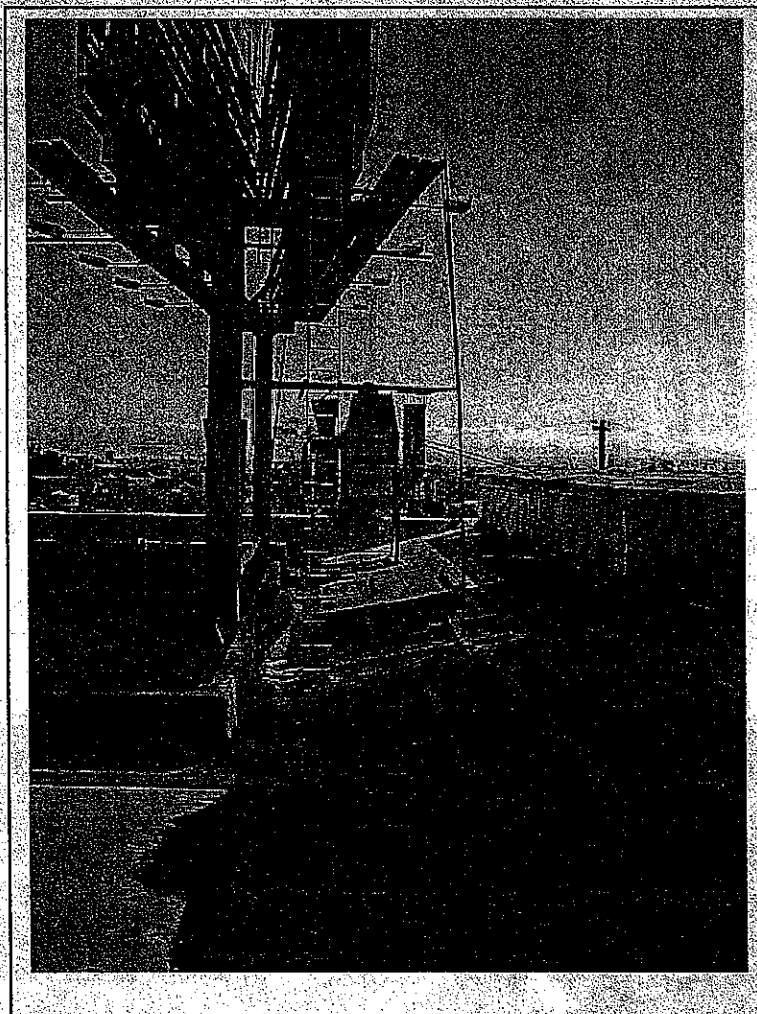
<b>Clayton Project No.</b> 70-03661.00	<b>Description</b>	View to the south of upper roof of main building with air filtering equipment and billboard	<b>22</b>  <b>Photo Date</b> April 17, 2003
	<b>Site Name</b>	1160-1168 36 <sup>th</sup> Avenue, 3601 and 3623 Adeline Street, Emeryville, California
