### Summary of Utility and Topographic Surveys 6235 College Avenue Oakland, California

September 28, 2017  
Fugro Project No. 04.72160042

### Summary of Utility and Topographic Survey Services, 6235 College Avenue, Oakland, California

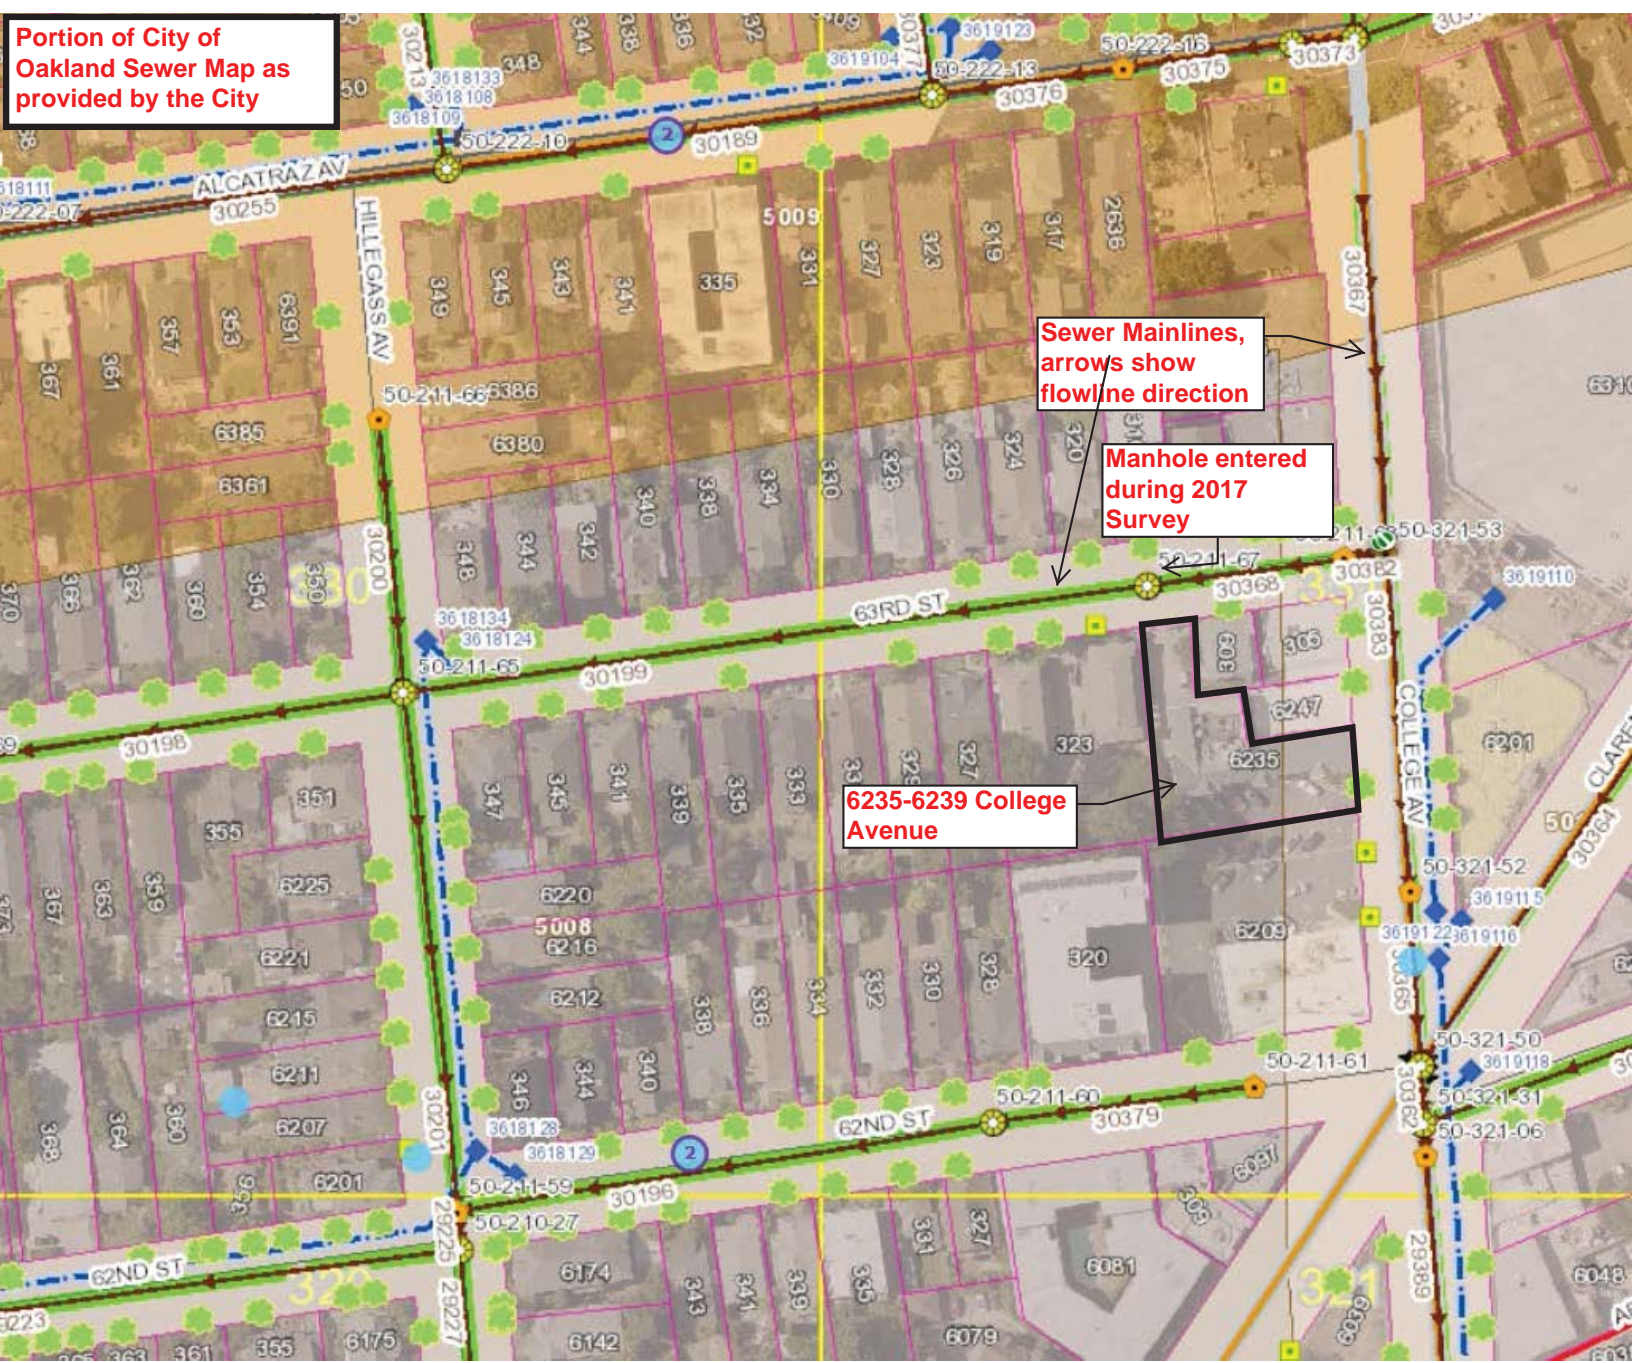
Portion of City of Oakland Sewer Map as provided by the City

Sewer Mainlines, arrows show flowline direction

Manhole entered during 2017 Survey
