Subject: Draft Phase I Environmental Site Assessment Report

DRAFT PHASE I ENVIRONMENTAL SITE ASSESSMENT

Children's Hospital and Research Center of Oakland

747 52nd Street Oakland, California

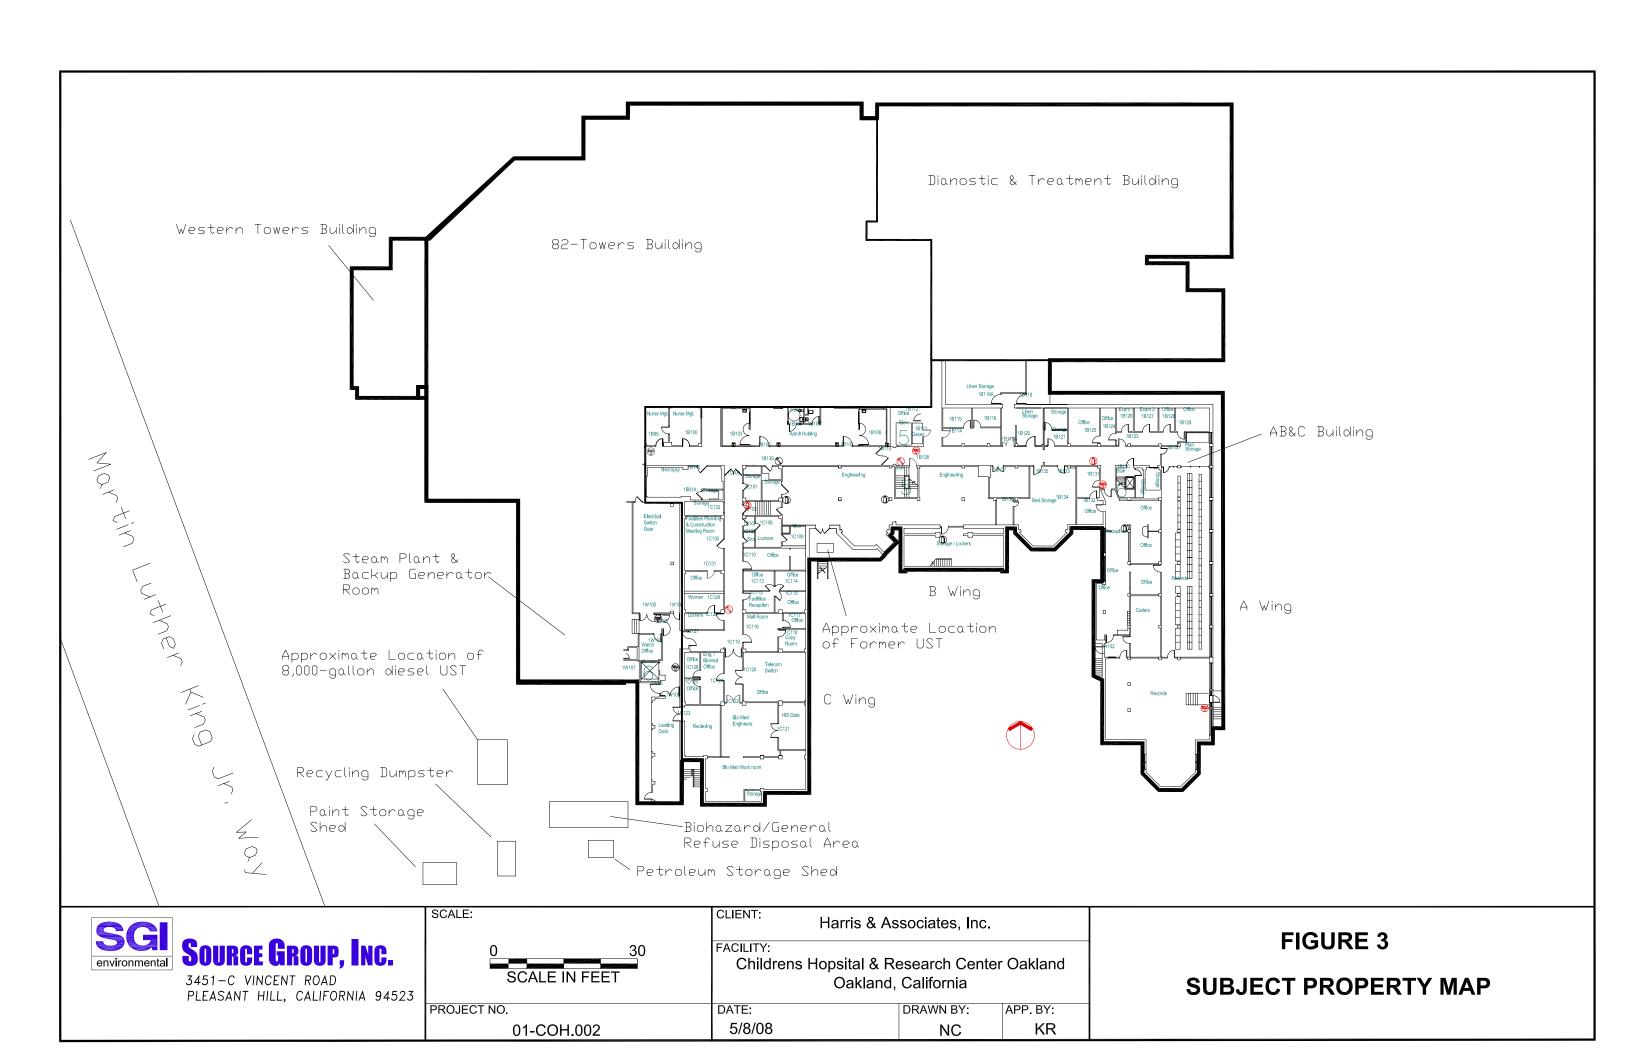
Former UST: According to CHRCO personnel (Mr. Michael Carlson) an underground storage tank (UST) was located south of the engineering building at the corner of B and C sections of the AB&C building (Figure 3). The contents of the UST are unknown and to the best of his knowledge, the UST has been removed. No further information regarding the UST was available. SGI understands that future projects may include excavation and dewatering associated with the reconstruction of hospital building wings B and C. Depending on the depth and location of future excavations and, or trenching, the potential exists to encounter soil and groundwater that has been impacted with releases associated with the former UST.

Former UST: According to CHRCO personnel (Mr. Michael Carlson) a UST was located south of the engineering building at the corner of B and C sections of the AB&C building (Figure 3). The contents of the UST are unknown and to the best of his knowledge, the UST has been removed. No further information regarding the UST was available. SGI understands that future projects may include excavation and dewatering associated with the reconstruction of hospital building wings B and C. Depending on the depth and location of future excavations and, or trenching, the potential exists to encounter soil and groundwater that has been impacted with releases associated with the former UST. Mitigation measures should be developed for worker health and safety considerations and the proper management of impacted soil and groundwater.

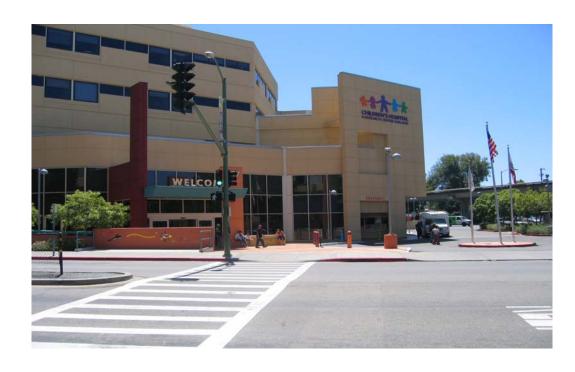
Photograph 1: View of the front of the Main Hospital Building looking south from the corner of 52nd Street and Martin Luther King Jr. Way.

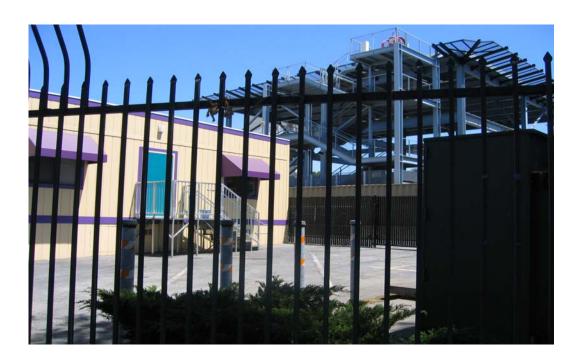
Photograph 2: View of Subject Property looking northeast from the southwest corner. Note helipad in background.

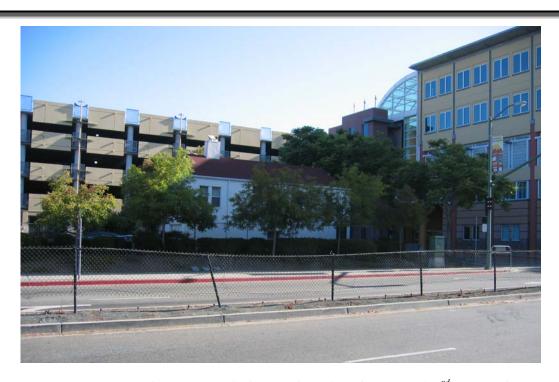
View of Subject Property looking northeast from the corner of 52nd Street and Martin Luther **Photograph 3:** King Jr. Way. Note parking garage in left background and Outpatient Care Center in right background.

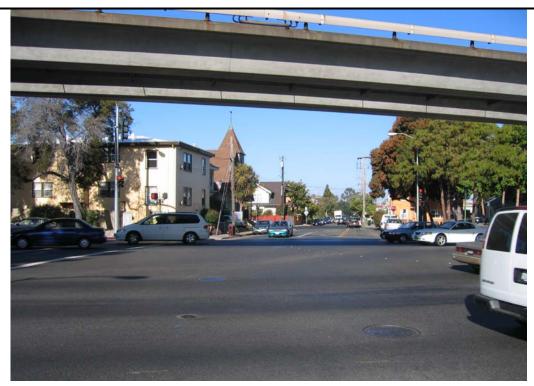
Photograph 4: View of the Subject Property looking west from the corner of 52nd Street and Martin Luther King Jr. Way. Note residential properties west of the Subject Property.

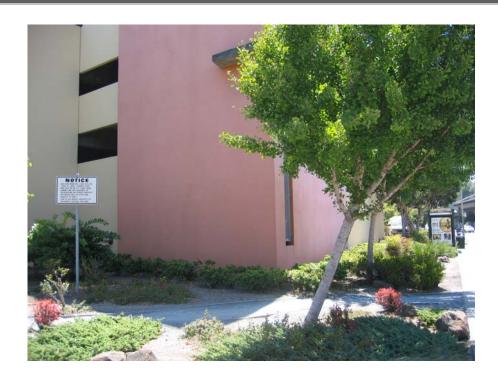
Photograph 5: View of the Subject Property looking southeast from the corner of 53rd Street and Martin Luther King Jr. Way. Note parking garage in foreground.

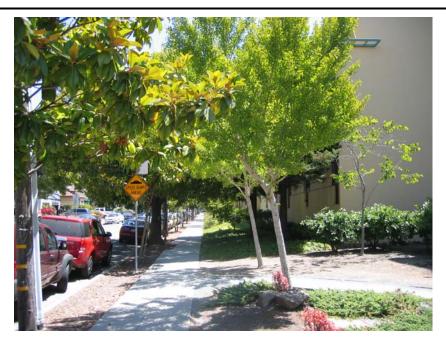
Photograph 6: View of the Subject Property looking east from the corner of 53^{rd} Street and Martin Luther King Jr. Way.

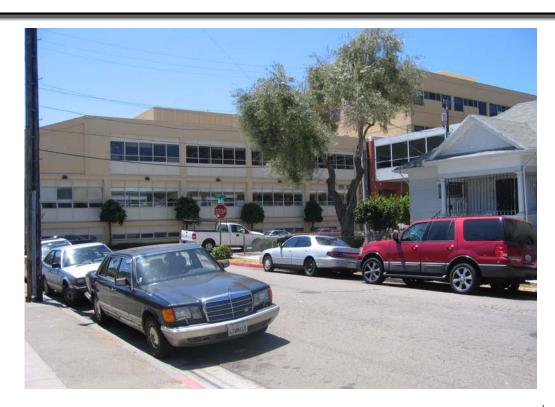
Photograph 7: View of Subject Property looking southwest from the corner of Dover Street and 53rd Street. Note D&T portion of the Main Hospital in the background.

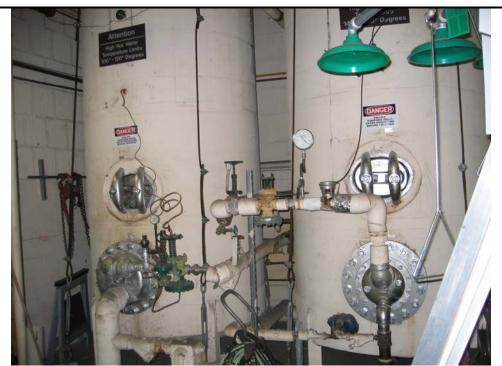
Photograph 8: View of boilers located in the engineering room.

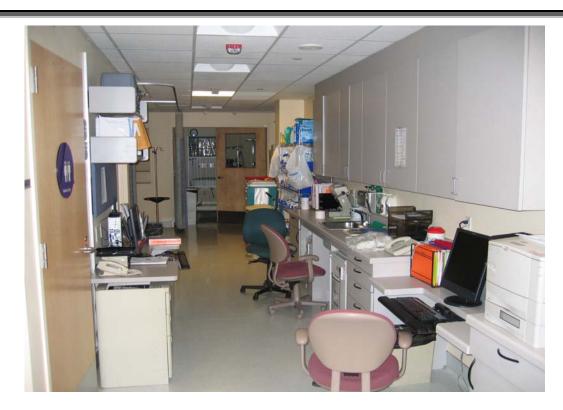
Photograph 9: View of one of the nurses' station located in the main hospital.

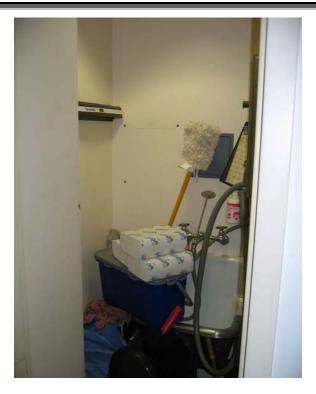
Photograph 11: View of a janitorial cleaning closet located in the main hospital.

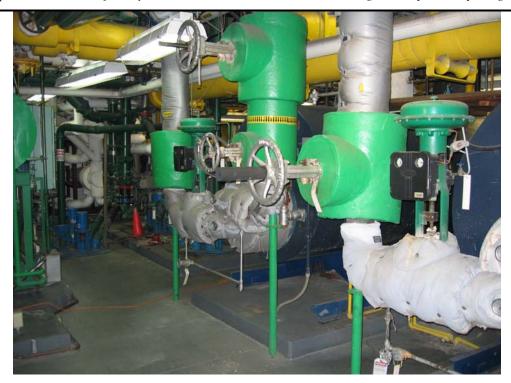
Photograph 16: View of the boilers located in the steam plant.

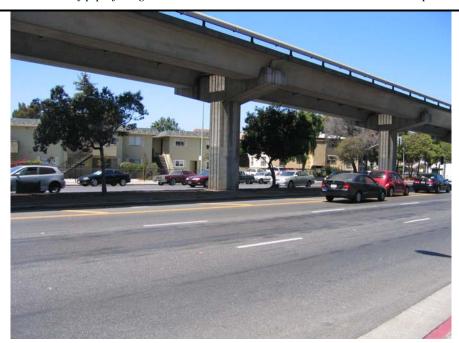
Photograph 22: View looking northwest from the southern portion of the Subject Property. Note BART transit line overhead and multi-level residential structures located in the background.

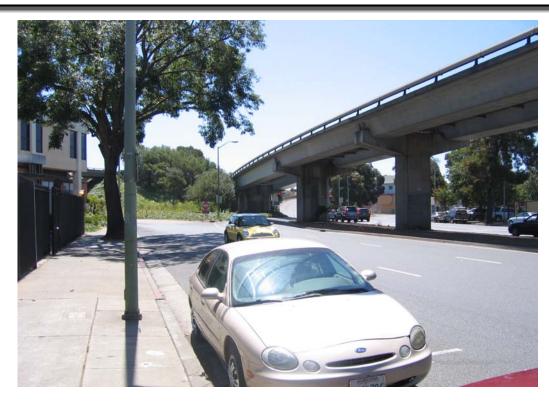
Photograph 23: View looking south from the western perimeter of the Subject Property. Note off-ramp to Highway 24.

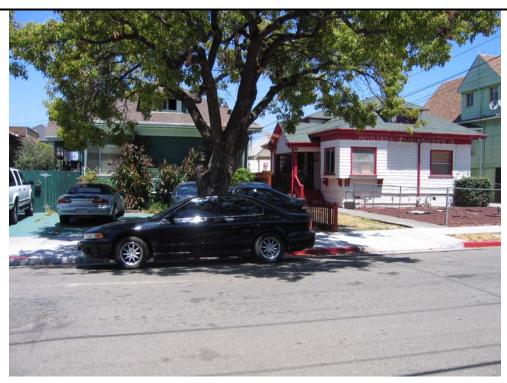
Photograph 24: View of residential homes located north of the Subject Property. View is looking north from the northern portion of the Subject Property.

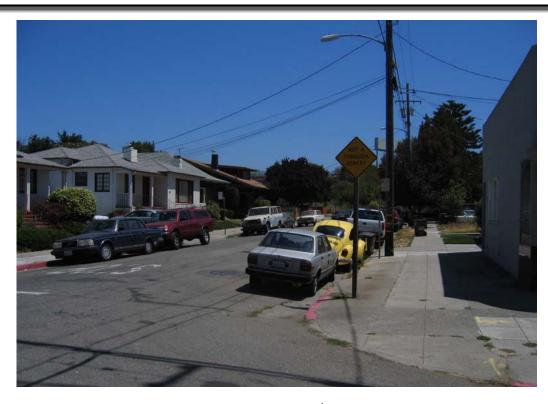
Photograph 25: View of looking east from the corner of 53rd and Dover Streets. Note residential homes in the foreground.

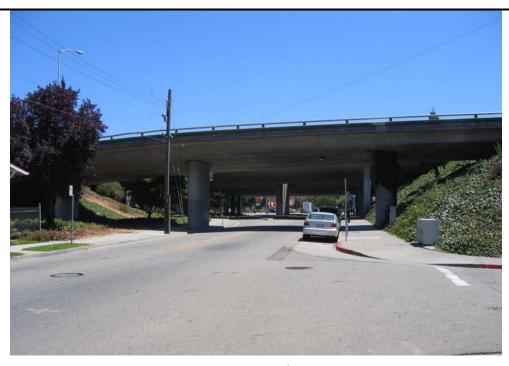
Photograph 26: View looking east from the corner of 52nd and Dover Streets. Note Highway 24 overpass in foreground.
